APPENDIX A

FACILITY ASSESSMENT PHOTO REPORTS

CITY HALL

1.0 Site Assessment

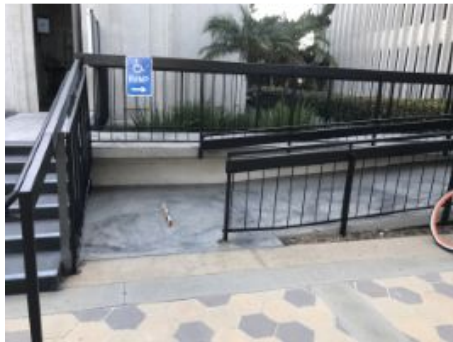
Deficiency: Ramps - Landings - Slope

Slopes exceeding the maximum 1:48 in any direction on the landing.

Recommended Remediation:

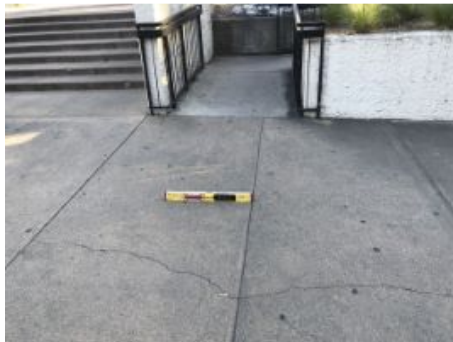
Deficiency: Accessible Route - Slopes - Cross Slope

The cross slope of accessible routes exceeds 1:48 (2.0 %). 2.5% to 3.0% slope measured at turn in accessible route from the accessible parking stalls to the ramp at the parking lot.

Recommended Remediation:

Remove and replace walk. Install walk that provides cross slopes at circulation route of 1:48 maximum.

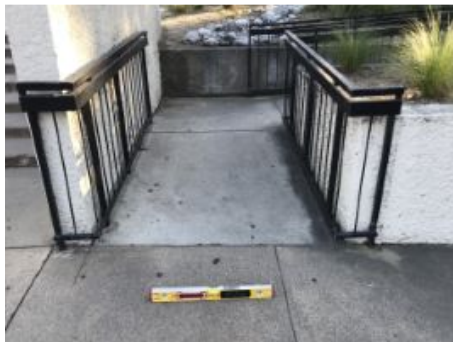
Deficiency: Ramps - Landings - Slope

Slopes exceeding the maximum 1:48 in any direction on the landing. 3.2% cross slope and 3.4% running slope measured at the bottom ramp landing. 3/4" high level change measured at the top ramp landing.

Recommended Remediation:

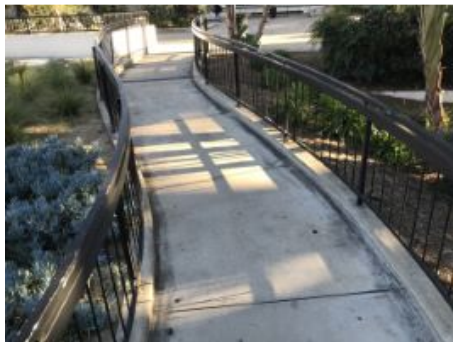
Deficiency: Ramps - Landings - Intermediate

Intermediate landings are not provided at every 30-inches in change of elevation, or fraction thereof.

Recommended Remediation:

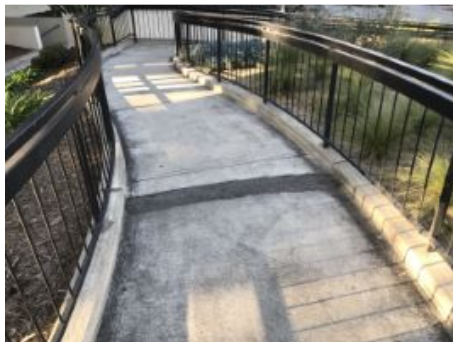
Deficiency: Ramps - Vertical Change - General

The accessible route has areas of vertical level changes on ramp run. 1" high level change measured along the top portion of the ramp.

Recommended Remediation:

The accessible route should be repaired to eliminate vertical level Changes in level other than the running slope and cross slope are not permitted on ramp runs.

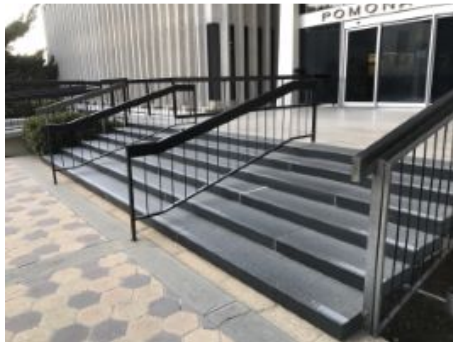
Deficiency: Stairs - Handrails - Height

Top of the handrail is not located within the height ranges of 34-inches minimum to 38-inches maximum AFF. 38-3/4" height measured to the top of the handrail extension gripping surface. Extensions are not provided at the bottom of all handrails.

Recommended Remediation:

Remove and replace handrails so the top of gripping surfaces of handrails are 34 inches minimum and 38 inches maximum vertically above walking surfaces. Handrail extensions shall be provide at top and bottom of stairs.

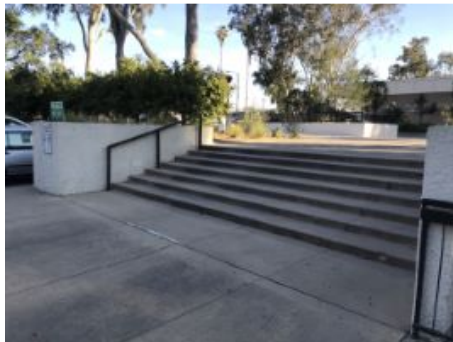
Deficiency: Stairs - Handrails - Both Sides

Handrails are not provided on both sides of the staircase. 33" height measured to the top of the handrail surface at the parking lot stairs. Extensions are not provided at the top and bottom of the handrails. 8" perimeter dimension measured at the handrails.

Recommended Remediation:

Remove and replace non-compliant handrails so they are provided on both sides of stairs and ramps. Handrail heights shall be 34-inches min. to 38-inches maximum AFF. Extensions shall provided at top and bottom of stairs, and handrail diameter needs to be compliant.

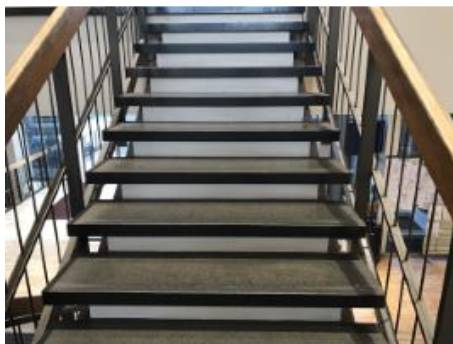
Comment #: CH-31 **Deficiency:** Stairs - Nosing - Projection

Projection of the nosing extends more than 1-1/4 inches maximum over the tread below.

Recommended Remediation:

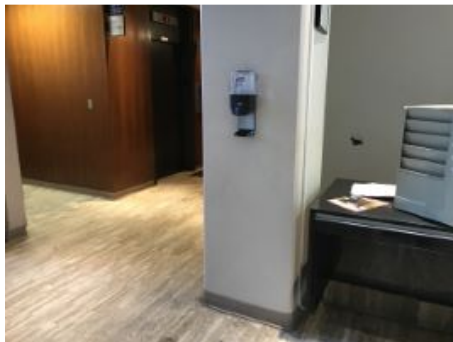
Deficiency: Accessible Route - Reach Ranges - Side Reach

Element for side reach is not located within 15-inches minimum to 48-inches maximum AFF (to to a 10-inch depth). 51" AFF measured to the antibacterial dispenser control.

Recommended Remediation:

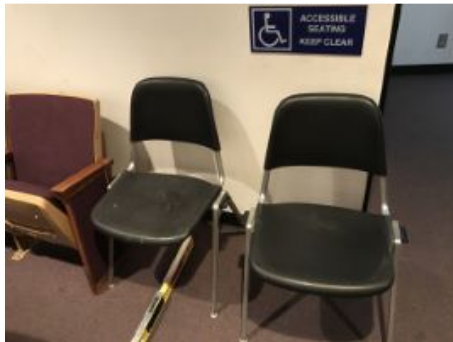
Comment #: CH-43 **Deficiency:** Assembly Areas - Wheelchair seating - Slopes

Assembly areas wheelchair spaces exceed maximum slopes of 1:48 (2.083%) or has changes in level. 3.5% to 4.4% running slope measured along the floor surface at the wheelchair spaces.

Recommended Remediation:

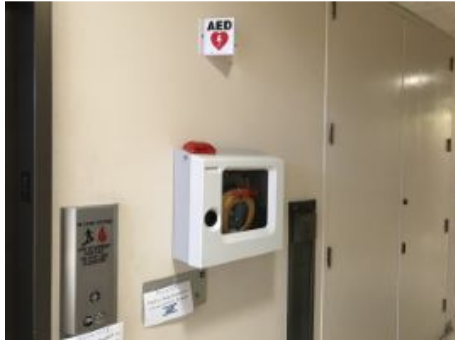
Comment #: CH-56 **Deficiency:** Accessible Route - Reach Ranges - Side Reach

Element for side reach is not located within 15-inches minimum to 48-inches maximum AFF (to to a 10-inch depth). 55" AFF reach measured to the defibrillator box control.

Recommended Remediation:

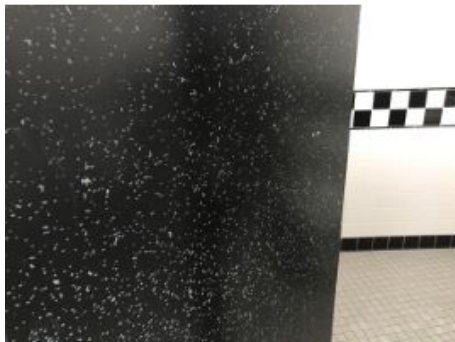
Deficiency: Accessible Toilet Stall - Door Hardware - Handle Both Sides

Pull hardware is not provided on interior sides of the accessible stall door.

Recommended Remediation:

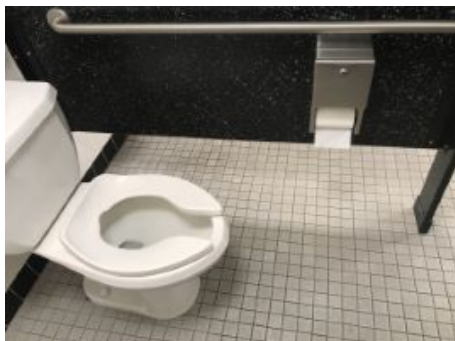
Deficiency: Accessible Toilet Stall - Dispensers - Toilet Paper Location

The toilet paper dispenser is outside of the allowable reach range. Toilet paper dispensers measured 11" to 12" in front of the water closet.

Recommended Remediation:

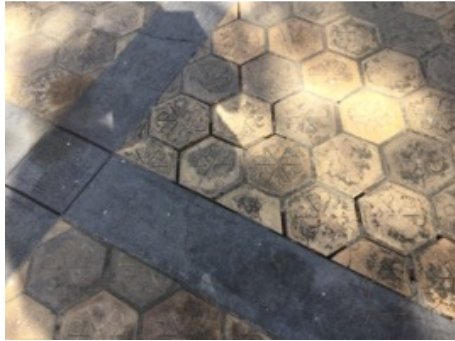
Comment #: CC-07 **Deficiency:** Accessible Route - Openings - Width

Accessible route grates / openings exceed 1/2" in the direction of travel.

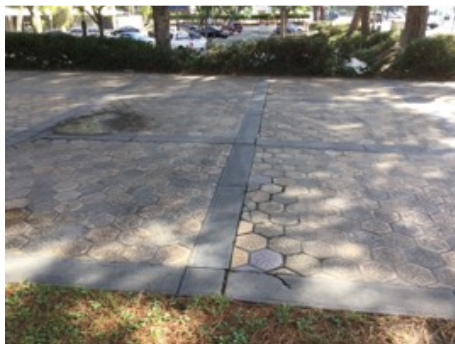
Comment #: CC-08 **Deficiency:** Accessible Route - Vertical Displacement - Height

Accessible route has multiple locations where changes in level over 1/4" vertical or 1/2" beveled occur.

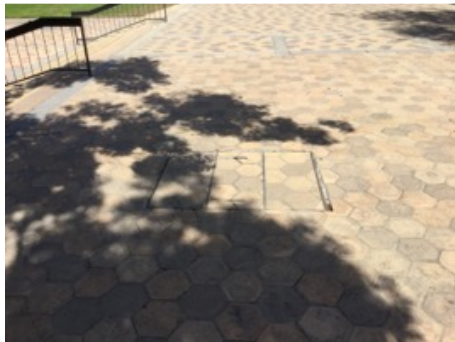
Deficiency: Accessible Route - Openings - Direction

Accessible route grates / openings exceed 1/2" in the direction of travel.

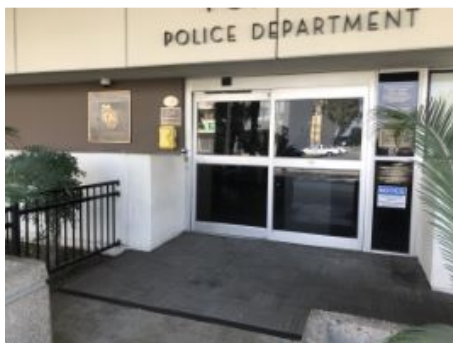
Deficiency: Accessible Route - Reach Ranges - Side Reach Obstructed

Obstructed elements is either deeper than 24" or more than 46-inches maximum AFF when deeper than 10-inches (to a maximum of 24-inches). 54" high reach measured to the emergency phone control. Phone is located over an obstruction measured 45" high.

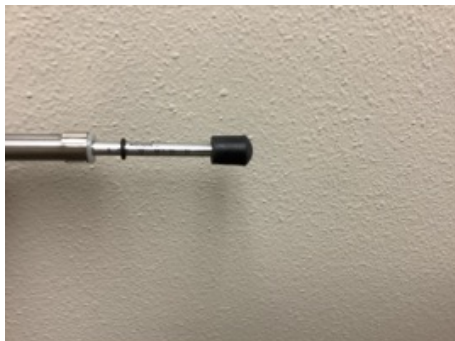
Deficiency: Restroom Doors - Operation - Opening Force

The force required to operate the door exceeds the allowable 5 lbf.

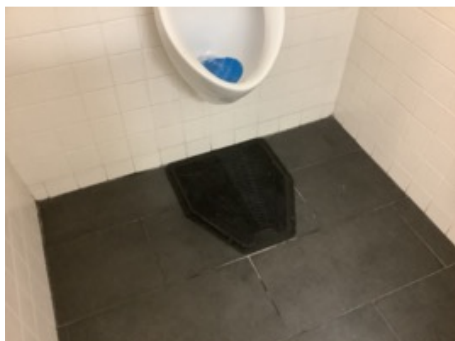
Deficiency: Restroom Access - Floor Surface - Mat

Carpet or carpet tile is not securely attached.

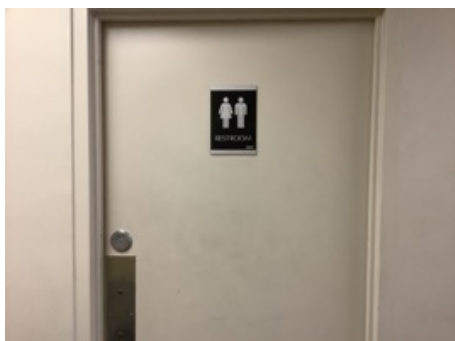
Deficiency: Restroom Access - Directional Signage - General

There are no directional signs indicating the location of the accessible restroom.

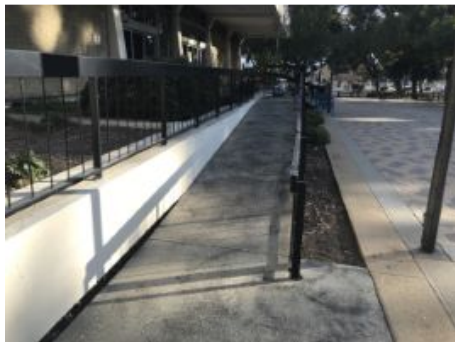
Deficiency: Ramps - Handrails - Height

Top of the handrail is not located within the height ranges of 34-inches minimum to 38-inches maximum AFF.

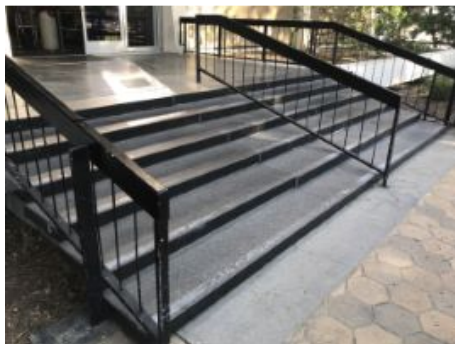
Deficiency: Stairs - Contrast Striping - Exterior Stair

A 2-inch minimum to 4-inch maximum clear visual contrast stripe is not provided on each step or has faded.

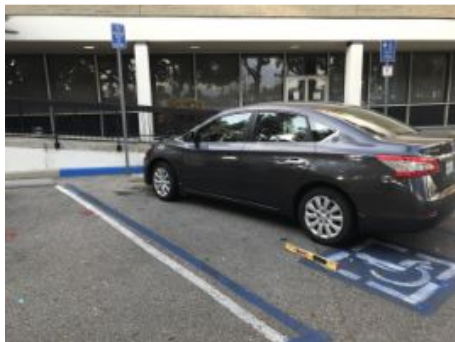
Deficiency: Parking - Accessible Stall - Slopes

The slope of the van/car stall in any direction exceeds 1:48 (2.0%) grade. 5.8% running slope measured at the van accessible parking stall. 3.0% cross slope measured at the van accessible parking stall.

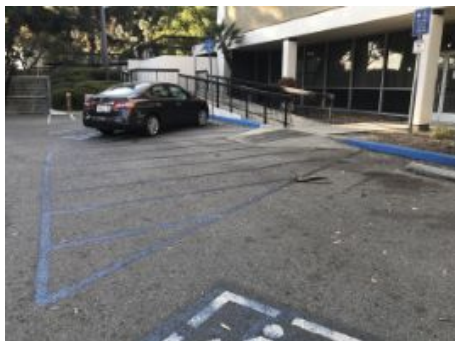
Deficiency: Parking - Access Aisle Markings - "No Parking"

Markings are faded and does not discourage parking in the access aisle. The words "No Parking" are not painted on the surface of the access aisle. Hatched lines at access aisle measured 38" on center.

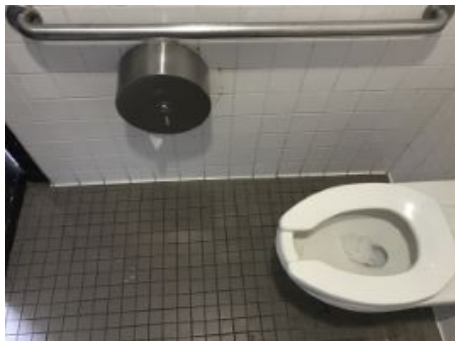
Deficiency: Accessible Toilet Stall - Dispensers - Toilet Paper Location

The toilet paper dispenser is outside of the allowable reach range.

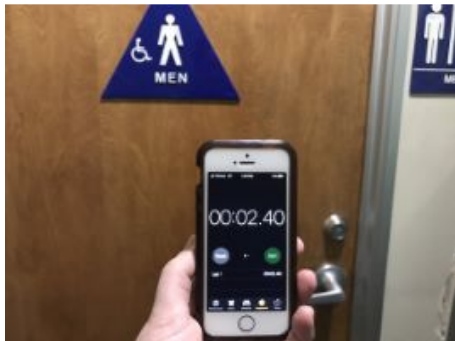
Deficiency: Restroom Doors - Operation - Closing Speed

The door closes faster than the minimum 5 seconds. 2.40 to 2.73 seconds closing speed measured at the restroom doors.

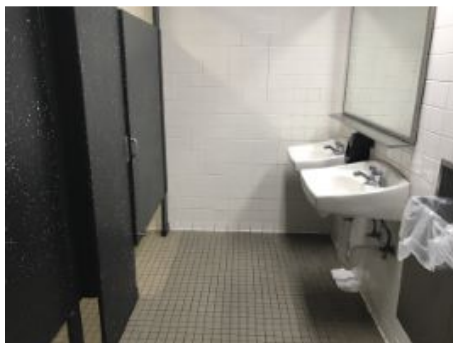
Deficiency: Accessible Toilet Stall - Door - Clearances-Pull Side

The accessible stall door does not provide 60-inches clearance on pull side of stall door.

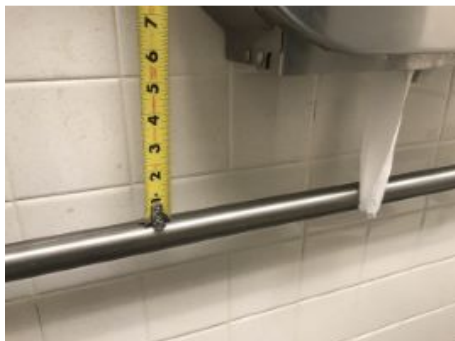
Deficiency: Accessible Toilet Stall - Side Grab Bar - Fixture Clearance

The dispenser does not provide minimum 12-inch clearance from top of side wall grab bar.

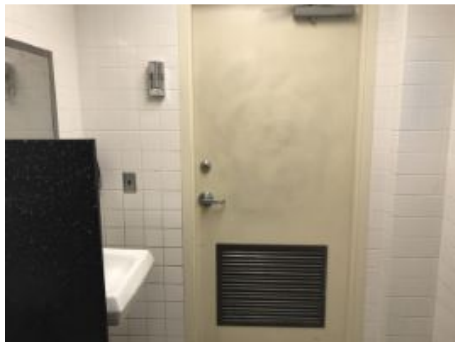
Deficiency: Restroom Doors - Clearances: Front - Push Side Approach

12-inch strike side clearance not provided on latch side of door due to depth of lavatory.

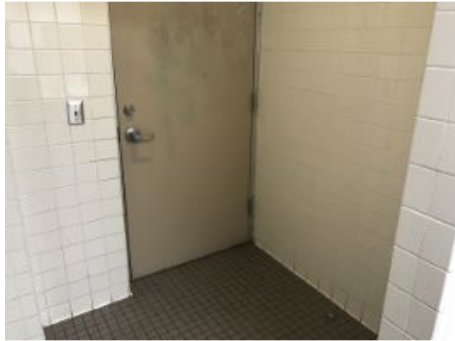
Deficiency: Restroom Doors - Dimensions - Width

The door does not provide a clear open width of minimum 32 inches when open 90 degrees. The doorstop at behind the door stops the restroom door from opening a full 90 degrees.

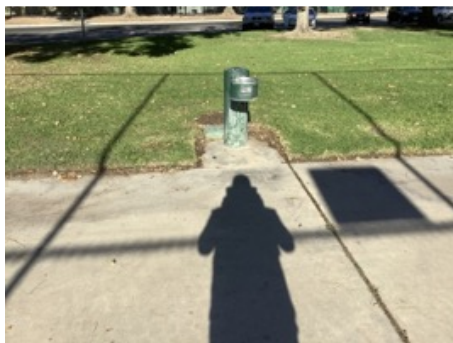
Deficiency: Drinking Fountain - Number Provided - Hi/Lo

One standing and one wheelchair accessible drinking fountain is not provided at each location.

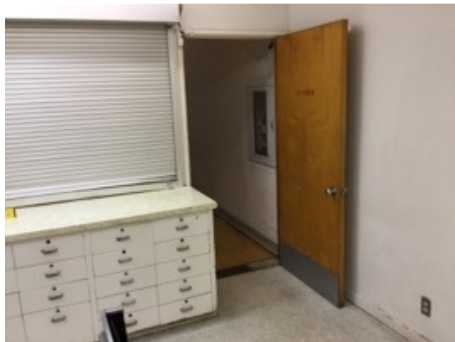
Deficiency: Interior Doors/Doorways/Gates - Hardware - Operation

The operable part requires tight grasping, pinching and/or twisting of the wrist to operate.

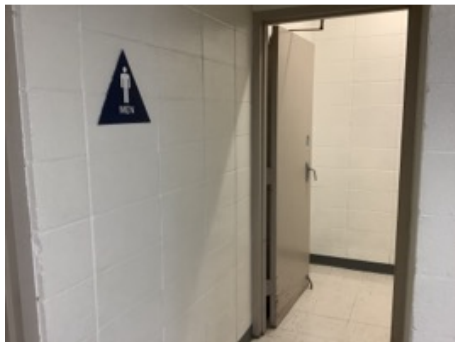
Deficiency: Restroom Doors - Geometric Sign - General

There is no geometric sign on the exterior door to the restrooms.

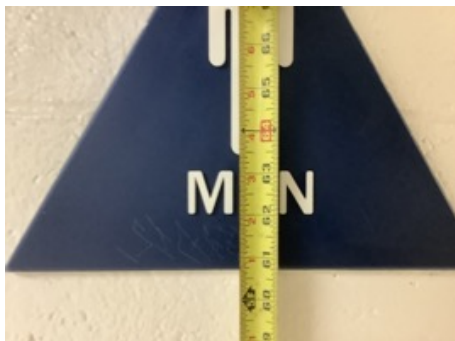
Deficiency: Restroom Doors - Geometric Sign - Height

The geometric sign is not mounted within the allowable height ranges.

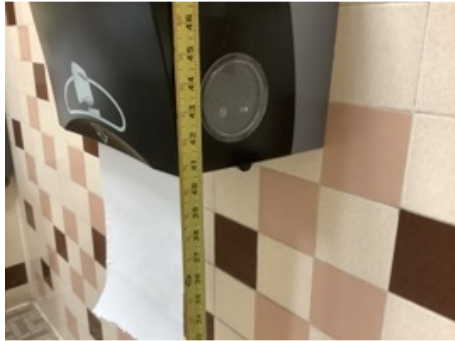
Deficiency: Restroom Interior Space - Protruding Objects - General

Objects in the restroom extend more than 4 inches from the wall with no cane detectable barrier.

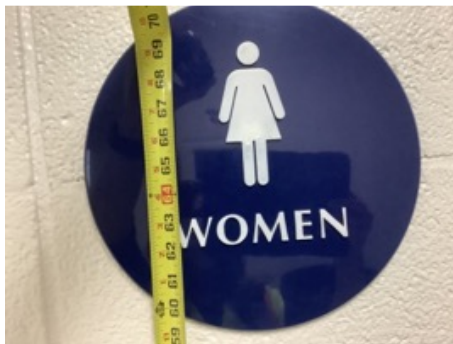
Deficiency: Restroom Doors - Geometric Sign - Height

The geometric sign is not mounted within the allowable height ranges.

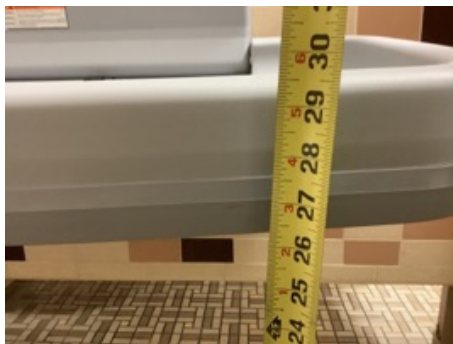
Deficiency: Baby Changing Station - Clear Floor Space - Knee Clearance

Baby changing station does not provide 27 inch minimum knee clearance.

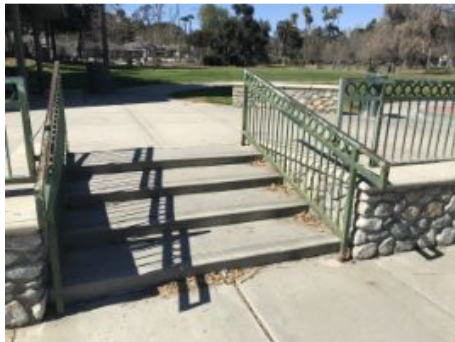
Deficiency: Ramps - Handrails - Gripping Surface

Bottom of the handrail surface is obstructed more than 20%.

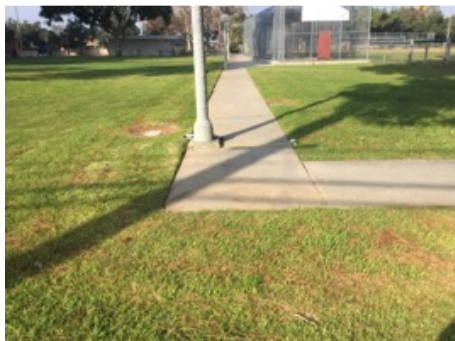
Deficiency: Accessible Route - Clear Width - General

Accessible route widths do not provide minimum 48-inches clear.

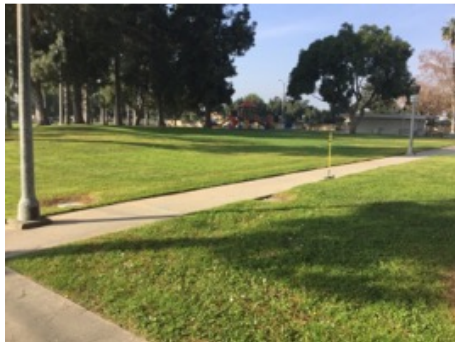
Deficiency: Accessible Route - Vertical Displacment - Height

Accessible route has multiple locations where changes in level over ¼” vertical or ½” beveled occur.

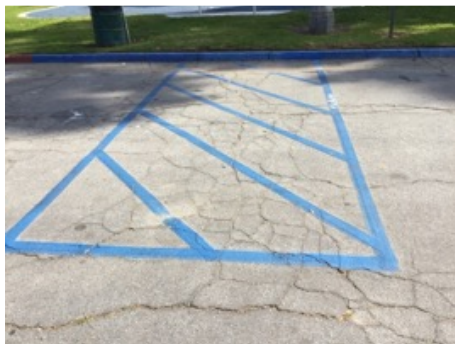
Deficiency: Parking - Access Aisle Markings - Hatched Line Color

The hatched lines on asphalt within the border line of the access aisle are not white.

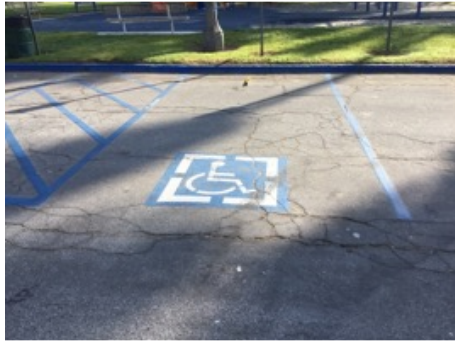
Deficiency: Parking - Accessible Stall - Slopes

The slope of the van/car stall in any direction exceeds 1:48 (2.0%) grade.

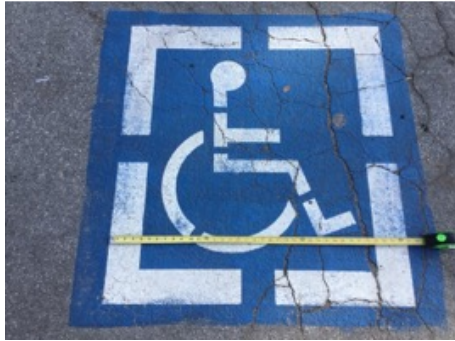
Deficiency: Parking - ISA - Size

The ISA identifying the accessible parking stall is smaller than 36 inches wide by 36 inches high (914 mm x 914 mm).

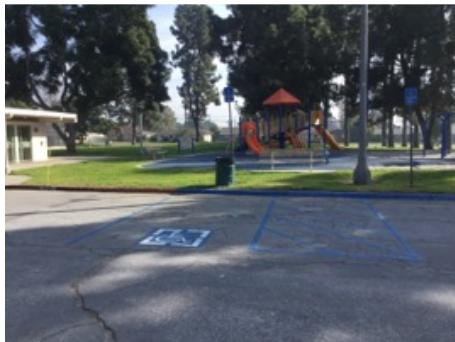
Deficiency: Parking - Signage - Van Stall

The van accessible stall is not identified with the words "Van Accessible".

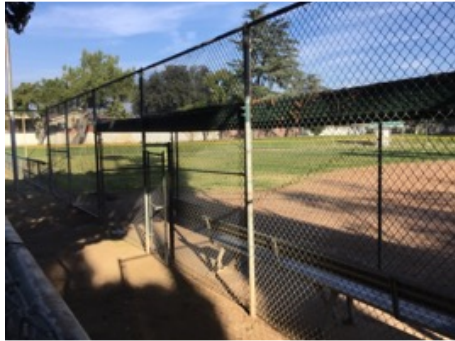
Comment #: TGP-41

Deficiency: Area of Sport Activity - Team or player seating - Wheelchair Space

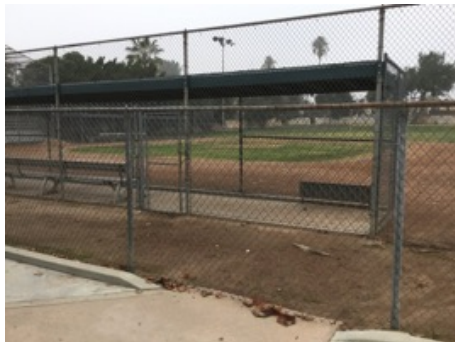
Comment #: TGP-42

Deficiency: Area of Sport Activity - Team or player seating - Wheelchair Space

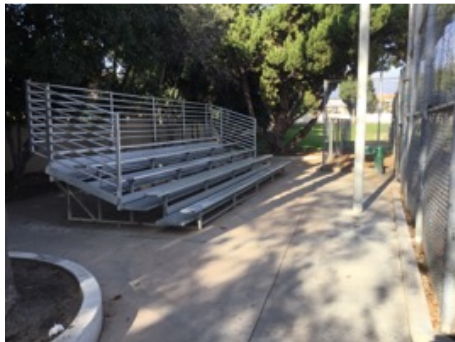
Deficiency: Bleachers - Wheelchair Seating - Location

Wheelchair spaces are not an integral part of bleacher seating.

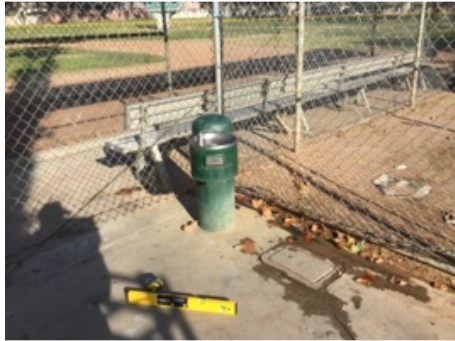
Deficiency: Drinking Fountain - Standing Person Unit - Height

Spout outlets of drinking fountains for standing persons is not located between 38" minimum and 43 " maximum above the finish floor or ground.

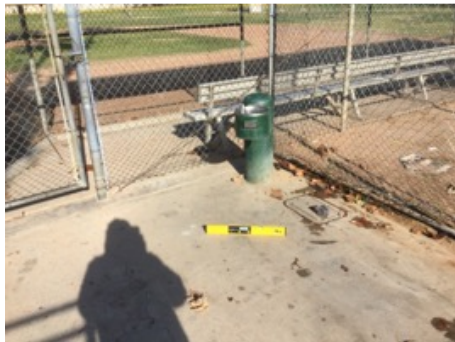
Deficiency: Drinking Fountain - Wheelchair Compliance - Clear Floor Grades

30" x 48" clear floor space slopes exceed 1:48 (2.083%)

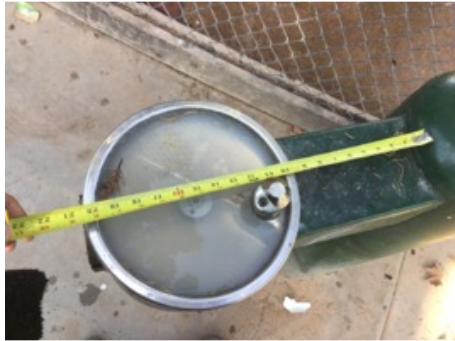
Deficiency: Drinking Fountain - Wheelchair Compliance - Spout Location

The spout is not located 15" minimum from the vertical support and 5" maximum from the front edge of the unit, including bumpers.

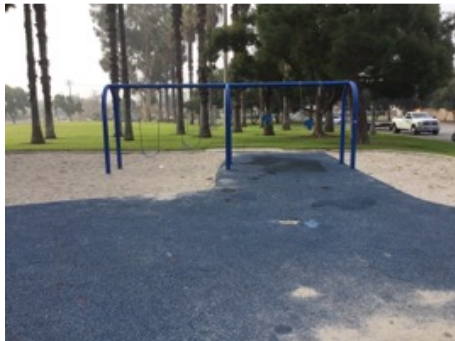
Deficiency: Playgrounds - Accessible Route - Site Amenities

An accessible path of travel from the playground is not provided to restrooms, drinking fountains, other accessible areas, and public telephones (if available) on site.

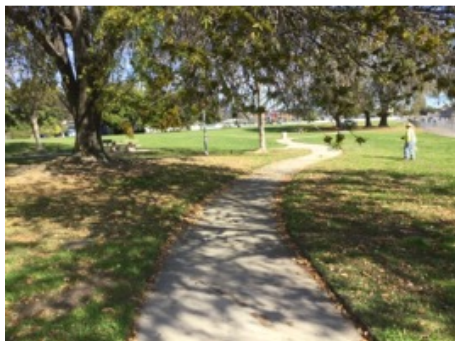
Deficiency: Accessible Route - Protrusion - Height

Objects in the path of travel extend more than 4 inches from the wall with no cane detectable barrier.

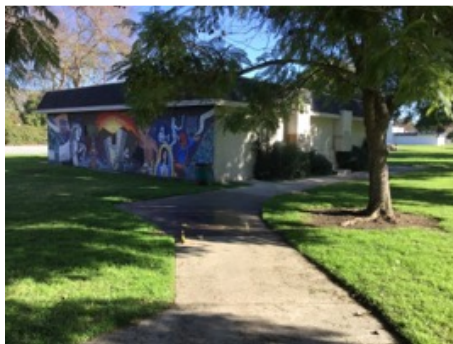
Deficiency: Accessible Route - Vertical Displacement - Height

Accessible route has multiple locations where changes in level over ¼" vertical or ½" beveled occur.

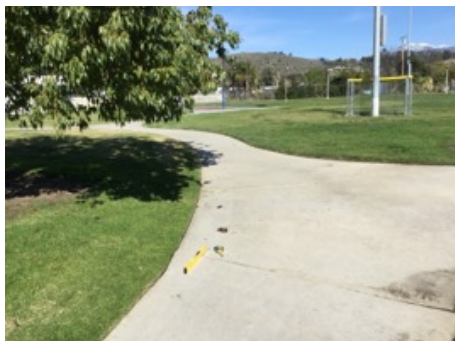
Accessible route has multiple locations where changes in level over 1/4" vertical or 1/2" beveled occur.

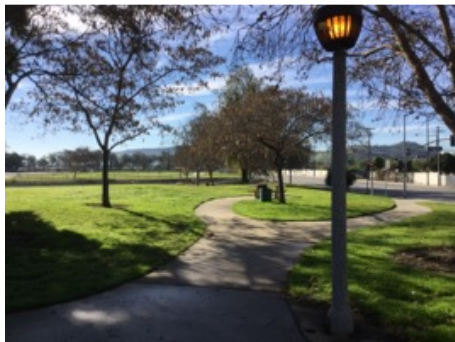
Accessible route has multiple locations where changes in level over 1/4" vertical or 1/2" beveled occur.

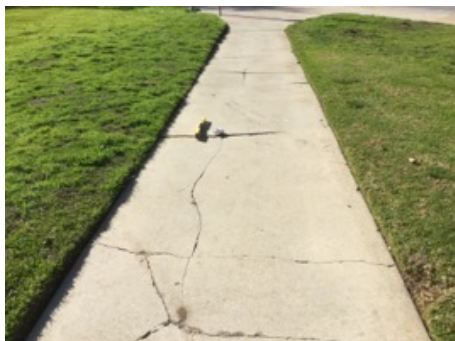
Accessible route has multiple locations where changes in level over 1/4" vertical or 1/2" beveled occur.

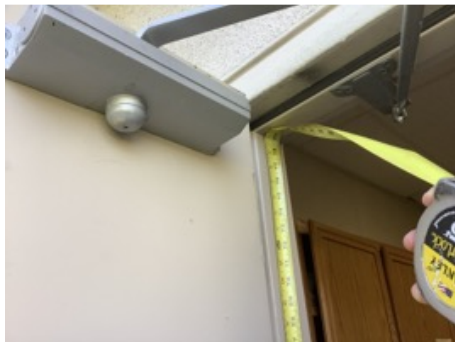
80" vertical clearance at door is not provided, and 78-inches is not provided at door closers or door stops?

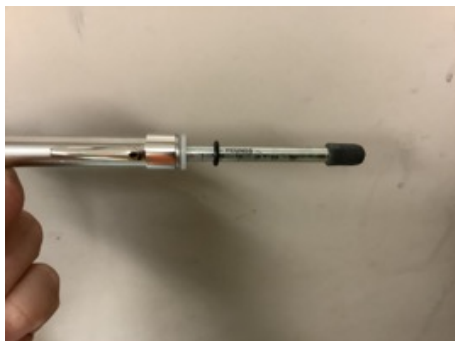
The force required to operate the door exceeds the allowable 5 lbf.

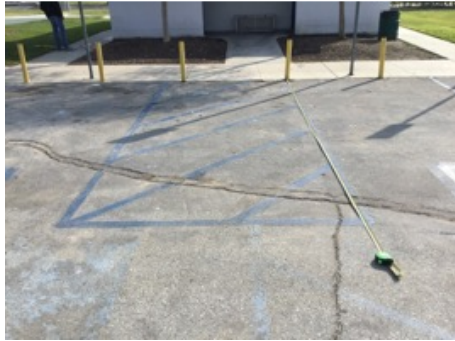
The access aisle is not marked with a blue painted border line around the entire perimeter.

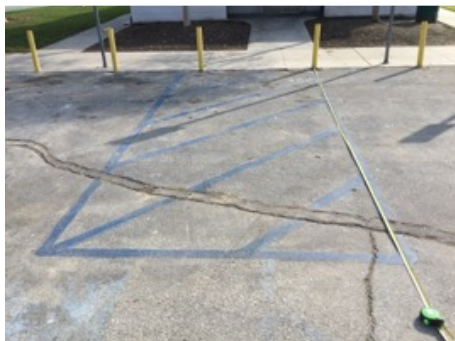
Markings are faded and does not discourage parking in the access aisle.

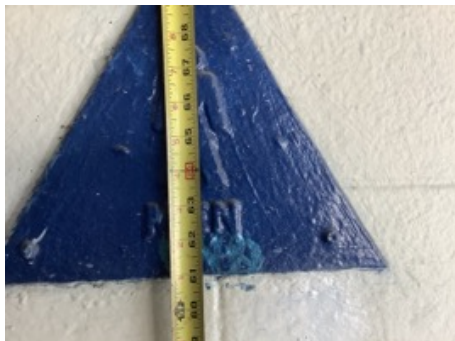
The geometric sign is not mounted within the allowable height ranges.

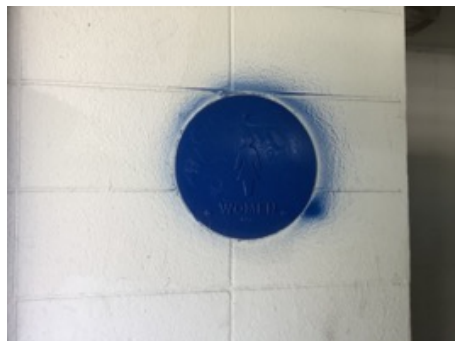
The geometric sign provided at the restroom does not contrast with the door.

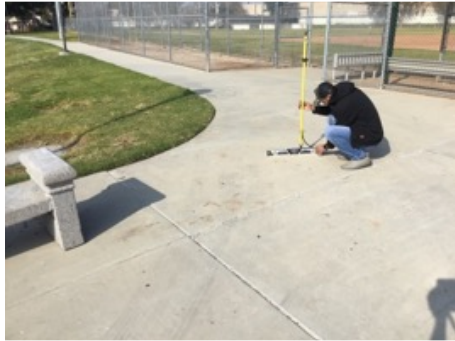
Deficiency: Accessible Route - Slopes - Cross Slope

The cross slope of accessible routes exceeds 1:48 (2.0 %).

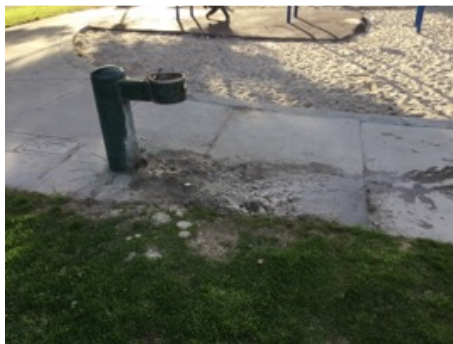
A 30" x 48" clear floor space is not provided for a forward approach at drinking fountain.

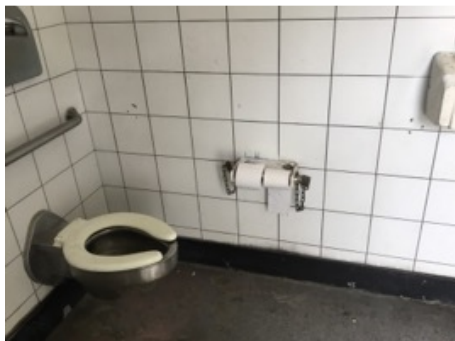
No side wall grab bar is installed.

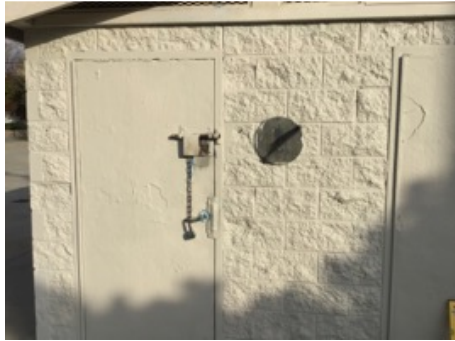
Permanent tactile restroom identification sign has been provided at the right side of the door, but doesn't meet compliance. Geometric items are a separate item in this report and need to be located on the door.

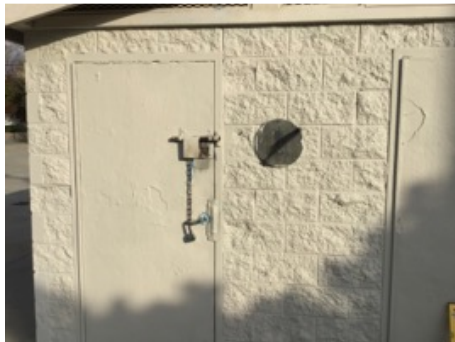
There is no geometric sign on the exterior door to the restrooms. Is not located on the exterior door and does not provide sufficient contrast.

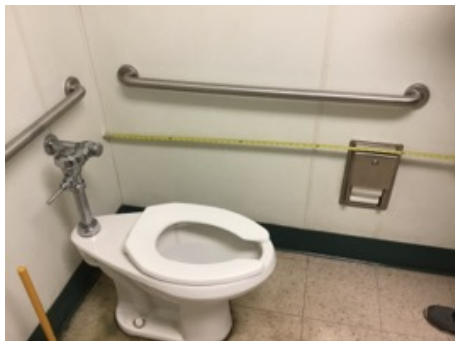
The toilet paper dispenser is outside of the allowable reach range.

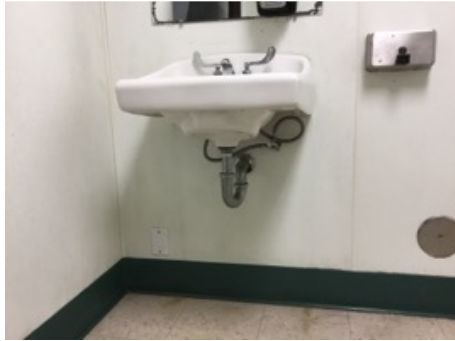
The pipe insulation does not cover everything under the sink including water supply lines and hose bib.

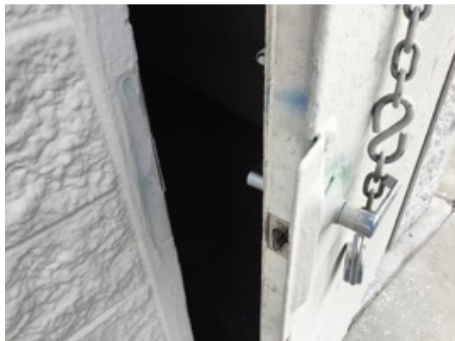
The door closes faster than the minimum 5 seconds.
