APPENDIX A

FACILITY ASSESSMENT PHOTO REPORTS

CITY HALL

1.0 Site Assessment

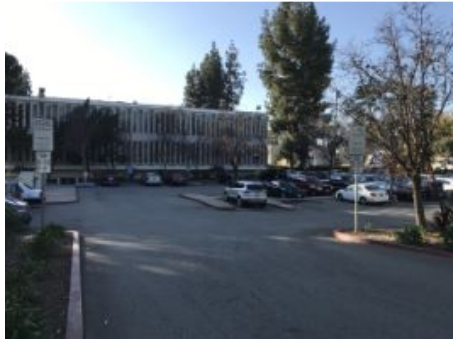
Comment #: CH-01

Deficiency: Parking - Tow Away Sign - Verbiage

A "tow-away" sign is not provided.

Measurement: 0 count

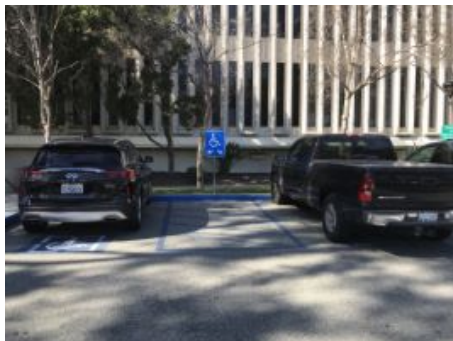
Comment #: CH-02

Deficiency: Parking - General Parking - Van Stall Space Count

One access space in every six access spaces (or portion of 6) is not van accessible. A van accessible parking stall is not provided. A total of 47 parking stalls are provided in the parking lot. A minimum of 1 standard and 1 van accessible parking stalls are required. A total of 2 standard and 0 van accessible parking stalls are provided.

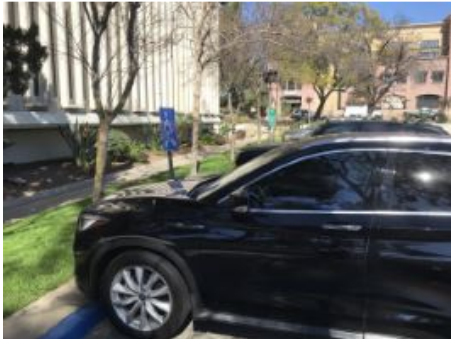
Comment #: CH-03

Deficiency: Parking - Signage - Van Stall

The van accessible stall is not identified with the words "Van Accessible".

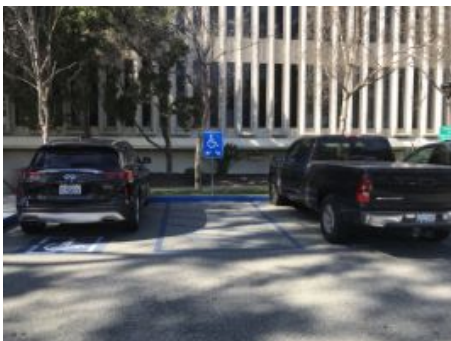
Comment #: CH-04

Deficiency: Parking - Signage - Minimum Fine

The parking identification sign does not includes the text "Minimum Fine \$250" below the ISA.

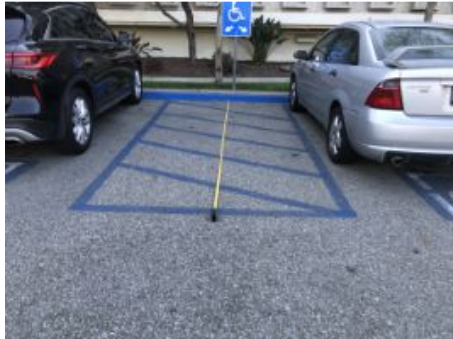
Comment #: CH-05

Deficiency: Parking - Accessible Stall - Length

The accessible van/car stall is less than 216 inches (18 ft. or 5486 mm) long.

Measurement: 181 inches

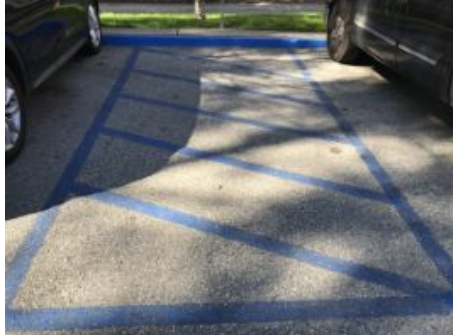
Comment #: CH-06

Deficiency: Parking - Access Aisle Markings - "No Parking"

Markings are faded and does not discourage parking in the access aisle.

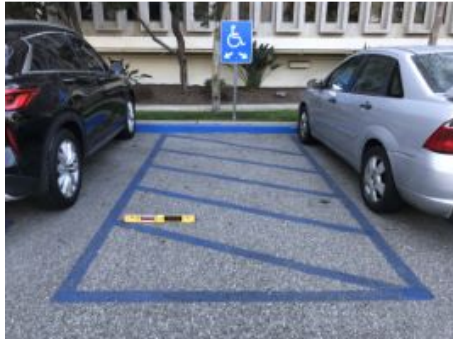
Comment #: CH-07

Deficiency: Parking - Access Aisle - Slope

The slope of the access aisle in any direction exceeds 1:48 (2.0%) grade.

Measurement: 5.1 % grade

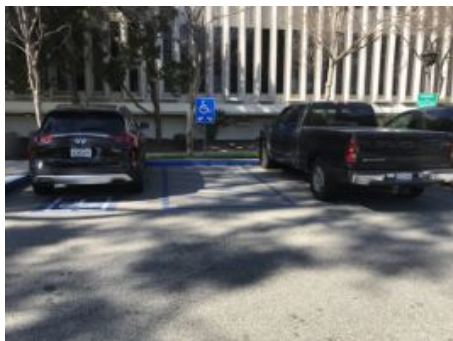
Comment #: CH-08

Deficiency: Parking - Accessible Route - Adjacent

Accessible parking spaces are not dispersed when serving multiple accessible entrances.

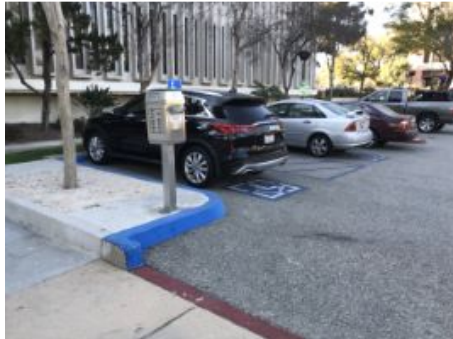
Comment #: CH-09

Deficiency: Accessible Route - Reach Ranges - Side Reach

Element for side reach is not located within 15-inches minimum to 48-inches maximum AFF (to to a 10-inch depth). 54-1/2" high reach measured to the pay box receptacle slot.

Measurement: 54.5 inches

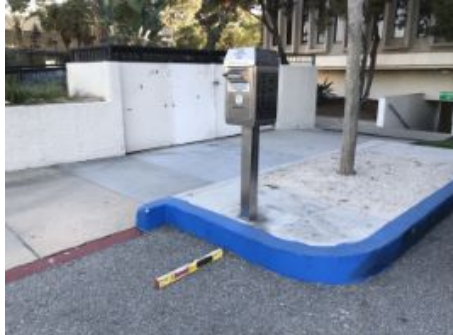
Comment #: CH-10

Deficiency: Accessible Route - Reach Ranges - Clear Floor Space

30" x 48" level clear ground space is not provided at the operable part. 2.7% cross slope measured at the pay station box.

Measurement: 2.7 % grade

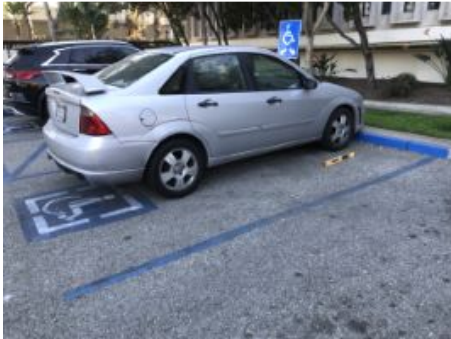
Comment #: CH-11

Deficiency: Parking - Accessible Stall - Slopes

The slope of the van/car stall in any direction exceeds 1:48 (2.0%) grade. 3.0% to 3.4% running slope measured at the second accessible parking stall.

Measurement: 3.4 % grade

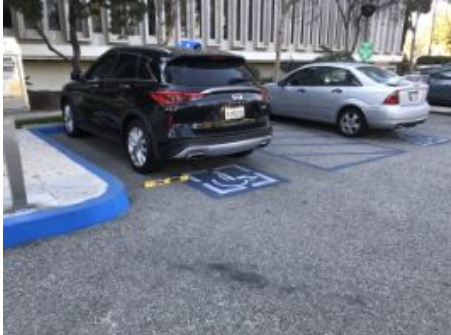
Comment #: CH-12

Deficiency: Parking - Accessible Stall - Slopes

The slope of the van/car stall in any direction exceeds 1:48 (2.0%) grade. Slopes range from 3.2% to 4.5% at the van accessible stall.

Measurement: 4.5 % grade

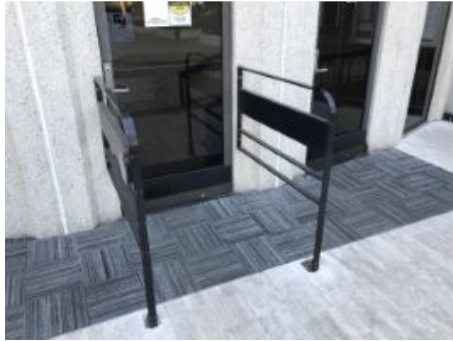
Comment #: CH-13 **Deficiency:** Accessible Route - Clear Width - General

Accessible route widths do not provide minimum 48-inches clear. 38-1/4" wide route measured between the metal railings at the automatic door entrance to the council chambers. The railing are 42" deep.

Measurement: 38.25 inches

Replace walks to provide a clear width of 48 inches (1219 mm) minimum. When, because of right-of-way restrictions, natural barriers or other existing conditions, the enforcing agency determines that compliance with the 48-inch (1219 mm) clear sidewalk width would create an unreasonable hardship, the clear width may be reduced to 36 inches (914 mm).

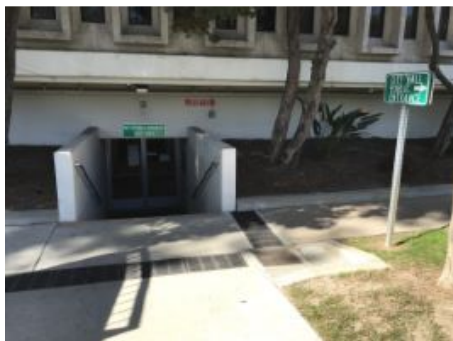
Comment #: CH-14 **Deficiency:** Exterior Doors/Doorways/Gates - ISA - All Entrances

The International Symbol of Accessibility (ISA) is missing at this door.

Recommendation would be to add a sticker with the ISA to the second door, or remove the sticker from the other door.

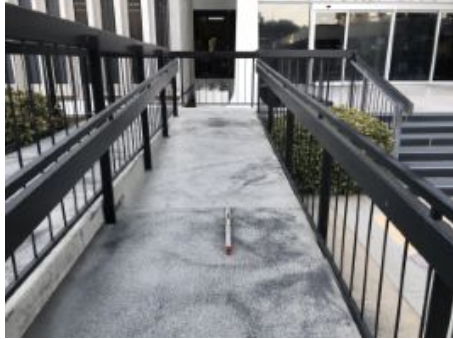
Comment #: CH-15

Deficiency: Ramps - Slopes - Running Slope

The running slope of the ramp is steeper than 1:12 (8.33%). 8.7% to 9.0% running slope measured along the ramp route.

Measurement: 9 % grade

Remove and replace the ramp. The running slope of the curb ramp segments shall be in-line with the direction of sidewalk travel. Ramp runs shall have a running slope not steeper than 1:12.

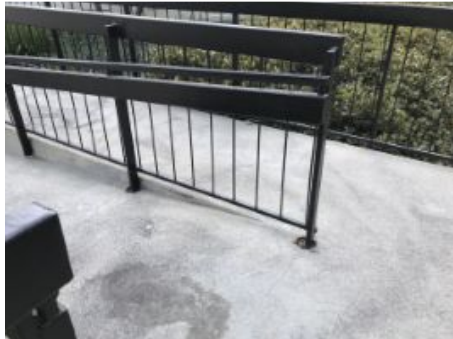
Comment #: CH-17

Deficiency: Ramps - Handrails - Extensions

Handrails at the top and/or bottom of the ramp do not extend 12-inches horizontally above the landing. 35" to 35-1/2" height measured to the top of the handrail gripping surface. Handrail extensions are not provided at the top and bottom of the ramp run.

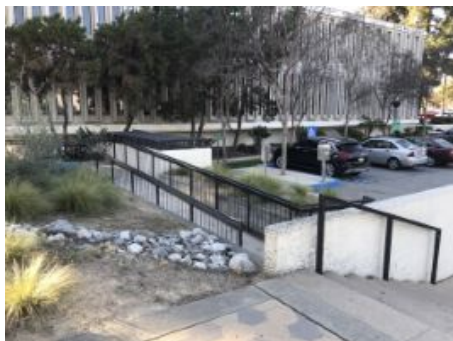
Comment #: CH-20

Deficiency: Ramps - Landings - Change in Direction Length

Ramp does not provide 72-inches landings at changes of direction. The two intermediate ramp landing at turns along the route measured 60" long in the direction of travel.

Measurement: 60 inches

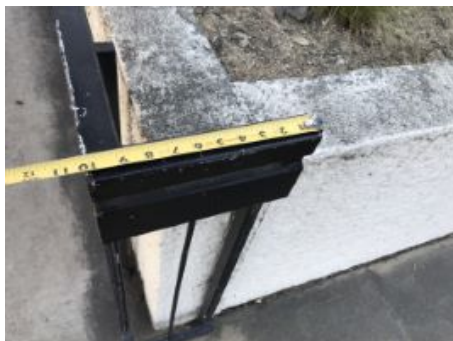
Comment #: CH-22

Deficiency: Stairs - Handrails - Extensions: Bottom

At the bottom of a stair flight, handrails shall extend at the slope of the stair flight for a horizontal distance equal to one tread depth beyond the last riser nosing. The extension shall be 12" min. and a height equal to that of the sloping portion of the handrail as measured above the stair nosings.

Measurement: 10 inches

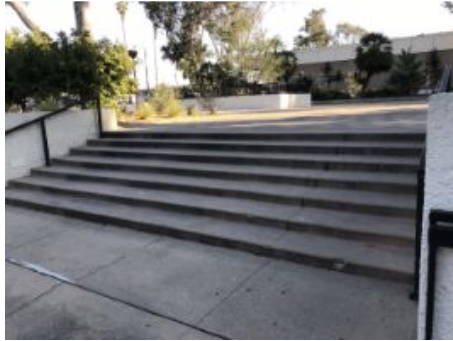
Comment #: CH-25

Deficiency: Stairs - Contrast Striping - Exterior Stair

A 2-inch minimum to 4-inch maximum clear visual contrast stripe is not provided on each step.

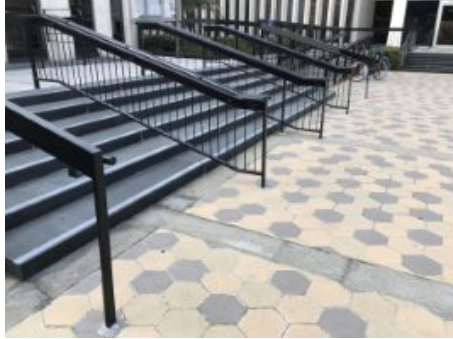
CH-27

Deficiency: Stairs - Handrails - Extensions-Top and Bottom

Handrails at the top and/or bottom of the stairs do not extend 12-inches horizontally above the landing. Handrail extensions at bottom of stairs is 10-1/2 inches.

Measurement: 10.5 inches

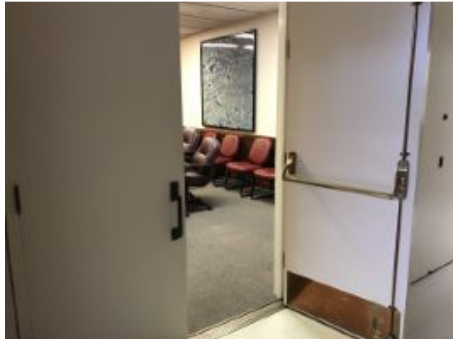
Comment #: CH-28 Deficiency: Interior Doors/Doorways/Gates - Dimensions - Width

32-inch clear opening is not provided when door is open at 90 degrees. 30" clear width measured at the board room entry door.

Measurement: 30 inches

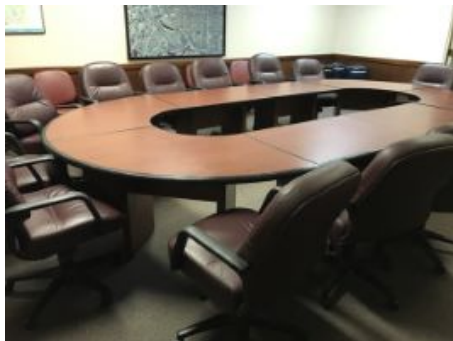
Comment #: CH-29 Deficiency: Work Surface - Clearances - General

42" AFF measured to the top of the work surface at the standing height reference computer station. 26" AFF knee clearance measured at the seated level reference computer stations. 22" wide clear floor space measured at the work stations in the board room.

Measurement: 22 inches

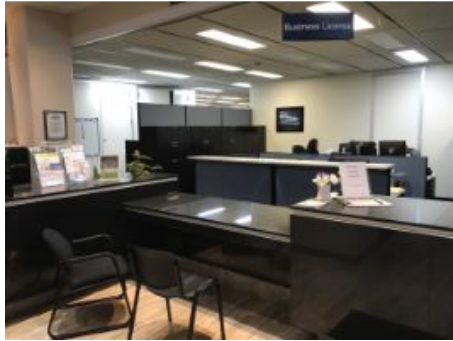
Comment #: CH-30 **Deficiency:** Transaction Counters - Dimensions - Counter Height

The counter surface is higher than the allowable 34 inches above the finished floor. 26-3/4" AFF knee clearance measured at the counter.

Measurement: 26.75 inches

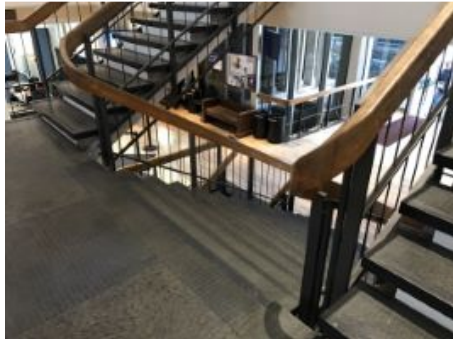
Comment #: CH-32

Deficiency: Stairs - Handrails - Height

Top of the handrail is not located within the height ranges of 34-inches minimum to 38-inches maximum AFF. 31" to 32" AFF measured to the top of the handrail gripping surface. Handrail extensions are not provided at the top and bottom of the stairs. Handrails are not at a consistent height at the top of the stairs.

Remove and replace handrail heights so the top of gripping surfaces of handrails are 34 inches (864 mm) minimum and 38 inches (965 mm) maximum vertically above walking surfaces.

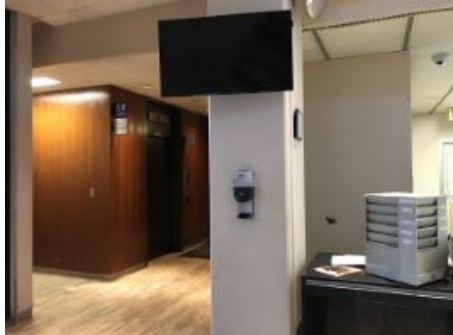
Comment #: CH-33

Deficiency: Accessible Route - Protrusion - Height

Objects in the path of travel extend more than 4 inches from the wall with no cane detectable barrier. 79-3/4" AFF vertical clearance measured to the TV in the lobby.

Measurement: 79.75 inches

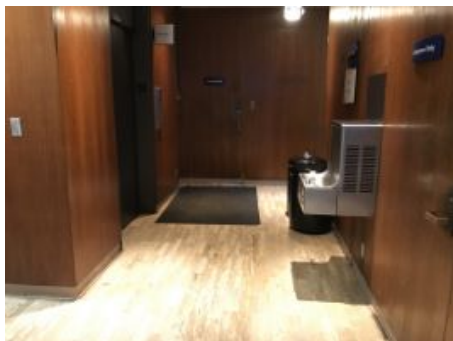
Comment #: CH-35

Deficiency: Drinking Fountain - Wheelchair Compliance - Knee Clearance

Knee and toe clearance is not provided at the lower level fountain.

Measurement: 25 inches

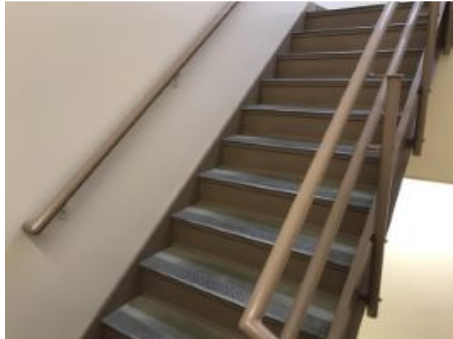
Comment #: CH-36 Deficiency: Stairs - Risers - Height

Riser height is not within the range of 4 inches high minimum and 7 inches high maximum. 7-1/2" AFF riser height measured along the stairs. 10-3/4" tread depth measured along the stairs.

Measurement: 7.5 inches

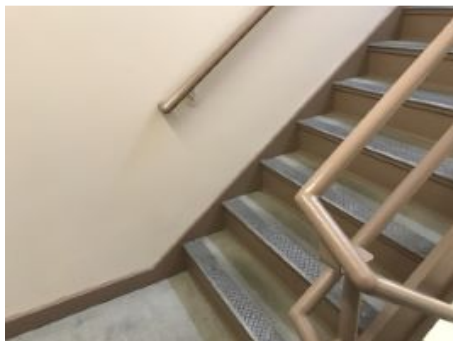
Comment #: CH-37 Deficiency: Stairs - Handrails - Extensions-Top and Bottom

Handrails at the top and/or bottom of the stairs do not extend 12-inches horizontally above the landing.

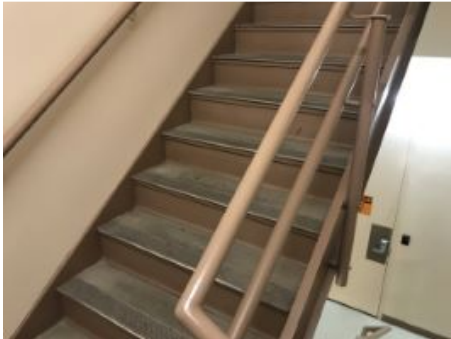
Comment #: CH-38

Deficiency: Stairs - Handrails - Height

Top of the handrail is not located within the height ranges of 34-inches minimum to 38-inches maximum AFF. 33" AFF measured to the top of the handrail gripping surface.

Measurement: 33 inches

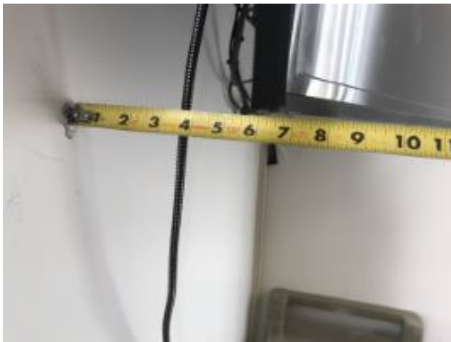
Comment #: CH-39

Deficiency: Accessible Route - Protrusion - Depth

Objects in the path of travel extend more than 4 inches from the wall with no cane detectable barrier. The TV in the conference room protrudes 7" into the accessible route at 59-3/4" AFF.

Measurement: 7 inches

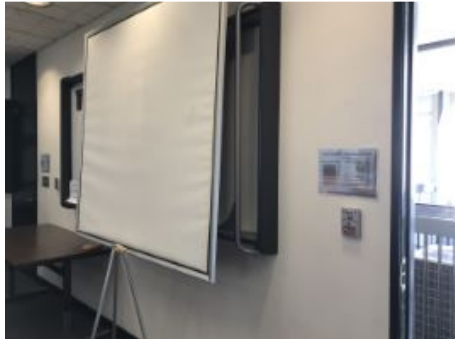
Comment #: CH-40

Deficiency: Accessible Route - Protrusion - Depth

Objects in the path of travel extend more than 4 inches from the wall with no cane detectable barrier. White screen in the conference room protrudes 14" into the accessible route at 35-1/2" AFF.

Measurement: 14 inches

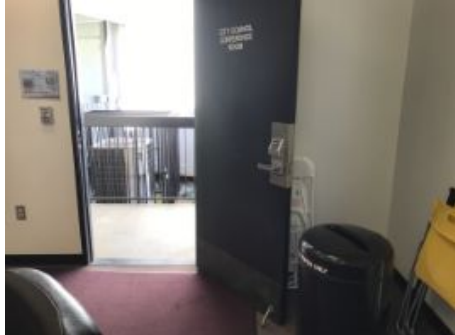
Comment #: CH-41

Deficiency: Interior Doors/Doorways/Gates - Tactile Sign - 18 Clear Space

The tactile wall and braille sign is not provided and sign is not located at a compliant location relative to the door.

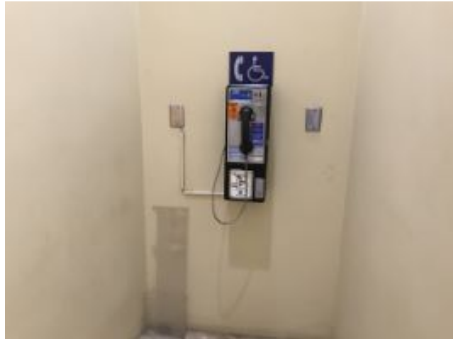
Comment #: CH-42 **Deficiency:** Accessible Route - Reach Ranges - Side Reach

Element for side reach is not located within 15-inches minimum to 48-inches maximum AFF (to to a 10-inch depth).

Measurement: 52.5 inches

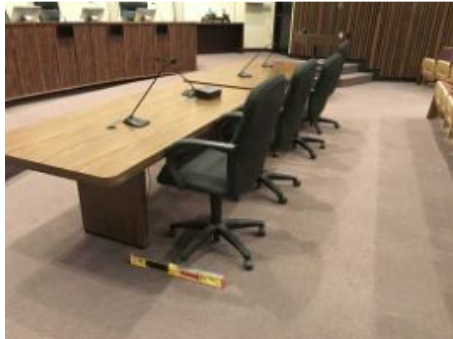
Comment #: CH-44

Deficiency: Accessible Route - Surface - Clear Floor Space

30" x 48" clear floor or ground space is not provided at the operable part. 4.7% running slope measured along the floor surface at the desk set up for public speaking.

Measurement: 4.7 % grade

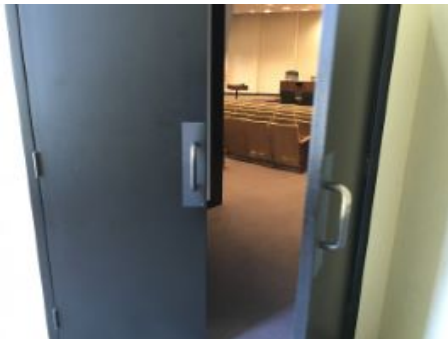
Comment #: CH-45

Deficiency: Interior Doors/Doorways/Gates - Dimensions - Width

Openings more than 24 inches deep do not provide a clear opening of 36 inches minimum. 27-3/4" to 28" clear width measured at the entry doors to the city hall.

Measurement: 27.75 inches

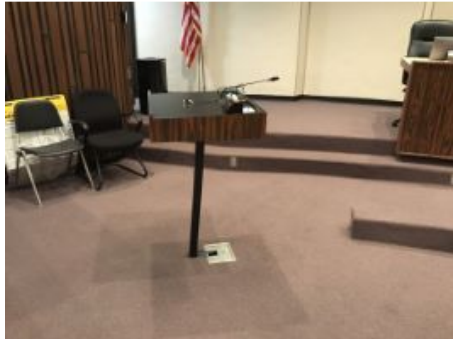
Comment #: CH-46

Deficiency: Work Surface - Clearances - General

41-3/4" AFF measured to the top of the podium surface.

Measurement: 41.75 inches

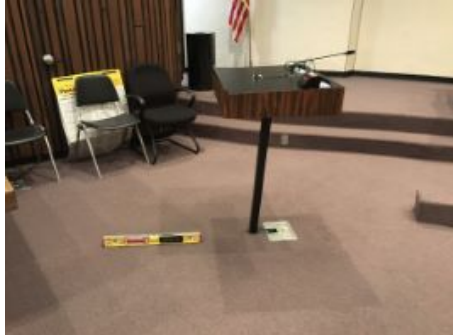
Comment #: CH-47

Deficiency: Work Surface - Clear Floor Space - Slopes

Clear floor space is not level adjacent to the podium and has slopes of 5.6%.

Measurement: 5.6 % grade

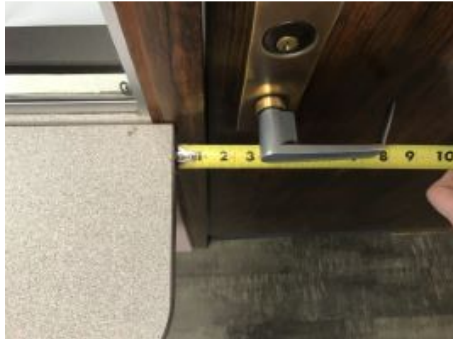
Comment #: CH-48

Deficiency: Interior Doors/Doorways/Gates - Clearances: Front - Latch Clearance

18-inches (exterior) not provided at latch side clearances. Depth of protrusion is 10-inches.

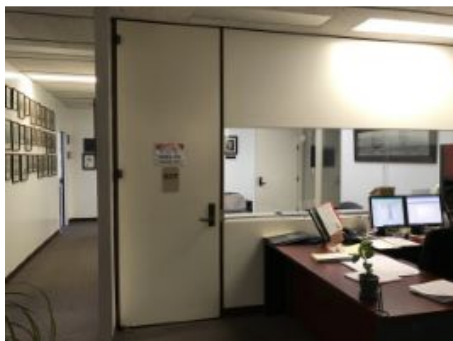
Comment #: CH-49

Deficiency: Interior Doors/Doorways/Gates - Tactile Sign - 18 Clear Space

The tactile wall sign is not provided in a compliant location relative to the door. Exit signage is not located adjacent to the latch side of the door. The signage is mounted on the surface of the door on the pull side of the door.

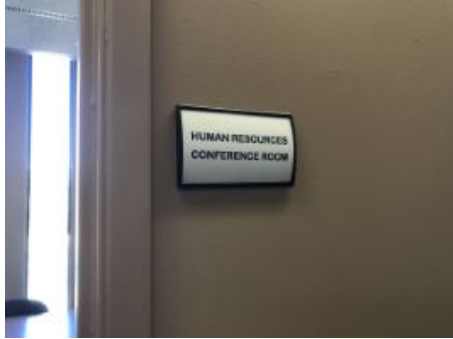
Comment #: CH-50

Deficiency: Interior Doors/Doorways/Gates - Tactile Sign - General

No permanent tactile exit sign has been provided at the following offices; Human Resources, Police, City Clerk, Passport Office, Mayor

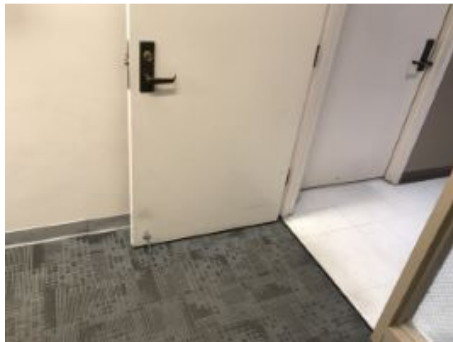
Comment #: CH-51

Deficiency: Interior Doors/Doorways/Gates - Hardware - Smooth Surface

Lower 10 inches of door is not smooth due to door stop being installed at bottom of door. Offices include the following; Human Resources, City Clerk, VPD and Successor, Mayor/City Clerk (2), Administration Board Room, Council Chambers Conference Room

Measurement: 2 inches

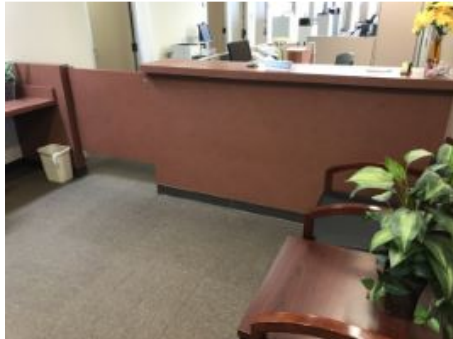
Comment #: CH-52

Deficiency: Transaction Counters - Dimensions - Counter Height

The counter surface is higher than the allowable 34 inches above the finished floor. The Housing Authority, Human Resources, and Mayor's office transaction counters transactions counters height range from 37-3/4" to 43-7/8" AFF when measured to the top of the service counter surfaces.

Measurement: 43.875 inches

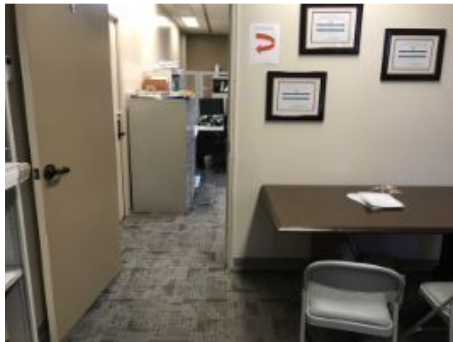
Comment #: CH-53

Deficiency: Interior Doors/Doorways/Gates - Clearances: Front - Latch Clearance

18-inches (exterior) not provided at latch side clearances.

Measurement: 10 inches

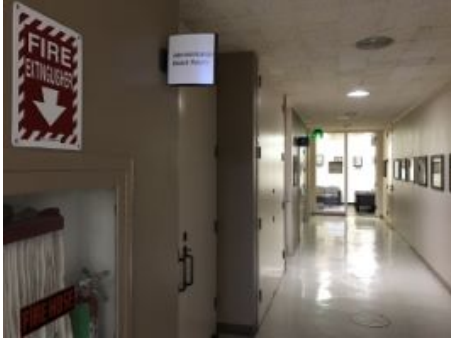
Comment #: CH-54 **Deficiency:** Accessible Route - Protrusion - Height

Objects in the path of travel extend more than 4 inches from the wall with no cane detectable barrier. 79" AFF vertical clearance measured to the unisex restroom signage. 78-1/2" AFF vertical clearance measured to the administration board room signage.

Measurement: 78.5 inches

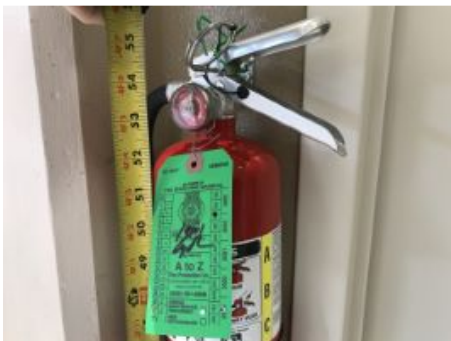
Comment #: CH-55 **Deficiency:** Accessible Route - Reach Ranges - Side Reach

Element for side reach is not located within 15-inches minimum to 48-inches maximum AFF (to a 10-inch depth). 54" AFF measured to the fire extinguisher control.

Measurement: 54 inches

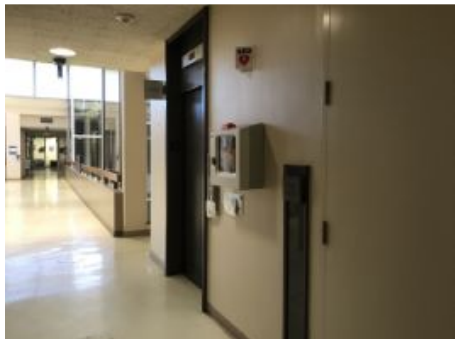
Comment #: CH-57 **Deficiency:** Accessible Route - Protrusion - Height

Objects in the path of travel extend more than 4 inches from the wall with no cane detectable barrier. Defibrillator box protrudes 7-3/4" into the accessible route at 48" AFF.

Measurement: 48 inches

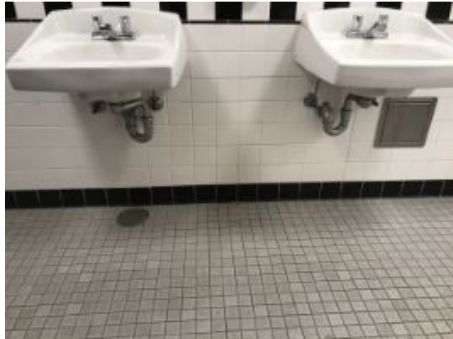
Comment #: CH-58

Deficiency: Lavatory - Covered Pipes/Hose Bib - General

The pipe insulation does not cover everything under the sink including water supply lines and hose bib.

Measurement: 3 count

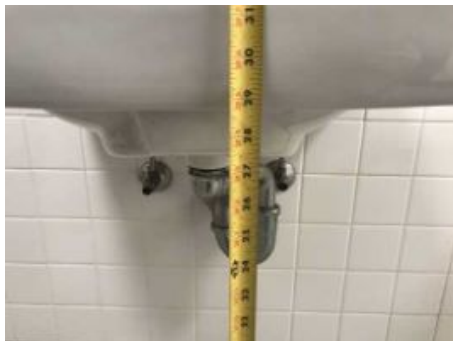
Comment #: CH-59

Deficiency: Lavatory - Knee/Toe Clearance - Height

The knee clearance at the lavatory is less than the allowable 29 inches. 17-3/4" deep toe clearance measured at the lavatories. 28-3/4" AFF measured to the bottom of the front of the lavatory in the men's restroom.

Measurement: 28.75 inches

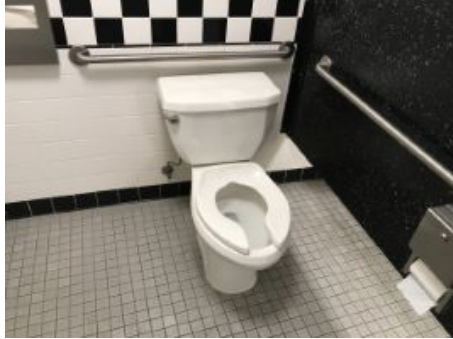
Comment #: CH-62

Deficiency: Accessible Toilet Stall - Water Closet - Location

The flush control for the water closet is not located on the open side of the accessible toilet. Water closet centerline measured 18-1/2" from the side partition.

Measurement: 18.5 inches

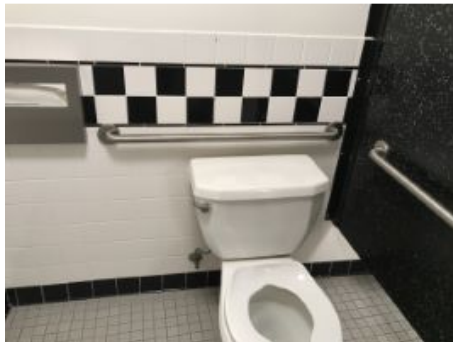
Comment #: CH-63

Deficiency: Accessible Toilet Stall - Rear Grab Bar - Open Side Distance From Centerline

The rear grab bar does not extend the full 24 inches past the centerline of the water closet. Rear wall grab bar extends 22" to the open side of the water closet.

Measurement: 22 inches

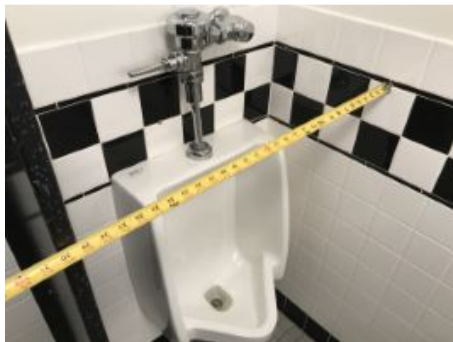
Comment #: CH-64

Deficiency: Urinal - Alcove Dimensions - Width

The alcove is deeper than 24 inches and does not provide the required minimum width of 36 inches. 29-1/4" by 47" clear floor space measured at the urinal.

Measurement: 29.25 inches

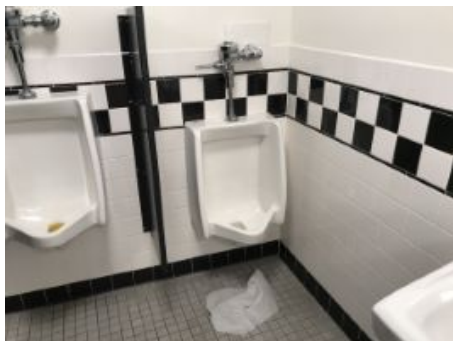
Comment #: CH-65

Deficiency: Urinal - Rim Dimensions - Height

The urinal rim height is greater than the allowable 17 inches AFF. 17-3/4" AFF measured to the urinal rim.

Measurement: 17.75 inches

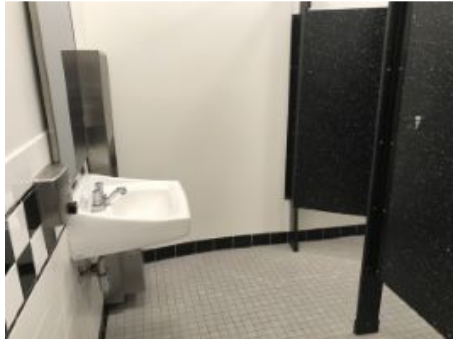
Comment #: CH-66

Deficiency: Accessible Toilet Stall - Dimensions - Stall Depth

60-inch minimum width of stall not provided. 56" to 57" wide clearance measured at the water closet.

Measurement: 56 inches

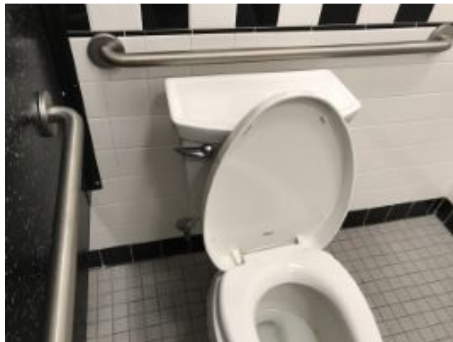
Comment #: CH-67

Deficiency: Accessible Toilet Stall - Water Closet - Flush Control Location

The flush control for the water closet is not located on the open side of the accessible toilet.

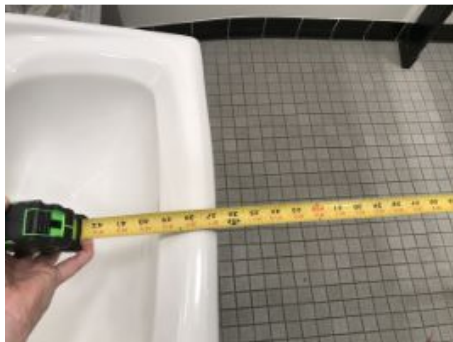
Comment #: CH-68

Deficiency: Accessible Toilet Stall - Door - Clearances - Push Side

The wheelchair stall door does not provide 44-inches minimum clearances.

Measurement: 36.75 inches

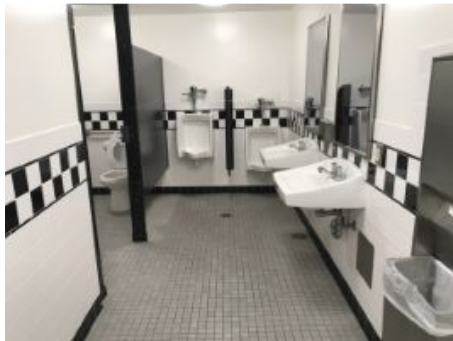
Comment #: CH-69

Deficiency: Restroom Interior Space - Protruding Objects - General

Objects in the restroom extend more than 4 inches from the wall with no cane detectable barrier. Lavatories protrude 17-3/4" into the accessible route at 29" to 30" AFF.

Measurement: 17.75 inches

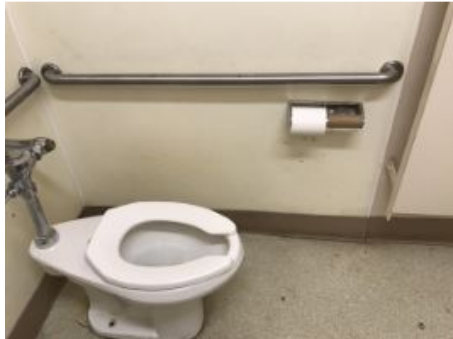
Comment #: CH-70

Deficiency: Accessible Toilet Stall - Dispensers - Toilet Paper Location

The toilet paper dispenser is outside of the allowable reach range.

Measurement: 12 inches

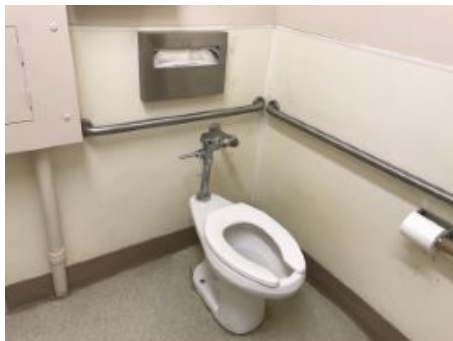
Comment #: CH-71

Deficiency: Accessible Toilet Stall - Dispensers - Seat Cover Height

The height of the operable part of the provided seat cover dispenser exceeds the allowable 40 inches AFF.

Measurement: 44 inches

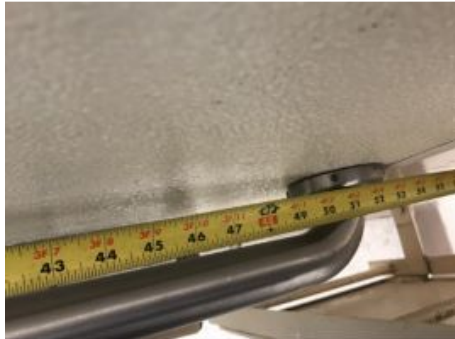
Comment #: CH-72

Deficiency: Accessible Toilet Stall - Side Grab Bar - End Distance to Rear Wall

The side grab bar does not extend minimum 54 inches from the rear wall.

Measurement: 51.25 inches

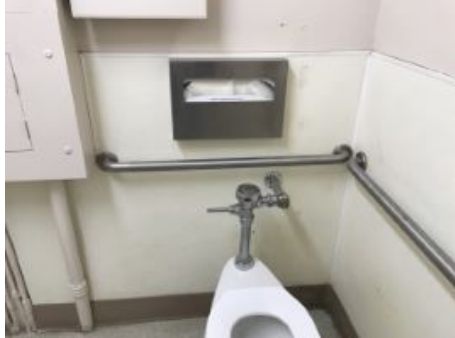
Comment #: CH-73

Deficiency: Accessible Toilet Stall - Rear Grab Bar - Above Clearance

The rear grab bar does not have a minimum 12 inch clear space above the grab bar.

Measurement: 3.5 inches

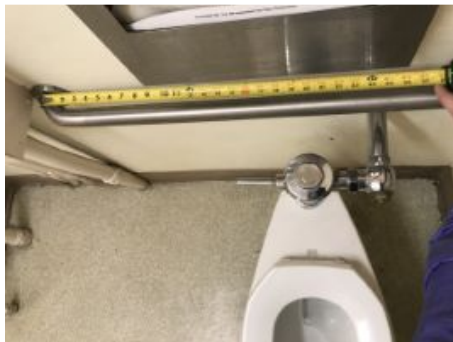
Comment #: CH-74

Deficiency: Accessible Toilet Stall - Rear Grab Bar - Open Side Distance From Centerline

The rear grab bar does not extend the full 24 inches past the centerline of the water closet.

Measurement: 20 inches

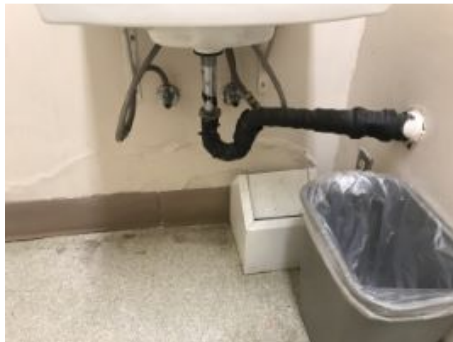
Comment #: CH-75

Deficiency: Lavatory - Covered Pipes/Hose Bib - General

The pipe insulation does not cover everything under the sink including water supply lines and hose bib.

Measurement: 1 count

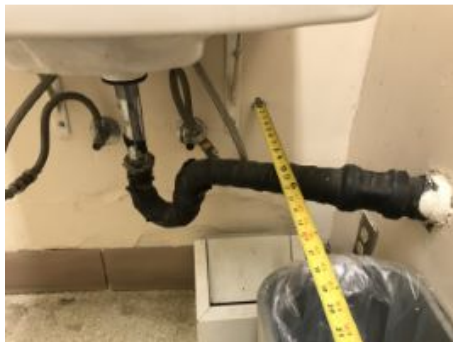
Comment #: CH-76

Deficiency: Lavatory - Knee/Toe Clearance - Width

Minimum 30 inch wide knee and toe space is not provided. 8" deep knee and toe clearances measured to the pipes under the lavatory.

Measurement: 8 Inches

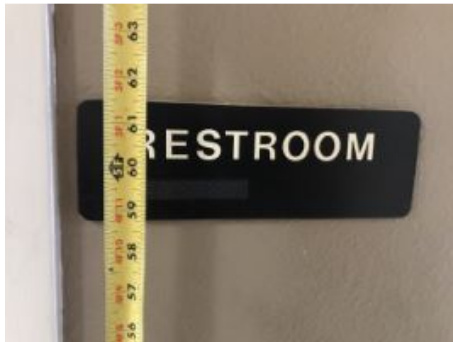
Comment #: CH-77

Deficiency: Restroom Doors - Tactile Sign - Height

The tactile sign is not mounted within the allowable height ranges. 60-1/4" AFF measured to the baseline of the lowest tactile character.

Measurement: 60.25 inches

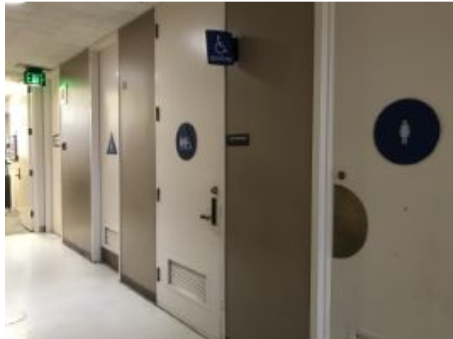
Comment #: CH-78

Deficiency: Restroom Doors - Operation - Opening Force

The force required to operate the door exceeds the allowable 5 lbf.

Measurement: 7 lbf

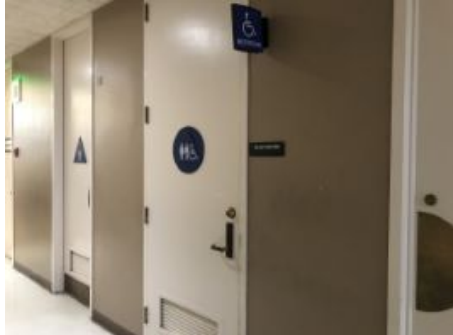
Comment #: CH-79

Deficiency: Restroom Doors - Operation - Closing Speed

The door closes faster than the minimum 5 seconds. 3.80 seconds closing speed measured at the restroom door.

Measurement: 3.8 seconds

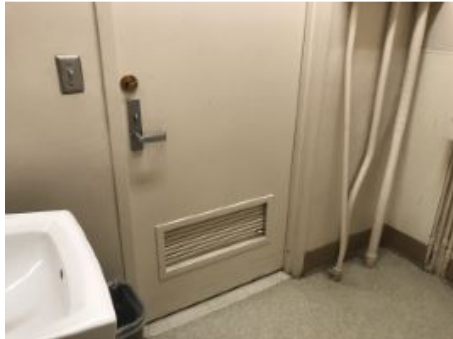
Comment #: CH-80

Deficiency: Restroom Doors - Clearances: Front - Latch Clearance

18-inch latch side clearance is not provided at the pull side of the door.

Measurement: 9.5 inches

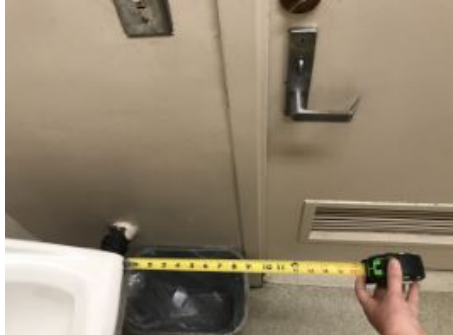
Comment #: CH-81

Deficiency: Restroom Doors - Clearances: Front - Latch Clearance

Latch side clearance is not provided at the pull side of the door.

Measurement: 9.75 inches

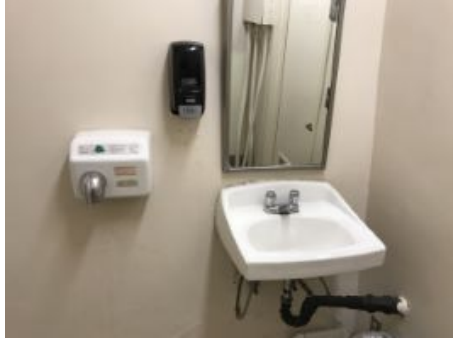
Comment #: CH-82 **Deficiency:** Restroom Interior Space - Amenities - Soap Dispenser Height

The soap dispenser exceeds the maximum allowable height.

Measurement: 51 inches

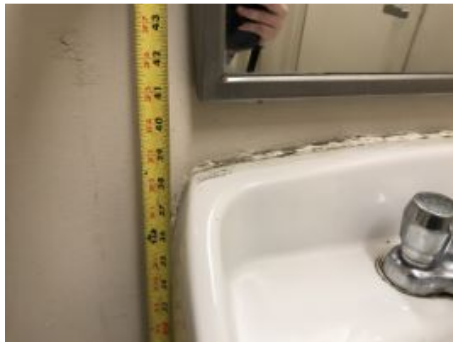
Comment #: CH-83 **Deficiency:** Restroom Interior Space - Amenities - Mirror Height

The mirror height exceeds the allowable 40 inches above the finished floor.

Measurement: 41.5 inches

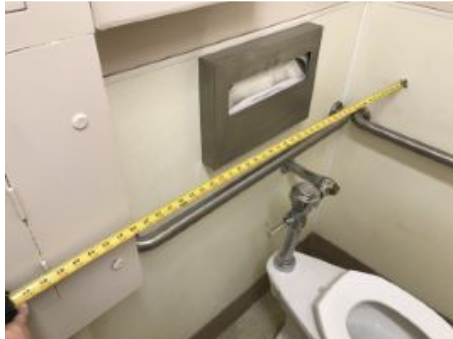
Comment #: CH-84

Deficiency: Water Closet - Clearance - Dimensions

Clearances at water closet does not provide minimum 60-inches from side wall to nearest obstruction. And/or it does not provide 48-inches from face of water closet to nearest obstruction. 39-1/2" clearance measured to the electrical panel at the water closet.

Measurement: 39.5 inches

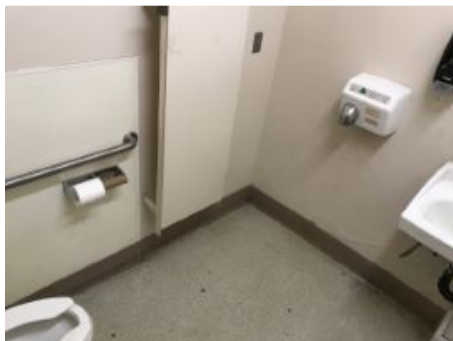
Comment #: CH-85

Deficiency: Water Closet - Clearance - Dimensions

Clearances at water closet does not provide minimum 60-inches from side wall to nearest obstruction. And/or it does not provide 48-inches from face of water closet to nearest obstruction. 44" wide clear floor space measured from the side wall to the lavatory in front of the water closet. Ladder enclosure protrudes 7 -1/4" into the clear floor space 22" in front of the water closet.

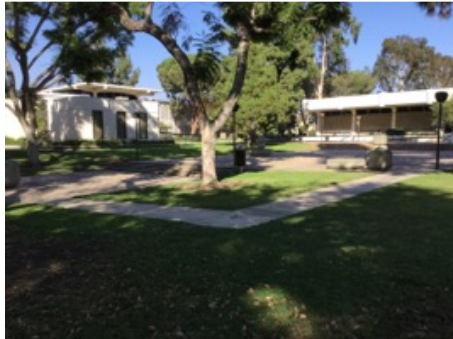
Comment #: CC-01

Deficiency: Accessible Route - Directional Signage - General

The non-accessible areas leading toward entrance and does not provide signage directing to an accessible entrance.

Measurement: 0 count

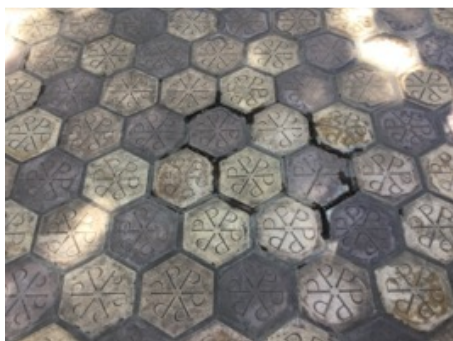
Comment #: CC-02

Deficiency: Accessible Route - Openings - Width

Accessible route grates / openings exceed 1/2" in the direction of travel.

Measurement: 1 inches

Replace grates, or fill openings, at locations where gratings/openings occur. Openings are allowed a maximum of 1/2" in the direction of travel.

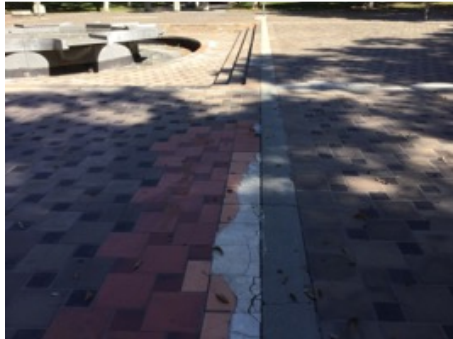
Comment #: CC-03

Deficiency: Accessible Route - Openings - Width

Accessible route grates / openings exceed 1/2" in the direction of travel.

Replace grates, or fill openings, at locations where gratings/openings occur. Openings are allowed a maximum of 1/2" in the direction of travel.

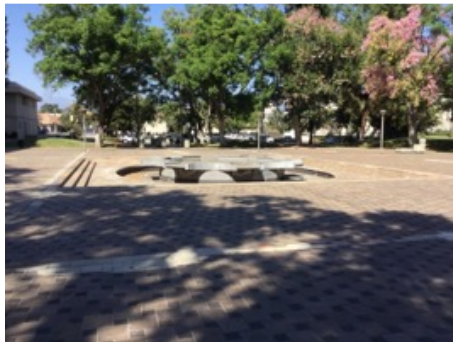
Comment #: CC-04

Deficiency: Accessible Route - Steps and edge protection -

About 57' x 57' recessed area with steps all around leading to round fountain in middle of area. No ramp. For steps - No warning stripes at nosings, no handrail. For fountain - No edge protection at drop off greater than 4". Missing covers at some recessed "boxes" (drains and access to filters?)

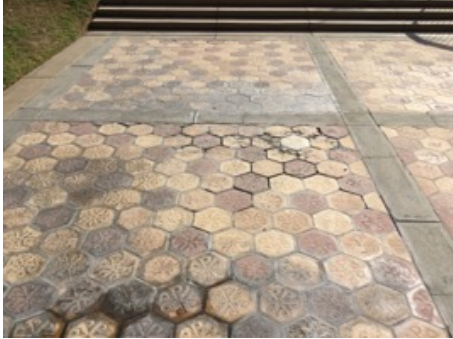
Comment #: CC-05

Deficiency: Accessible Route - Openings - Width

Accessible route grates / openings exceed 1/2" in the direction of travel.

Measurement: .75 inches

Replace grates, or fill openings, at locations where gratings/openings occur. Openings are allowed a maximum of 1/2" in the direction of travel.

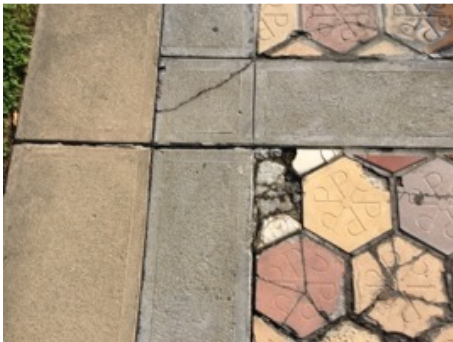
Comment #: CC-06

Deficiency: Accessible Route - Openings - Direction

Accessible route grates / openings exceed 1/2" in the direction of travel in upper courtyard.

Measurement: .75 inches

Replace grates, or fill openings, at locations where gratings/openings occur. Openings are allowed a maximum of 1/2" in the direction of travel.

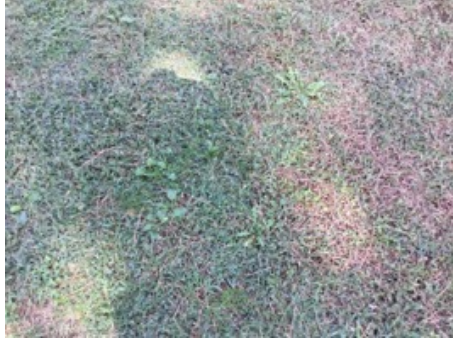
Comment #: CC-09

Deficiency: Accessible Route - Openings - Width

Accessible route grates / openings exceed 1/2" in the direction of travel.

Measurement: 3 inches

Replace grates, or fill openings, at locations where gratings/openings occur. Openings are allowed a maximum of 1/2" in the direction of travel.

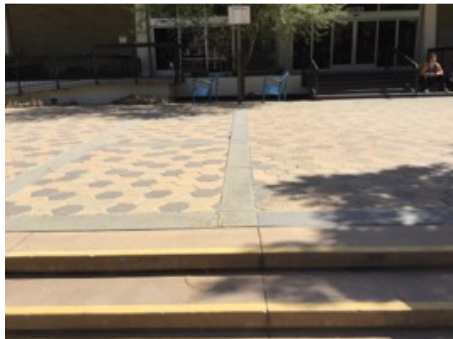
Comment #: CC-10

Deficiency: Accessible Route - Openings - Direction

Accessible route grates / openings exceed 1/2" in the direction of travel.

Replace grates, or fill openings, at locations where gratings/openings occur. Openings are allowed a maximum of 1/2" in the direction of travel.

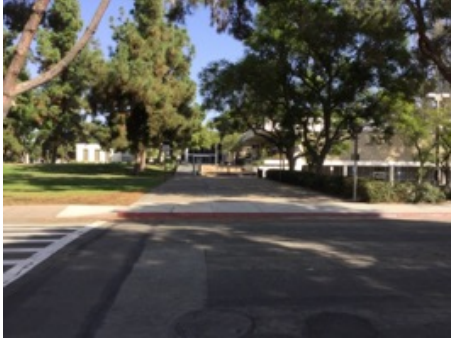
Comment #: CC-11

Deficiency: Accessible Route - Openings - Direction

Accessible route grates / openings exceed 1/2" in the direction of travel.

Measurement: inches

Recommended Remediation:

Replace grates, or fill openings, at locations where gratings/openings occur. Openings are allowed a maximum of 1/2" in the direction of travel.

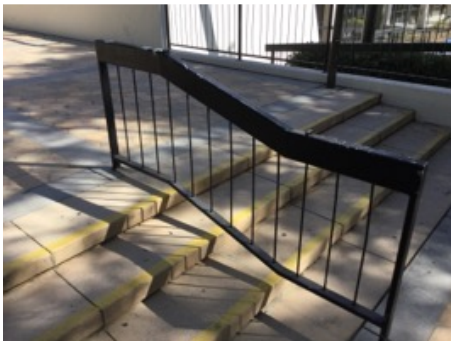
Comment #: CC-12

Deficiency: Ramps - Handrails - Both Sides

Handrails are not provided on both sides of the ramp. Anti skateboarding needs to be removed from railings, and railings need to be replaced.

Measurement: 16 count

Recommended Remediation:

Install missing handrails so they are provided on both sides of stairs and ramps.

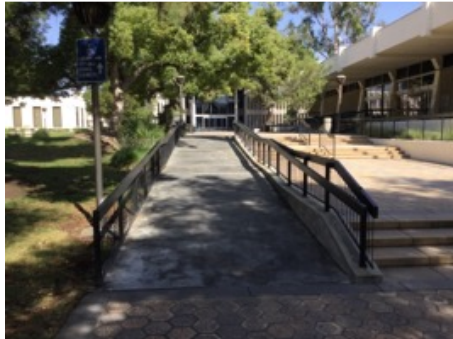
Comment #: CC-13

Deficiency: Ramps - Handrails - Both Sides

Handrails are not compliant on both sides of the ramp.

Measurement: 10 count

Recommended Remediation:

Replace non compliant handrails so they are provided on both sides of stairs and ramps. Skateboard deterrents can not be installed on top of handrails.

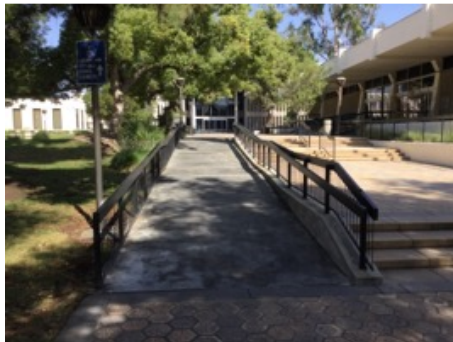
Comment #: CC-14

Deficiency: Ramps - Slopes - Running Slope

The running slope of the ramp is steeper than 1:12 (8.33%). 48' of the pedestrian ramp along west side of stairs between SA3 (Thomas & W 7th) and library. Slopes vary 9.6% to 10%

Measurement: 10 % grade

Recommended Remediation:

Remove and replace the ramp. The running slope of the curb ramp segments shall be in-line with the direction of sidewalk travel. Ramp runs shall have a running slope not steeper than 1:12.

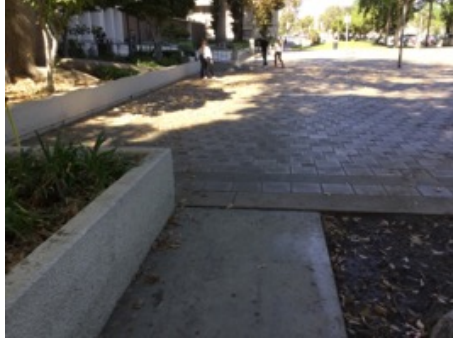
Comment #: CC-15

Deficiency: Accessible Route - Vertical Displacement - Height

Accessible route has multiple locations where changes in level over 1/4" vertical or 1/2" beveled occur.

Measurement: .75 inches

Recommended Remediation:

Replace/grind locations where changes in elevation occur. Changes in level of 1/4" high maximum shall be permitted to be vertical and without edge treatment.

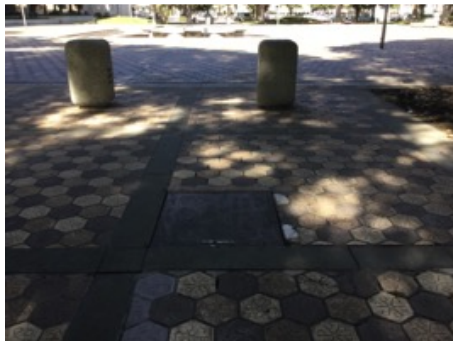
Comment #: CC-16

Deficiency: Accessible Route - Vertical Displacement - Height

Accessible route has multiple locations where changes in level over 1/4" vertical or 1/2" beveled occur.

Measurement: .75 inches

Recommended Remediation:

Replace/grind locations where changes in elevation occur. Changes in level of 1/4" high maximum shall be permitted to be vertical and without edge treatment.

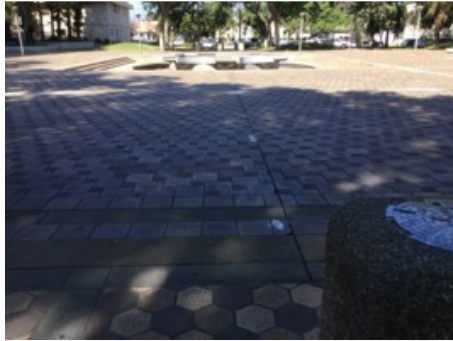
Comment #: CC-17

Deficiency: Accessible Route - Openings - Direction

Accessible route grates / openings exceed 1/2" in the direction of travel.

Measurement: .75 inches

Recommended Remediation:

Replace grates, or fill openings, at locations where gratings/openings occur. Openings are allowed a maximum of 1/2" in the direction of travel.

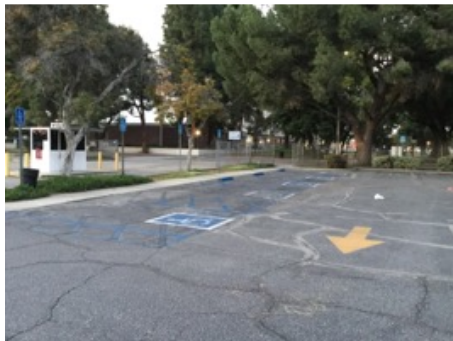
Comment #: CC-18

Deficiency: Parking - General Parking - Car Stall Space Count

There are not enough accessible parking spaces designated as per Table 11B -208.2. A minimum of one car standard stall and access aisle shall be provided.

Measurement: 6 % grade

Recommended Remediation:

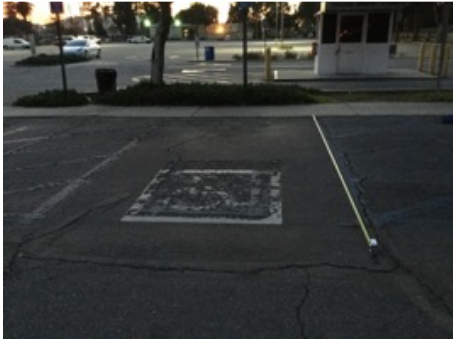
Comment #: CC-19

Deficiency: Parking - Accessible Stall - Length

The accessible van/car stall is less than 216 inches (18 ft. or 5486 mm) long.

Measurement: 183 inches

Recommended Remediation:

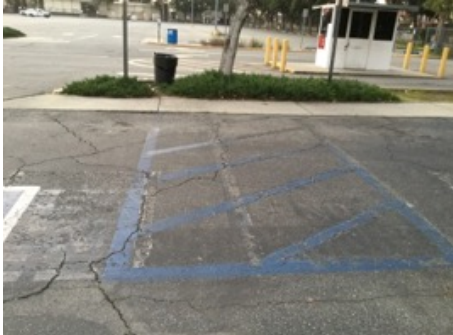
Comment #: CC-20

Deficiency: Parking - Access Aisle Markings - Border Line Markings

The access aisle is not marked with a blue painted border line around the entire perimeter.

Measurement: 6 count

Recommended Remediation:

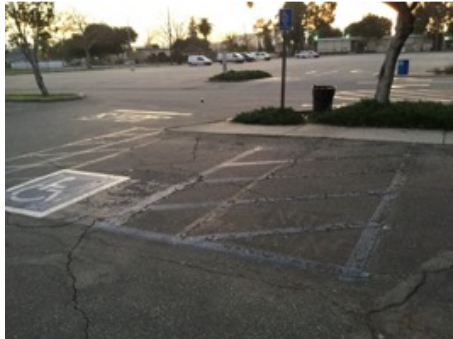
Comment #: CC-21

Deficiency: Parking - Access Aisle Markings - "No Parking"

Markings are faded and does not discourage parking in the access aisle.

Measurement: 6 count

Recommended Remediation:

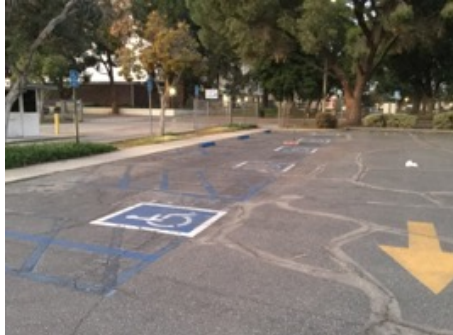
Comment #: CC-22

Deficiency: Parking - Access Aisle - Slope

The slope of the access aisle in any direction exceeds 1:48 (2.0%) grade.

Measurement: 3.2 % grade

Recommended Remediation:

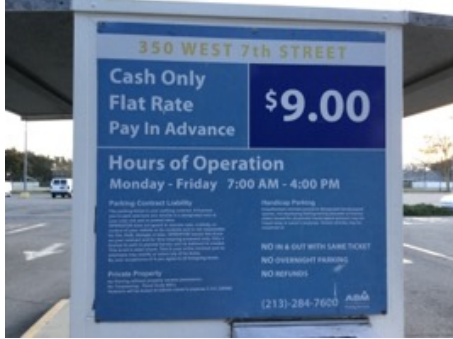
Comment #: CC-23 **Deficiency:** Parking - Tow Away Sign - Location

The "Unauthorized Parking Sign" sign is not located at the entrance to the off-street parking.

Measurement: 1 count

Recommended Remediation:

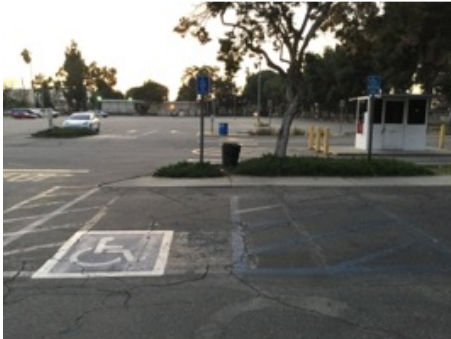
Comment #: CC-25

Deficiency: Parking - General Parking - Van Stall Space Count

One access space in every six access spaces (or portion of 6) is not van accessible.

Measurement: 1 count

Recommended Remediation:

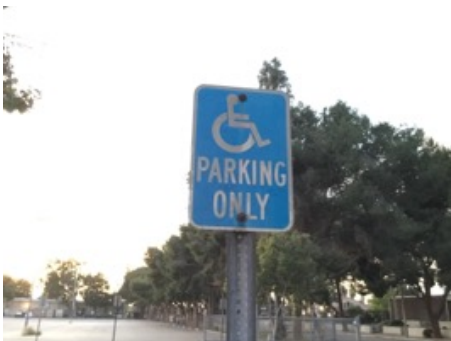
Comment #: CC-26

Deficiency: Parking - Signage - Finish

The parking identification sign does not have a reflective finish.

Measurement: 6 count

Recommended Remediation:

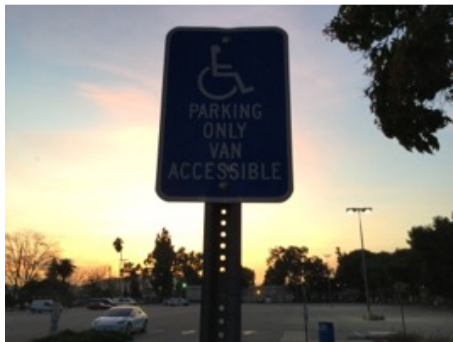
Comment #: CC-27

Deficiency: Parking - Signage - Minimum Fine

The parking identification sign does not include the text "Minimum Fine \$250" below the ISA.

Measurement: 6 count

Recommended Remediation:

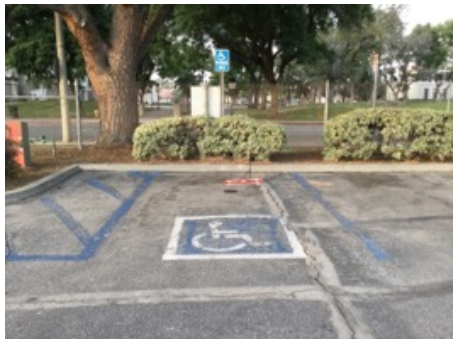
Comment #: CC-28

Deficiency: Parking - Accessible Stall - Slopes

The slope of the van/car stall in any direction exceeds 1:48 (2.0%) grade.

Measurement: 4.3 % grade

Recommended Remediation:

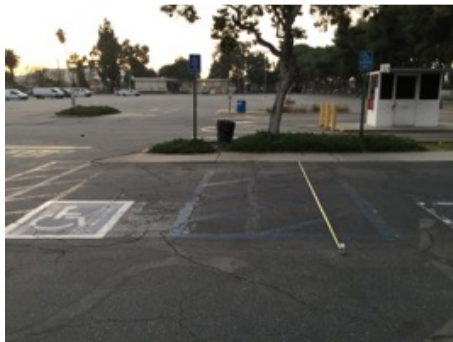
Comment #: CC-29

Deficiency: Parking - Access Aisle Markings - Length

The access aisle does not extend the full required length of the parking stall(s) served.

Measurement: 184 inches

Recommended Remediation:

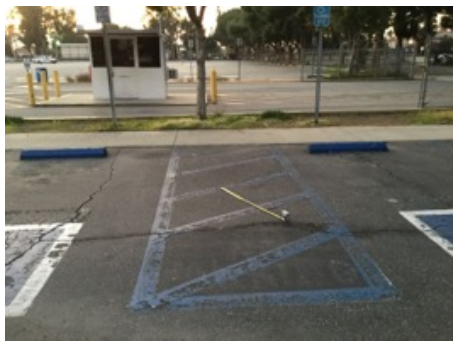
Comment #: CC-30

Deficiency: Parking - Access Aisle Markings - Hatched Line Spacing

The hatched lines within the border line of the access aisle are spaced greater than 36 inches (914 mm) on center apart.

Measurement: 32 inches

Recommended Remediation:
