APPENDIX A

FACILITY ASSESSMENT PHOTO REPORTS

CITY HALL

1.0 Site Assessment

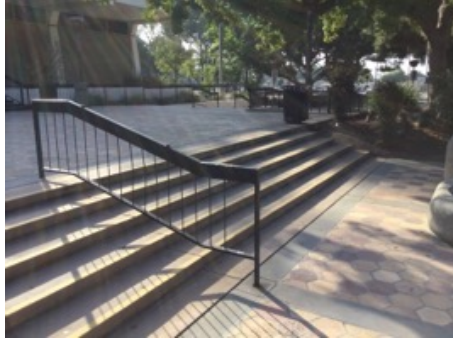
Comment #: CC-31

Deficiency: Stairs - Contrast Striping - Exterior Stair

A 2-inch minimum to 4-inch maximum clear visual contrast stripe is fading and is beginning to chip off.

Measurement: 5 count

Recommended Remediation:

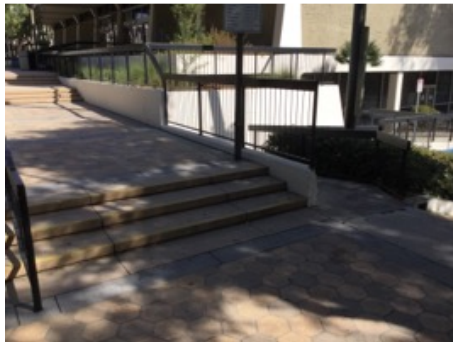
Comment #: CC-32

Deficiency: Stairs - Contrast Striping - Exterior Stair

A 2-inch minimum to 4-inch maximum clear visual contrast stripe is worn from use and needs to be replaced on each step.

Measurement: 3 count

Recommended Remediation:

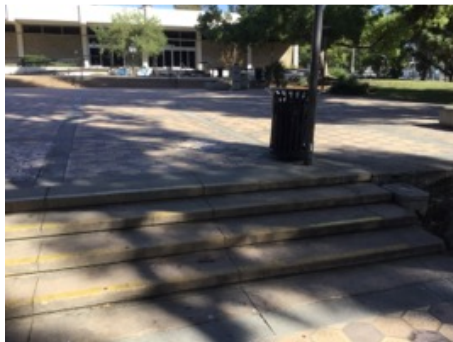
Comment #: CC-33

Deficiency: Stairs - Contrast Striping - Exterior Stair

A 2-inch minimum to 4-inch maximum clear visual contrast stripe is not provided on each step.

Measurement: 2 inches

Recommended Remediation:

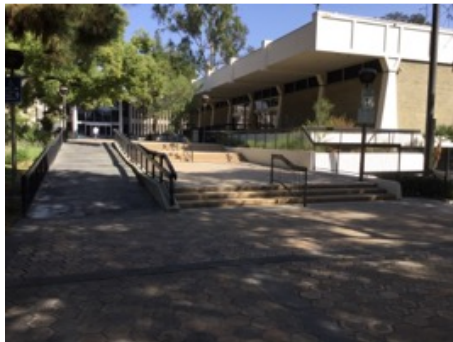
Comment #: CC-34

Deficiency: Stairs - Handrails - Extensions: Bottom

At the bottom of a stair flight, handrails shall extend at the slope of the stair flight for a horizontal distance equal to one tread depth beyond the last riser nosing. The extension shall be 12" min. and a height equal to that of the sloping portion of the handrail as measured above the stair nosings.

Measurement: 20 inches

Recommended Remediation:

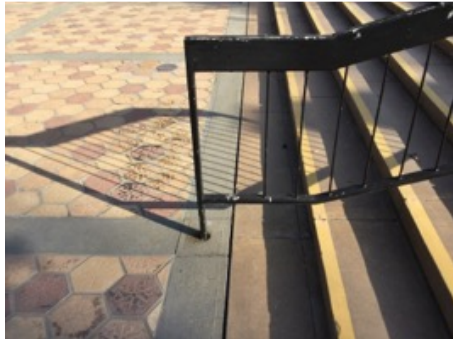
Comment #: CC-35

Deficiency: Stairs - Handrails - Gripping Surface

Bottom of the handrail surface is obstructed more than 20%. Handrails and extensions are not compliant.

Measurement: 4 count

Recommended Remediation:

Remove and replace handrails. Install continuous handrail gripping surfaces along their length and so there are no obstructions along their tops or sides. The bottoms of handrail gripping surfaces shall not be obstructed for more than 20 percent of their length. Provide compliant extensions top and bottom of handrails.

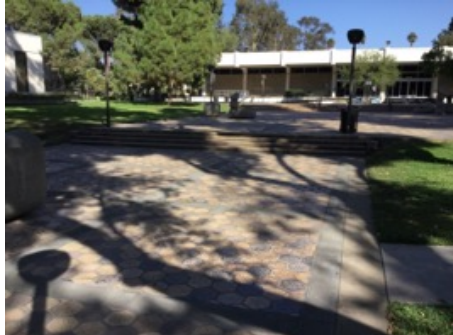
Comment #: CC-36

Deficiency: Stairs - Handrails - Both Sides

Handrails are not provided on both sides of the staircase.

Measurement: 2 count

Recommended Remediation:

Install missing handrails so they are provided on both sides of stairs and ramps.

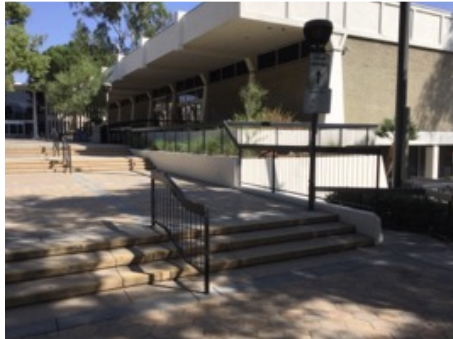
Comment #: CC-37

Deficiency: Stairs - Handrails - Both Sides

Handrails are not provided on both sides of the staircase.

Measurement: 120 count

Recommended Remediation:

Replace non compliant handrails so they are provided on both sides of stairs and ramps.

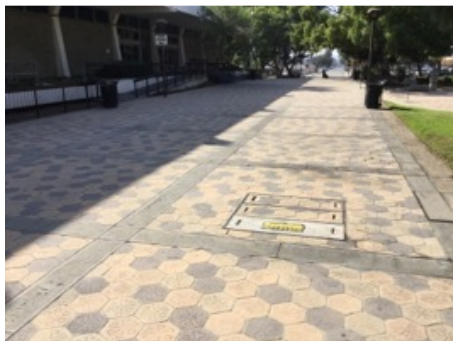
Comment #: CC-38

Deficiency: Accessible Route - Openings - Width

Accessible route grates / openings exceed 1/2" in the direction of travel.

Measurement: 1.25 inches

Recommended Remediation:

Replace grates, or fill openings, at locations where gratings/openings occur. Openings are allowed a maximum of 1/2" in the direction of travel.

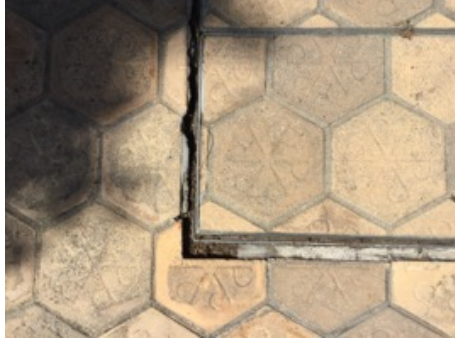
Comment #: CC-39

Deficiency: Accessible Route - Openings - Width

Accessible route grates / openings exceed 1/2" in the direction of travel.

Measurement: 1 inches

Recommended Remediation:

Replace grates, or fill openings, at locations where gratings/openings occur. Openings are allowed a maximum of 1/2" in the direction of travel.

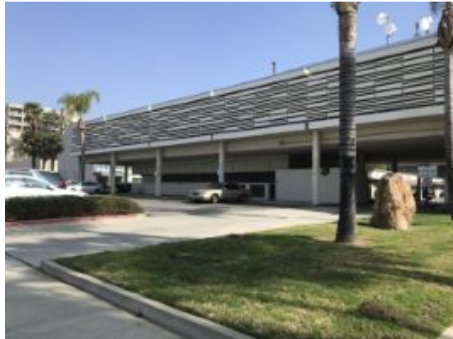
Comment #: PD-01

Deficiency: Parking - Tow Away Sign - Verbiage

The verbiage on the "tow-away" sign is provided.

Measurement: 1 count

Recommended Remediation:

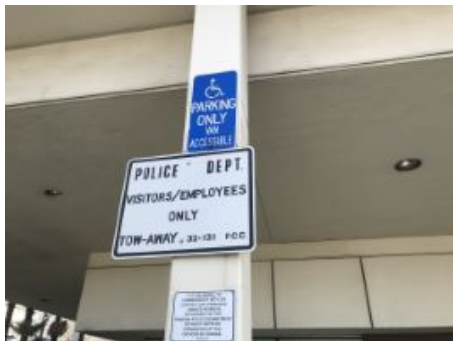
Comment #: PD-02

Deficiency: Parking - Signage - Minimum Fine

The parking identification sign does not include the text "Minimum Fine \$250" below the ISA.

Measurement: 0 count

Recommended Remediation:

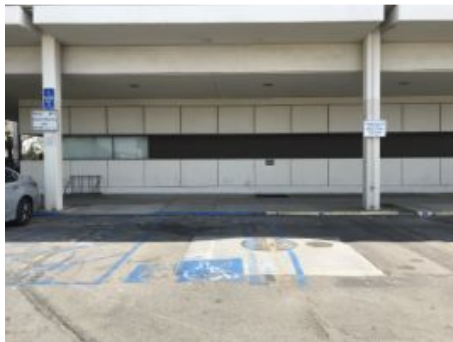
Comment #: PD-03

Deficiency: Parking - Signage - Location

The parking identification sign with ISA is not installed at car accessible parking stall.

Measurement: 0 count

Recommended Remediation:

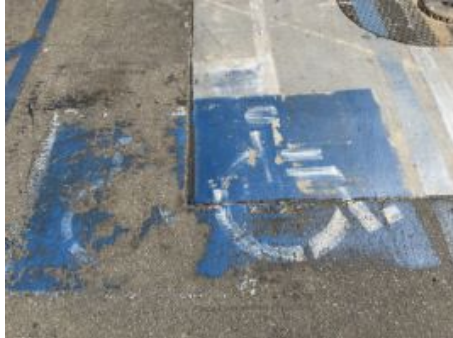
Comment #: PD-04

Deficiency: Parking - Accessible Stall - Markings

Measurement: 1 count

Recommended Remediation:

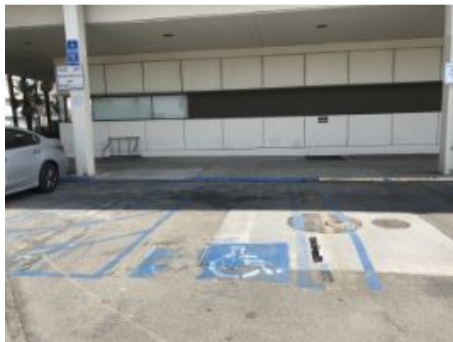
Comment #: PD-05

Deficiency: Parking - Accessible Stall - Slopes

The slope of the van/car stall in any direction exceeds 1:48 (2.0%) grade. 12.0% running slope and 8.0% cross slope measured at the parking stall.

Measurement: 12 % grade

Recommended Remediation:

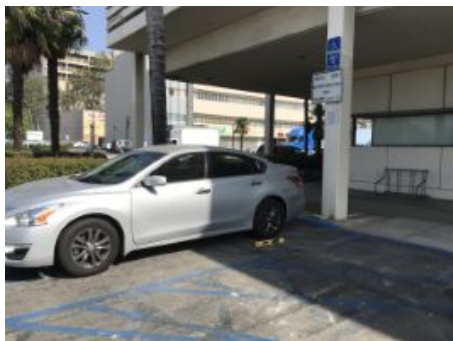
Comment #: PD-06

Deficiency: Parking - Accessible Stall - Slopes

The slope of the van/car stall in any direction exceeds 1:48 (2.0%) grade.

Measurement: 3.9 % grade

Recommended Remediation:

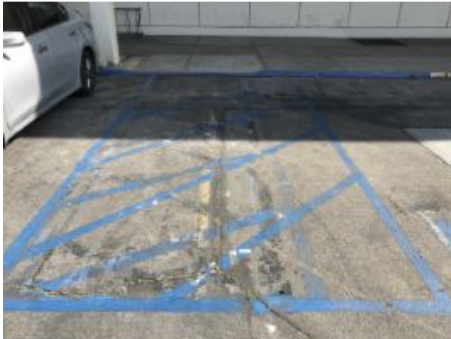
Comment #: PD-07

Deficiency: Parking - Access Aisle Markings - "No Parking"

Markings are faded and does not discourage parking in the access aisle.

Measurement: 0 count

Recommended Remediation:

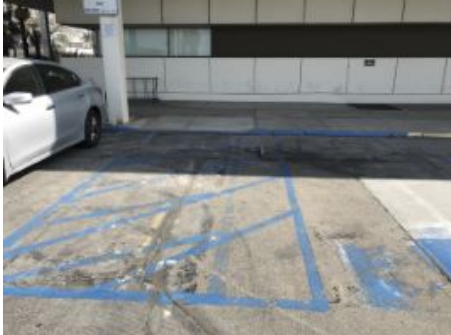
Comment #: PD-08

Deficiency: Parking - Access Aisle - Slope

The slope of the access aisle in any direction exceeds 1:48 (2.0%) grade.

Measurement: 2.9 % grade

Recommended Remediation:

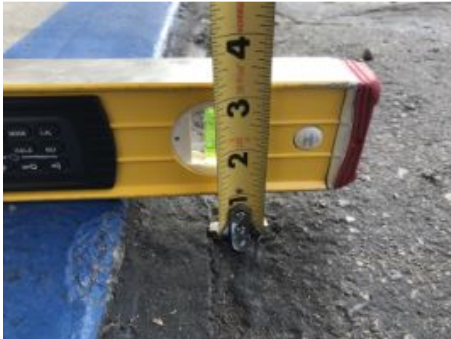
Comment #: PD-09

Deficiency: Accessible Route - Vertical Displacement - Height

Accessible route has multiple locations where changes in level over ¼” vertical or ½” beveled occur.

Measurement: 1 inches

Recommended Remediation:

Replace/grind locations where changes in elevation occur. Changes in level of ¼” high maximum shall be permitted to be vertical and without edge treatment.

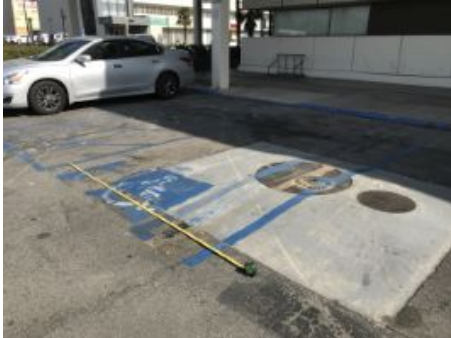
Comment #: PD-10

Deficiency: Parking - Accessible Car Stall - Width

The accessible car stall is less than 108 inches (9 ft. or 2743 mm) wide.

Measurement: 100.75 inches

Recommended Remediation:

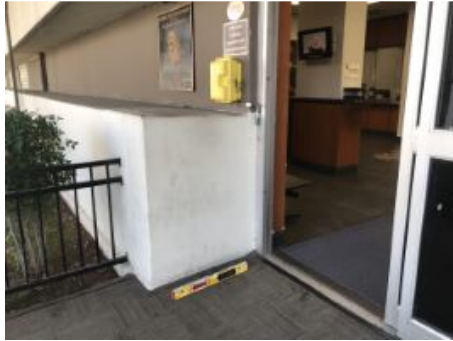
Comment #: PD-11

Deficiency: Accessible Route - Reach Ranges - Clear Floor Space

30" x 48" level clear ground space is not provided at the operable part.

Measurement: 4.9 % grade

Recommended Remediation:

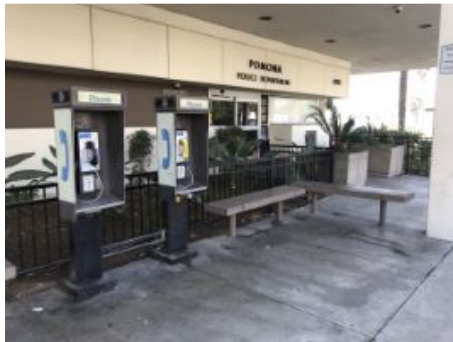
Comment #: PD-12

Deficiency: Accessible Route - Reach Ranges - Side Reach

Element for side reach is not located within 15-inches minimum to 48-inches maximum AFF (to to a 10-inch depth).

Measurement: 54 inches

Recommended Remediation:

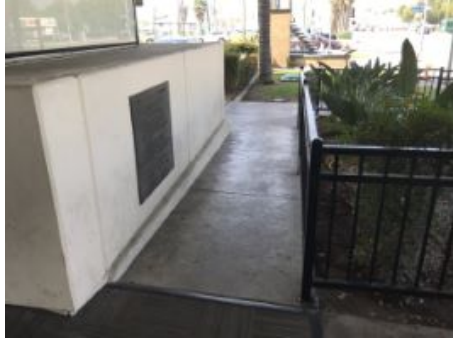
Comment #: PD-13

Deficiency: Accessible Route - Clear Width - General

Accessible route widths do not provide minimum 48-inches clear. 42" wide route measured along the route from the parking lot to the building entrance. Route is 22' long.

Measurement: 42 inches

Recommended Remediation:

Replace walks to provide a clear width of 48 inches (1219 mm) minimum. When, because of right-of-way restrictions, natural barriers or other existing conditions, the enforcing agency determines that compliance with the 48-inch (1219 mm) clear sidewalk width would create an unreasonable hardship, the clear width may be reduced to 36 inches (914 mm).

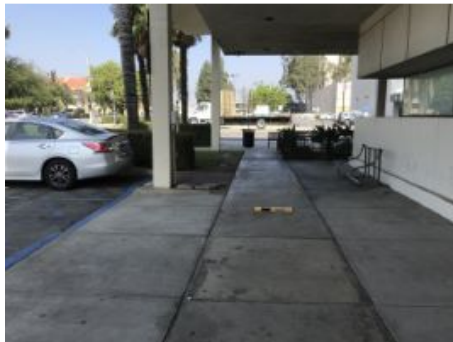
Comment #: PD-14

Deficiency: Accessible Route - Slopes - Cross Slope

The cross slope of accessible routes exceeds 1:48 (2.0 %). 2.4% to 2.7% cross slope measured where the route from the accessible parking spaces turns towards the building entrance.

Measurement: 2.7 % grade

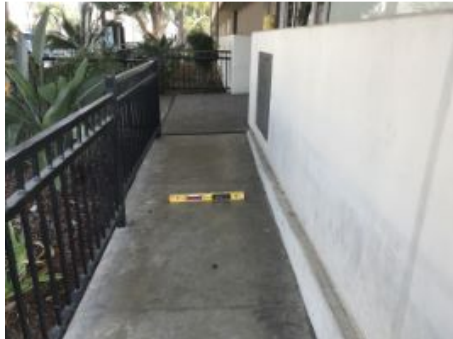
Comment #: PD-15

Deficiency: Accessible Route - Slopes - Cross Slope

The cross slope of accessible routes exceeds 1:48 (2.0 %). 3.1% to 3.6% cross slope measured along the route. Route is 7' long.

Measurement: 3.6 % grade

Remove and replace walk. Install walk that provides cross slopes at circulation route of 1:48 maximum.

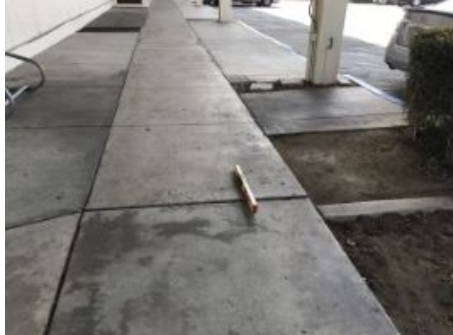
Comment #: PD-16

Deficiency: Accessible Route - Vertical Displacement - Height

Accessible route has multiple locations where changes in level over 1/4" vertical or 1/2" beveled occur.

Measurement: .75 inches

Replace/grind locations where changes in elevation occur. Changes in level of 1/4" high maximum shall be permitted to be vertical and without edge treatment.

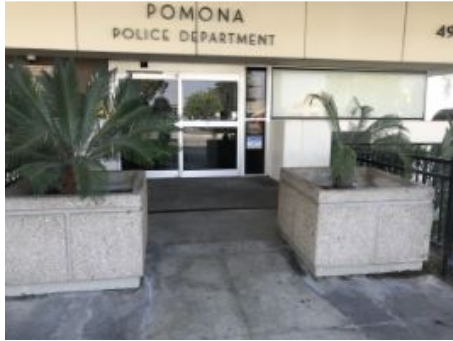
Comment #: PD-17

Deficiency: Accessible Route - Clear Width - General

Accessible route widths do not provide minimum 48-inches clear. 40" wide route measured bushes at the planters located along either of the route to the building entrance.

Measurement: 40 inches

Replace walks to provide a clear width of 48 inches (1219 mm) minimum. When, because of right-of-way restrictions, natural barriers or other existing conditions, the enforcing agency determines that compliance with the 48-inch (1219 mm) clear sidewalk width would create an unreasonable hardship, the clear width may be reduced to 36 inches (914 mm).

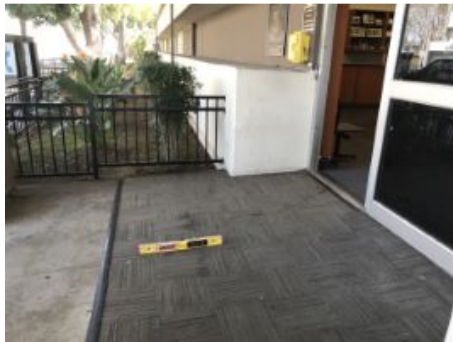
Comment #: PD-18

Deficiency: Accessible Route - Slopes - Cross Slope

The cross slope of accessible routes exceeds 1:48 (2.0 %). 4.2% to 4.9% cross slope measured along the route. Route is 7' long.

Measurement: 4.9 % grade

Remove and replace walk. Install walk that provides cross slopes at circulation route of 1:48 maximum.

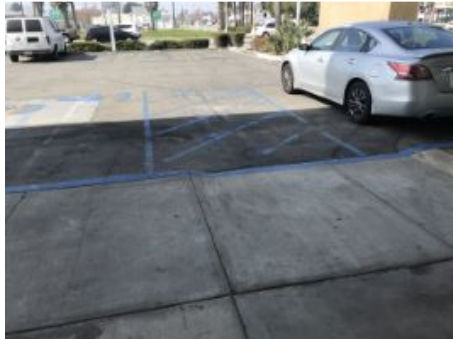
Comment #: PD-19

Deficiency: Accessible Route - Hazardous Vehicular Areas - Detectable Warning

The detectable warning surface is not installed at hazardous vehicular area boundary.

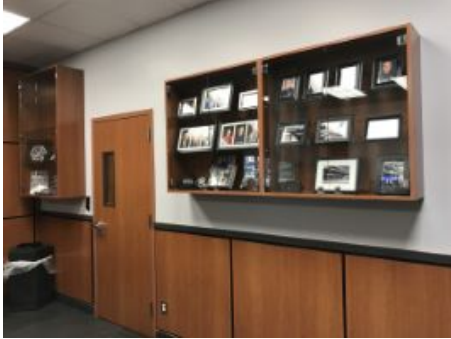
Comment #: PD-21

Deficiency: Accessible Route - Protrusion - Depth

Objects in the path of travel extend more than 4 inches from the wall with no cane detectable barrier. Trophy case protrudes 10" into the circulation path at 55-1/2" AFF

Measurement: 10 inches

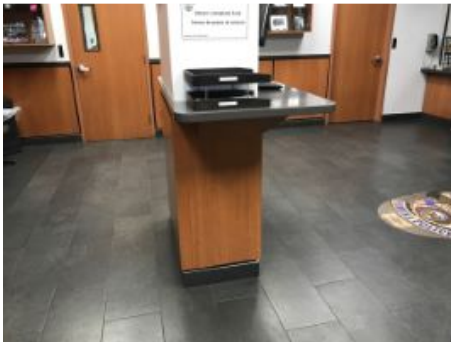
Comment #: PD-22

Deficiency: Accessible Route - Protrusion - Depth

Objects in the path of travel extend more than 4 inches from the wall with no cane detectable barrier. Computer counter protrudes 11" into the accessible route at 42" AFF.

Measurement: 11 inches

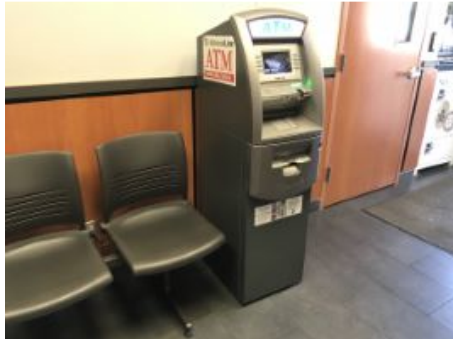
Comment #: PD-23

Deficiency: Accessible Route - Reach Ranges - Side Reach

Element for side reach is not located within 15-inches minimum to 48-inches maximum AFF (to to a 10-inch depth).

Measurement: 48.5 inches

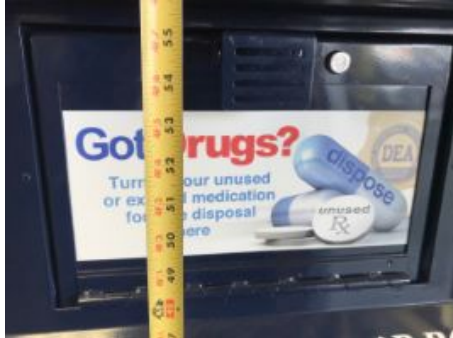
Comment #: PD-24

Deficiency: Accessible Route - Reach Ranges - Side Reach

Element for side reach is not located within 15-inches minimum to 48-inches maximum AFF (to to a 10-inch depth).

Measurement: 54 inches

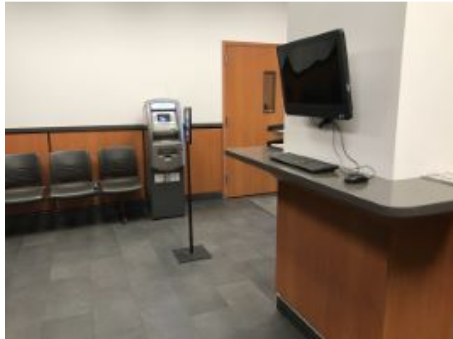
Comment #: PD-25

Deficiency: Transaction Counters - Dimensions - Counter Height

The counter surface is higher than the allowable 34 inches above the finished floor.

Measurement: 43.5 inches

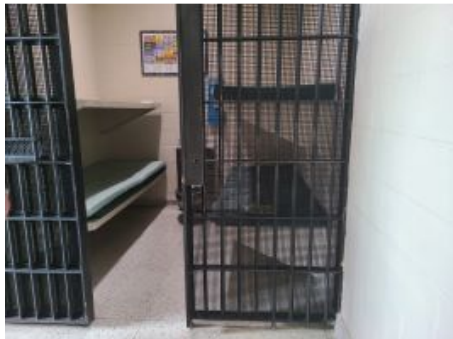
Comment #: PD-26

Deficiency: Jail Cells and Showers - General -

Jail cells and showers are not accessible.

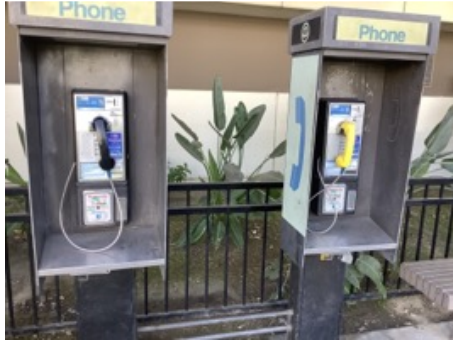
Comment #: PD-27

Deficiency: Telephone - TTY - General

TTY and volume control are not provided. Include the international sign of hearing impaired

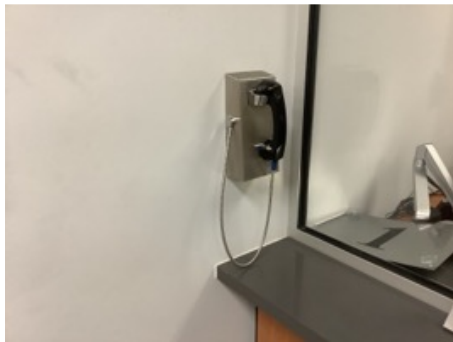
Comment #: PD-28

Deficiency: Telephone - Volume Control - General

The handset provided does not have compliant volume control.

Replace the handset with one that has volume control. The handset volume controls shall be equipped with a receiver volume control that provides a gain adjustable up to 20dB minimum. For incremental volume control, provide at least one intermediate step of 12dB of gain minimum. An automatic reset shall be provided.

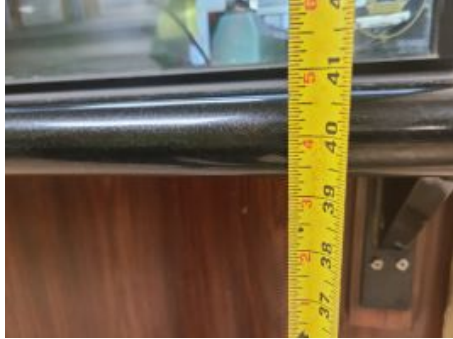
Comment #: PD-29

Deficiency: Transaction Counters - Dimensions - Counter Height

The counter surface is higher than the allowable 34 inches above the finished floor.

Measurement: 30.75 inches

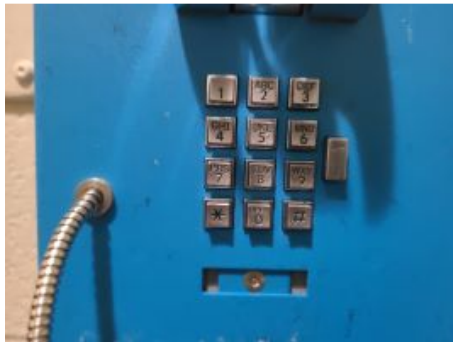
Comment #: PD-30

Deficiency: Telephone - TTY - General

TTY and volume control are not provided. Include the international sign of hearing impaired

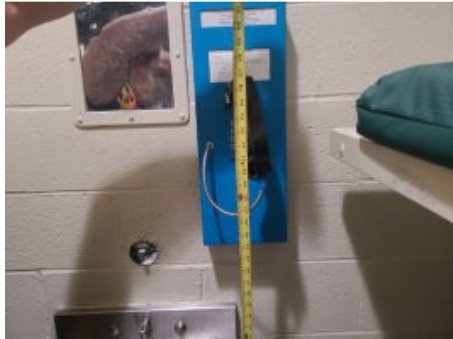
Comment #: PD-31

Deficiency: Telephone - Location - Height

Not all buttons are located within the allowable reach ranges.

Measurement: 54 inches

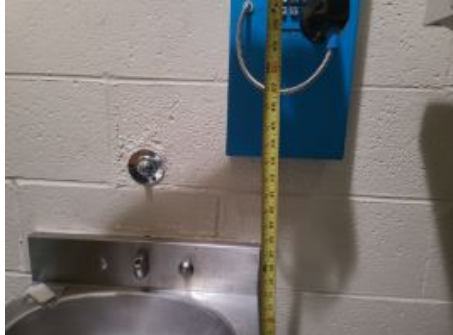
Comment #: PD-32

Deficiency: Telephone - Clear Floor Space - General

Clear floor space is not provided at the phone.

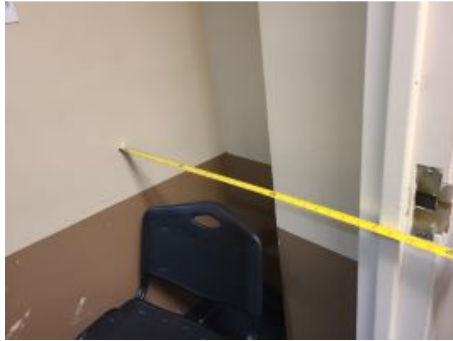
Comment #: PD-33

Deficiency: Interior Space - Turning Space - Radius

The room does not allow for a clear turning radius of 60 inches or a T-turn of 60 inches.

Measurement: 56 inches

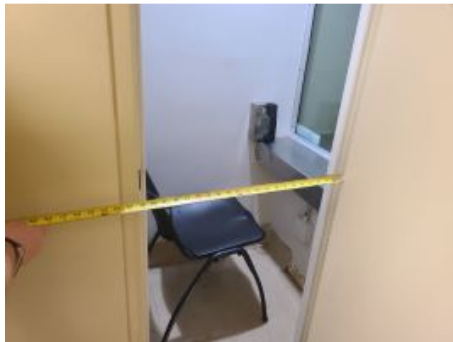
Comment #: PD-34

Deficiency: Interior Doors/Doorways/Gates - Dimensions - Width

32-inch clear opening is not provided when door is open at 90 degrees.

Measurement: 20.5 inches

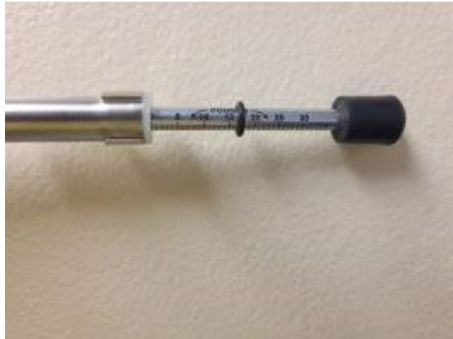
Comment #: PD-35

Deficiency: Interior Doors/Doorways/Gates - Operation - Opening Force

The force required to operate the door exceeds the allowable 5 lbf.

Measurement: 17 lbf

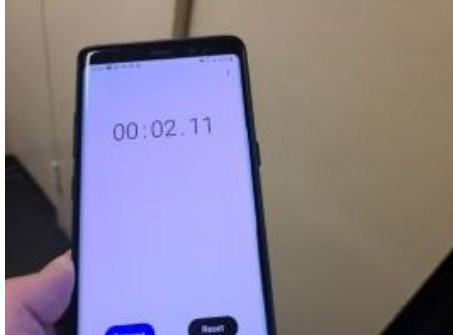
Comment #: PD-36

Deficiency: Interior Doors/Doorways/Gates - Operation - Closing Speed

The door closes faster than the minimum 5 seconds.

Measurement: 2.11 seconds

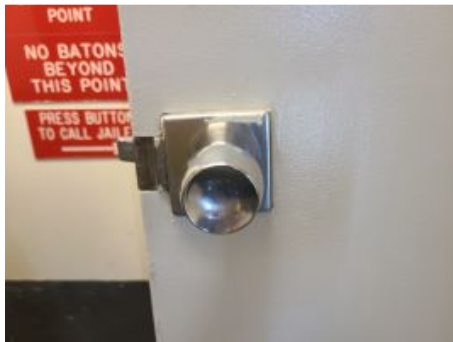
Comment #: PD-37

Deficiency: Interior Doors/Doorways/Gates - Hardware - Operation

The operable part requires tight grasping, pinching and/or twisting of the wrist to operate.

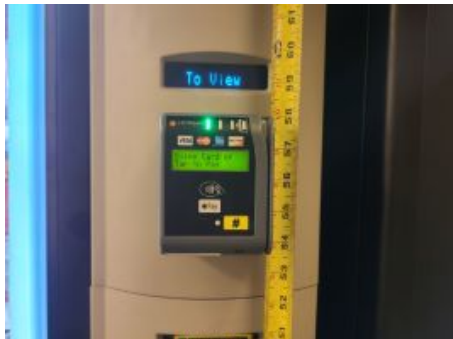
Comment #: PD-38

Deficiency: Accessible Route - Reach Ranges - Side Reach

Element for side reach is not located within 15-inches minimum to 48-inches maximum AFF (to to a 10-inch depth).

Measurement: 58 inches

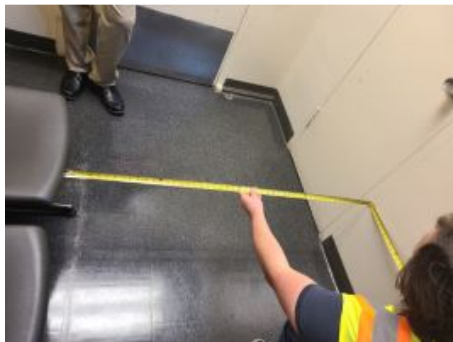
Floor/Area: Jail
Room/Spot: Visitors Room
Notes: Visitor Side

Deficiency: Interior Doors/Doorways/Gates - Clearances: Front - Pull Side Approach

Reconfigure doorway landing to provide a minimum 60-inch door maneuvering space.

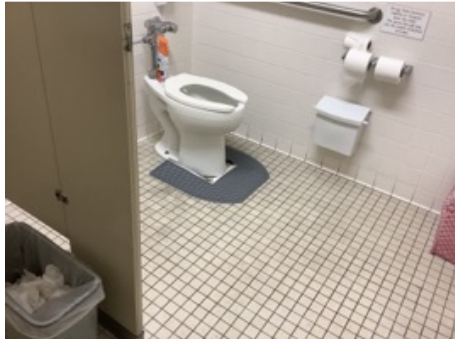
Comment #: PD-40

Deficiency: Restroom Access - Floor Surface - Mat

Carpet or carpet tile is not securely attached.

Mat may cause tripping hazard due to not being securely attached.

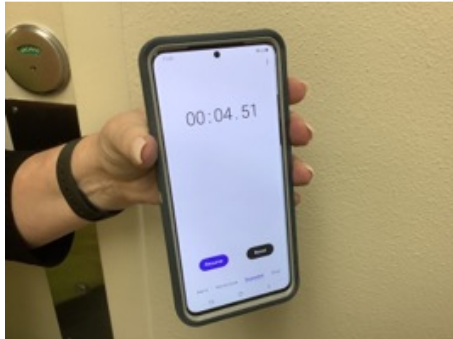
Comment #: PD-42

Deficiency: Restroom Doors - Operation - Closing Speed

The door closes faster than the minimum 5 seconds.

Measurement: 4.51 seconds

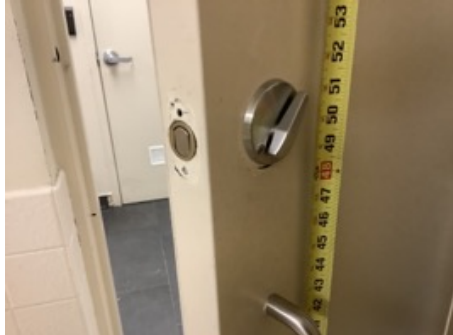
Comment #: PD-43

Deficiency: Restroom Doors - Hardware - Handle Height

The door hardware is located outside the allowable height ranges.

Measurement: 51 inches

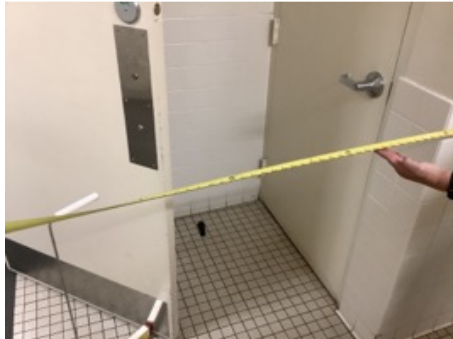
Comment #: PD-44

Deficiency: Restroom Doors - Clearances: Front - Pull Side Approach

60 inches of maneuvering space beyond the pull side of the door is not provided.

Measurement: 49.25 inches

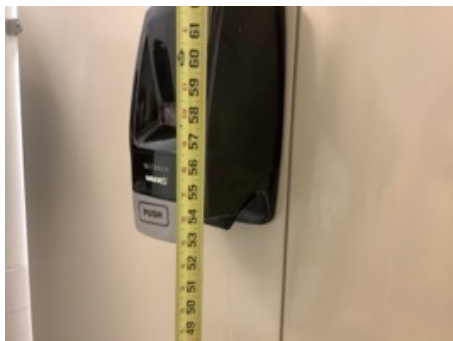
Comment #: PD-45

Deficiency: Restroom Interior Space - Amenities - Soap Dispenser Height

The soap dispenser exceeds the maximum allowable height.

Measurement: 54 inches

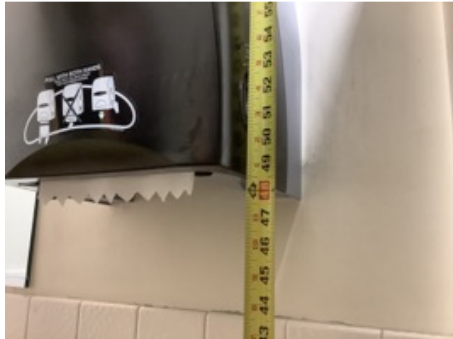
Comment #: PD-46

Deficiency: Restroom Interior Space - Amenities - Paper Towel Height

The paper towel dispenser exceeds the maximum allowable height.

Measurement: 52.5 inches

In California, all operable parts, including coin slots, shall be 40 inches (1016 mm) maximum above the finish floor. ADA allows accessories to meet reach ranges as noted below;

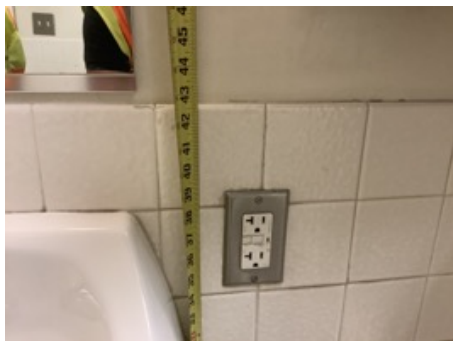
Comment #: PD-47

Deficiency: Restroom Interior Space - Amenities - Mirror Height

The mirror height exceeds the allowable 40 inches above the finished floor.

Measurement: 44 inches

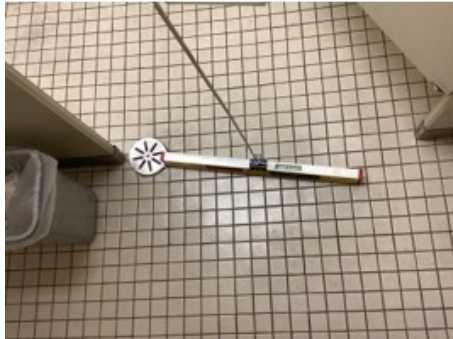
Comment #: PD-48

Deficiency: Restroom Interior Space - Floor Surface - Slopes

The floor surface has slopes that exceeds the allowable 1:48 (2%) grade in any direction.

Measurement: 2.7 % grade

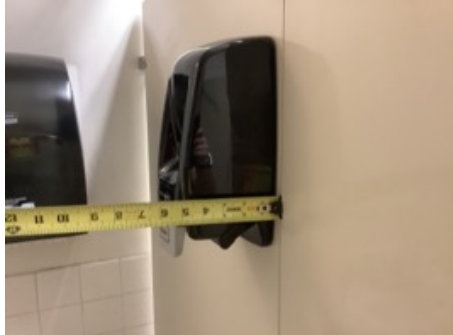
Comment #: PD-49

Deficiency: Restroom Interior Space - Protruding Objects - General

Objects in the restroom extend more than 4 inches from the wall with no cane detectable barrier.

Measurement: 5.25 inches

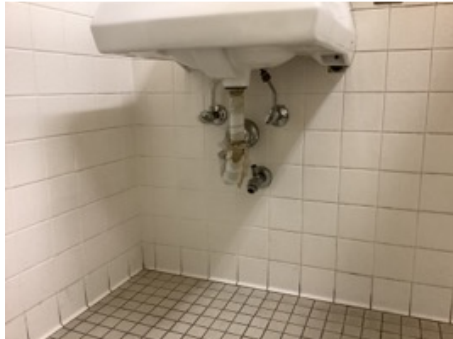
Comment #: PD-50

Deficiency: Lavatory - Covered Pipes/Hose Bib - General

The pipe insulation does not cover everything under the sink including water supply lines and hose bib.

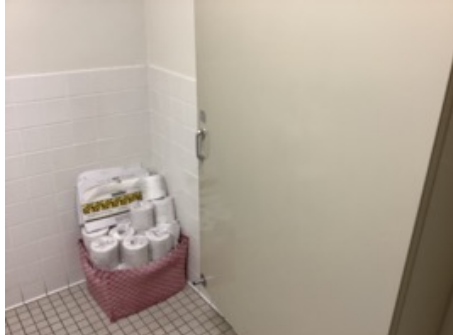
Comment #: PD-51

Deficiency: Accessible Toilet Stall - Door - Self-Closing Door

The stall door is not self closing.

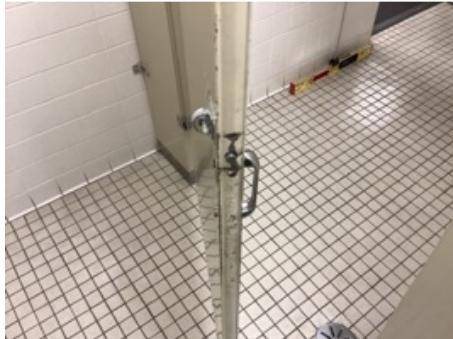
Comment #: PD-52

Deficiency: Accessible Toilet Stall - Door Hardware - Handle Both Sides

There is no pull handle on the interior side of the stall door.

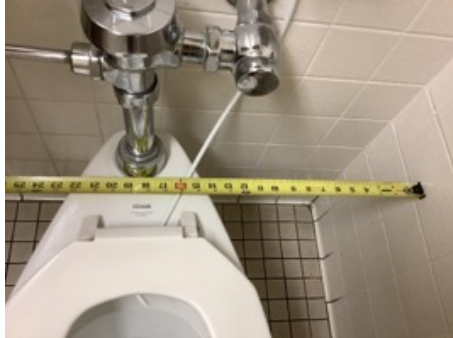
Comment #: PD-53

Deficiency: Accessible Toilet Stall - Water Closet - Location

The water closet is not a compliant distance from the adjacent wall.

Measurement: 18.5 inches

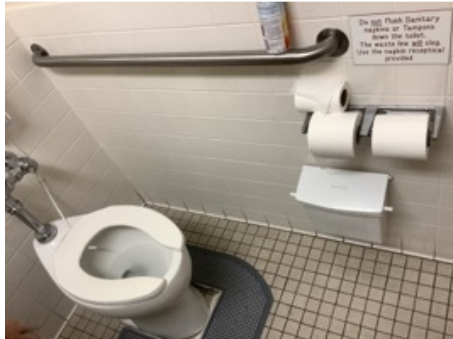
Comment #: PD-54

Deficiency: Accessible Toilet Stall - Dispensers - Toilet Paper Location

The toilet paper dispenser is outside of the allowable reach range.

Measurement: 19.5 inches

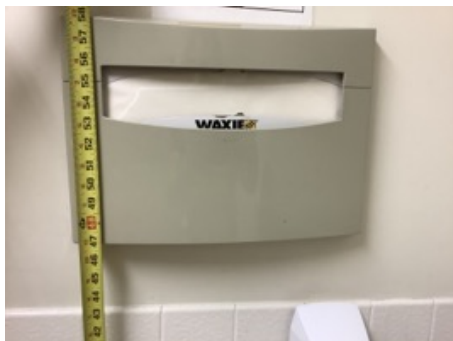
Comment #: PD-55

Deficiency: Accessible Toilet Stall - Dispensers - Seat Cover Height

The height of the operable part of the provided seat cover dispenser exceeds the allowable 40 inches AFF, is not located on an accessible route, no 30" x 48" clear floor space and reaching over water closet.

Measurement: 54.5 inches

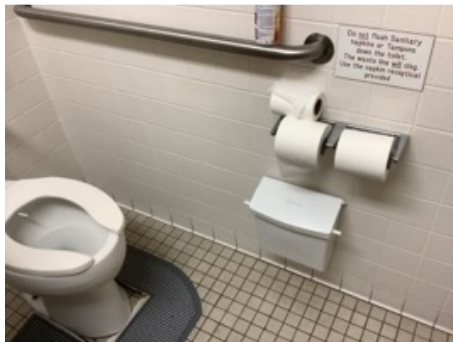
Comment #: PD-56

Deficiency: Accessible Toilet Stall - Dispensers - Sanitary Napkin Location

The sanitary napkin disposal unit is in the wrong location in front of the toilet paper dispenser.

Measurement: 1 count

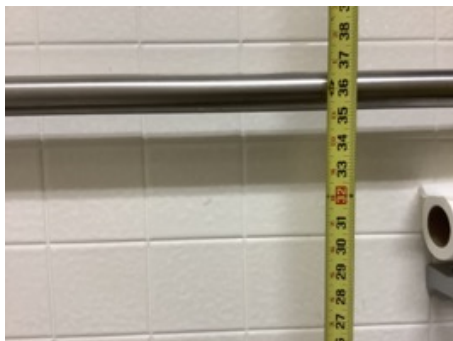
Comment #: PD-57

Deficiency: Accessible Toilet Stall - Side Grab Bar - Height

The side grab bar is mounted outside the allowable heights AFF.

Measurement: 37 inches

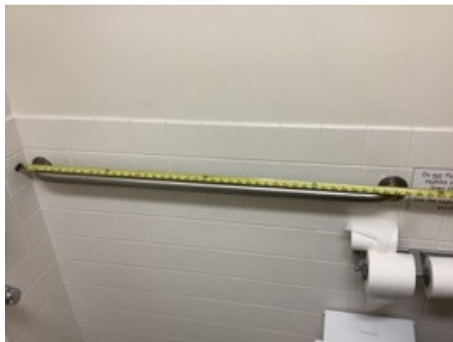
Floor/Area: Jail
Room/Spot: Gender Neutral Restroom
Notes: Left

Deficiency: Accessible Toilet Stall - Side Grab Bar - End Distance to Rear Wall

The side wall grab bar shall be 42 inches (1067 mm) long minimum, located 12 inches (305 mm) maximum from the rear wall and extending 54 inches (1372 mm) minimum from the rear wall with the front end positioned 24 inches (610 mm) minimum in front of the water closet.

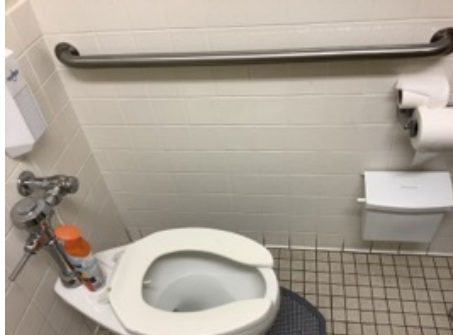
Floor/Area: Jail
Room/Spot: Gender Neutral Restroom
Notes: Left

Deficiency: Accessible Toilet Stall - Side Grab Bar - Distance to Water Closet

The side wall grab bar shall be 42 inches (1067 mm) long minimum, located 12 inches (305 mm) maximum from the rear wall and extending 54 inches (1372 mm) minimum from the rear wall with the front end positioned 24 inches (610 mm) minimum in front of the water closet.

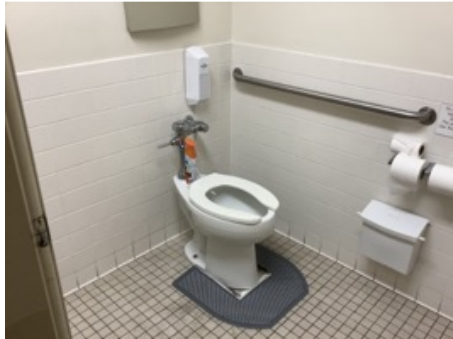
Comment #: PD-60

Deficiency: Accessible Toilet Stall - Grab Bars - General

Grab bars are missing.

Measurement: 1 count

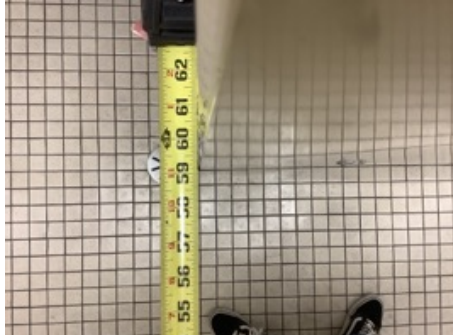
Comment #: PD-61

Deficiency: Accessible Toilet Stall - Dimensions - Stall Width

Width of stall is less than 60-inches when measured perpendicular to the side wall.

Measurement: 59.75 inches

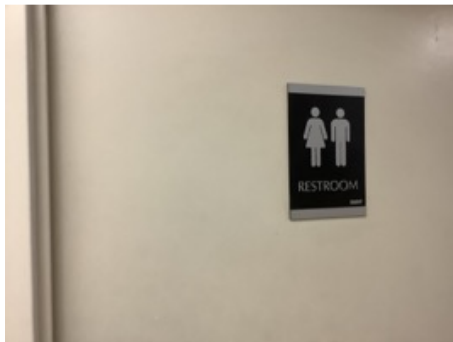
Comment #: PD-64

Deficiency: Restroom Doors - Tactile Sign - ISA General

Where restrooms are not accessible the accessible restroom is not identified by the ISA.

Measurement: 1 count

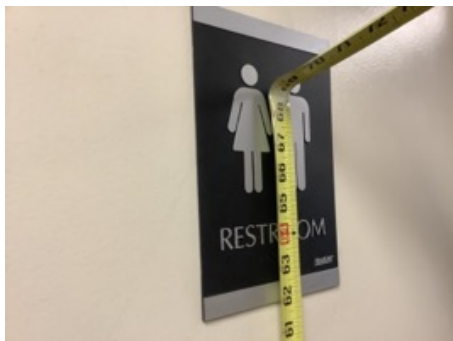
Comment #: PD-65

Deficiency: Restroom Doors - Tactile Sign - Height

The tactile sign is not mounted within the allowable height ranges.

Measurement: 63.75 inches

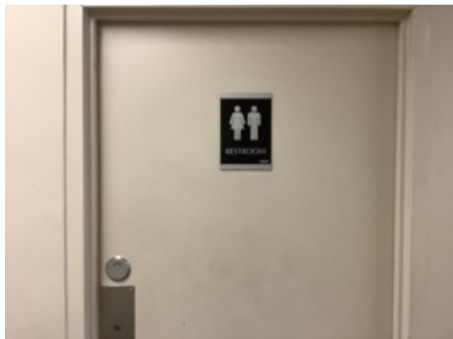
Comment #: PD-66

Deficiency: Restroom Doors - Geometric Sign - General

There is no geometric sign on the exterior door to the restrooms.

Measurement: 1 count

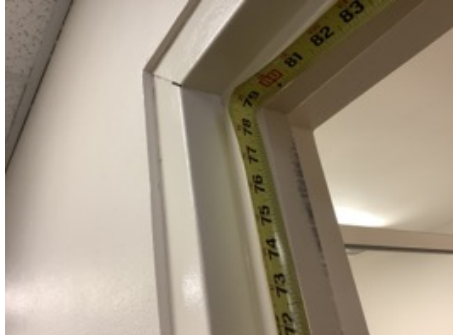
Comment #: PD-67

Deficiency: Restroom Doors - Dimensions - Clear Height

The door does not provide clear height.

Measurement: 78.75 inches

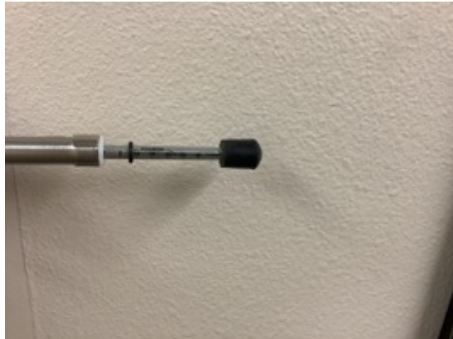
Comment #: PD-68

Deficiency: Restroom Doors - Operation - Opening Force

The force required to operate the door exceeds the allowable 5 lbf.

Measurement: 8 lbf

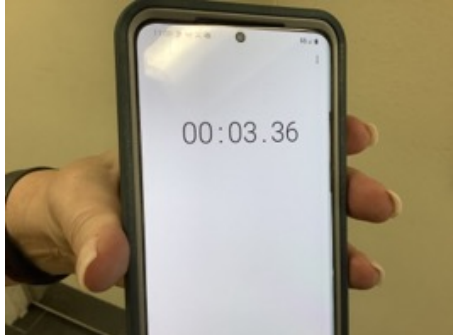
Comment #: PD-69

Deficiency: Restroom Doors - Operation - Closing Speed

The door closes faster than the minimum 5 seconds.

Measurement: 3.36 seconds

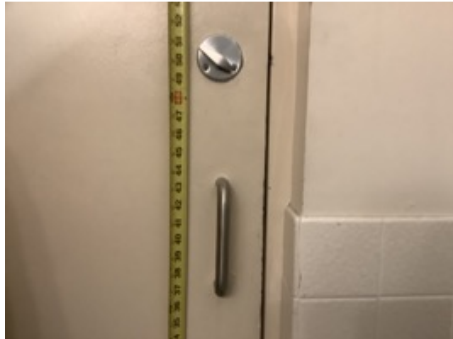
Comment #: PD-70

Deficiency: Restroom Doors - Hardware - Handle Height

The door hardware is located outside the allowable height ranges.

Measurement: 51 inches

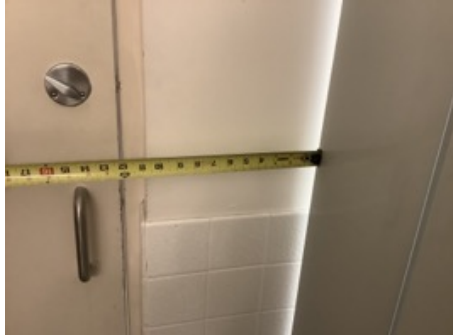
Comment #: PD-71

Deficiency: Restroom Doors - Clearances: Front - Latch Clearance

Latch side clearance is not provided at the pull side of the door.

Measurement: 12.75 inches

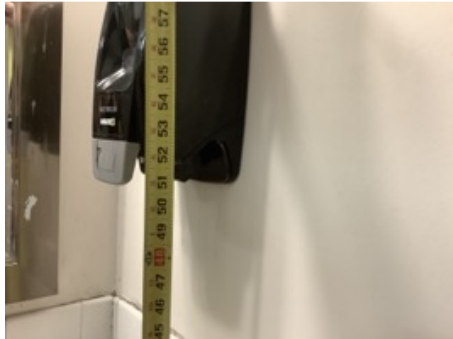
Comment #: PD-72

Deficiency: Restroom Interior Space - Amenities - Soap Dispenser Height

The soap dispenser exceeds the maximum allowable height.

Measurement: 52 inches

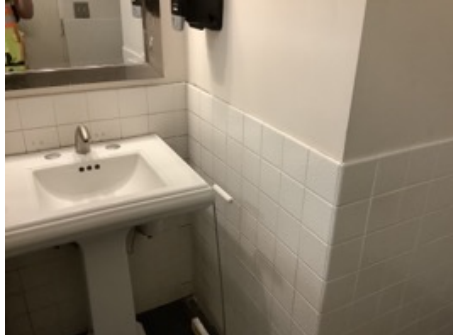
Comment #: PD-73

Deficiency: Restroom Interior Space - Amenities - Soap Dispenser Clear Floor Space

The soap dispenser does not have the required 30 inch X 48 inch clear floor space.

Measurement: 0 inches

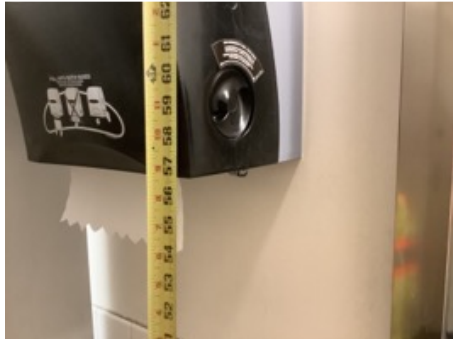
Comment #: PD-74

Deficiency: Restroom Interior Space - Amenities - Paper Towel Height

The paper towel dispenser exceeds the maximum allowable height.

Measurement: 60 inches

In California, all operable parts, including coin slots, shall be 40 inches (1016 mm) maximum above the finish floor. ADA allows accessories to meet reach ranges as noted below;

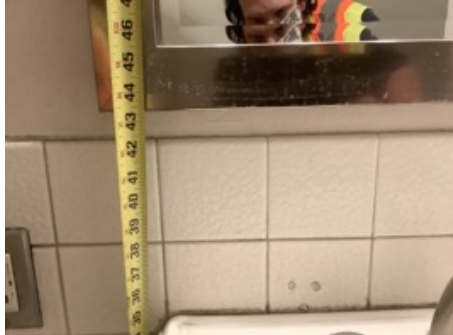
Comment #: PD-75

Deficiency: Restroom Interior Space - Amenities - Mirror Height

The mirror height exceeds the allowable 40 inches above the finished floor.

Measurement: 45.5 inches

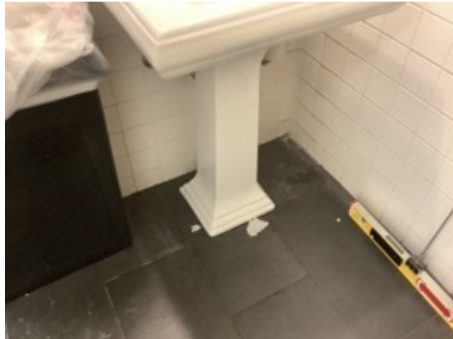
Comment #: PD-76

Deficiency: Lavatory - Clear Floor Space - General

There is no clear floor space provided at the lavatory.

Measurement: 0 inches

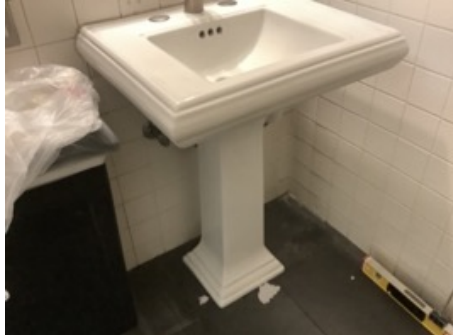
Comment #: PD-77

Deficiency: Lavatory - Knee/Toe Clearance - Incremental Depth

The knee clearance at the lavatory does not match the depth to reach the operable parts.

Measurement: 7.75 inches

Provide knee clearance at the accessible lavatory as noted below.

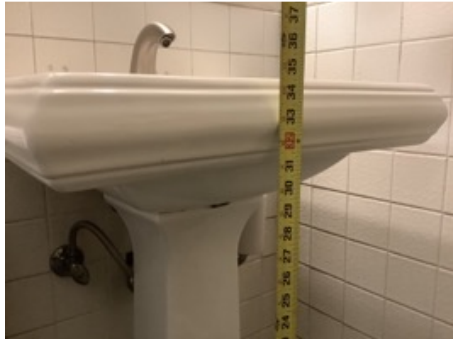
Comment #: PD-78

Deficiency: Lavatory - Counter Surface - Height

The height of the lavatory counter surface exceeds the allowable 34 inches AFF.

Measurement: 34.5 inches

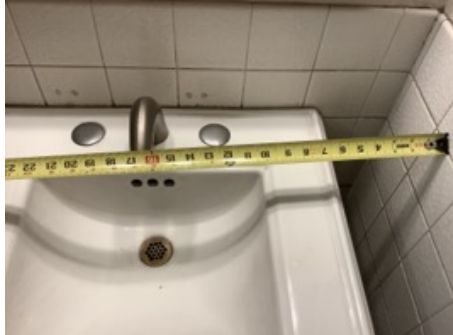
Comment #: PD-79

Deficiency: Lavatory - Location - Centerline Distance

The lavatory is not located so that the distance to the adjacent side wall is minimum 18 inches.

Measurement: 16.5 inches

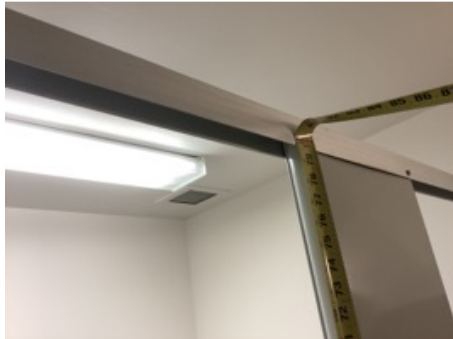
Comment #: PD-80

Deficiency: Accessible Toilet Stall - Door - Clear Height

The stall door does not provide clear height.

Measurement: 79.75 inches

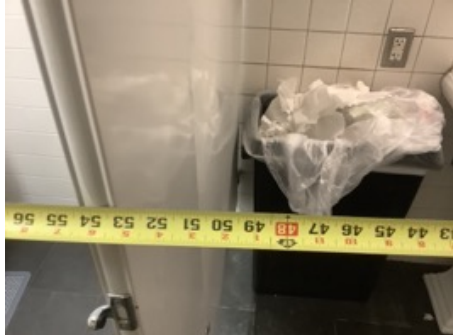
Comment #: PD-81

Deficiency: Accessible Toilet Stall - Side Opening Door - Outward Swing Door Clearance

Pull side of stall door does not provide 60-inches maneuvering clearance and/or swings into the clear floor space for another amenity.

Measurement: 53.25 inches

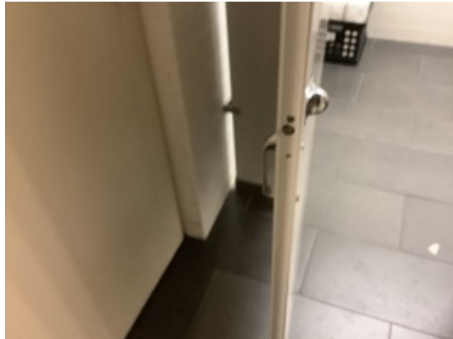
Comment #: PD-82

Deficiency: Accessible Toilet Stall - Door Hardware - Handle Both Sides

There is no pull handle on the interior side of the stall door.

Measurement: 1 count

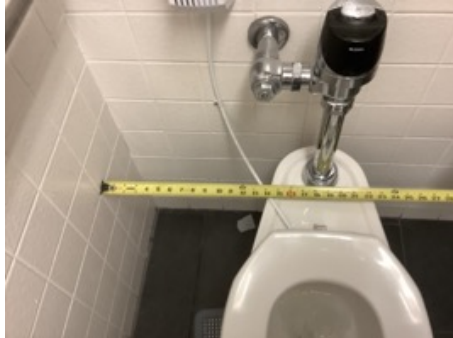
Comment #: PD-83

Deficiency: Accessible Toilet Stall - Water Closet - Location

The water closet is not a compliant distance from the adjacent wall.

Measurement: 18.5 inches

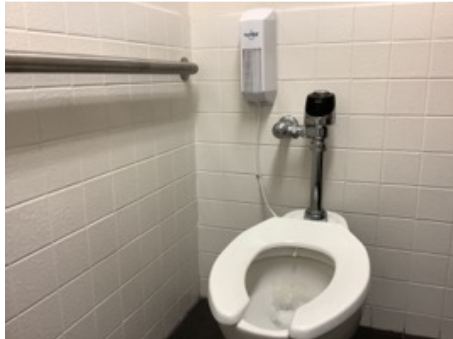
Comment #: PD-84

Deficiency: Accessible Toilet Stall - Water Closet - Flush Control Location

The flush control for the water closet is not located on the open side of the accessible toilet.

Measurement: 1 count

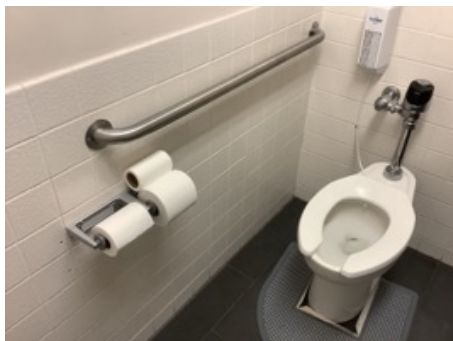
Comment #: PD-85

Deficiency: Accessible Toilet Stall - Dispensers - Toilet Paper Location

The toilet paper dispenser is outside of the allowable reach range.

Measurement: 14 inches

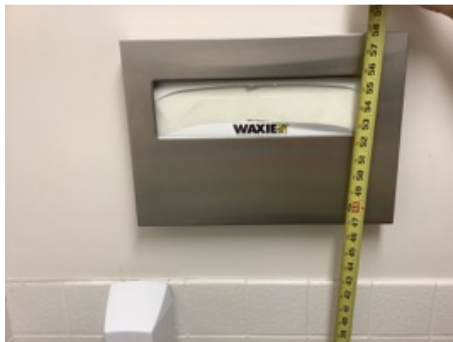
Comment #: PD-86

Deficiency: Accessible Toilet Stall - Dispensers - Seat Cover Height

The height of the operable part of the provided seat cover dispenser exceeds the allowable 40 inches AFF, is not located on an accessible route, no 30" x 48" clear floor space and reaching over water closet.

Measurement: 54 inches

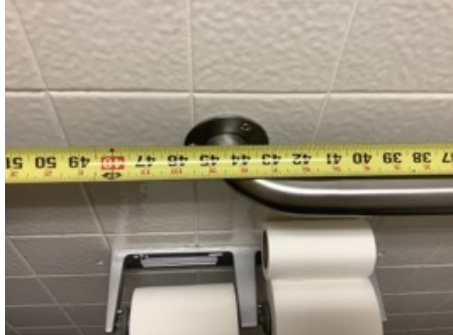
Comment #: PD-87

Deficiency: Accessible Toilet Stall - Side Grab Bar - End Distance to Rear Wall

The side grab bar does not extend minimum 54 inches from the rear wall.

Measurement: 44.25 inches

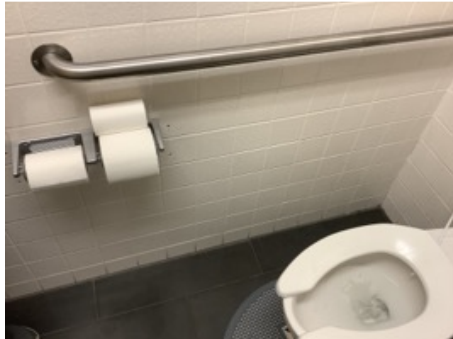
Comment #: PD-88

Deficiency: Accessible Toilet Stall - Side Grab Bar - Distance to Water Closet

The side grab bar does not extend 24 inches (610 mm) minimum in front of the water closet.

Measurement: 15.5 inches

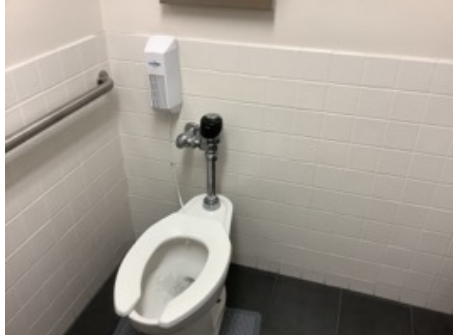
Comment #: PD-89

Deficiency: Accessible Toilet Stall - Grab Bars - General

Grab bars are missing.

Measurement: 1 count

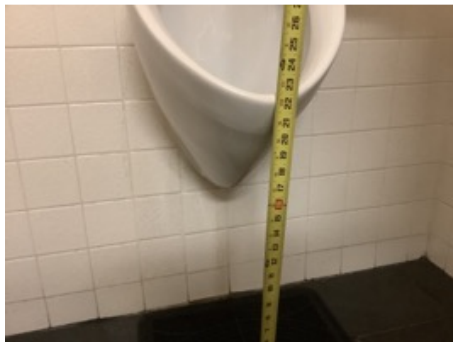
Comment #: PD-90

Deficiency: Urinal - Rim Dimensions - Height

The urinal rim height is greater than the allowable 17 inches AFF.

Measurement: 22.5 inches

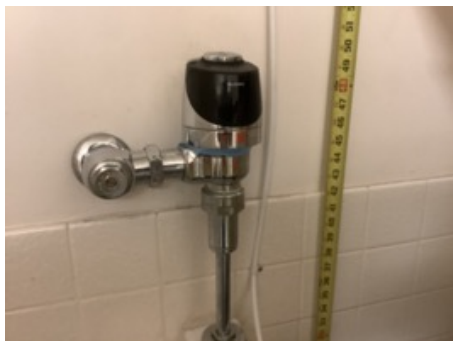
Comment #: PD-91

Deficiency: Urinal - Flush Control - Height

The flush control for the urinal is higher than the maximum allowable height.

Measurement: 50 inches

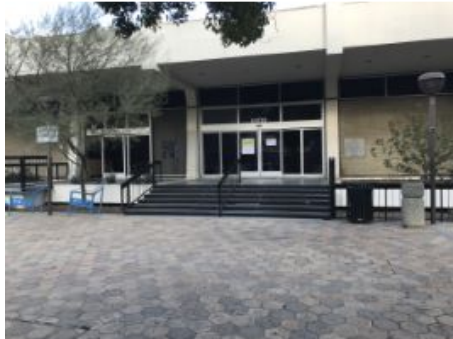
Comment #: LIB-01

Deficiency: Accessible Route - Directional Signage - General

The non-accessible entrance does not have signage directing to an accessible entrance. The library has two stories with the entrance located on the main level. The parking is located along the lower level. There are multiple doors to the library that face the parking lot along the lower level with no directional signage.

Measurement: 0 count

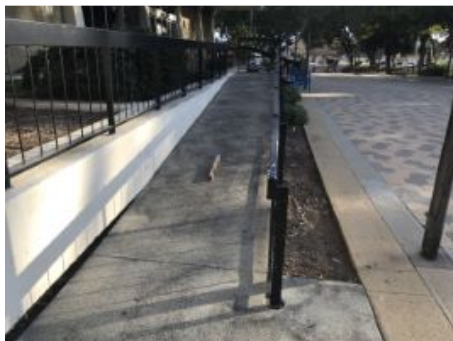
Comment #: LIB-02

Deficiency: Ramps - Slopes - Running Slope

The running slope of the ramp is steeper than 1:12 (8.33%). Ramp run ranges from 8.8% to 9.4%.

Measurement: 9.4 % grade

Remove and replace the ramp. The running slope of the curb ramp segments shall be in-line with the direction of sidewalk travel. Ramp runs shall have a running slope not steeper than 1:12.

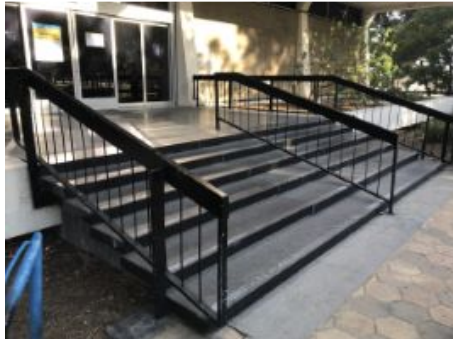
Comment #: LIB-05

Deficiency: Stairs - Handrails - Height

Top of the handrail is not located within the height ranges of 34-inches minimum to 38-inches maximum AFF. Extensions are not provided at the bottom of the handrails. 32" height measured to the top of the handrails.

Measurement: 32 inches

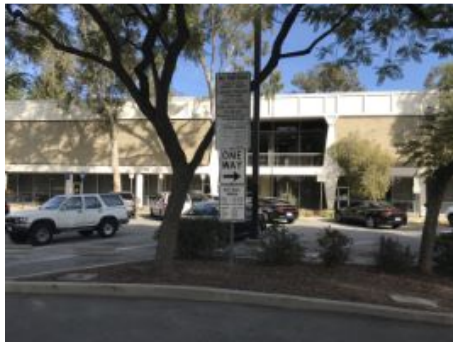
Comment #: LIB-06

Deficiency: Parking - Tow Away Sign - Verbiage

The verbiage on the "tow-away" sign is not compliant with 2019 CBC.

Measurement: 1 count

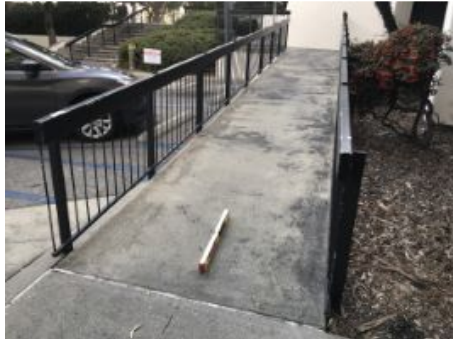
Comment #: LIB-07

Deficiency: Ramps - Slopes - Running Slope

The running slope of the ramp is steeper than 1:12 (8.33%). 8.8% to 9.7% running slope measured along the ramp.

Measurement: 9.7 % grade

Remove and replace the ramp. The running slope of the curb ramp segments shall be in-line with the direction of sidewalk travel. Ramp runs shall have a running slope not steeper than 1:12.

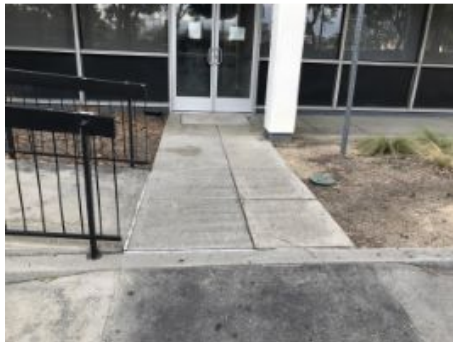
Comment #: LIB-08

Deficiency: Ramps - Landings - Bottom Length

The bottom landing of the ramp does not extend 72-inches in the direction of the ramp run. 64-1/2" long top landing and 62" long bottom landing measured at the bottom ramp run.

Measurement: 64.5 inches

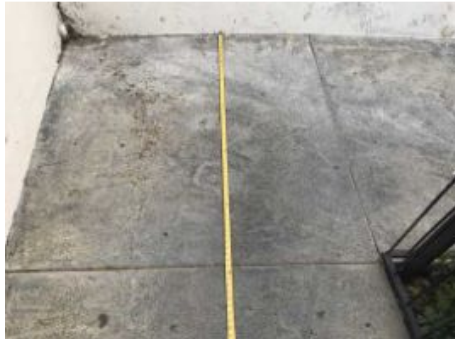
Comment #: LIB-09

Deficiency: Ramps - Landings - Bottom Length

The bottom landing of the ramp does not extend 72-inches in the direction of the ramp run where ramp changes direction. 59" x 59" landing measured at the bottom landing of the upper ramp run.

Measurement: 59 inches
