APPENDIX A

FACILITY ASSESSMENT PHOTO REPORTS

CITY HALL

1.0 Site Assessment

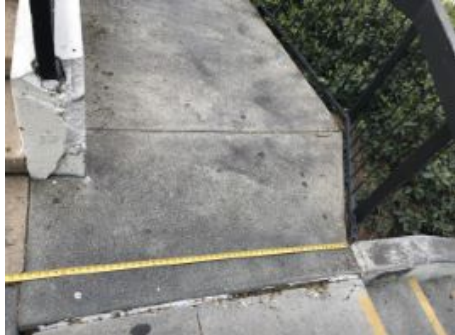
Comment #: LIB-10

Deficiency: Ramps - Landings - Length

Ramp does not provide 72-inches landings at changes of direction. Ramp top landing measured 44-1/2" wide. 4.4% running slope measured at the top landing. 1" to 4" wide gaps measured at the top landing.

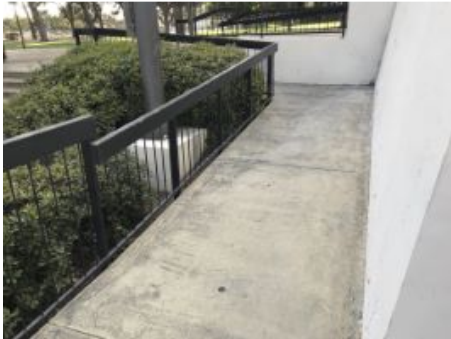
Comment #: LIB-11

Deficiency: Ramps - Handrails - Both Sides

Handrails are not provided on both sides of the ramp.

Install missing handrails so they are provided on both sides of stairs and ramps.

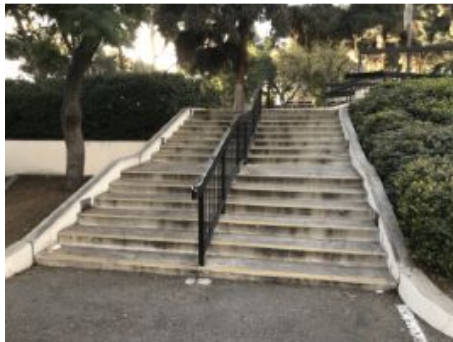
Comment #: LIB-12

Deficiency: Stairs - Risers - Height

Riser height is not within the range of 4 inches high minimum and 7 inches high maximum. 3" to 4-1/2" tread height measured at the parking lot stairs.

Measurement: 3 inches

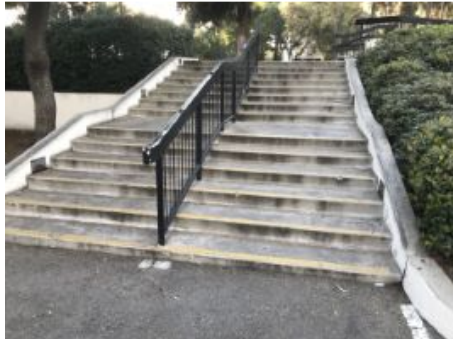
Comment #: LIB-13

Deficiency: Stairs - Handrails - Extensions-Top and Bottom

Handrails at the top and/or bottom of the stairs do not extend 12-inches horizontally above the landing.

Measurement: 0 inches

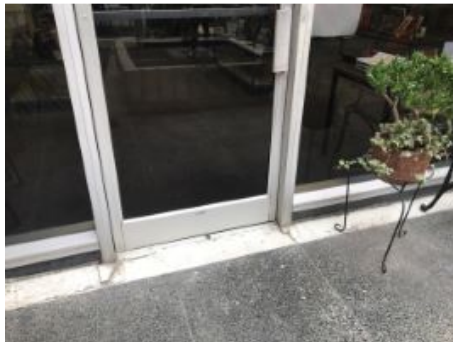
Comment #: LIB-14

Deficiency: Exterior Doors/Doorways/Gates - Threshold - Height

The threshold height exceeds the allowable tolerances.

Measurement: 1 inches

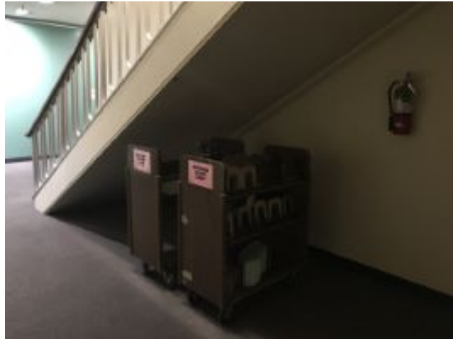
Comment #: LIB-15

Deficiency: Accessible Route - Protrusion - Vertical Clearance

Objects in the path of travel extend more than 4 inches from the wall with no cane detectable barrier.

Measurement: 80 inches

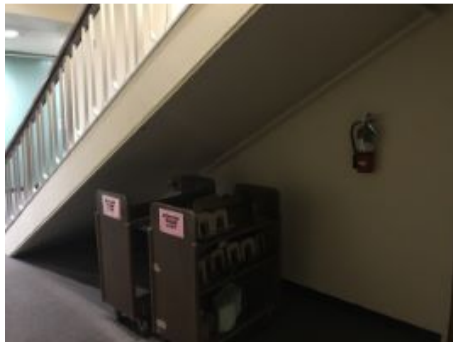
Comment #: LIB-16

Deficiency: Accessible Route - Vertical Clearance - Height

Fire extinguisher is located in an area where vertical clearance is less than 80-inches minimum.

Measurement: 74.75 inches

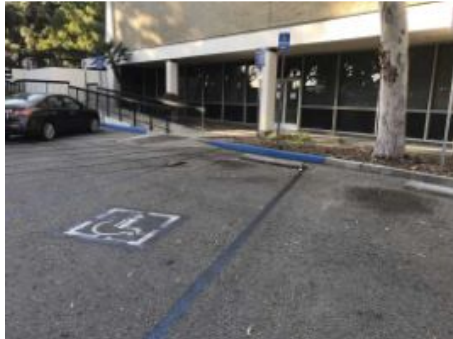
Comment #: LIB-17

Deficiency: Parking - Signage - Minimum Fine

The parking identification sign does not include the text "Minimum Fine \$250" below the ISA.

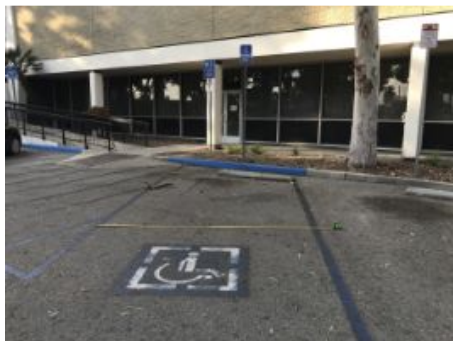
Comment #: LIB-18

Deficiency: Parking - Accessible Car Stall - Width

The accessible car stall is less than 108 inches (9 ft. or 2743 mm) wide.

Measurement: 107.5 inches

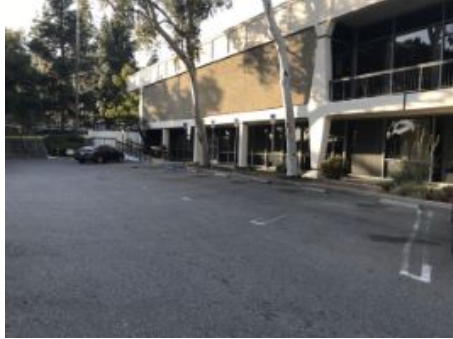
Comment #: LIB-19

Deficiency: Parking - Accessible Route - Adjacent

Accessible parking spaces are not dispersed when serving multiple accessible entrances. Parking stall P-3 is not located at the nearest accessible entrance. The space is located at the opposite end of the row from the accessible entrance. Nine (9) non-accessible parking stalls are located between parking stall P-3 and the accessible entrance.

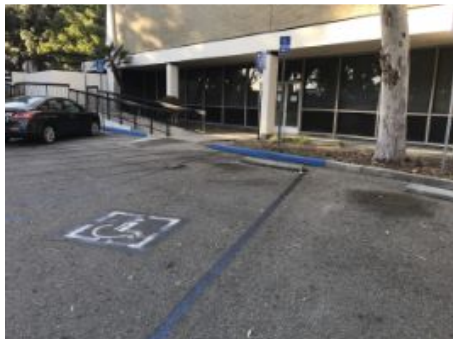
Comment #: LIB-20

Deficiency: Parking - Signage - Minimum Fine

The parking identification sign does not include the text "Minimum Fine \$250" below the ISA.

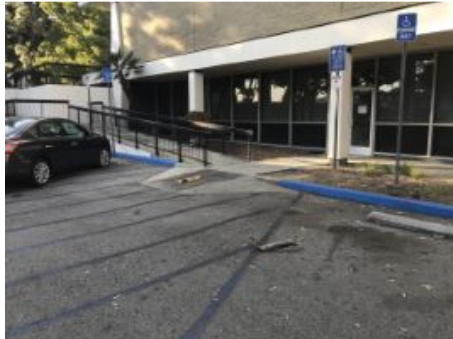
Comment #: LIB-23

Deficiency: Parking - Access Aisle - Slope

The slope of the access aisle in any direction exceeds 1:48 (2.0%) grade. A built-up curb ramp is located within the access aisle. 9.4% running slope measured at the curb ramp.

Measurement: 9.4 % grade

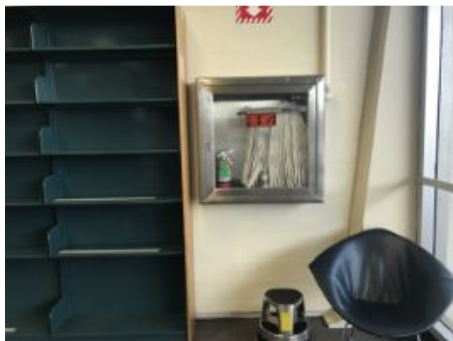
Comment #: LIB-24

Deficiency: Accessible Route - Reach Ranges - Side Reach

Element for side reach is not located within 15-inches minimum to 48-inches maximum AFF (to to a 10-inch depth). 53" to 58" AFF measured to the fire extinguisher and fire hose cabinet controls.

Measurement: 58 inches

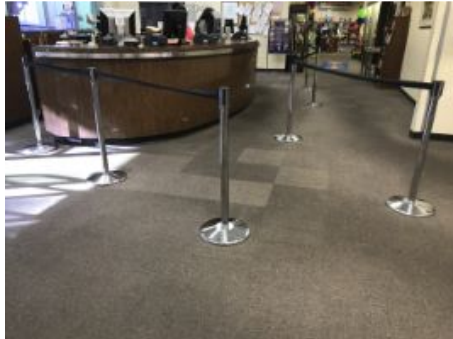
Comment #: LIB-25

Deficiency: Accessible Route - Protrusion - Post Mounted Objects

Protruding objects posted on two posts more than 12" apart: the lowest part of the object is over 27" or under 80" above finish floor. Stanchion ribbons are measured 35" AFF when stanchions are located greater than 12" from each other.

Measurement: 35 inches

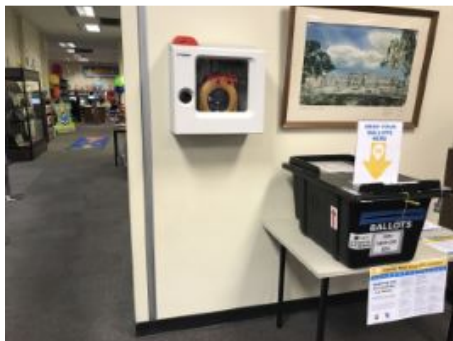
Comment #: LIB-26

Deficiency: Accessible Route - Reach Ranges - Side Reach

Element for side reach is not located within 15-inches minimum to 48-inches maximum AFF (to to a 10-inch depth). 55" AFF measured to the defibrillator box control.

Measurement: 55 inches

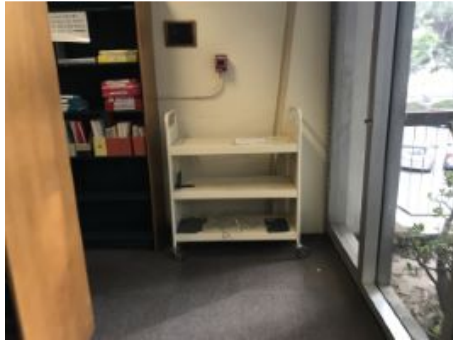
Comment #: LIB-27

Deficiency: Accessible Route - Reach Ranges - Side Reach Obstructed

Obstructed elements is either deeper than 24" or more than 46-inches maximum AFF when deeper than 10-inches (to a maximum of 24-inches). 57" to 60" AFF measured to the fire alarm pulls.

Measurement: 60 inches

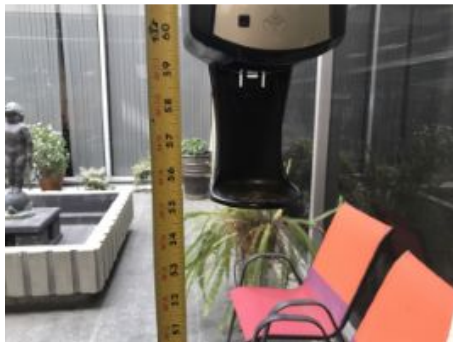
Comment #: LIB-28

Deficiency: Accessible Route - Reach Ranges - Side Reach

Element for side reach is not located within 15-inches minimum to 48-inches maximum AFF (to to a 10-inch depth). 59" AFF measured to the antibacterial dispensers.

Measurement: 59 inches

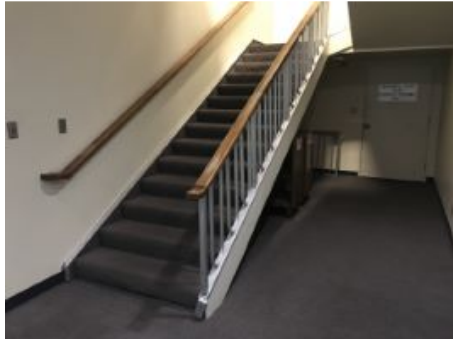
Comment #: LIB-29

Deficiency: Stairs - Contrast Striping - Interior Stair

A 2-inch minimum to 4-inch maximum clear visual contrast stripe is not provided on the upper approach and lower tread.

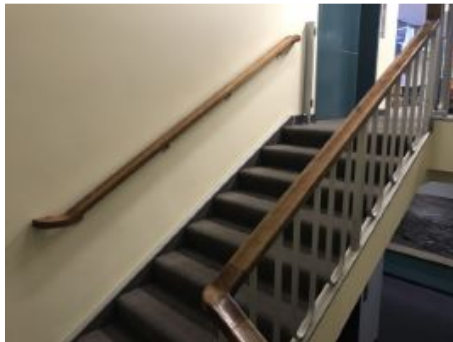
Comment #: LIB-30

Deficiency: Stairs - Handrails - General

Handrails are not provided on both sides of the staircase. 31" AFF measured to the top of the handrails. 7" extensions provided at the top and bottom of the stairwell. 10" perimeter dimension measured at the handrails.

Remove/replace handrails that are provided on both sides of stairs and ramps.

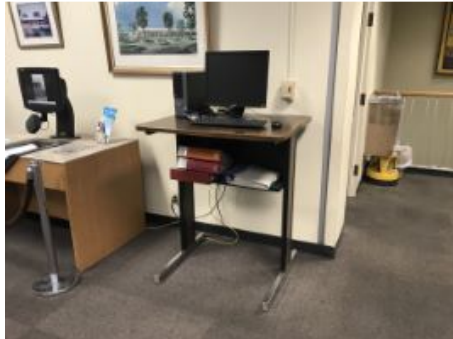
Comment #: LIB-31

Deficiency: Work Surface - Clearances - General

42" AFF measured to the top of the work surface at the standing height reference computer station. 26" AFF knee clearance measured at the seated level reference computer stations.

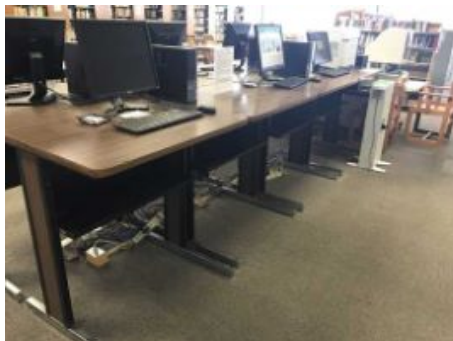
Comment #: LIB-32

Deficiency: Work Surface - Clearances - General

29" wide clear floor space measured to the keypad tray at the teen center computer stations. 25" AFF knee clearance measured to the keypad tray at the teen center computer stations. 20" wide clear floor space or 25" AFF knee clearance measured at the computer stations in the main library area. 37" AFF measured to the top of the standing height computer stations.

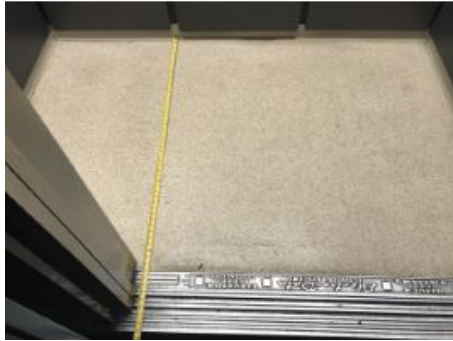
Comment #: LIB-33

Deficiency: Elevator - Car - Dimensions

The elevator car dimensions are not compliant. 49-1/2" interior dimension measured from the back wall to the front return. 53-1/2" dimension measured from the back wall to the inside face of the door.

Measurement: 49.5 inches

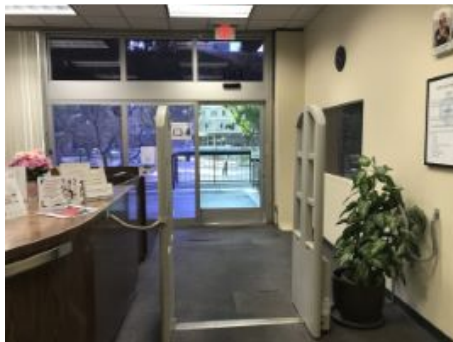
Comment #: LIB-34

Deficiency: Interior Doors/Doorways/Gates - Tactile Sign - General

No permanent tactile exit sign has been provided.

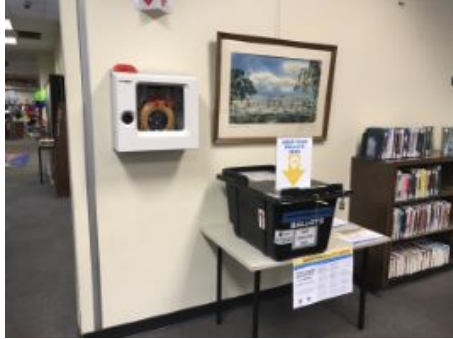
Comment #: LIB-35

Deficiency: Accessible Route - Protrusion - Depth

Objects in the path of travel extend more than 4 inches from the wall with no cane detectable barrier. Defibrillator box protrudes 7-1/2" into the accessible route at 48" AFF.

Measurement: 7.5 inches

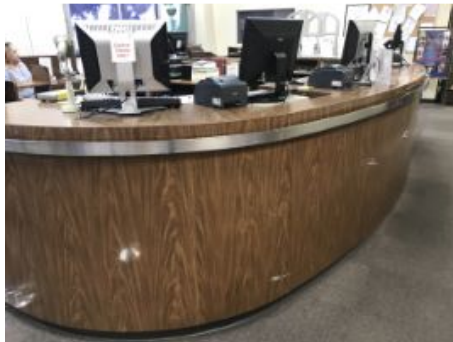
Comment #: LIB-36

Deficiency: Transaction Counters - Dimensions - Counter Height

The counter surface is higher than the allowable 34 inches above the finished floor.

Measurement: 42 inches

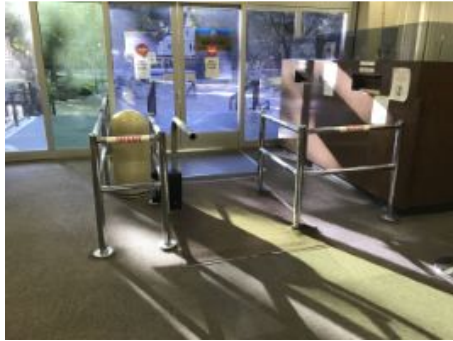
Comment #: LIB-37

Deficiency: Accessible Route - Clear Width - General

Accessible route widths do not provide minimum 36 or 44 inches clear as applicable. 33-3/4" wide route measured between the metal railings at the front entrance. The route is measured 38" deep.

Measurement: 33.75 inches

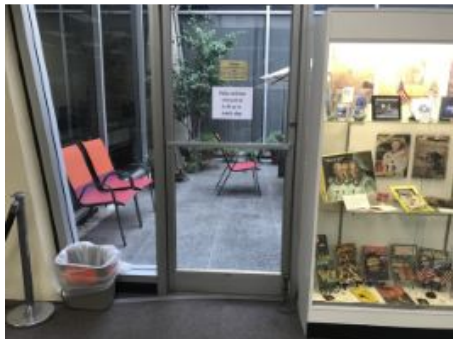
Comment #: LIB-38

Deficiency: Interior Doors/Doorways/Gates - Hardware - Smooth Surface

Lower 10 inches of door is not smooth.

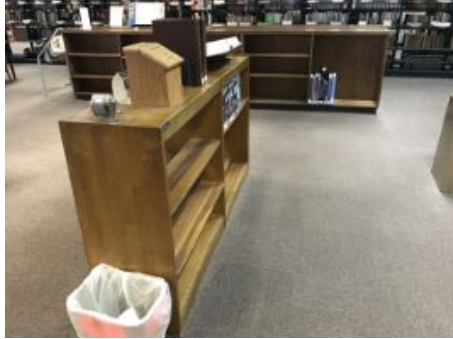
Comment #: LIB-39

Deficiency: Accessible Route - Reach Ranges - Side Reach

Element for side reach is not located within 15-inches minimum to 48-inches maximum AFF (to to a 10-inch depth). 51-3/4" AFF measured to the top of the suggestion box.

Measurement: 51.75 inches

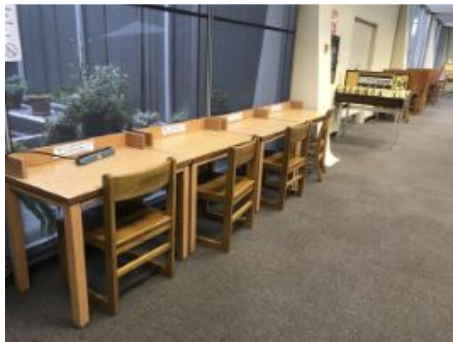
Comment #: LIB-40

Deficiency: Work Surface - Clearances - General

24" to 26" AFF knee clearance measured at the different types of study desks.

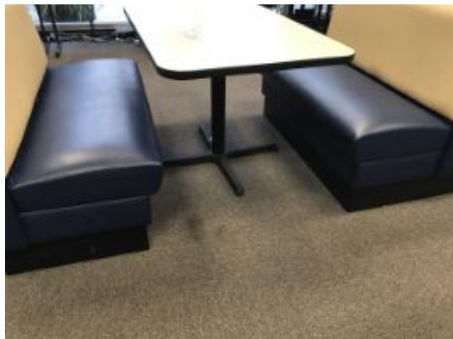
Comment #: LIB-41

Deficiency: Work Surface - Clearances - General

9-inch toe clearance provided at dining surface.

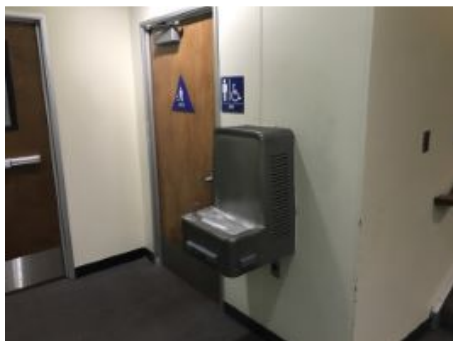
Comment #: LIB-42

Deficiency: Drinking Fountain - Typical at Both - Pedestrian Protection

Pedestrian protection not provided at drinking fountains.

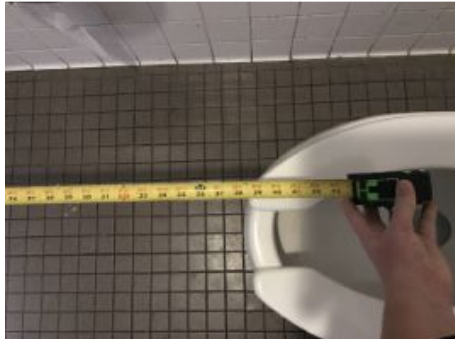
Comment #: LIB-43

Deficiency: Accessible Toilet Stall - Dimensions - Depth in Front of Water Closet

48-inches minimum not provided from face of water closet when door is front approach. Clearances at each stall is 36.75 and 38.5 inches clear.

Measurement: 36.75 inches

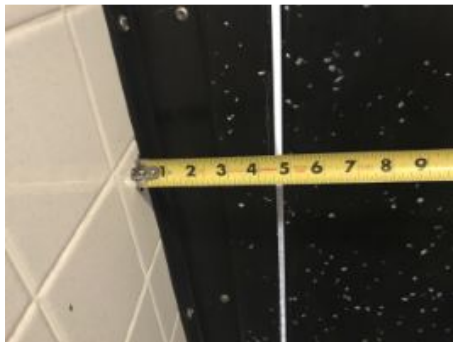
Comment #: LIB-45

Deficiency: Accessible Toilet Stall - Door Opening - 4-inch Max

Door is located more than 4-inches from wall or partition. Stall doors are located in the front partition and measured 4-1/2" to 20-1/4" from the side wall farthest from the water closet.

Measurement: 20.25 inches

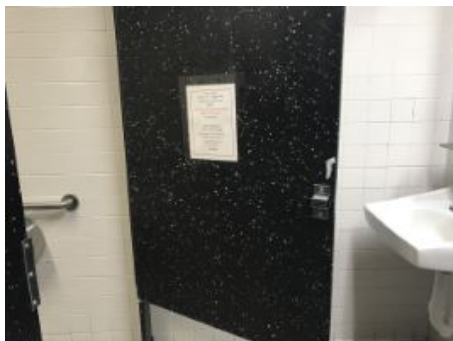
Comment #: LIB-46

Deficiency: Accessible Toilet Stall - Door - Pulls

Door pulls not provided on both sides of door.

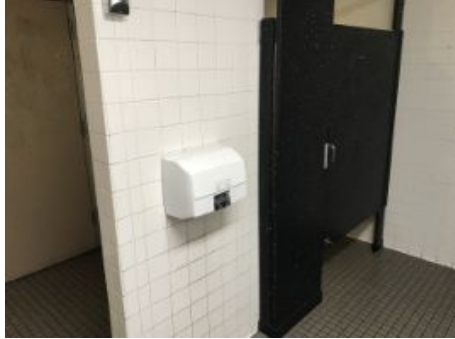
Comment #: LIB-47

Deficiency: Restroom Interior Space - Protruding Objects - General

Objects in the restroom extend more than 4 inches from the wall with no cane detectable barrier. Hand dryers protrude 7" into the circulation path at 38" AFF.

Measurement: 7 inches

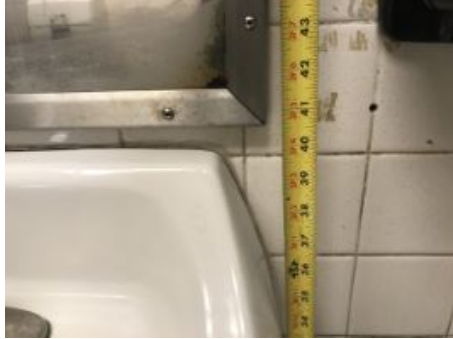
Comment #: LIB-49

Deficiency: Restroom Interior Space - Amenities - Mirror Height

The mirror height exceeds the allowable 40 inches above the finished floor. 41 -1/2" to 45" AFF measured to the mirror reflective surface.

Measurement: 45 inches

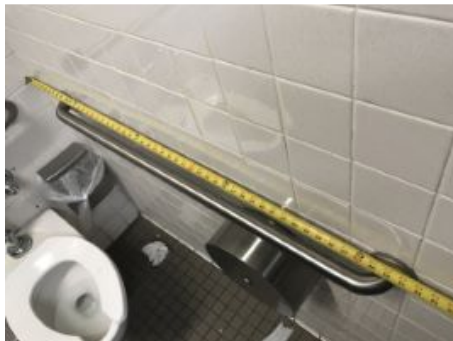
Comment #: LIB-50

Deficiency: Accessible Toilet Stall - Side Grab Bar - Total Length

The side grab bar does not extend 54-inches from rear wall.

Measurement: 50 inches

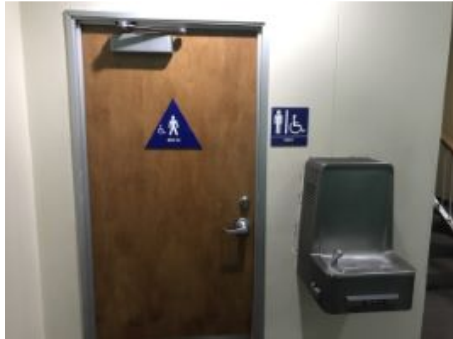
Comment #: LIB-51

Deficiency: Restroom Doors - Clearances: Front - Push Side Approach

12-inches strike side clearance is not provided when door has a closer and latch installed. 9-1/2" maneuvering clearance measured adjacent to the latch on the push side of the restroom door.

Measurement: 9.5 inches

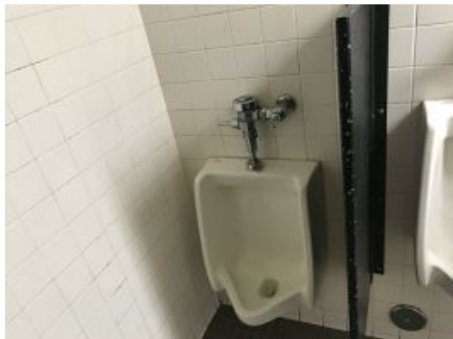
Comment #: LIB-52

Deficiency: Urinal - Clear Floor Space - General

A clear floor space minimum 30 inches by 48 inches is not provided at the urinal. 29-1/2" wide clear floor space measured at the urinal

Measurement: 29.5 inches

Recommended Remediation:

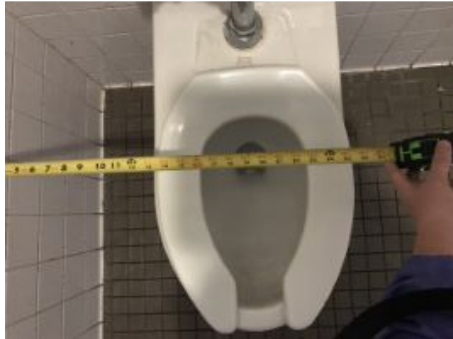
Comment #: LIB-53

Deficiency: Accessible Toilet Stall - Water Closet - Location

The water closet is not a compliant distance from the adjacent wall. Water closet centerline measured 19-1/4" to 19-1/2" from the side wall.

Measurement: 19.5 inches

Recommended Remediation:

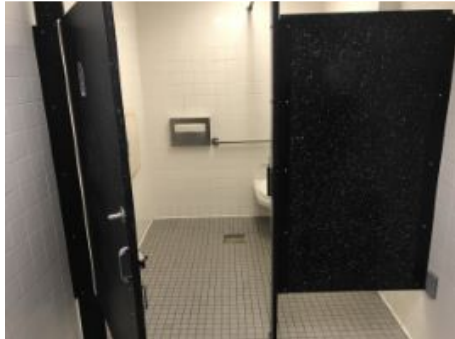
Comment #: LIB-55

Deficiency: Accessible Toilet Stall - Door - Self-Closing Door

The stall door is not self closing.

Recommended Remediation:

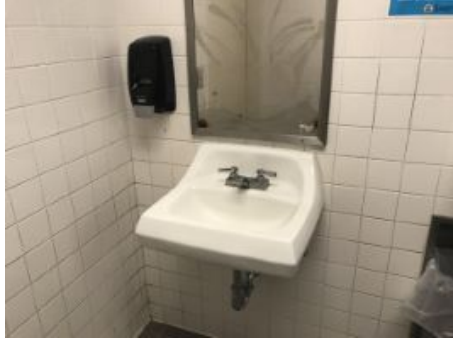
Comment #: LIB-57

Deficiency: Restroom Interior Space - Amenities - Soap Dispenser Height

The soap dispenser exceeds the maximum allowable height. Soap dispensers are located 43" and 44" AFF.

Measurement: 44 inches

Recommended Remediation:

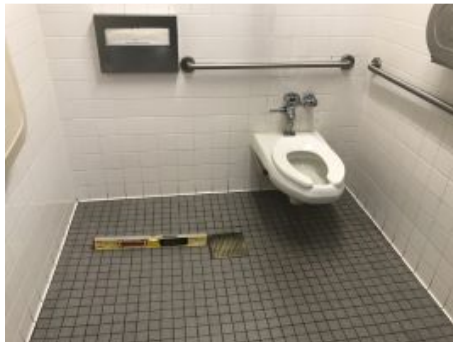
Comment #: LIB-58

Deficiency: Restroom Interior Space - Floor Surface - Slopes

The floor surface has slopes that exceeds the allowable 1:48 (2%) grade in any direction. 3.6% to 5.8% cross slope measured at the water drain in the boys restroom water closet. 3.0% cross slope measured at the water drain the girls restroom water closet.

Measurement: 5.8 % grade

Recommended Remediation:

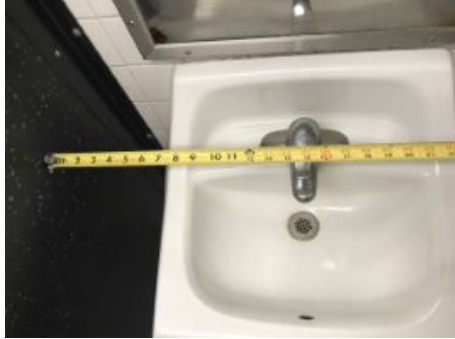
Comment #: LIB-59

Deficiency: Lavatory - Location - Centerline Distance

The lavatory is not located so that the distance to the adjacent side wall is minimum 18 inches.

Measurement: 14.75 inches

Recommended Remediation:

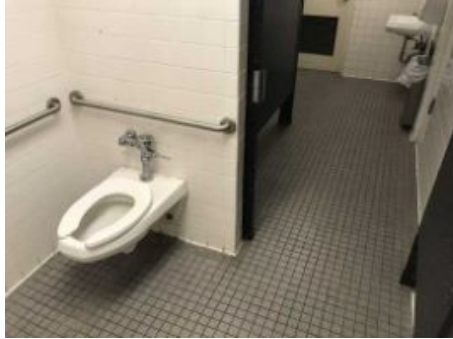
Comment #: LIB-61

Deficiency: Accessible Toilet Stall - Water Closet - Seat Height

The water closet seat is greater than 2 inches high.

Measurement: 19.75 inches

Recommended Remediation:

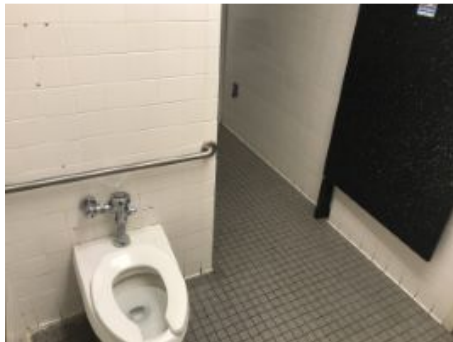
Comment #: LIB-62

Deficiency: Accessible Toilet Stall - Dimensions - General

The wheelchair stall with in-swinging door does not have the required dimensions or stall arrangement to provide correct maneuvering clearances within stall.

Recommended Remediation:

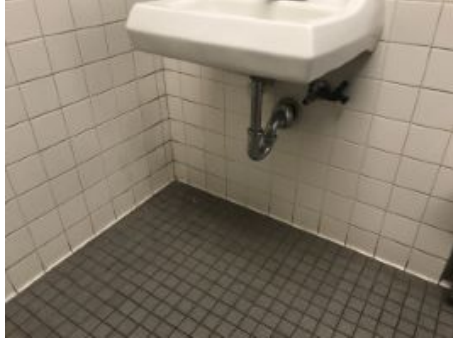
Comment #: LIB-63

Deficiency: Lavatory - Covered Pipes/Hose Bib - General

The pipe insulation does not cover everything under the sink including water supply lines and hose bib.

Recommended Remediation:

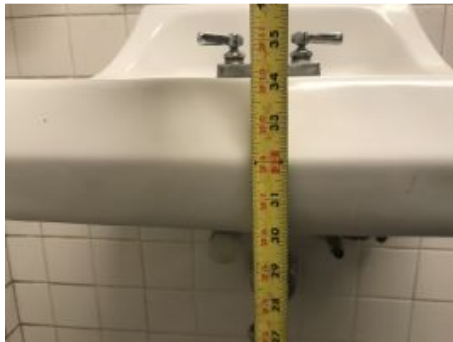
Comment #: LIB-64

Deficiency: Lavatory - Counter Surface - Height

The height of the lavatory counter surface exceeds the allowable 34 inches AFF.

Measurement: 34.125 inches

Recommended Remediation:

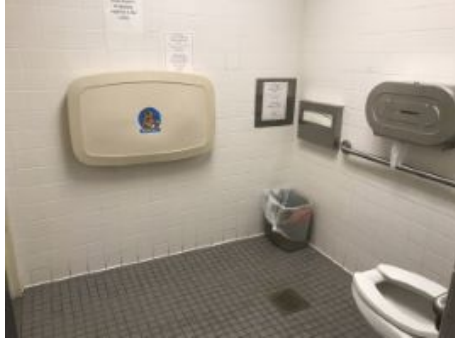
Comment #: LIB-65

Deficiency: Baby Changing Station - Accessible Stall - Location

Baby Changing Station is located within the accessible stall.

Recommended Remediation:

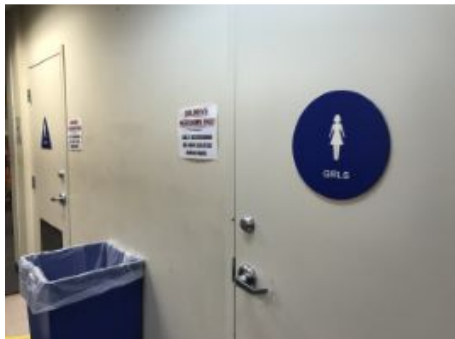
Comment #: LIB-66

Deficiency: Restroom Doors - Tactile Sign - 18 Clear Space

The tactile wall sign is not provided in at a compliant location relative to the door.

Recommended Remediation:

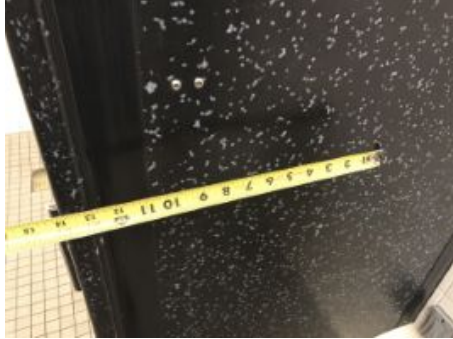
LIB-67

Deficiency: Accessible Toilet Stall - Door - Clearances-Pull Side

The accessible stall door does not provide 60-inches clearance on pull side of stall door for a depth of 18". 14" strike side clearance measured adjacent to the stall door, and 48" deep maneuvering clearance measured perpendicular to the stall door on the pull side of the stall door.

Measurement: 14 inches

Recommended Remediation:

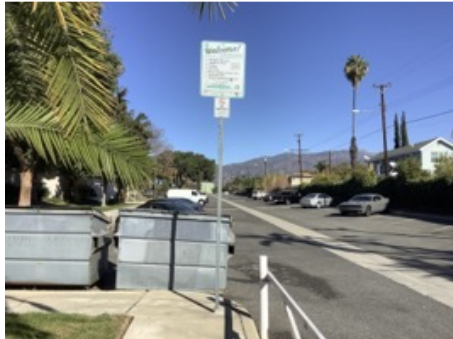
Comment #: PALO-001

Deficiency: Parking - Tow Away Sign - General

There is no "Unauthorized Parking Sign" sign at the entrance to the off-street parking.

Recommended Remediation:

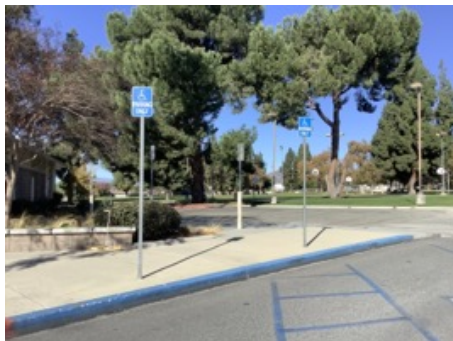
Comment #: PALO-002

Deficiency: Parking - Signage - Minimum Fine

The parking identification sign does not include the text "Minimum Fine \$250" below the ISA.

Recommended Remediation:

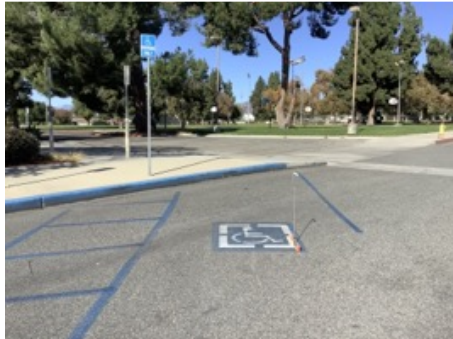
Comment #: PALO-003

Deficiency: Parking - Signage - Sign

The parking identification sign is not permanently posted immediately adjacent or at the head of the space within the parking stall width.

Recommended Remediation:

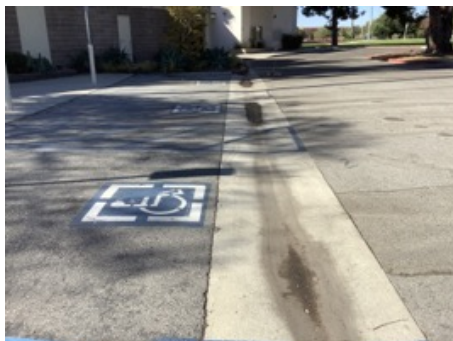
Comment #: PALO-004

Deficiency: Parking - ISA - Bottom Corner

The lower corner or lower side of the ISA identifying the accessible parking stall is not aligned with the end of the parking stall length.

Measurement: 50 inches

Recommended Remediation:

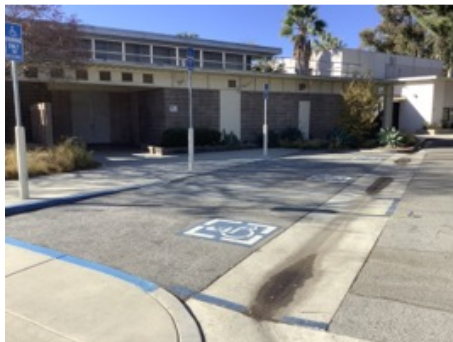
Comment #: PALO-005

Deficiency: Parking - Accessible Stall - Length

The accessible van/car stall is less than 216 inches (18 ft. or 5486 mm) long.

Measurement: 205 inches

Recommended Remediation:

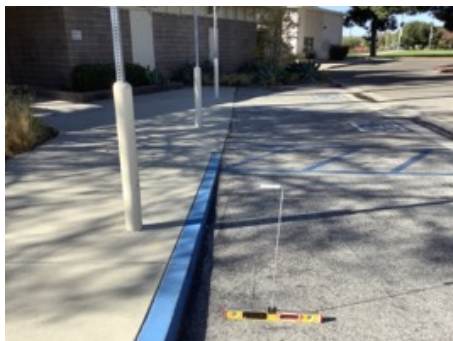
Comment #: PALO-006

Deficiency: Parking - Accessible Stall - Wheel Stop

Wheel stops are not provided.

Recommended Remediation:

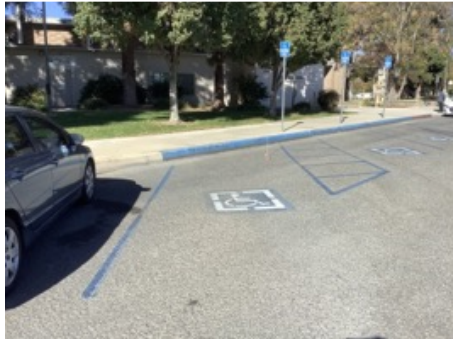
Comment #: PALO-007

Deficiency: Parking - Access Aisle Markings - General

There is no adjacent access aisle marked.

Recommended Remediation:

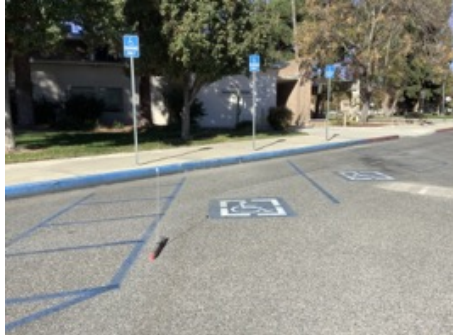
Comment #: PALO-008

Deficiency: Parking - Access Aisle Markings - General

There is no adjacent access aisle marked.

Recommended Remediation:

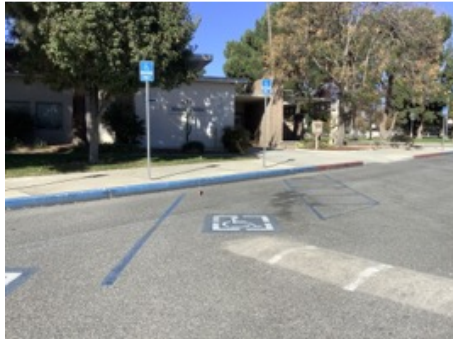
Comment #: PALO-009

Deficiency: Parking - Access Aisle Markings - General

There is no adjacent access aisle marked.

Recommended Remediation:

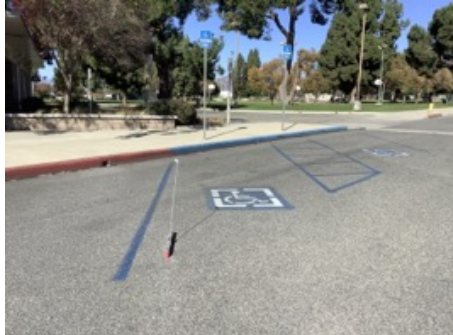
Comment #: PALO-010

Deficiency: Parking - Access Aisle Markings - General

There is no adjacent access aisle marked.

Recommended Remediation:

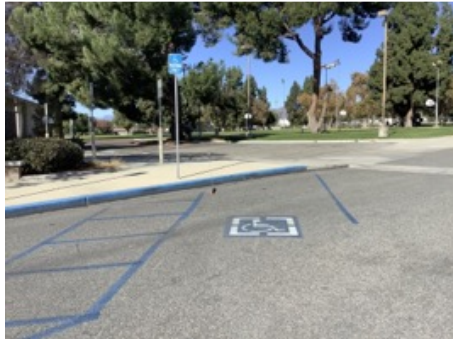
Comment #: PALO-011

Deficiency: Parking - Access Aisle Markings - General

There is no adjacent access aisle marked.

Recommended Remediation:

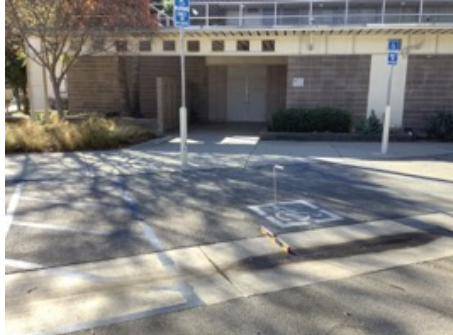
Comment #: PALO-012

Deficiency: Parking - Access Aisle Markings - General

There is no adjacent access aisle marked.

Recommended Remediation:

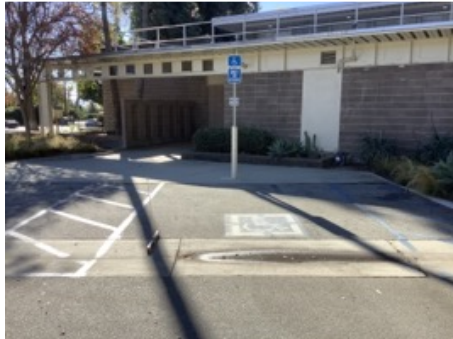
Comment #: PALO-013

Deficiency: Parking - Access Aisle Markings - General

There is no adjacent access aisle marked.

Recommended Remediation:

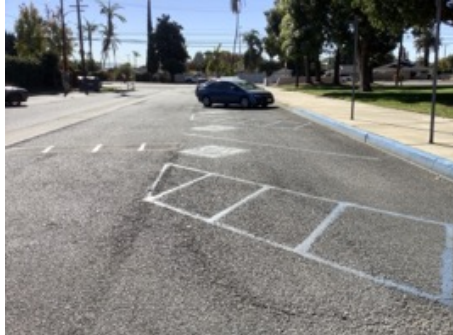
Comment #: PALO-014

Deficiency: Parking - Access Aisle Markings - Angled Parking

Angled parking stall access aisle does not extend the full required length of the parking stall(s) served on both sides.

Measurement: 3 inches

Recommended Remediation:

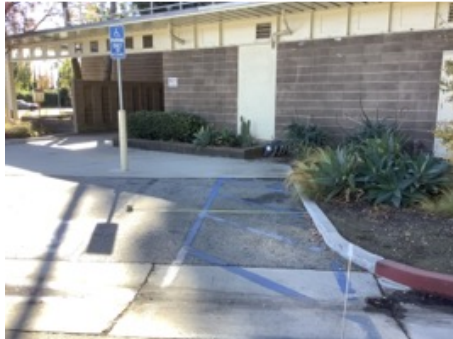
Comment #: PALO-015

Deficiency: Parking - Access Aisle Markings - Width

The marked access aisle is less than 60 inches (5 ft. or 1524 mm) wide for a car stall and/or 144 inches for a van stall.

Measurement: 57 inches

Recommended Remediation:

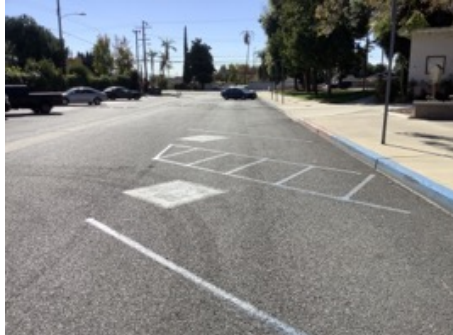
Comment #: PALO-016

Deficiency: Parking - Access Aisle Markings - Length

The access aisle does not extend the full required length of the parking stall(s) served.

Measurement: 3 inches

Recommended Remediation:

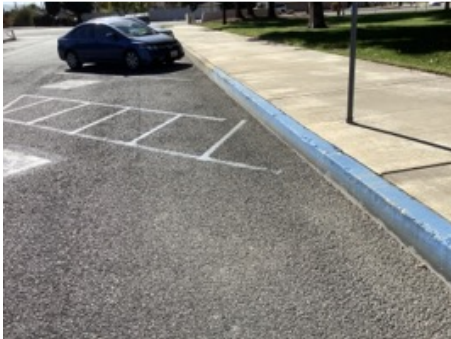
Comment #: PALO-017

Deficiency: Parking - Access Aisle Markings - Border Line Markings

The access aisle is not marked with a blue painted border line around the entire perimeter.

Recommended Remediation:

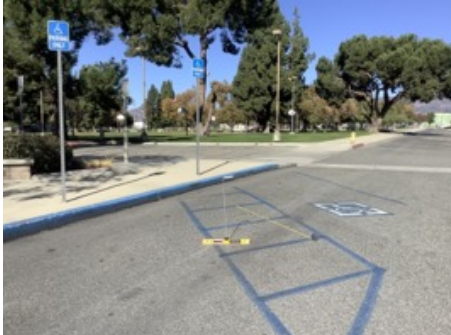
Comment #: PALO-018

Deficiency: Parking - Access Aisle Markings - Hatched Line Spacing

The hatched lines within the border line of the access aisle are spaced greater than 36 inches on center apart.

Measurement: 48 inches

Recommended Remediation:

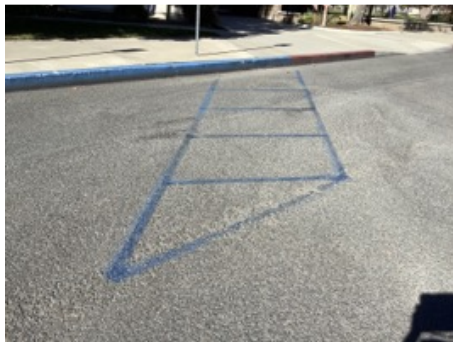
Comment #: PALO-019

Deficiency: Parking - Access Aisle Markings - "No Parking"

Missing 12" white 'No Parking' markings OR Markings are faded and does not discourage parking in the access aisle.

Recommended Remediation:

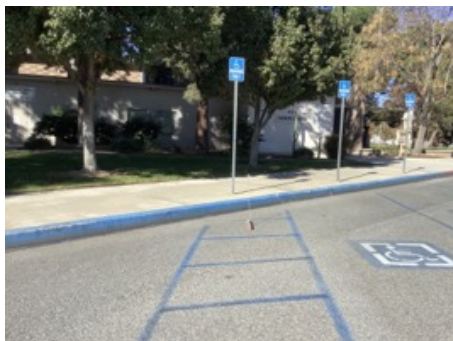
Comment #: PALO-020

Deficiency: Parking - Access Aisle - Slope

The slope of the access aisle in any direction exceeds 1:48 (2.0%) grade.

Measurement: 2.8 % grade

Recommended Remediation:

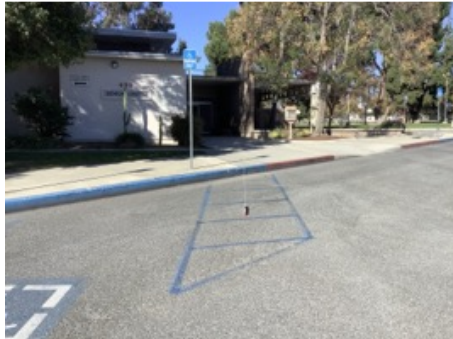
Comment #: PALO-021

Deficiency: Parking - Access Aisle - Slope

The slope of the access aisle in any direction exceeds 1:48 (2.0%) grade.

Measurement: 2.4 % grade

Recommended Remediation:

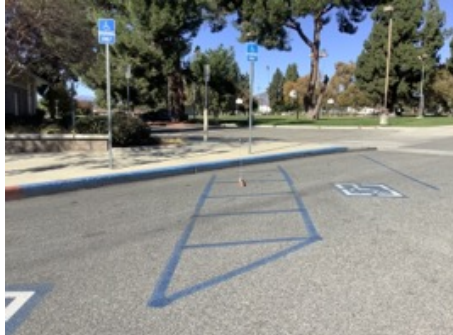
Comment #: PALO-022

Deficiency: Parking - Access Aisle - Slope

The slope of the access aisle in any direction exceeds 1:48 (2.0%) grade.

Measurement: 3.3 % grade

Recommended Remediation:

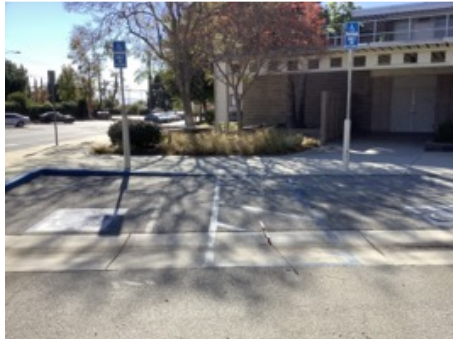
Comment #: PALO-023

Deficiency: Parking - Access Aisle - Slope

The slope of the access aisle in any direction exceeds 1:48 (2.0%) grade.

Measurement: 6.5 % grade

Recommended Remediation:

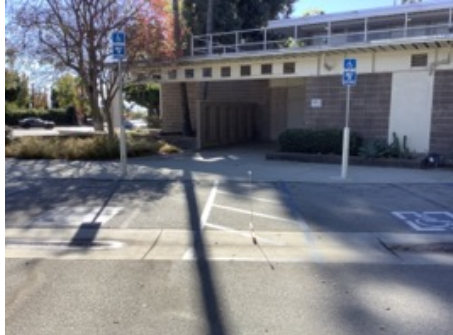
Comment #: PALO-024

Deficiency: Parking - Access Aisle - Slope

The slope of the access aisle in any direction exceeds 1:48 (2.0%) grade.

Measurement: 5.4 % grade

Recommended Remediation:

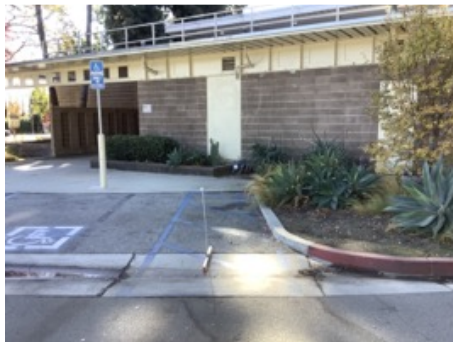
Comment #: PALO-025

Deficiency: Parking - Access Aisle - Slope

The slope of the access aisle in any direction exceeds 1:48 (2.0%) grade.

Measurement: 6.4 % grade

Recommended Remediation:

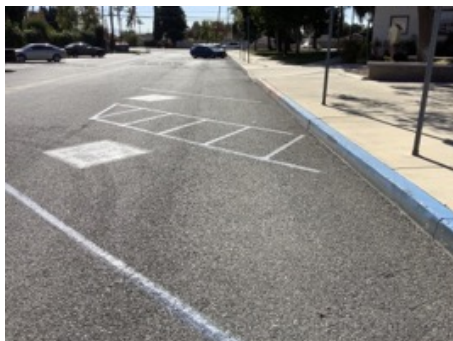
Comment #: PALO-026

Deficiency: Parking - Accessible Route - Adjacent

Access aisle is not located to an accessible route.

Recommended Remediation:

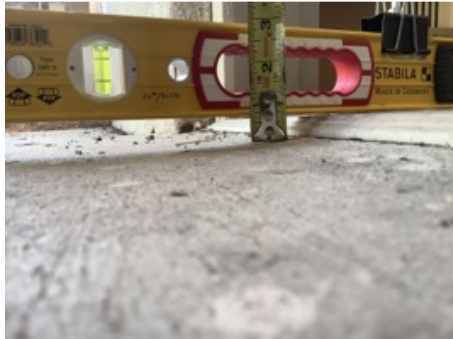
Comment #: PALO-027

Deficiency: Exterior Doors/Doorways/Gates - Threshold - Height

The threshold height exceeds the allowable tolerances.

Measurement: .75 inches

Recommended Remediation:

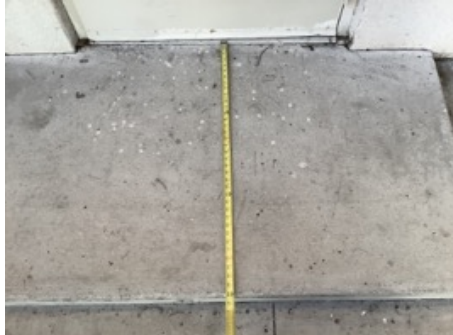
Comment #: PALO-028

Deficiency: Exterior Doors/Doorways/Gates - Clearances: Front - Pull Side Approach

60 inches of maneuvering space beyond the pull side of the door is not provided.

Measurement: 36 inches

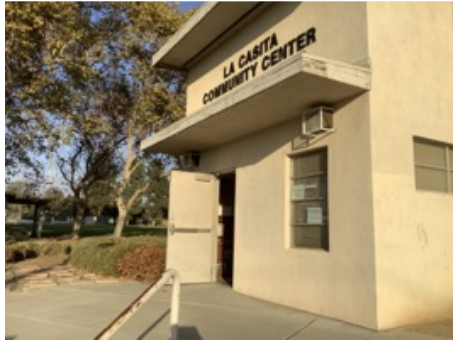
Comment #: PALO-031

Deficiency: Exterior Doors/Doorways/Gates - ISA - All Entrances

The International Symbol of Accessibility (ISA) is missing at this door.

Measurement: 1 count

Recommendation would be to add a sticker with the ISA to the second door, or remove the sticker from the other door.

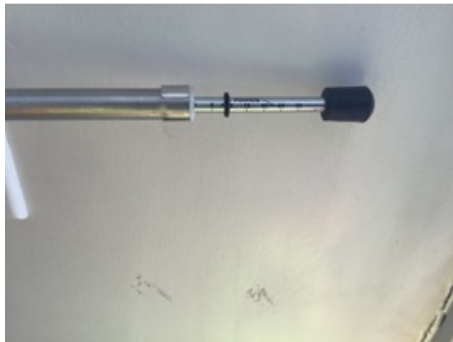
Comment #: PALO-032

Deficiency: Exterior Doors/Doorways/Gates - Operation - Opening Force

The force required to operate the door exceeds the allowable 5 lbf.

Measurement: 10 lbf

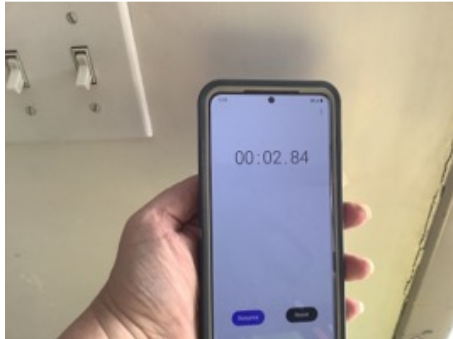
Comment #: PALO-033

Deficiency: Exterior Doors/Doorways/Gates - Operation - Closing Speed

The door closes faster than the minimum 5 seconds.

Measurement: 2.84 seconds

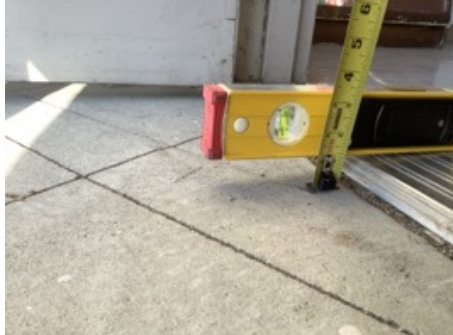
Comment #: PALO-034

Deficiency: Exterior Doors/Doorways/Gates - Threshold - Height

The threshold height exceeds the allowable tolerances.

Measurement: .75 inches

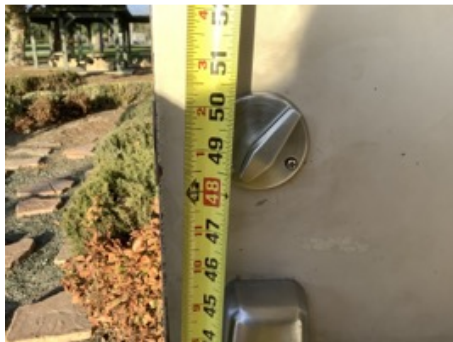
Comment #: PALO-035

Deficiency: Exterior Doors/Doorways/Gates - Hardware - Handle Height

Door hardware is not located 34-inches minimum to 44-inches maximum AFF.

Measurement: 50.25 inches

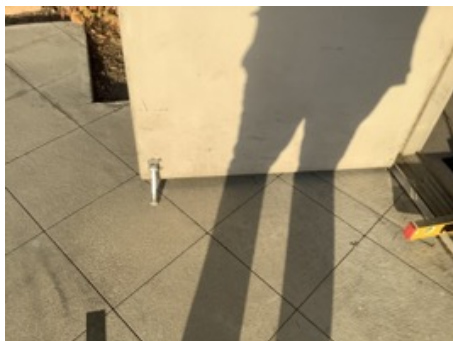
Comment #: PALO-036

Deficiency: Exterior Doors/Doorways/Gates - Hardware - Smooth Surface

Lower 10 inches of door is not smooth.

Measurement: 2 inches

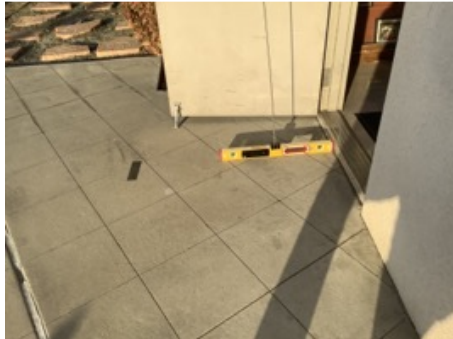
Comment #: PALO-037

Deficiency: Exterior Doors/Doorways/Gates - Landing - Slopes

Slopes more than 1:48 (2%) grade, or changes in elevation are located at door landings.

Measurement: 3.4 % grade

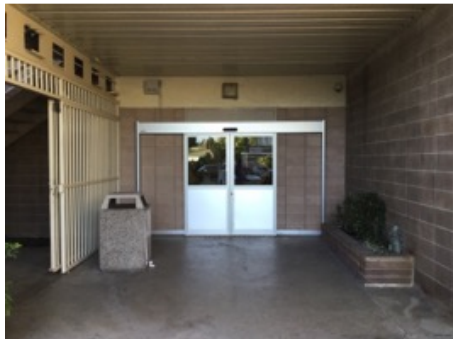
Comment #: PALO-038

Deficiency: Exterior Doors/Doorways/Gates - ISA - All Entrances

The International Symbol of Accessibility (ISA) is missing at this door.

Measurement: 0 count

Recommendation would be to add a sticker with the ISA to the second door, or remove the sticker from the other door.

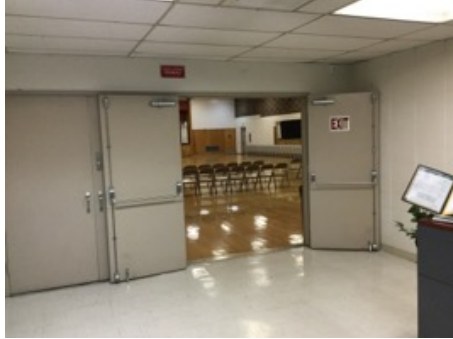
Comment #: PALO-039

Deficiency: Interior Doors/Doorways/Gates - Hardware - Smooth Surface

Lower 10 inches of door is not smooth.

Measurement: 0 inches

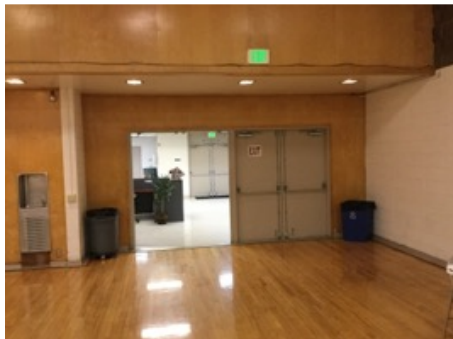
Comment #: PALO-040

Deficiency: Interior Doors/Doorways/Gates - Tactile Sign - General

No permanent tactile exit sign has been provided. There is an illuminated exit sign above interior side of two pairs of doors between auditorium and lobby. However, there is not a tactile exit sign. There are plastic signs that read "EXIT". But for tactile sign, it shall read "EXIT ROUTE".

Measurement: 0 count

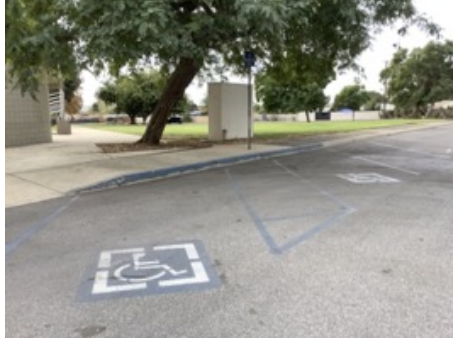
Comment #: PALO-041

Deficiency: Parking - Tow Away Sign - General

There is no "Unauthorized Parking Sign" sign at the entrance to the off-street parking.

Measurement: 0 count

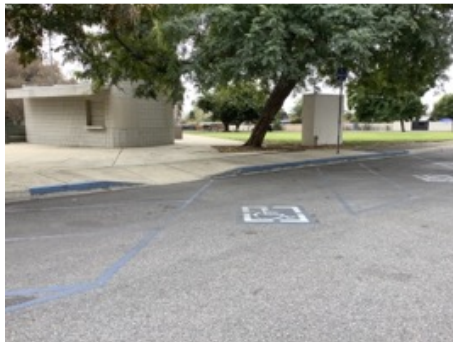
Comment #: PALO-042

Deficiency: Parking - Signage - ISA

The accessible identification sign does not include the ISA in white on a blue background.

Measurement: 0 count

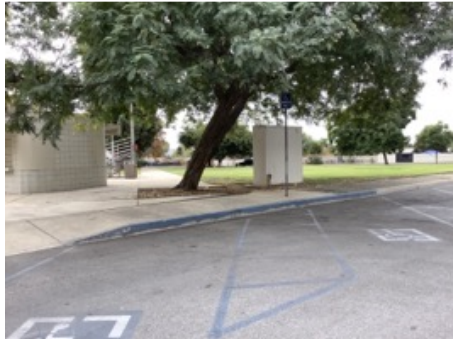
Comment #: PALO-043

Deficiency: Parking - Signage - Van Stall

The van accessible stall is not identified with the words "Van Accessible".

Measurement: 0 count

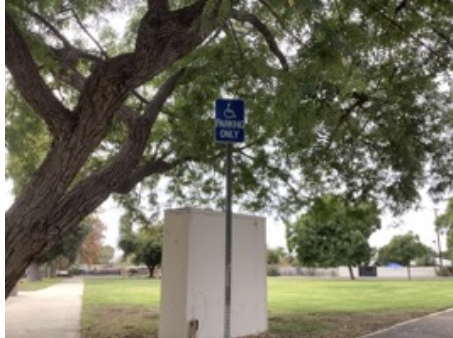
Comment #: PALO-044

Deficiency: Parking - Signage - Minimum Fine

The parking identification sign does not includes the text "Minimum Fine \$250" below the ISA.

Measurement: 0 count

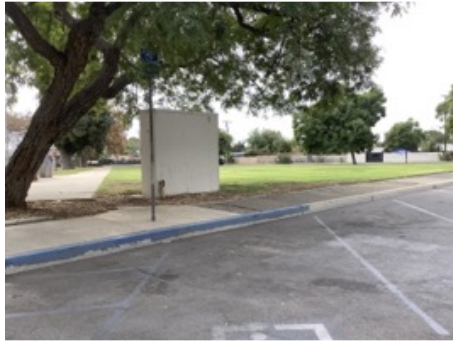
Comment #: PALO-045

Deficiency: Parking - Signage - Sign

The parking identification sign is not permanently posted immediately adjacent or at the head of the space within the parking stall width.

Measurement: 0 count

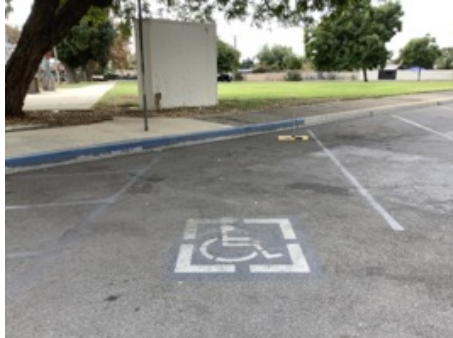
Comment #: PALO-046

Deficiency: Parking - Accessible Stall - Slopes

The slope of the van/car stall in any direction exceeds 1:48 (2.0%) grade.

Measurement: 2.5 % grade

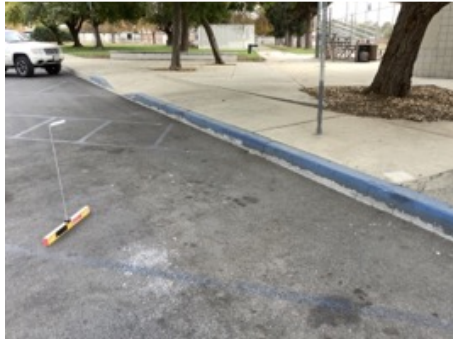
Comment #: PALO-047

Deficiency: Parking - Accessible Stall - Wheel Stop

Wheel stops are not provided.

Measurement: 0 count

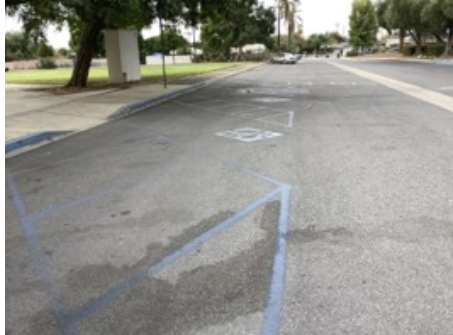
Comment #: PALO-048

Deficiency: Parking - Access Aisle Markings - Angled Parking

Angled parking stall access aisle does not extend the full required length of the parking stall(s) served on both sides.

Measurement: 0 inches

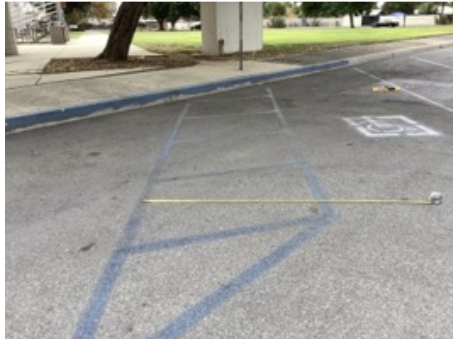
Comment #: PALO-049

Deficiency: Parking - Access Aisle Markings - Width

The marked access aisle is less than 60 inches (5 ft. or 1524 mm) wide for a car stall and/or 144 inches for a van stall.

Measurement: 58 inches

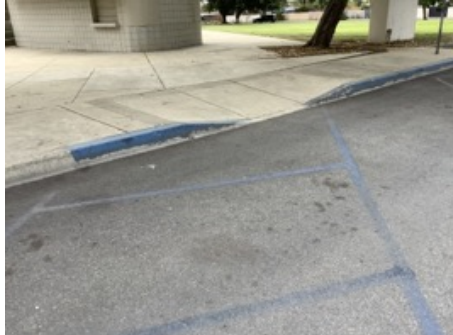
Comment #: PALO-050

Deficiency: Parking - Access Aisle Markings - Border Line Markings

The access aisle is not marked with a blue painted border line around the entire perimeter.

Measurement: 0 count

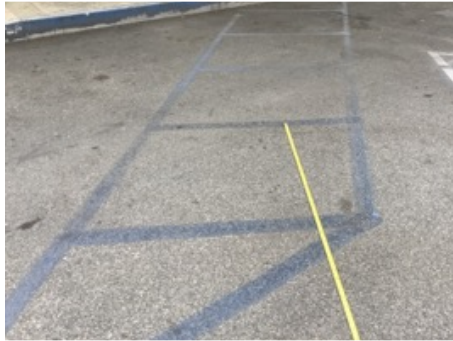
Comment #: PALO-051

Deficiency: Parking - Access Aisle Markings - Hatched Line Spacing

The hatched lines within the border line of the access aisle are spaced greater than 36 inches on center apart.

Measurement: 45 inches

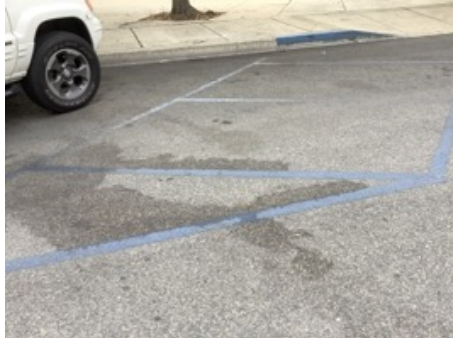
Comment #: PALO-052

Deficiency: Parking - Access Aisle Markings - "No Parking"

Missing 12" white 'No Parking' markings OR Markings are faded and does not discourage parking in the access aisle.

Measurement: 0 count

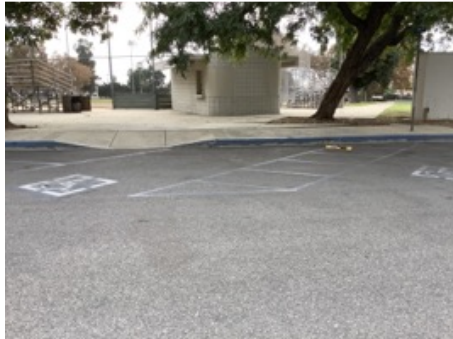
Comment #: PALO-053

Deficiency: Parking - Access Aisle - Arrangement

The access aisle requires persons to pass behind parking stalls that are not their own.

Measurement: 1 count

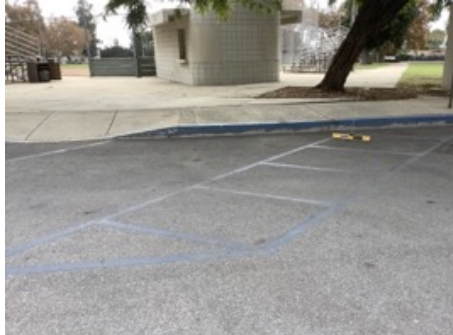
Comment #: PALO-054

Deficiency: Parking - Accessible Route - Adjacent

Access aisle is not located to an accessible route.

Measurement: 1 count

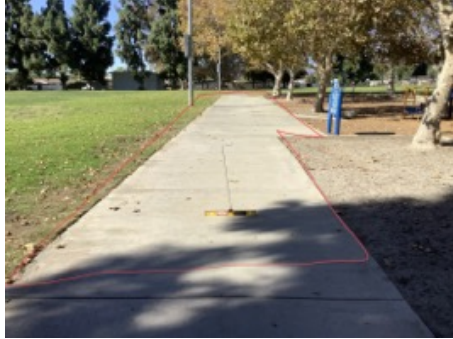
Comment #: PALO-055

Deficiency: Accessible Route - Slopes - Cross Slope

The cross slope of accessible routes exceeds 1:48 (2.0 %).

Measurement: 2.7 % grade

Remove and replace walk. Install walk that provides cross slopes at circulation route of 1:48 maximum.

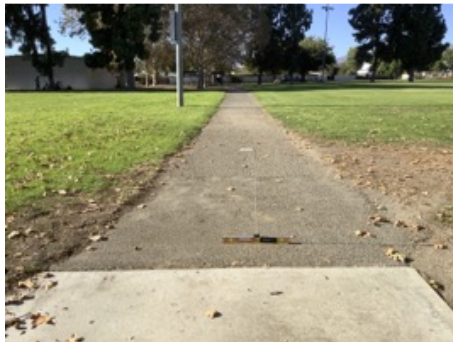
Comment #: PALO-056

Deficiency: Accessible Route - Slopes - Cross Slope

The cross slope of accessible routes exceeds 1:48 (2.0 %).

Measurement: 5.4 % grade

Remove and replace walk. Install walk that provides cross slopes at circulation route of 1:48 maximum.

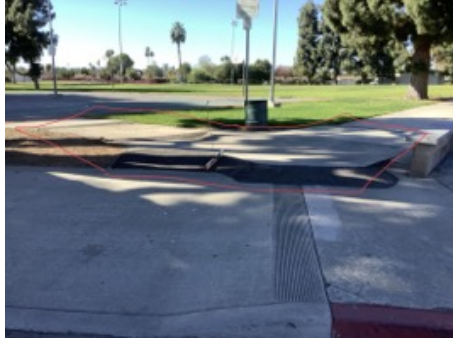
Comment #: PALO-057

Deficiency: Accessible Route - Slopes - Running Slope

The slope in the direction of travel exceeds the allowable 5%.

Measurement: 21.2 % grade
