APPENDIX A

FACILITY ASSESSMENT PHOTO REPORTS

CITY HALL

1.0 Site Assessment

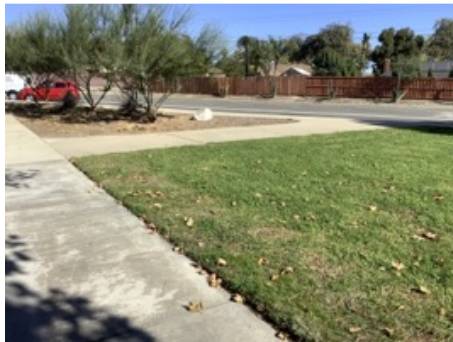
Comment #: PALO-058

Deficiency: Accessible Route - Slopes - Cross Slope

The cross slope of accessible routes exceeds 1:48 (2.0 %).

Measurement: 3.7 % grade

Remove and replace walk. Install walk that provides cross slopes at circulation route of 1:48 maximum.

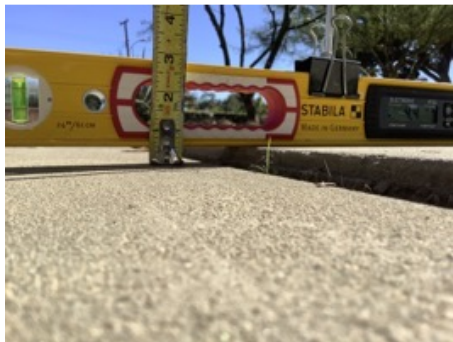
Comment #: PALO-059

Deficiency: Accessible Route - Vertical Displacement - Height

Accessible route has multiple locations where changes in level over 1/4" vertical or 1/2" beveled occur.

Measurement: .5 inches

Replace/grind locations where changes in elevation occur. Changes in level of 1/4" high maximum shall be permitted to be vertical and without edge treatment. Changes in level between 1/4" high minimum and 1/2" high maximum shall be beveled with a slope not steeper than 1:2. ADA Advisory: Change in level of 1/2" is permitted to be 1/4" vertical plus 1/4" beveled.

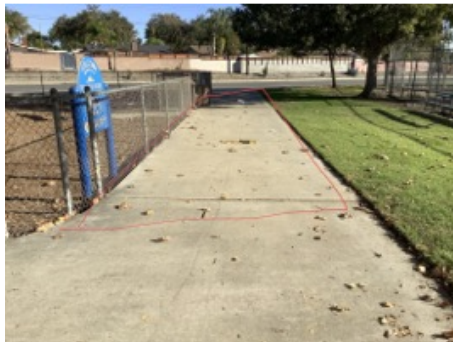
Comment #: PALO-060

Deficiency: Accessible Route - Slopes - Cross Slope

The cross slope of accessible routes exceeds 1:48 (2.0 %).

Measurement: 2.6 % grade

Remove and replace walk. Install walk that provides cross slopes at circulation route of 1:48 maximum.

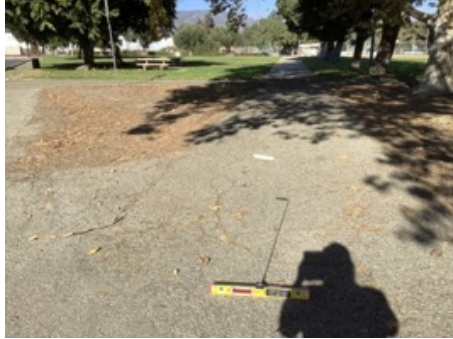
Comment #: PALO-061

Deficiency: Accessible Route - Slopes - Cross Slope

The cross slope of accessible routes exceeds 1:48 (2.0 %).

Measurement: 3.8 % grade

Remove and replace walk. Install walk that provides cross slopes at circulation route of 1:48 maximum.

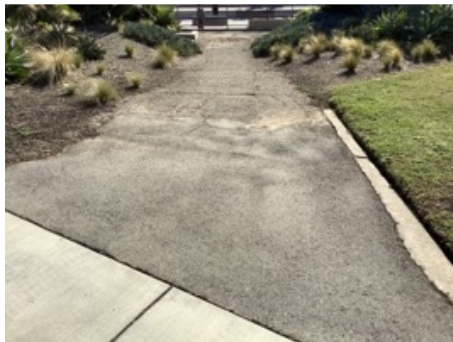
Comment #: PALO-062

Deficiency: Accessible Route - Surface - Continuity

Accessible route does not provide a firm, stable and slip resistant surface.

Measurement: 1 count

Replace and provide floor and/or ground surfaces that is stable, firm, and slip resistant

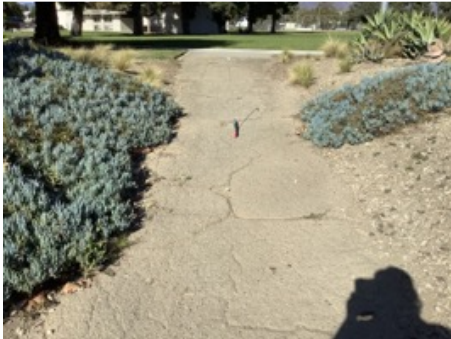
Comment #: PALO-063

Deficiency: Accessible Route - Slopes - Running Slope

The slope in the direction of travel exceeds the allowable 5%.

Measurement: 8 % grade

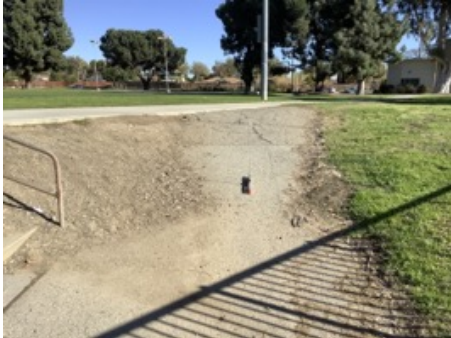
Comment #: PALO-064

Deficiency: Accessible Route - Slopes - Running Slope

The slope in the direction of travel exceeds the allowable 5%.

Measurement: 15 % grade

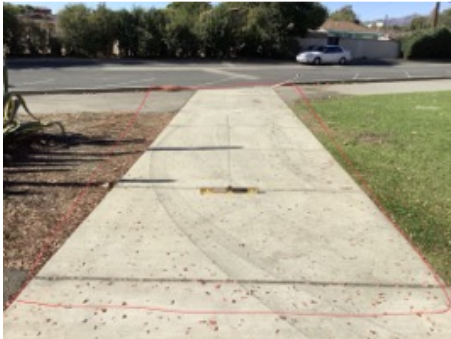
Comment #: PALO-065

Deficiency: Accessible Route - Slopes - Cross Slope

The cross slope of accessible routes exceeds 1:48 (2.0 %).

Measurement: 3.7 % grade

Remove and replace walk. Install walk that provides cross slopes at circulation route of 1:48 maximum.

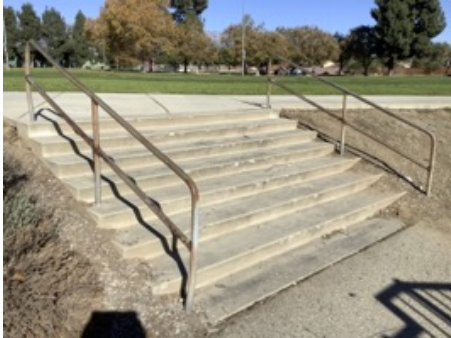
Comment #: PALO-066

Deficiency: Stairs - Contrast Striping - Exterior Stair

A 2-inch minimum to 4-inch maximum clear visual contrast stripe is not provided on each step.

Measurement: 0 inches

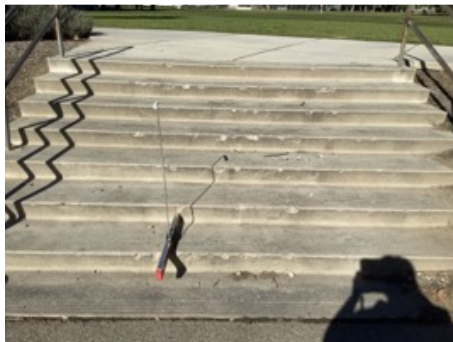
Comment #: PALO-067

Deficiency: Stairs - Surface - Slope

Slope of tread exceeds 1:48.

Measurement: 4.3 % grade

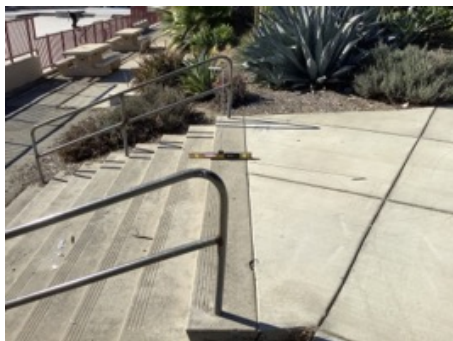
Comment #: PALO-068

Deficiency: Stairs - Handrails - Extensions: Top

Handrails at the top and/or bottom of the stairs do not extend 12-inches horizontally above the landing.

Measurement: 0 inches

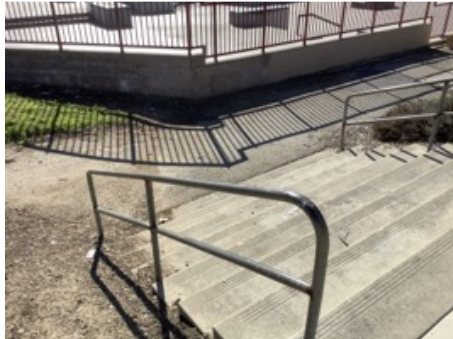
Comment #: PALO-069

Deficiency: Stairs - Handrails - Extensions: Bottom

At the bottom of a stair flight, handrails shall extend at the slope of the stair flight for a horizontal distance equal to one tread depth beyond the last riser nosing. The extension shall be 12" min. and a height equal to that of the sloping portion of the handrail as measured above the stair nosings.

Measurement: 0 inches

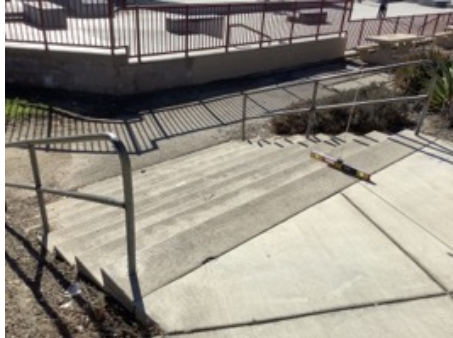
Comment #: PALO-070

Deficiency: Stairs - Handrails - Extensions-Top and Bottom

Handrails at the top and/or bottom of the stairs do not extend 12-inches horizontally above the landing.

Measurement: 0 inches

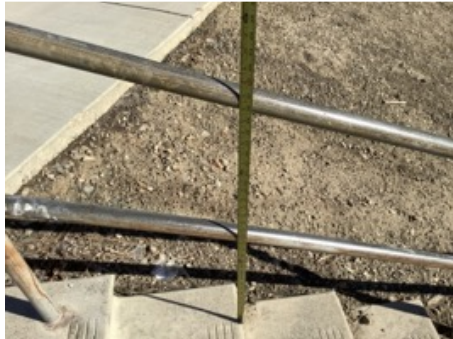
Comment #: PALO-071

Deficiency: Stairs - Handrails - Height

Top of the handrail is not located within the height ranges of 34-inches minimum to 38-inches maximum AFF.

Measurement: 31.5 inches

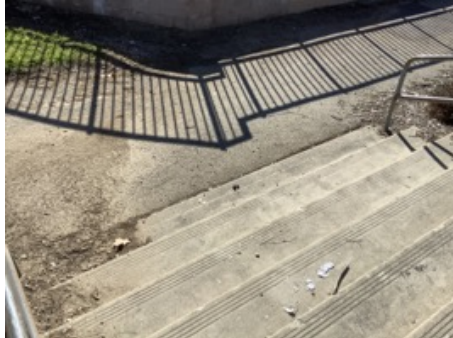
Comment #: PALO-072

Deficiency: Stairs - Handrails - Extensions

Handrail extensions do not return to a wall, guard, or landing surface and are not part of an adjacent stair run.

Measurement: 0

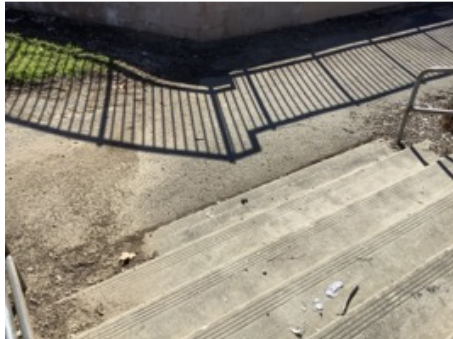
Comment #: PALO-073

Deficiency: Stairs - Handrails - Extensions

The bottom of the handrail extensions are not cane detectable and are a protrusion due to exceeding the maximum 27-inches AFF when located in an accessible route.

Measurement: 0 inches

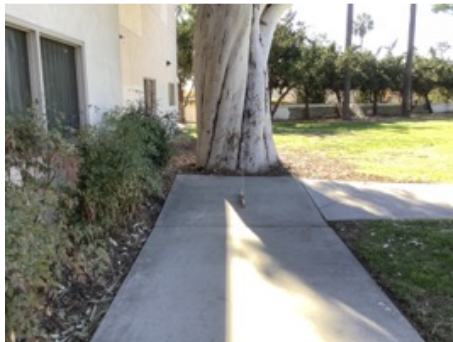
Comment #: PALO-074

Deficiency: Accessible Route - Slopes - Running Slope

The slope in the direction of travel exceeds the allowable 5%.

Measurement: 7.3 % grade

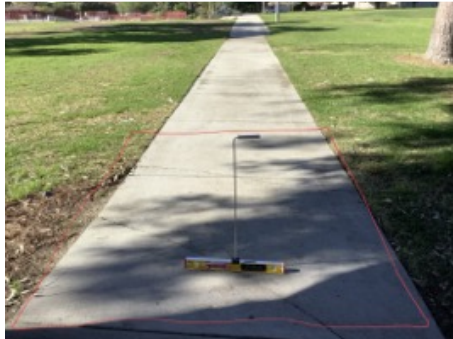
Comment #: PALO-075

Deficiency: Accessible Route - Slopes - Cross Slope

The cross slope of accessible routes exceeds 1:48 (2.0 %).

Measurement: 3.6 % grade

Remove and replace walk. Install walk that provides cross slopes at circulation route of 1:48 maximum.

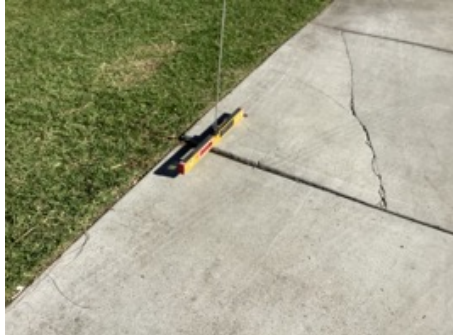
Comment #: PALO-076

Deficiency: Accessible Route - Vertical Displacement - Height

Accessible route has multiple locations where changes in level over 1/4" vertical or 1/2" beveled occur.

Measurement: 1 inches

Replace/grind locations where changes in elevation occur. Changes in level of 1/4" high maximum shall be permitted to be vertical and without edge treatment. Changes in level between 1/4" high minimum and 1/2" high maximum shall be beveled with a slope not steeper than 1:2. ADA Advisory: Change in level of 1/2" is permitted to be 1/4" vertical plus 1/4" beveled.

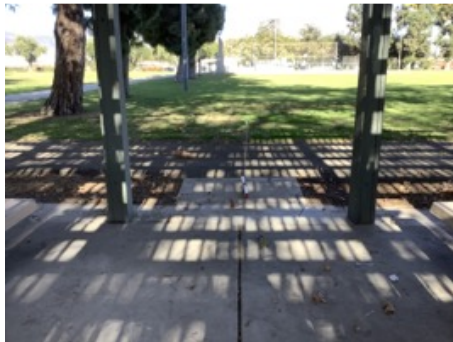
Comment #: PALO-078

Deficiency: Accessible Route - Slopes - Running Slope

The slope in the direction of travel exceeds the allowable 5%.

Measurement: 10.2 % grade

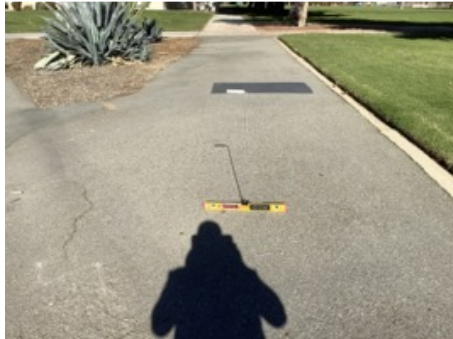
Comment #: PALO-079

Deficiency: Accessible Route - Slopes - Cross Slope

The cross slope of accessible routes exceeds 1:48 (2.0 %).

Measurement: 2.4 % grade

Remove and replace walk. Install walk that provides cross slopes at circulation route of 1:48 maximum.

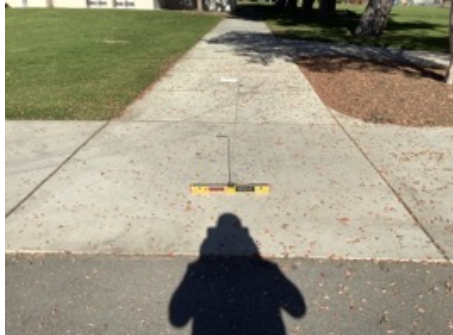
Comment #: PALO-080

Deficiency: Accessible Route - Slopes - Cross Slope

The cross slope of accessible routes exceeds 1:48 (2.0 %).

Measurement: 2.4 % grade

Remove and replace walk. Install walk that provides cross slopes at circulation route of 1:48 maximum.

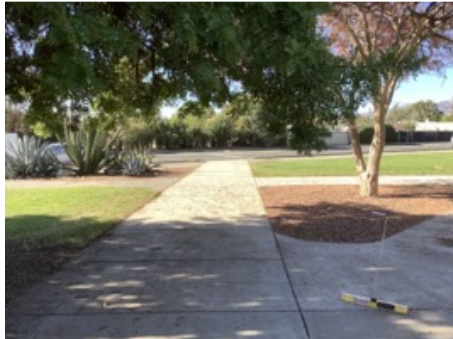
Comment #: PALO-081

Deficiency: Accessible Route - Vertical Clearance - Height

Fire extinguisher is located in an area where vertical clearance is less than 80-inches minimum.

Measurement: 53 inches

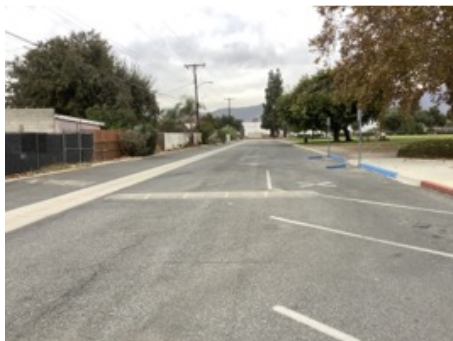
Comment #: PALO-082

Deficiency: Parking - Tow Away Sign - General

There is no "Unauthorized Parking Sign" sign at the entrance to the off-street parking.

Measurement: 0 count

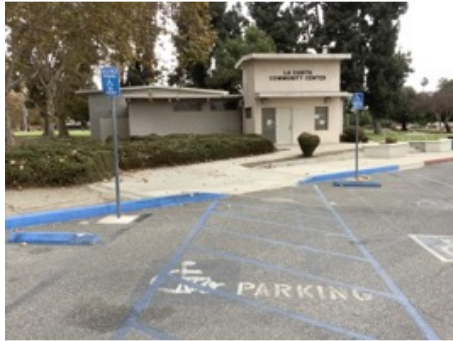
Comment #: PALO-083

Deficiency: Parking - Signage - Minimum Fine

The parking identification sign does not include the text "Minimum Fine \$250" below the ISA.

Measurement: 0 count

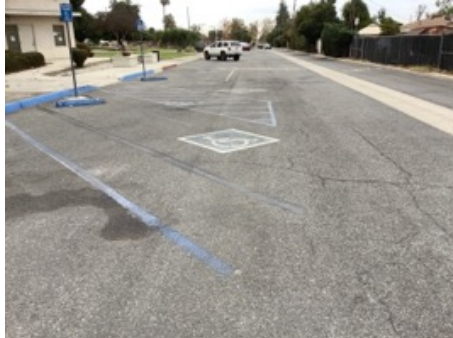
Comment #: PALO-084

Deficiency: Parking - ISA - Bottom Corner

The lower corner or lower side of the ISA identifying the accessible parking stall is not aligned with the end of the parking stall length.

Measurement: 0 inches

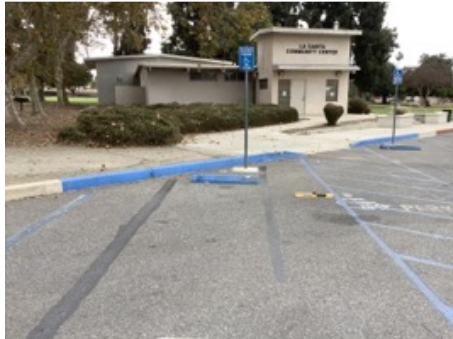
Comment #: PALO-085

Deficiency: Parking - Accessible Stall - Slopes

The slope of the van/car stall in any direction exceeds 1:48 (2.0%) grade.

Measurement: 2.7 % grade

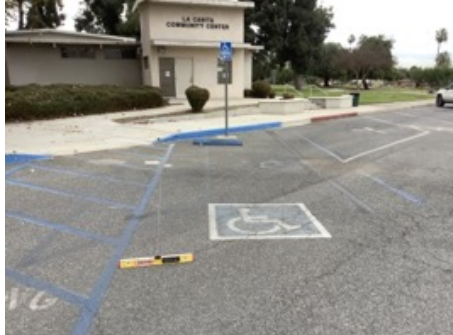
Comment #: PALO-086

Deficiency: Parking - Accessible Stall - Slopes

The slope of the van/car stall in any direction exceeds 1:48 (2.0%) grade.

Measurement: 2.9 % grade

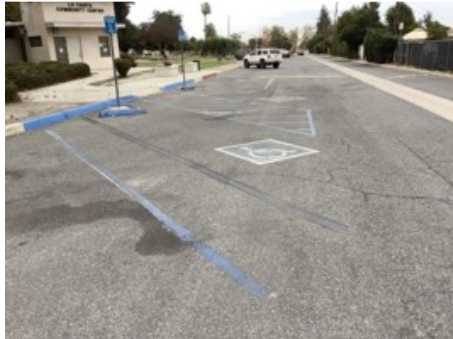
Comment #: PALO-087

Deficiency: Parking - Access Aisle Markings - Angled Parking

Angled parking stall access aisle does not extend the full required length of the parking stall(s) served on both sides.

Measurement: 1 inches

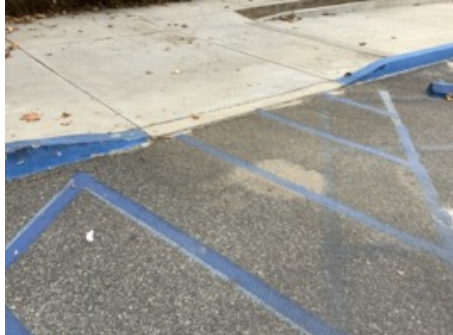
Comment #: PALO-088

Deficiency: Parking - Access Aisle Markings - Border Line Markings

The access aisle is not marked with a blue painted border line around the entire perimeter.

Measurement: 1 count

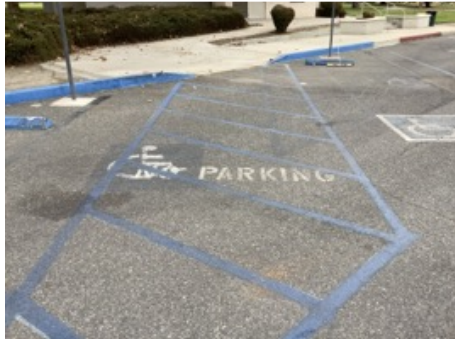
Comment #: PALO-089

Deficiency: Parking - Access Aisle Markings - "No Parking"

Missing 12" white 'No Parking' markings OR Markings are faded and does not discourage parking in the access aisle.

Measurement: 1 count

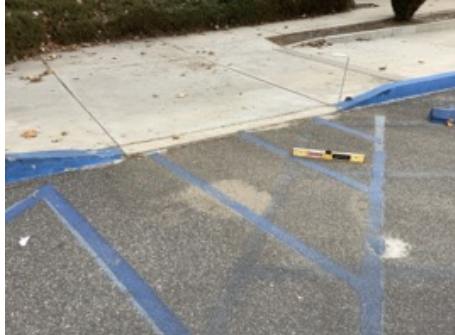
Comment #: PALO-090

Deficiency: Parking - Access Aisle - Slope

The slope of the access aisle in any direction exceeds 1:48 (2.0%) grade.

Measurement: 3.3 % grade

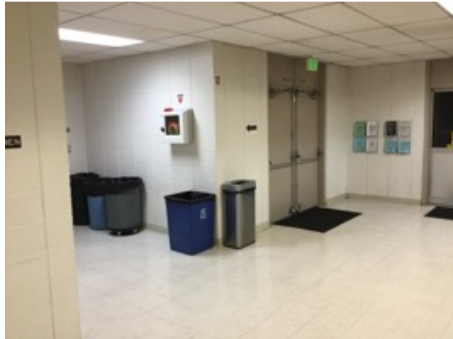
Comment #: PALO-091

Deficiency: Accessible Route - Protrusion - Depth

There is a wall-mounted AED cabinet in hall between lobby and women's restroom. Cabinet protrudes 7.5 inches from wall, it's bottom is 53.5 inches AFF, and it recessed, ring handle is 60.5 inches AFF.

Measurement: 7.5 inches

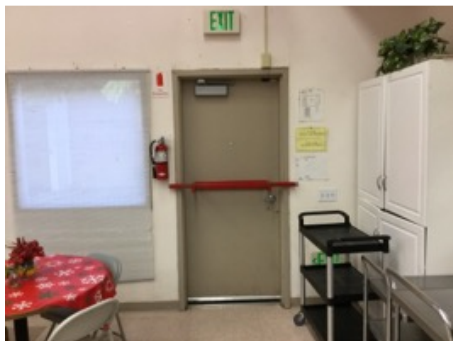
Comment #: PALO-092

Deficiency: Accessible Route - Reach Ranges - Side Reach

Fire Extinguisher for side reach is not located within 15-inches minimum to 48-inches maximum AFF (to a 10-inch depth).

Measurement: 49 inches

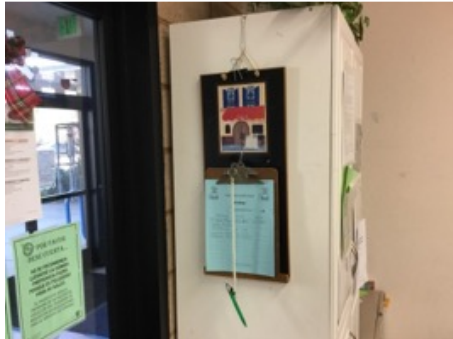
Comment #: PALO-093

Deficiency: Accessible Route - Reach Ranges - Side Reach

Obstructed elements is either deeper than 24" or more than 46-inches maximum AFF when deeper than 10-inches (to a maximum of 24-inches). Bottom of it is 50.5 inches AFF. (Lower "birthday" clipboard.)

Measurement: 50.5 inches

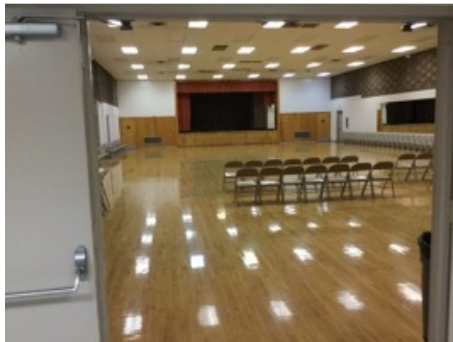
Comment #: PALO-094

Deficiency: Accessible Route - Surface - Continuity

Unable to verify floor slip resistance. Unsure if accessible route provides a firm, stable and slip resistant surface. Sign stating 'No Dance Wax Permitted'.

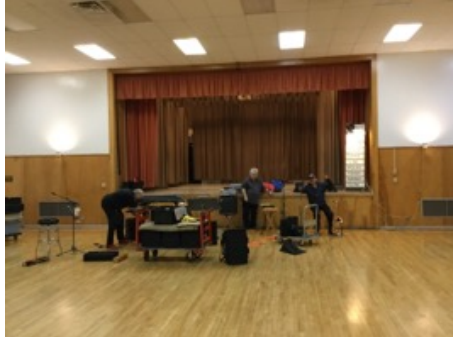
Comment #: PALO-095

Deficiency: Performance Areas - Accessible Route - Assembly area connection

A circulation path directly connecting a performance area to an assembly seating area does not have an accessible route directly connecting them.

Measurement: 0 count

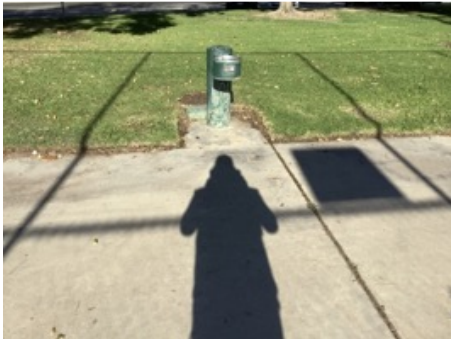
Comment #: PALO-097

Deficiency: Drinking Fountain - Number Provided - 50 percent

When dispersed, 50% are not compliant for standing and/or 50% are not complaint for wheelchair accessible on the site are .

Measurement: 0 count

Remove/replace so when more than the minimum number of drinking fountains are provided, 50 percent of the total number of drinking fountains shall be provided for standing person, and 50 percent of the total number of drinking fountains shall be provided as wheelchair accessible. Must be evenly distributed for a total of 100% of the drinking fountains.

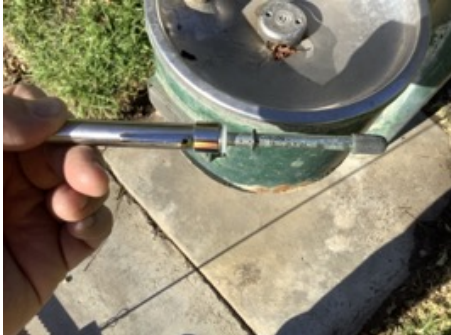
Comment #: PALO-098

Deficiency: Drinking Fountain - Wheelchair Compliance - Operable Parts-Force

Is the force required to activate operable parts 5 pounds maximum?

Measurement: 10 pound

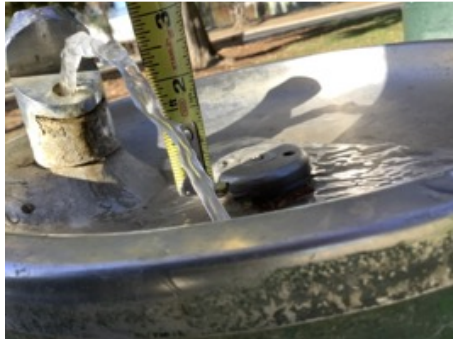
Comment #: PALO-099

Deficiency: Drinking Fountain - Wheelchair Compliance - Water Flow

The spout does not provide a flow of water 4 high minimum.

Measurement: 3 inches

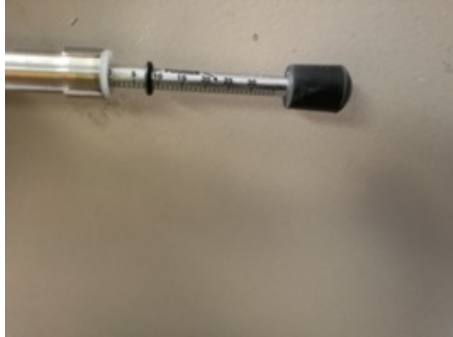
Comment #: PALO-0101

Deficiency: Interior Doors/Doorways/Gates - Operation - Opening Force

The force required to operate the door exceeds the allowable 5 lbf.

Measurement: 7 lbf

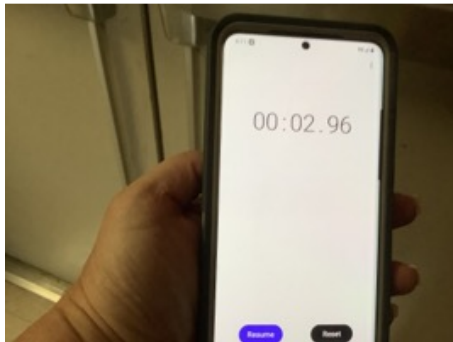
Comment #: PALO-0102

Deficiency: Interior Doors/Doorways/Gates - Operation - Closing Speed

The door closes faster than the minimum 5 seconds.

Measurement: 2.96 seconds

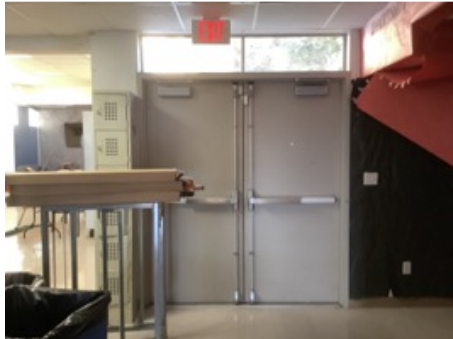
Comment #: PALO-0103

Deficiency: Interior Doors/Doorways/Gates - Hardware - Smooth Surface

Lower 10 inches of door is not smooth.

Measurement: 0 inches

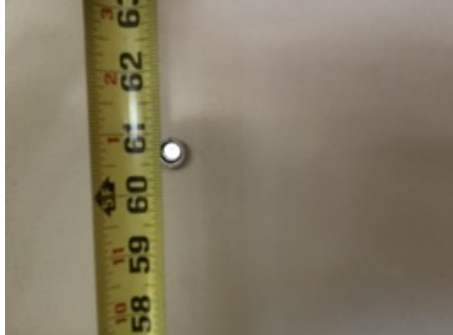
Comment #: PALO-0104

Deficiency: Interior Doors/Doorways/Gates - Hardware - Vision Light Height

The vision light is higher than the allowable height.

Measurement: 60.75 inches

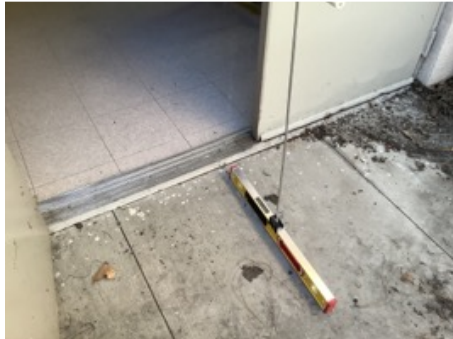
Comment #: PALO-0105

Deficiency: Interior Doors/Doorways/Gates - Landing - Slopes

Slopes more than 1:48 (2%) grade, or changes in elevation are located at door landings.

Measurement: 4.0 % grade

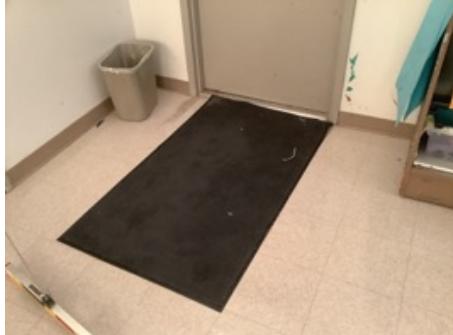
Comment #: PALO-0106

Deficiency: Interior Space - Mat - General

Carpet or carpet tile is not securely attached and is not fastened to the floor surface at edges.

Mat may cause tripping hazard due to not being securely attached. Carpet or carpet tile shall be securely attached and shall have a firm cushion, pad, or backing or no cushion or pad. Carpet or carpet tile shall have a level loop, textured loop, level cut pile, or level cut/uncut pile texture. Pile height shall be 1/2 inch maximum. Exposed edges of carpet shall be fastened to floor surfaces and shall have trim on the entire length of the exposed edge. Carpet edge trim shall not exceed 1/4" vertical or 1/2" maximum if beveled 2:1.

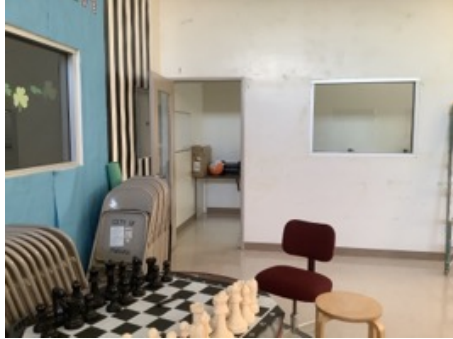
Comment #: PALO-0107

Deficiency: Interior Doors/Doorways/Gates - Clearances: Front - Pull Side Approach

60 inches of maneuvering space beyond the pull side of the door is not provided. The chair rack blocks the clearance.

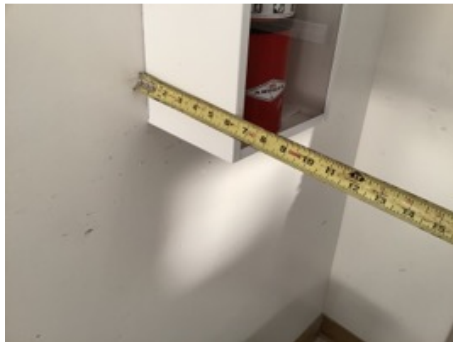
Comment #: PALO-0108

Deficiency: Accessible Route - Protrusion - Depth

Objects in the path of travel extend more than 4 inches from the wall with no cane detectable barrier.

Measurement: 6.25 inches

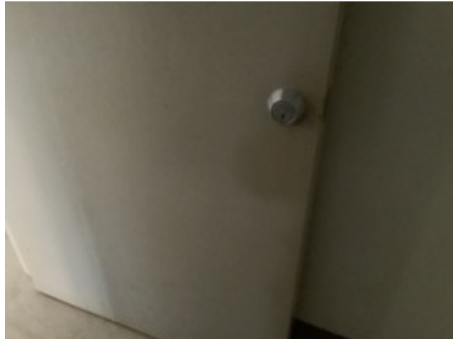
Comment #: PALO-0109

Deficiency: Interior Doors/Doorways/Gates - Hardware - Operation

The operable part requires tight grasping, pinching and/or twisting of the wrist to operate.

Measurement: 0 count

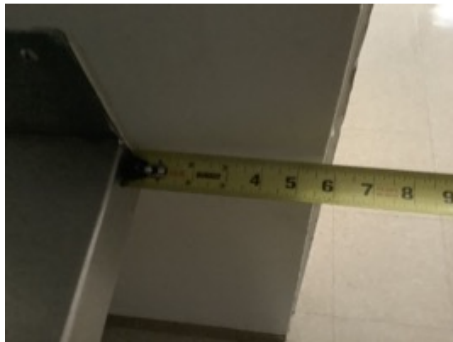
Comment #: PALO-0110

Deficiency: Interior Doors/Doorways/Gates - Clearances: Front - Latch Clearance

18-inches (exterior) not provided at latch side clearances.

Measurement: 5.75

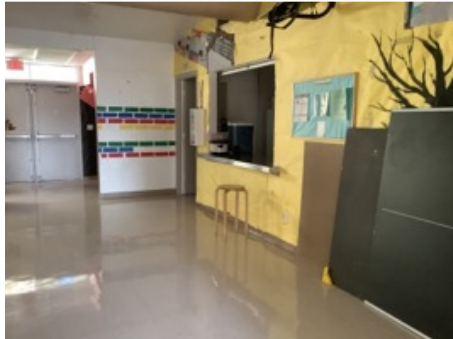
Comment #: PALO-0111

Deficiency: Transaction Counters - Dimensions - Counter Height

The counter surface is higher than the allowable 34 inches above the finished floor.

Measurement: 35.5 inches

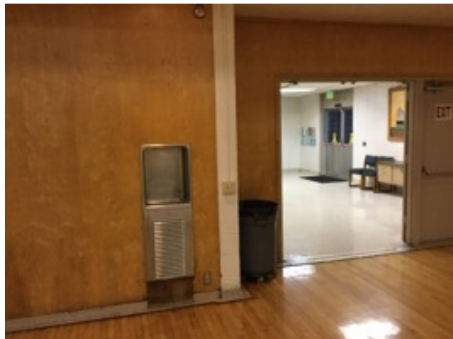
Comment #: PALO-0112

Deficiency: Drinking Fountain - Number Provided - Hi/Lo

One standing and one wheelchair accessible drinking fountain is not provided at each location.

Measurement: 1 count

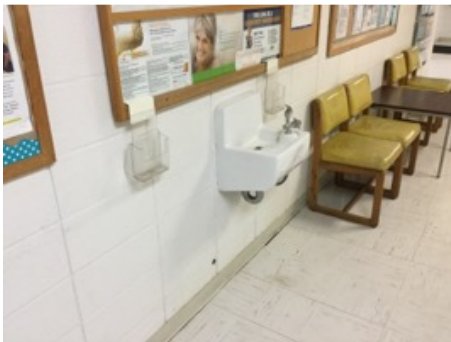
Comment #: PALO-0113

Deficiency: Drinking Fountain - Number Provided - Hi/Lo

One standing and one wheelchair accessible drinking fountain is not provided at each location.

Measurement: 1 count

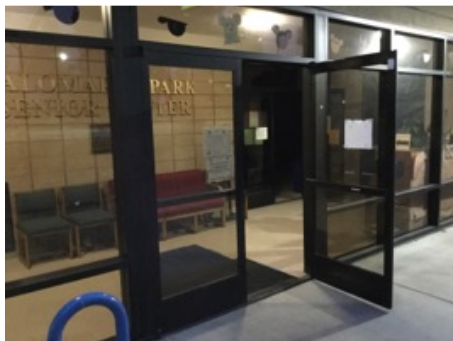
Comment #: PALO-0114

Deficiency: Exterior Doors/Doorways/Gates - Operation - Opening Force

The force required to operate the door exceeds the allowable 5 lbf.

Measurement: 10 lbf

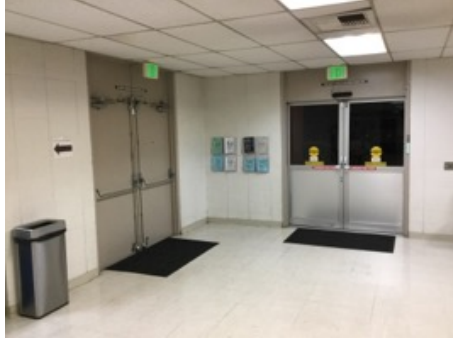
Comment #: PALO-0115

Deficiency: Exterior Doors/Doorways/Gates - Tactile Sign - General

No permanent tactile exit sign has been provided.

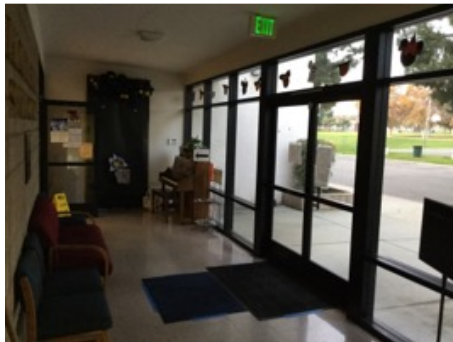
Comment #: PALO-0116

Deficiency: Exterior Doors/Doorways/Gates - Tactile Sign - General

No permanent tactile exit sign has been provided.

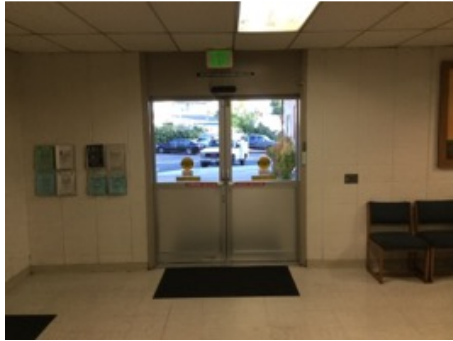
Comment #: PALO-0117

Deficiency: Interior Doors/Doorways/Gates - Tactile Sign - General

No permanent tactile exit sign has been provided.

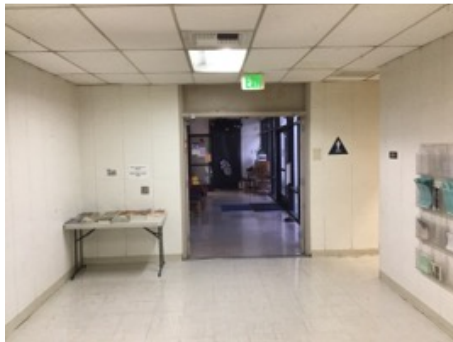
Comment #: PALO-0118

Deficiency: Interior Doors/Doorways/Gates - Tactile Sign - General

No permanent tactile exit sign has been provided.

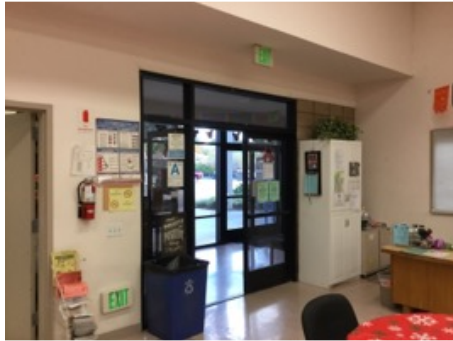
Comment #: PALO-0119

Deficiency: Interior Doors/Doorways/Gates - Tactile Sign - General

No permanent tactile exit sign has been provided.

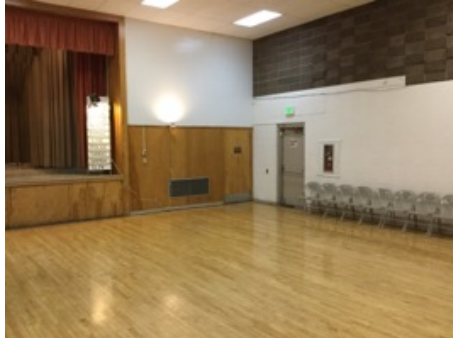
Comment #: PALO-0120

Deficiency: Interior Doors/Doorways/Gates - Tactile Sign - 18 Clear Space

There is no tactile and braille wall sign.

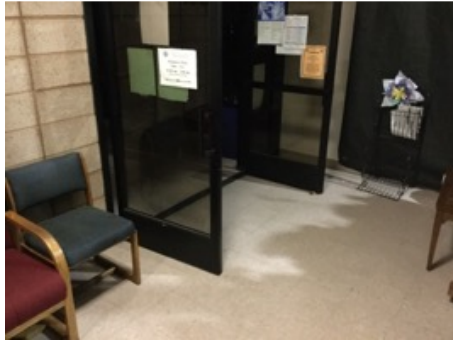
Comment #: PALO-0121

Deficiency: Interior Doors/Doorways/Gates - Threshold - Height

The threshold height exceeds the allowable tolerances. Between rear lobby and dining room, there is a pair of manual, side-hinged, storefront doors. Threshold is 0.50 inches high and beveled at greater than 1:2 (0.50" H x 0.75" D), latter of which is not compliant.

Measurement: .5 inches

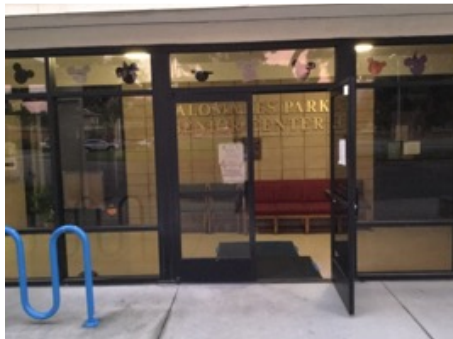
Comment #: PALO-0122

Deficiency: Interior Doors/Doorways/Gates - Threshold - Height

The threshold height exceeds the allowable tolerances. At primary public entrance to rear lobby of community center is a pair of manual, side-hinged, storefront doors. Threshold is 0.75 inches high (0.50" H and 0.25" above exterior landing) and beveled at greater than 1:2 (0.50" H x 0.75" D) both of which are not compliant.

Measurement: .75 inches

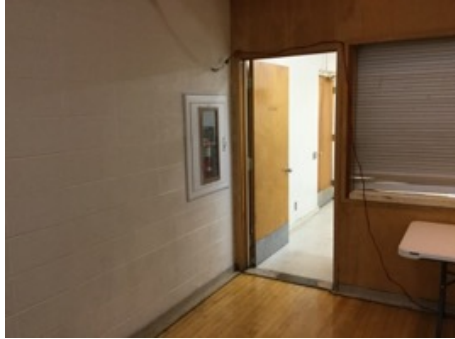
Comment #: PALO-0123

Deficiency: Interior Doors/Doorways/Gates - Tactile Sign - General

No permanent tactile sign has been provided. Door to kitchen from auditorium has a painted sign, "KITCHEN", but there is not a tactile room ID sign.

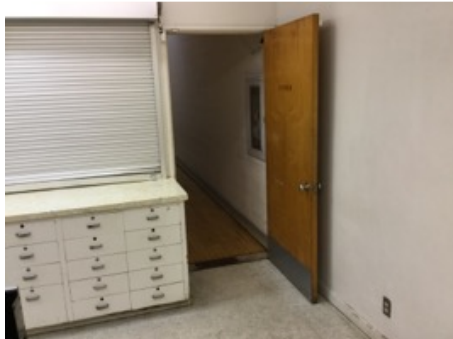
Floor/Area: Kitchen

Deficiency: Interior Doors/Doorways/Gates - Clearances: Front - Latch Clearance

Extend landing to provide 18-inch strike side clearance at latch side of door.

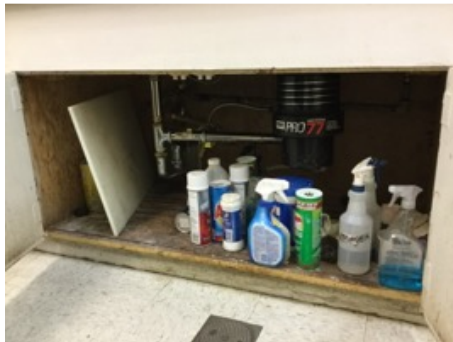
Floor/Area: Kitchen

Deficiency: Kitchen - Knee/Toe Clearance - Height

At sinks required to be accessible 4, the knee clearance shall be 27 inches high minimum above the finish floor or ground at a depth of 8 inches minimum above the finish floor or ground at the front edge of a counter with a built-in lavatory or at the front edge of a wall-mounted lavatory fixture

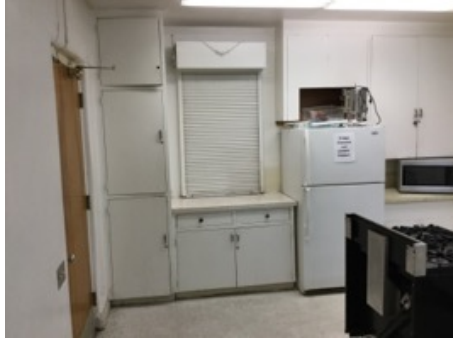
Comment #: PALO-0127

Deficiency: Kitchen - Storage - General

The storage does not appear to have at least 50% of cabinet shelf space within reach ranges (15"-48"; 46" max when shelving is 10" deep) AND/OR with handles that cannot be operated with one hand, and require tight grasping, pinching, or twisting of the wrist, or require more than 5 pounds force to operate, AND/OR without clear floor space. Less than 50% of the storage is

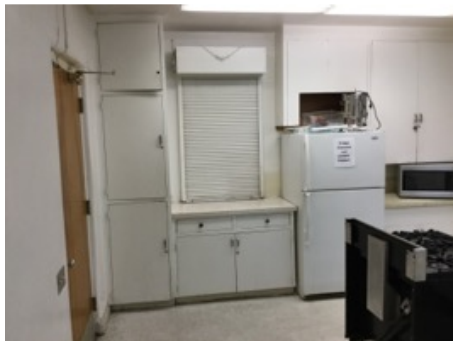
Comment #: PALO-0128

Deficiency: Lavatory - Counter Surface - Height

The height of the sink and counter surface exceeds the allowable 34 inches AFF.

Measurement: 36 inches

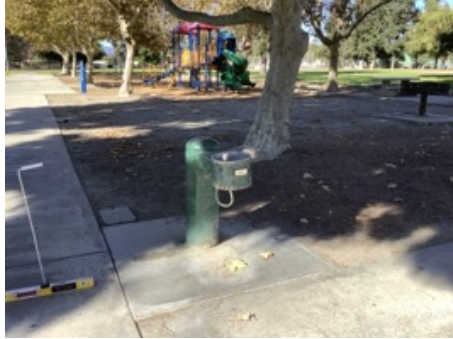
Comment #: PALO-0129

Deficiency: Drinking Fountain - Number Provided - Hi/Lo

One standing and one wheelchair accessible drinking fountain is not provided at each location.

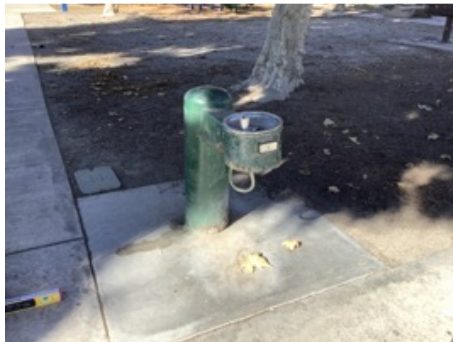
Comment #: PALO-0130

Deficiency: Drinking Fountain - Number Provided - 50 percent

When dispersed, 50% are not compliant for standing and/or 50% are not complaint for wheelchair accessible on the site are .

Remove/replace so when more than the minimum number of drinking fountains are provided, 50 percent of the total number of drinking fountains shall be provided for standing person, and 50 percent of the total number of drinking fountains shall be provided as wheelchair accessible. Must be evenly distributed for a total of 100% of the drinking fountains.

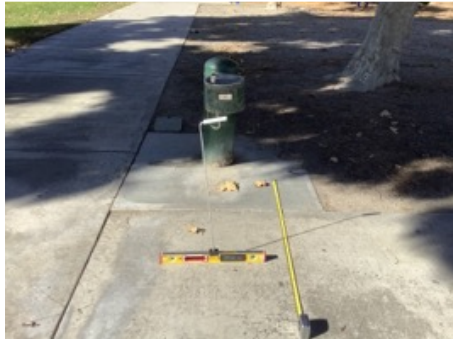
Comment #: PALO-0131

Deficiency: Drinking Fountain - Wheelchair Compliance - Clear Floor Grades

30" x 48" clear floor space slopes exceed 1:48 (2.083%)

Measurement: 2.5 % grade

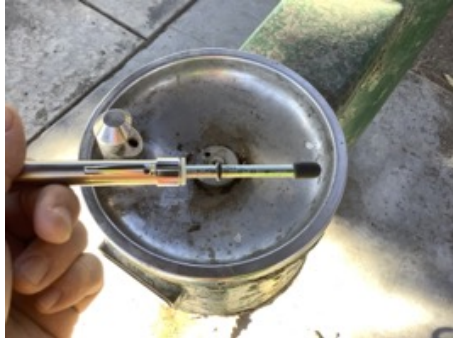
Comment #: PALO-0132

Deficiency: Drinking Fountain - Wheelchair Compliance - Operable Parts-Force

Is the force required to activate operable parts 5 pounds maximum?

Measurement: 12 pound

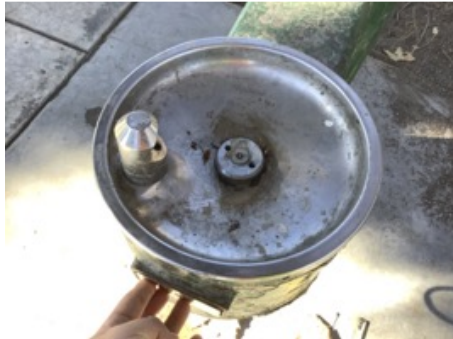
Comment #: PALO-0133

Deficiency: Drinking Fountain - Wheelchair Compliance - Water Flow

The spout does not provide a flow of water 4 high minimum.

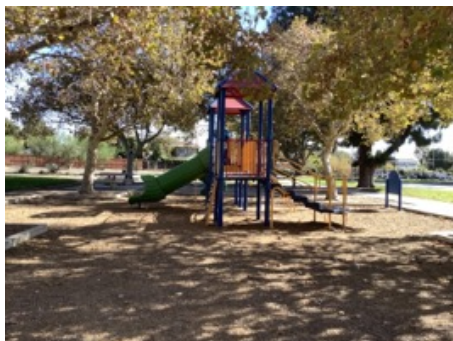
Comment #: PALO-0134

Deficiency: Playgrounds - Accessible Route - Site Amenities

An accessible path of travel from the playground is not provided to restrooms, drinking fountains, other accessible areas, and public telephones (if available) on site.

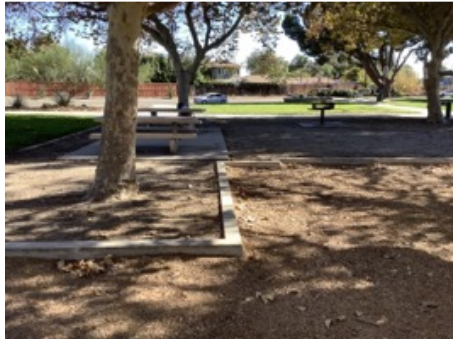
Comment #: PALO-0135

Deficiency: Picnic Tables - Accessible Route - General

No accessible route is provided to the picnic tables and bbq.

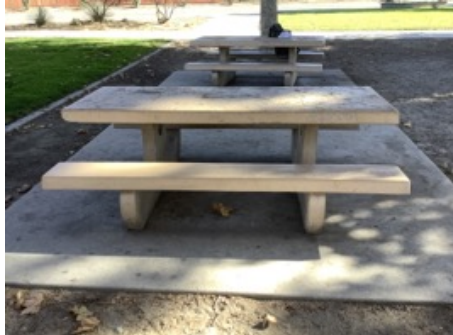
Comment #: PALO-0136

Deficiency: Picnic Tables - Accessible Route - General

No accessible route is provided to the picnic tables and bbq.

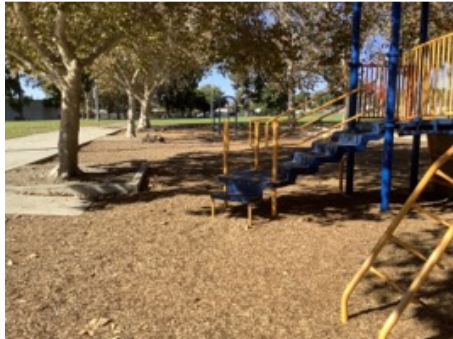
Comment #: PALO-0137

Deficiency: Playgrounds - Accessible Route - Play Area - Ground Level

One 60-inch minimum wide accessible route is not provided within the play area.

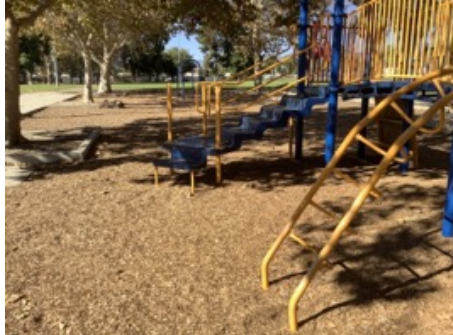
Comment #: PALO-0138

Deficiency: Playgrounds - Accessible Route - Play Area-Elevated Component

The clear width of accessible routes connecting elevated play components 36 inches minimum?

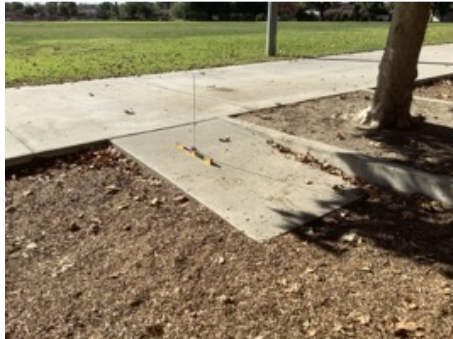
Comment #: PALO-0139

Deficiency: Playgrounds - Accessible Route - Ramps - Ground Level

Ground level ramp runs connecting ground level play components have a running slope steeper than 1:16 (6.25%).

Measurement: 7.3 % grade

Replace ramps so that at Ground level all ramp runs connecting ground level play components shall have a running slope not steeper than 1:16 (6.25%).

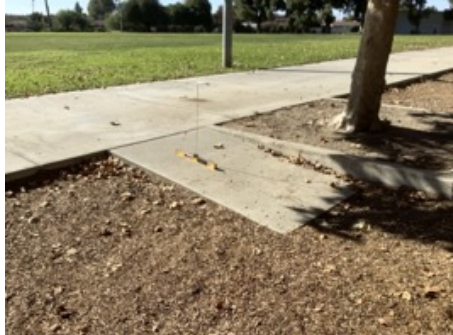
Comment #: PALO-0140

Deficiency: Playgrounds - Accessible Route - Ramp Handrail - Height

The top of handrail gripping surfaces is not located between 20 inches minimum and 28 inches maximum above the ramp surface.

Add or replace so the top of handrail gripping surfaces shall be 20 inches (508 mm) minimum and 28 inches (711 mm) maximum above the ramp surface.

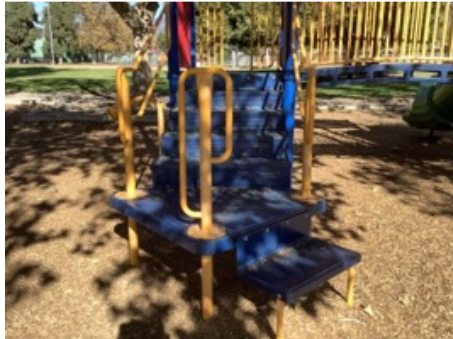
Comment #: PALO-0141

Deficiency: Playgrounds - Transfer System - Contrast Striping

Transfer step does not provide contrast striping, or contrast striping is not compliant.

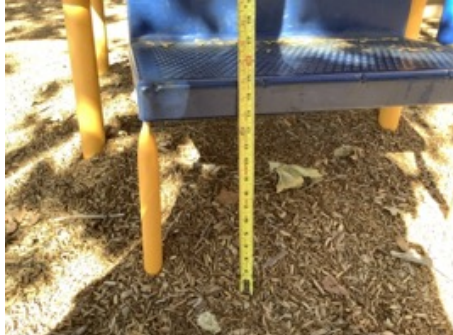
Comment #: PALO-0142

Deficiency: Playgrounds - Transfer System - Transfer Platform-Height

Transfer platform exceeds maximum 11" and does not provide a level 30" x 48" clear floor space centered 24" for a parallel approach.

Measurement: 15

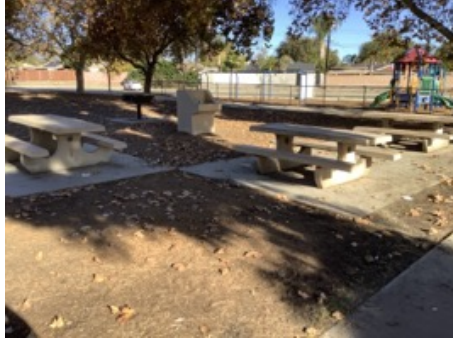
Comment #: PALO-0143

Deficiency: Picnic Tables - Accessible Route - General

No accessible route is provided to the picnic tables and bbq.

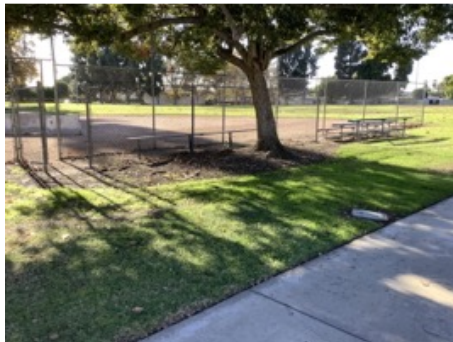
Comment #: PALO-0144

Deficiency: Sport Courts - Accessible Route - Connection

A minimum of one accessible route a minimum of 48-inches does not directly connect both sides of the sport court.

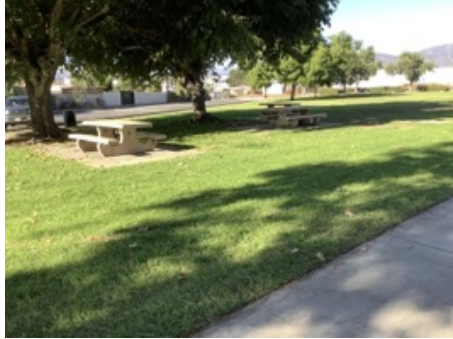
Comment #: PALO-0145

Deficiency: Picnic Tables - Accessible Route - General

No accessible route is provided to the picnic tables and bbq.

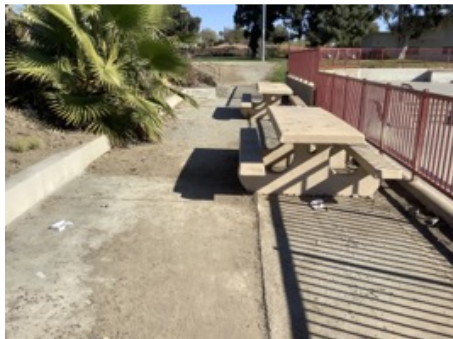
Comment #: PALO-0146

Deficiency: Picnic Tables - Accessible Route - General

No accessible route is provided to the picnic tables and bbq.

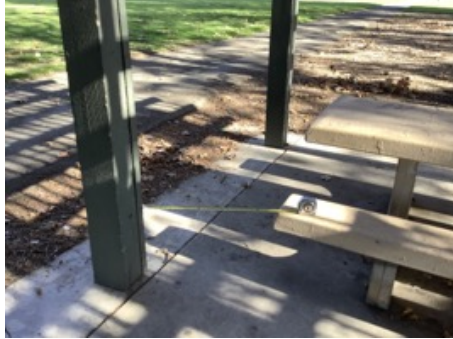
Comment #: PALO-0147

Deficiency: Picnic Tables - Accessible Route - General

No accessible route is provided to the picnic tables and bbq.

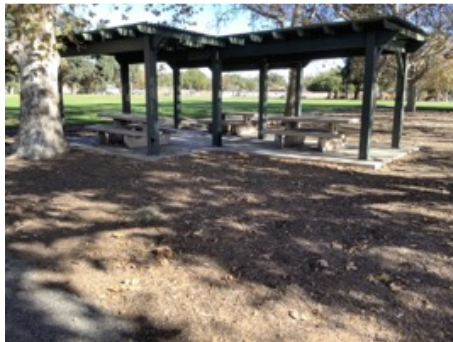
Comment #: PALO-0148

Deficiency: Accessible Route - Surface - Continuity

Accessible route does not provide a firm, stable and slip resistant surface.

Replace and provide floor and/or ground surfaces that is stable, firm, and slip resistant

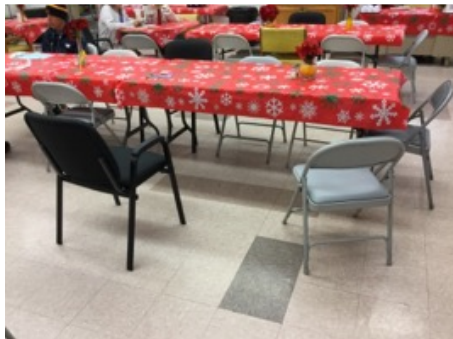
Comment #: PALO-0150

Deficiency: Seating - Picnic Table - Count

There are not a minimum of 5% accessible seats provided at all types of tables. Knee clearances are less than 27" at current tables.

Measurement: 26.75 count

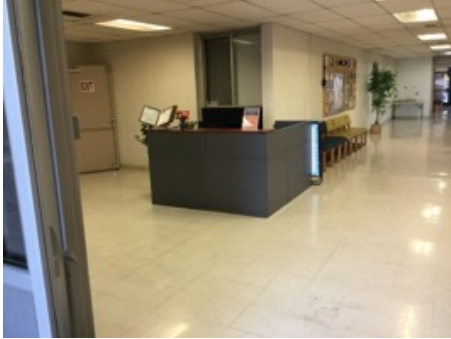
Comment #: PALO-0151

Deficiency: Transaction Counters - Dimensions - Counter Height

The counter surface is higher than the allowable 34 inches above the finished floor. The lobby has an L-shaped reception desk. However, top of transaction counter is 43 inches AFF and top of adjacent partition is 42 inches AFF. There is not a low or accessible transaction counter.

Measurement: 43 inches

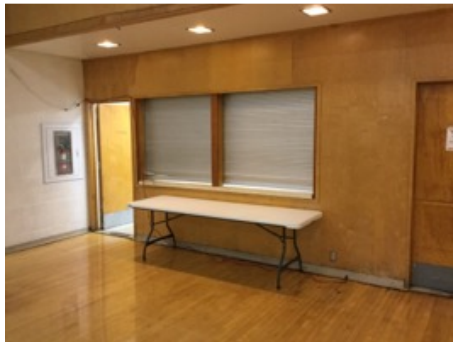
Comment #: PALO-0152

Deficiency: Transaction Counters - Dimensions - Counter Height

The counter surface is higher than the allowable 34 inches above the finished floor.

Measurement: 36 inches

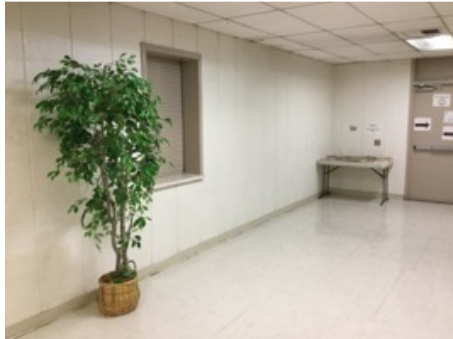
Comment #: PALO-0153

Deficiency: Transaction Counters - Dimensions - Counter Height

The counter surface is higher than the allowable 34 inches above the finished floor.

Measurement: 37 inches

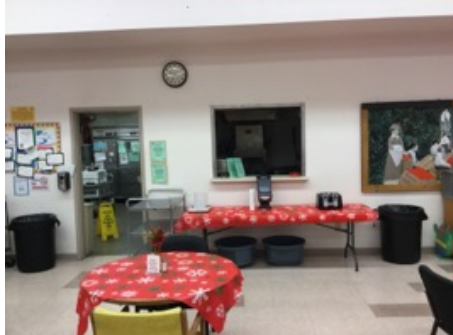
Comment #: PALO-0154

Deficiency: Transaction Counters - Dimensions - Counter Height

The counter surface is higher than the allowable 34 inches above the finished floor.

Measurement: 44.75 inches

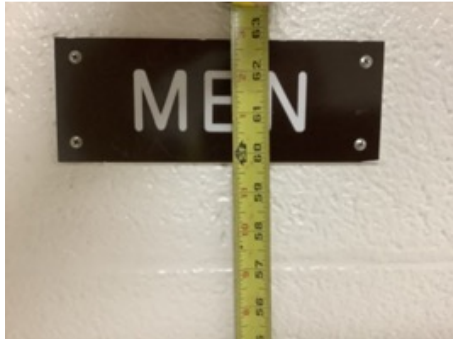
Comment #: PALO-0155

Deficiency: Restroom Doors - Tactile Sign - Height

The tactile sign is not mounted within the allowable height ranges.

Measurement: 60.5 inches

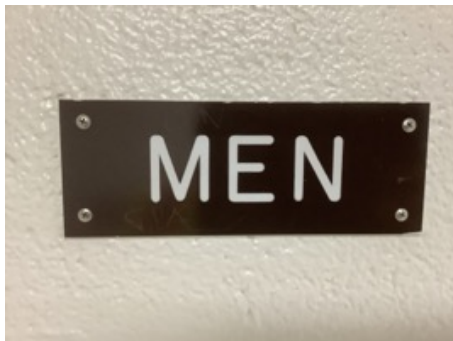
Comment #: PALO-0156

Deficiency: Restroom Doors - Tactile Sign - Braille

The braille provided at the restroom door is not readable, obstructed and/or not Grade 2.

Measurement: 1 count

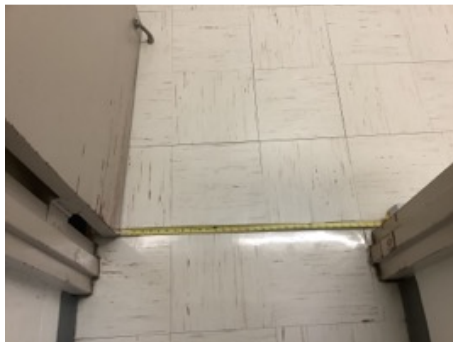
Comment #: PALO-0159

Deficiency: Restroom Doors - Dimensions - Width

The door does not provide a clear open width of minimum 32 inches when open 90 degrees.

Measurement: 31 inches

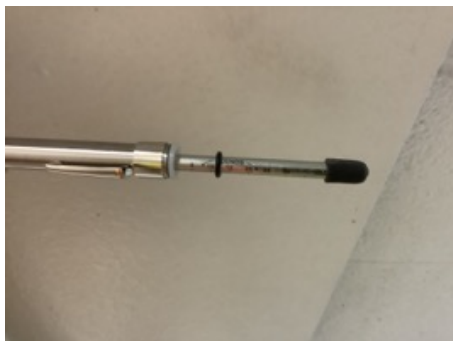
Comment #: PALO-0160

Deficiency: Restroom Doors - Operation - Opening Force

The force required to operate the door exceeds the allowable 5 lbf.

Measurement: 1 lbf

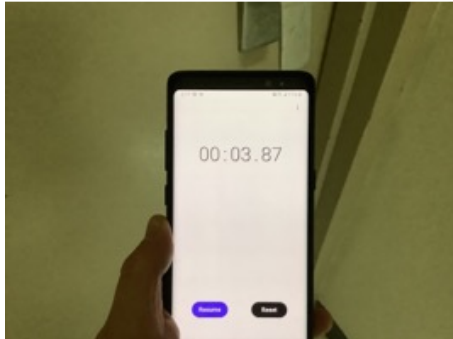
Comment #: PALO-0161

Deficiency: Restroom Doors - Operation - Closing Speed

The door closes faster than the minimum 5 seconds.

Measurement: 3.87 seconds

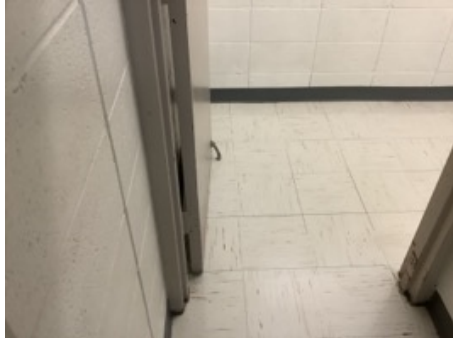
Comment #: PALO-0162

Deficiency: Restroom Doors - Operation - 90 Degrees

The door does not open 90 degrees.

Measurement: 80 count

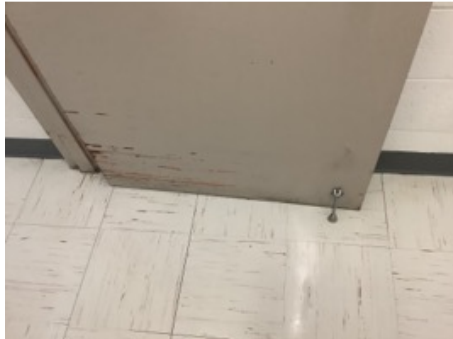
Comment #: PALO-0163

Deficiency: Restroom Doors - Hardware - Smooth Surface

The doorway is not smooth for the bottom ten inches.

Measurement: 1 inches

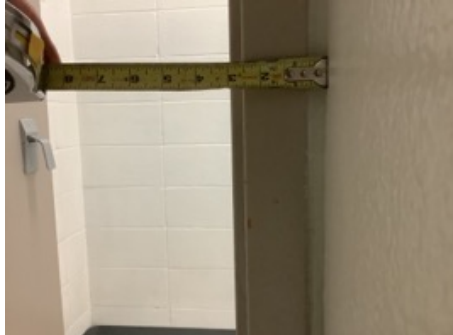
Comment #: PALO-0164

Deficiency: Restroom Doors - Clearances: Front - Push Side Approach

12-inch strike side clearance not provided on latch side of door.

Measurement: 3 inches

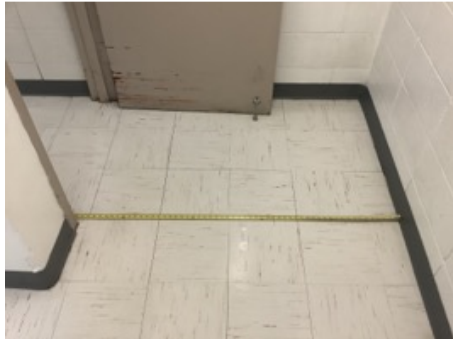
Comment #: PALO-0165

Deficiency: Restroom Doors - Clearances: Latch Side - Pull Side Approach

60 inches of maneuvering space beyond the pull side of the door is not provided.

Measurement: 55 inches

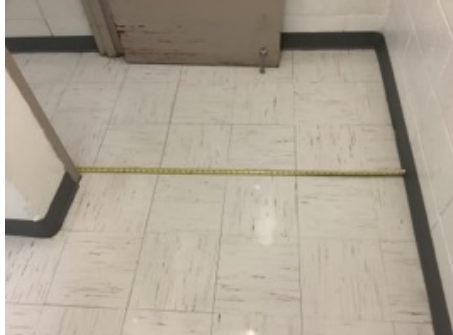
Comment #: PALO-0166

Deficiency: Restroom Doors - Clearances: Latch Side - Latch Clearance

Latch side clearance is not provided at the pull side of the door.

Measurement: 0 inches

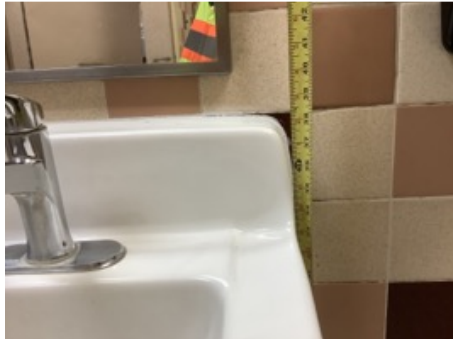
Comment #: PALO-0167

Deficiency: Restroom Interior Space - Amenities - Mirror Height

The mirror height exceeds the allowable 40 inches above the finished floor.

Measurement: 40.25 inches

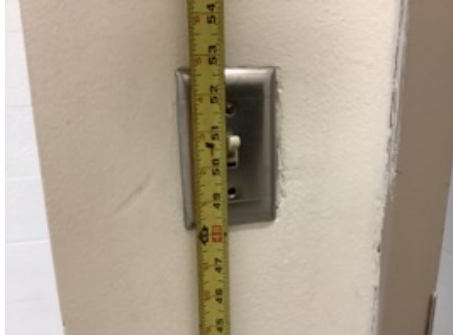
Comment #: PALO-0168

Deficiency: Restroom Interior Space - Amenities - Light Switch Height

The light switch exceeds the maximum allowable height.

Measurement: 51 inches
