APPENDIX A

FACILITY ASSESSMENT PHOTO REPORTS

CITY HALL

1.0 Site Assessment

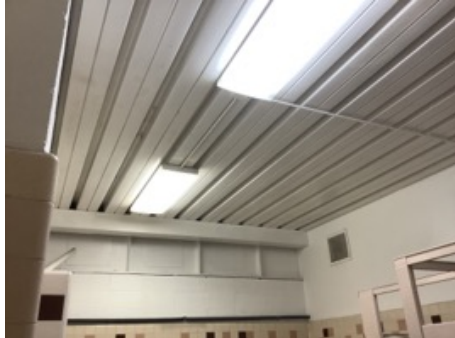
Comment #: PALO-0170

Deficiency: Restroom Interior Space - Fire Strobes - General

No visible alarm notifications are provided.

Measurement: 0 count

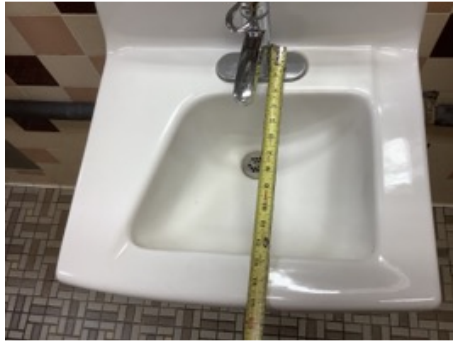
Comment #: PALO-0171

Deficiency: Lavatory - Location - Depth

Lavatory controls are less than 17-inches or more than 19 inches from the face of the lavatory.

Measurement: 15 inches

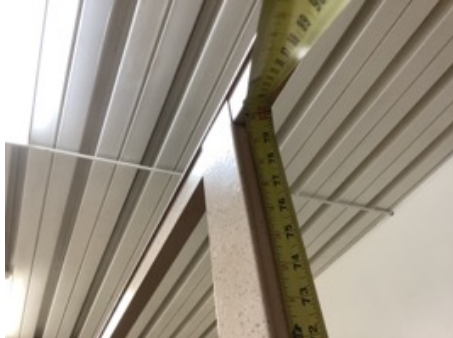
Comment #: PALO-0172

Deficiency: Accessible Toilet Stall - Door - Clear Height

The stall door does not provide clear height.

Measurement: 79.5 inches

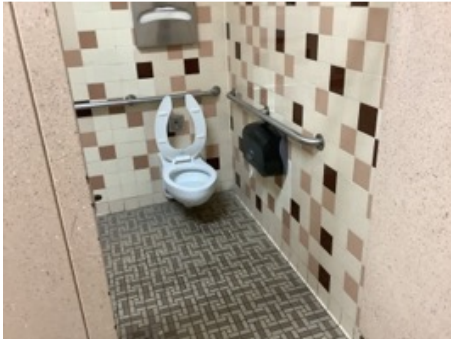
Comment #: PALO-0173

Deficiency: Accessible Toilet Stall - End Opening Door - 4-Inch Clearance

Where located in the front wall or partition, the door opening is more than the allowable 4 inches from the side wall or partition on the farthest side from the water closet.

Measurement: 1 inches

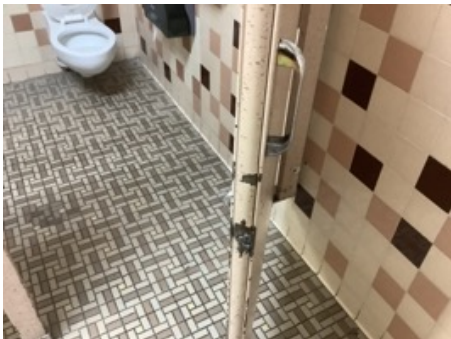
Comment #: PALO-0174

Deficiency: Accessible Toilet Stall - Door Hardware - Handle Both Sides

There is no pull handle on the interior side of the stall door.

Measurement: 1 count

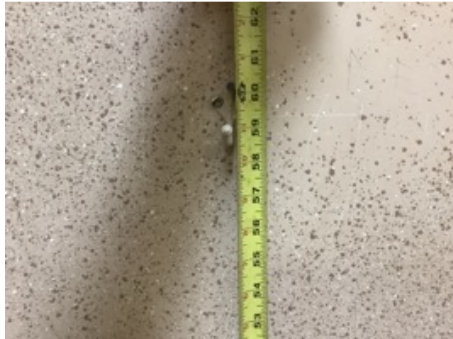
Comment #: PALO-0175

Deficiency: Accessible Toilet Stall - Door Hardware - Coat Hook Height

The operable part of the provided coat hook is higher than the allowable 48 inches AFF.

Measurement: 59 inches

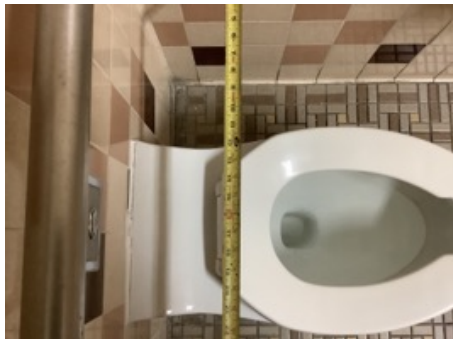
Comment #: PALO-0176

Deficiency: Accessible Toilet Stall - Water Closet - Location

The water closet is not a compliant distance from the adjacent wall.

Measurement: 16.5 inches

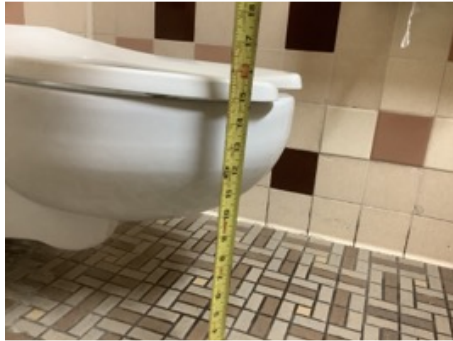
Comment #: PALO-0177

Deficiency: Accessible Toilet Stall - Water Closet - Height

The toilet seat exceeds the allowable 17 - 19 inches AFF measured to the top of the seat.

Measurement: 15.75 inches

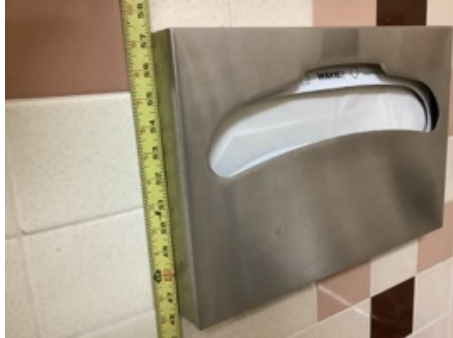
Comment #: PALO-0178

Deficiency: Accessible Toilet Stall - Dispensers - Seat Cover Height

The height of the operable part of the provided seat cover dispenser exceeds the allowable 40 inches AFF.

Measurement: 54 inches

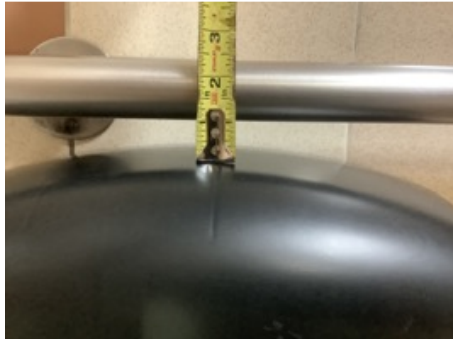
Comment #: PALO-0179

Deficiency: Accessible Toilet Stall - Side Grab Bar - Fixture Clearance

The dispenser does not provide minimum 1.5 inch hand clearance to the ends or bottom of the side grab bar.

Measurement: 1 inches

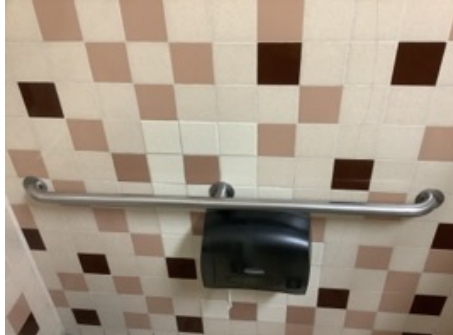
Comment #: PALO-0180

Deficiency: Accessible Toilet Stall - Side Grab Bar - Wall Clearance

The side grab bar does not provide clearance to the wall of 1 1/2 inches.

Measurement: 1.5 inches

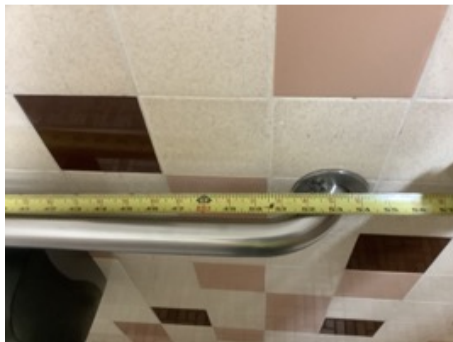
Comment #: PALO-0181

Deficiency: Accessible Toilet Stall - Side Grab Bar - End Distance to Rear Wall

The side grab bar does not extend minimum 54 inches from the rear wall.

Measurement: 53 inches

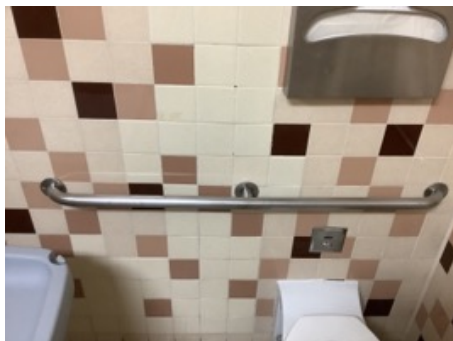
Comment #: PALO-0182

Deficiency: Accessible Toilet Stall - Rear Grab Bar - Wall Clearance

The rear grab bar does not provide clearance to the wall of 1 1/2 inches.

Measurement: 1.5 inches

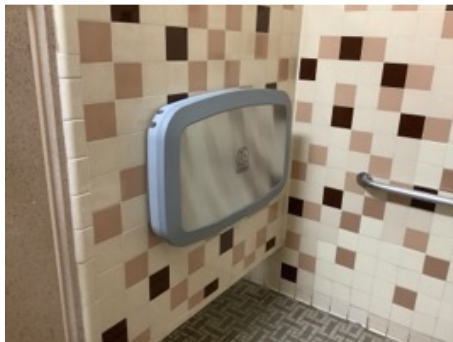
Floor/Area: Senior Center
Room/Spot: Men's Restroom

Deficiency: Baby Changing Station - Accessible Route - Located in Accessible Toilet Stall

ADA does not specify location of changing table.

Baby changing tables shall comply with operable parts and work station requirements. Baby changing tables when deployed shall not obstruct the required width of an accessible route. Baby changing tables shall not be located in accessible toilet compartments within a multiple accommodation toilet facility.

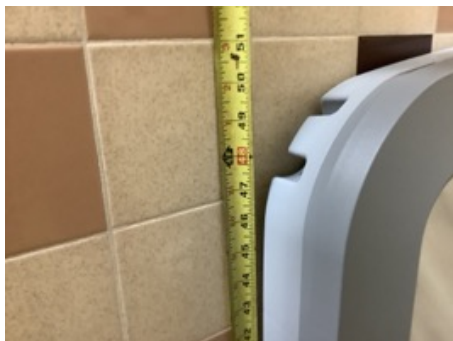
Floor/Area: Senior Center
Room/Spot: Men's Restroom

Deficiency: Baby Changing Station - Operable Parts - Height

Provided operable parts shall be operable with one hand and shall not require tight grasping, pinching, or twisting of the wrist. The force required to activate operable parts shall be 5 pounds maximum. Recommend installing a strap for the opening with a circular handle that does not require grasping.

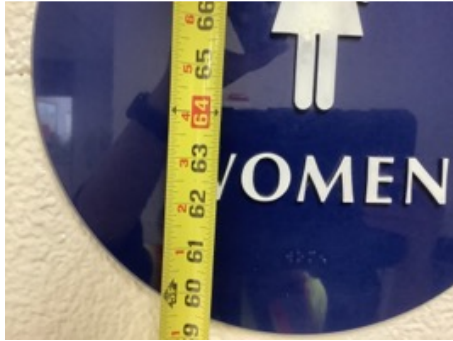
Comment #: PALO-0185

Deficiency: Restroom Doors - Tactile Sign - Height

The tactile sign is not mounted within the allowable height ranges.

Measurement: 62 inches

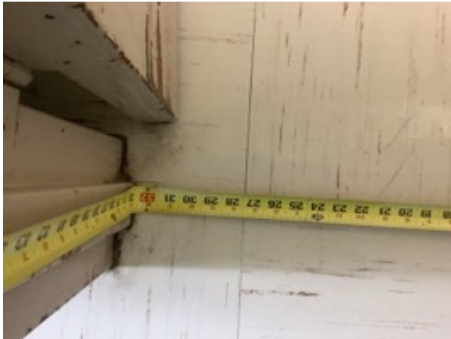
Comment #: PALO-0187

Deficiency: Restroom Doors - Dimensions - Width

The door does not provide a clear open width of minimum 32 inches when open 90 degrees.

Measurement: 30.5 inches

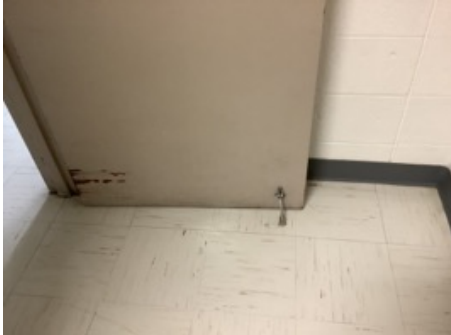
Comment #: PALO-0188

Deficiency: Restroom Doors - Hardware - Smooth Surface

The doorway is not smooth for the bottom ten inches.

Measurement: 2 inches

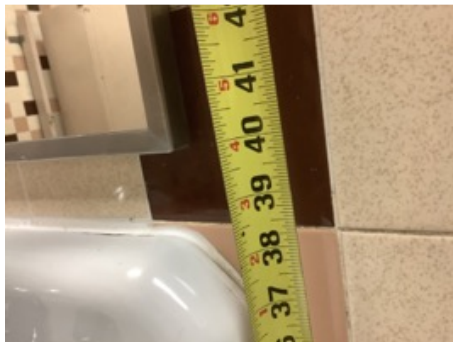
Comment #: PALO-0189

Deficiency: Restroom Interior Space - Amenities - Mirror Height

The mirror height exceeds the allowable 40 inches above the finished floor.

Measurement: 40.25 inches

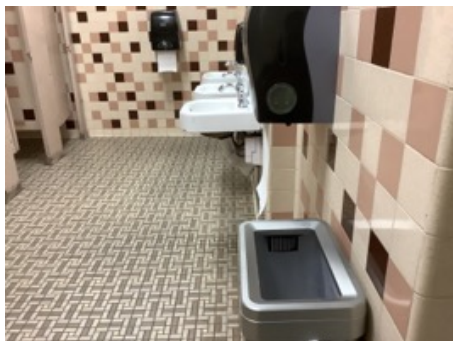
Comment #: PALO-0190

Deficiency: Restroom Interior Space - Protruding Objects - General

Objects in the restroom extend more than 4 inches from the wall with no cane detectable barrier.

Measurement: 9.5 inches

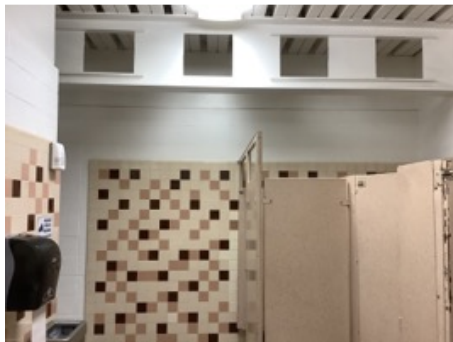
Comment #: PALO-0191

Deficiency: Restroom Interior Space - Fire Strobes - General

No visible alarm notifications are provided.

Measurement: 0 count

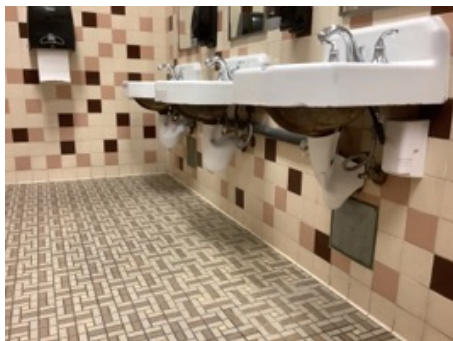
Comment #: PALO-0192

Deficiency: Lavatory - Covered Pipes/Hose Bib - General

The pipe insulation does not cover everything under the sink including water supply lines and hose bib.

Measurement: 3 count

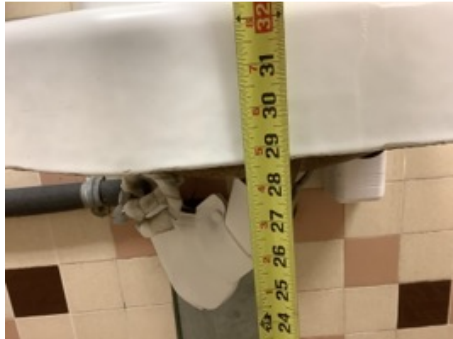
Comment #: PALO-0193

Deficiency: Lavatory - Knee/Toe Clearance - Height

The knee clearance at the lavatory is less than the allowable 29 inches.

Measurement: 28.75 inches

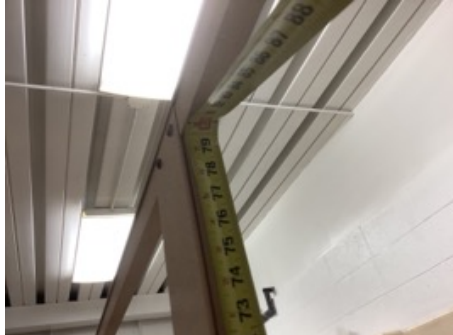
Comment #: PALO-0194

Deficiency: Accessible Toilet Stall - Door - Clear Height

The stall door does not provide clear height.

Measurement: 79.5 inches

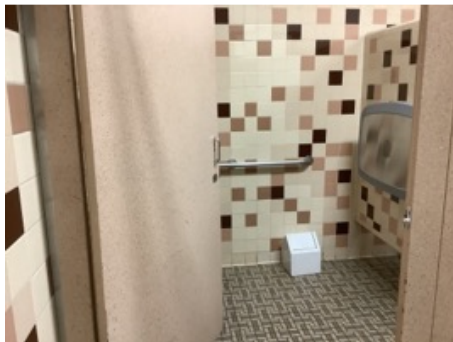
Comment #: PALO-0195

Deficiency: Accessible Toilet Stall - Door - Self-Closing Door

The stall door is not self closing.

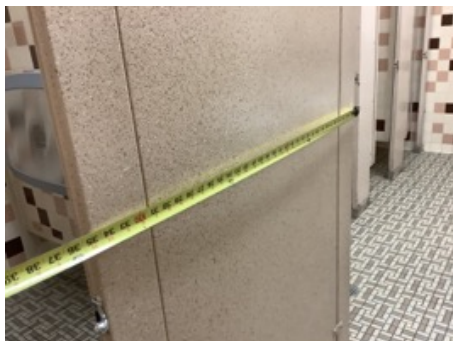
Comment #: PALO-0196

Deficiency: Accessible Toilet Stall - End Opening Door - 4-Inch Clearance

Where located in the front wall or partition, the door opening is more than the allowable 4 inches from the side wall or partition on the farthest side from the water closet.

Measurement: 35 inches

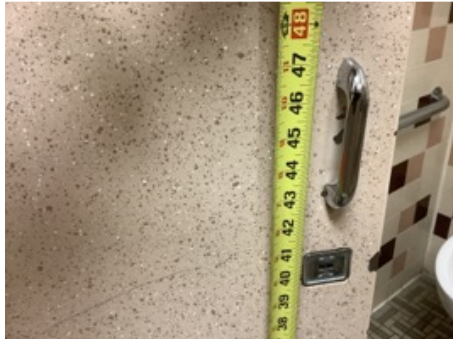
Comment #: PALO-0197

Deficiency: Accessible Toilet Stall - Door Hardware - Handle Height

The door pull is mounted at a height outside of the allowable reach ranges.

Measurement: 45 inches

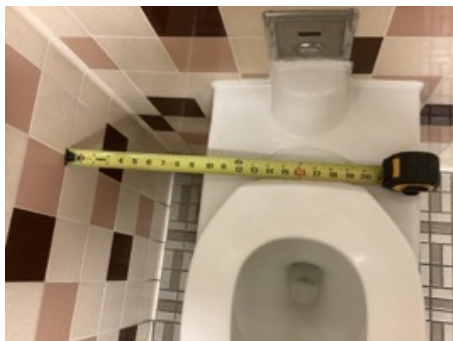
Comment #: PALO-0198

Deficiency: Accessible Toilet Stall - Water Closet - Location

The water closet is not a compliant distance from the adjacent wall.

Measurement: 16.5 inches

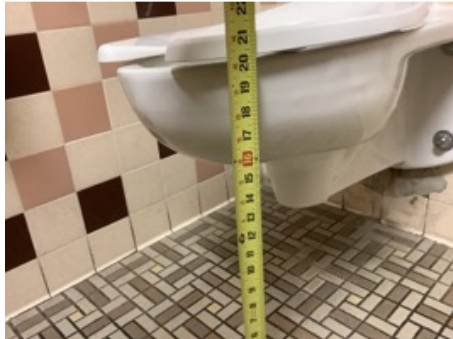
Comment #: PALO-0199

Deficiency: Accessible Toilet Stall - Water Closet - Height

The toilet seat exceeds the allowable 17 - 19 inches AFF measured to the top of the seat.

Measurement: 21.25 inches

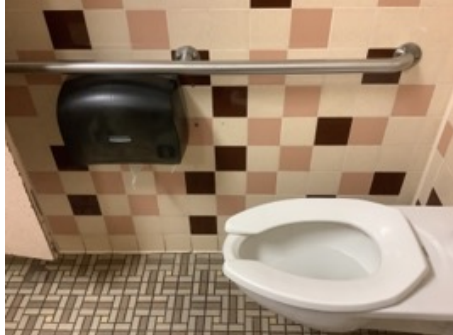
Comment #: PALO-0200

Deficiency: Accessible Toilet Stall - Dispensers - Toilet Paper Location

The toilet paper dispenser is outside of the allowable reach range.

Measurement: 12.25 inches

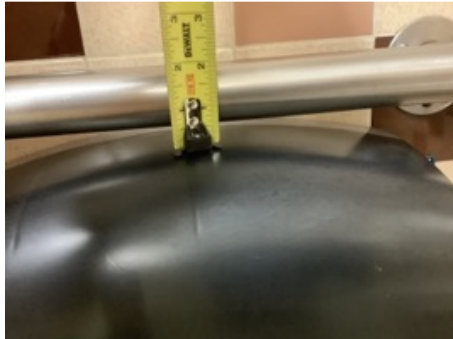
Comment #: PALO-0201

Deficiency: Accessible Toilet Stall - Dispensers - Toilet Paper Below Grab Bar

The toilet paper dispenser is located above the side grab bar.

Measurement: .5 inches

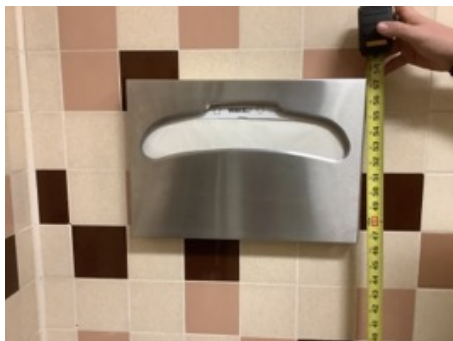
Comment #: PALO-0202

Deficiency: Accessible Toilet Stall - Dispensers - Seat Cover Height

The height of the operable part of the provided seat cover dispenser exceeds the allowable 40 inches AFF.

Measurement: 53.5 inches

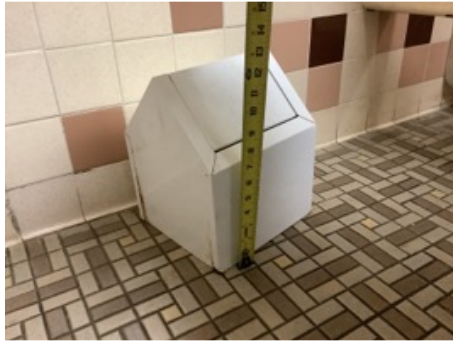
Comment #: PALO-0203

Deficiency: Accessible Toilet Stall - Dispensers - Sanitary Napkin Height

The height of the operable part of the provided sanitary napkin receptacle exceeds the allowable 40 inches AFF.

Measurement: 8 inches

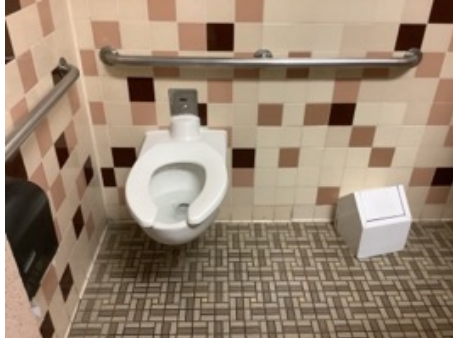
Comment #: PALO-0204

Deficiency: Accessible Toilet Stall - Dispensers - Sanitary Napkin Location

The sanitary napkin disposal unit is in the wrong location in front of the toilet paper dispenser.

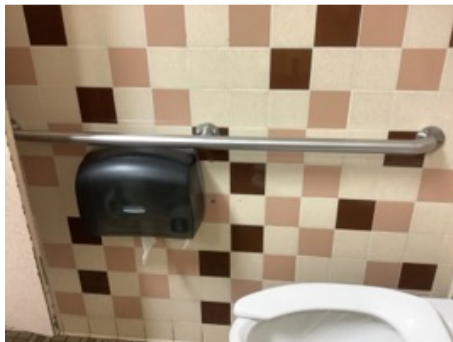
Comment #: PALO-0205

Deficiency: Accessible Toilet Stall - Side Grab Bar - Fixture Clearance

The dispenser does not provide minimum 1.5 inch hand clearance to the ends or bottom of the side grab bar.

Measurement: .5 inches

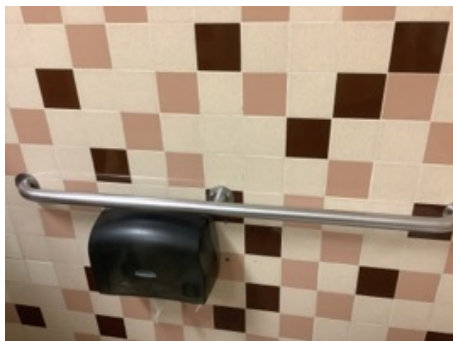
Comment #: PALO-0206

Deficiency: Accessible Toilet Stall - Side Grab Bar - Wall Clearance

The side grab bar does not provide clearance to the wall of 1 1/2 inches.

Measurement: 1.5 inches

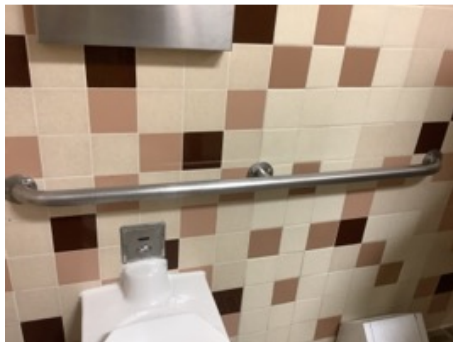
Comment #: PALO-0207

Deficiency: Accessible Toilet Stall - Rear Grab Bar - Wall Clearance

The rear grab bar does not provide clearance to the wall of 1 1/2 inches.

Measurement: 1.5 inches

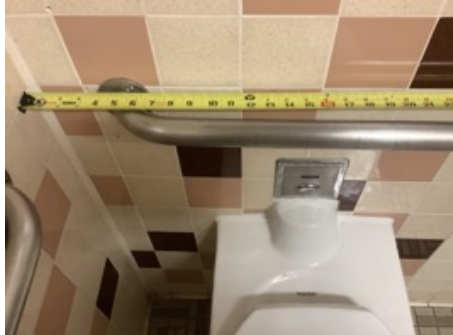
Comment #: PALO-0208

Deficiency: Accessible Toilet Stall - Rear Grab Bar - Wall Side Distance From Centerline

The rear grab bar does not extend the full 12 inches towards the wall side from the centerline of the water closet.

Measurement: 11.5 inches

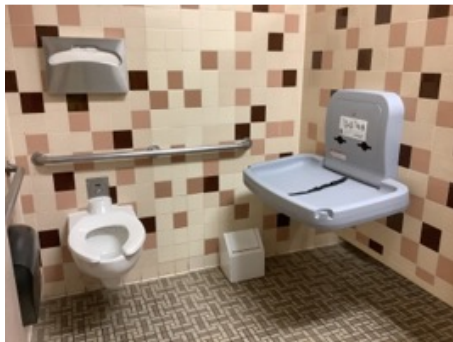
Deficiency: Baby Changing Station - Accessible Route - Located in Accessible Toilet Stall

Floor/Area: Senior Center
Room/Spot: Women's Restroom

Baby changing tables shall comply with operable parts and work station requirements. Baby changing tables when deployed shall not obstruct the required width of an accessible route. Baby changing tables shall not be located in accessible toilet compartments within a multiple accommodation toilet facility.

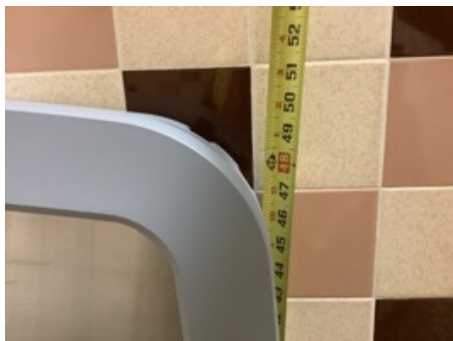
Deficiency: Baby Changing Station - Operable Parts - Height

Floor/Area: Senior Center
Room/Spot: Women's Restroom

Provided operable parts shall be operable with one hand and shall not require tight grasping, pinching, or twisting of the wrist. The force required to activate operable parts shall be 5 pounds maximum. Recommend installing a strap for the opening with a circular handle that does not require grasping.

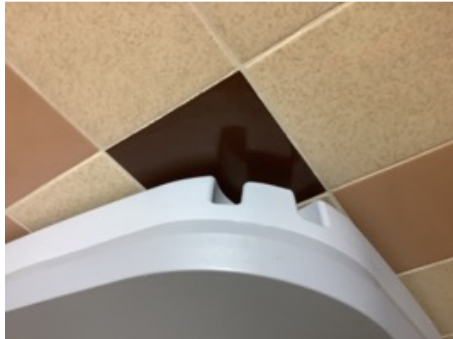
Comment #: PALO-0211

Deficiency: Baby Changing Station - Operable Parts - Operation

The operable part requires tight grasping, pinching and/or twisting of the wrist to operate.

Provided operable parts shall be operable with one hand and shall not require tight grasping, pinching, or twisting of the wrist. The force required to activate operable parts shall be 5 pounds maximum. Recommend installing a strap for the opening with a circular handle that does not require grasping.

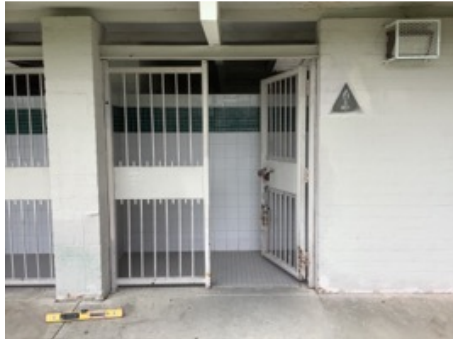
Comment #: PALO-0213

Deficiency: Restroom Doors - Tactile Sign - General

No permanent tactile restroom identification sign has been provided.

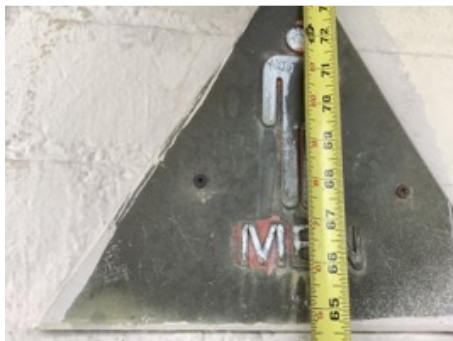
Comment #: PALO-0214

Deficiency: Restroom Doors - Geometric Sign - Height

The geometric sign is not mounted within the allowable height ranges.

Measurement: 69 inches

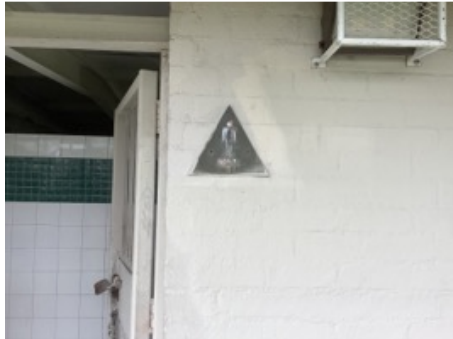
Comment #: PALO-0215

Deficiency: Restroom Doors - Geometric Sign - Color Contrast

The geometric sign provided at the restroom does not contrast with the door.

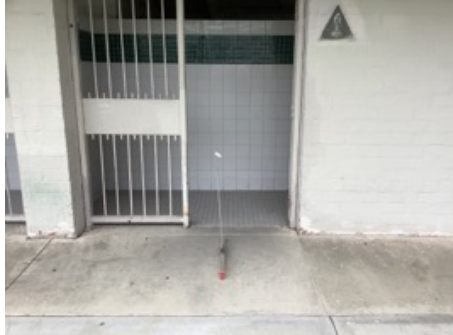
Comment #: PALO-0216

Deficiency: Restroom Doors - Landing - Slopes

The slopes at the door landings exceed the allowable 2.0% grade.

Measurement: 6 % grade

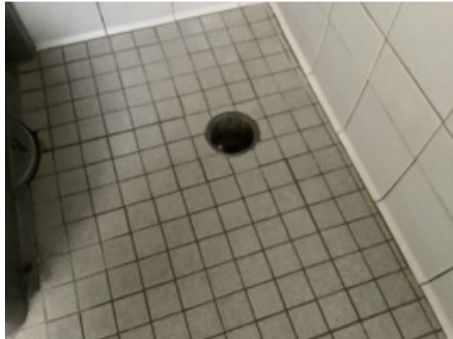
Comment #: PALO-0217

Deficiency: Restroom Interior Space - Floor Surface - Recessed Drain

The restroom drain is recessed into the floor creating a change in level.

Measurement: 2 inches

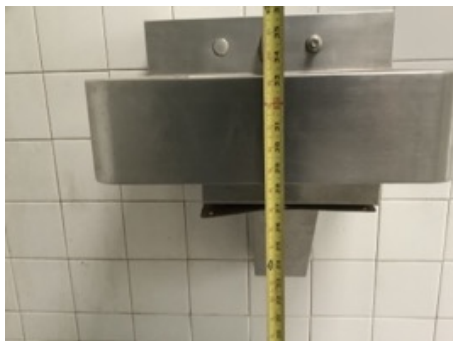
Comment #: PALO-0218

Deficiency: Lavatory - Knee/Toe Clearance - Height

The knee clearance at the lavatory is less than the allowable 29 inches.

Measurement: 28.25 inches

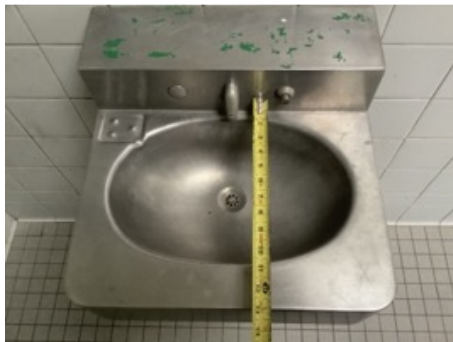
Comment #: PALO-0219

Deficiency: Lavatory - Location - Depth

Lavatory controls are less than 17-inches or more than 19 inches from the face of the lavatory.

Measurement: 12.75 inches

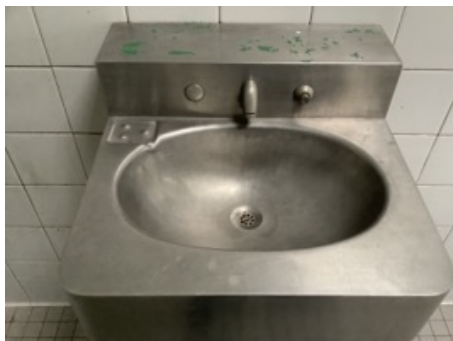
Comment #: PALO-0220

Deficiency: Lavatory - Controls - Operation

The operable parts of the lavatory require tight grasping pinching or twisting to operate.

Replace with lever operated, push type, or electronically controlled mechanisms, or approved controls with 5 lbf maximum operating force. Self-closing valves shall remain on for at least 10 seconds.

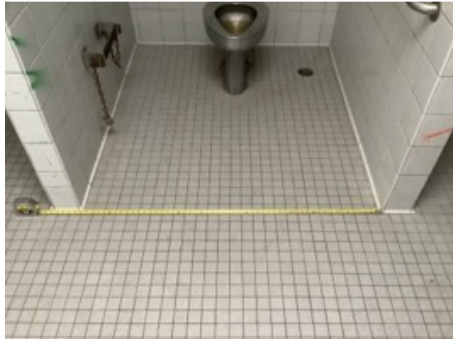
Comment #: PALO-0221

Deficiency: Accessible Toilet Stall - Dimensions - Stall Width

Width of stall is less than 60-inches when measured perpendicular to the side wall.

Measurement: 53 inches

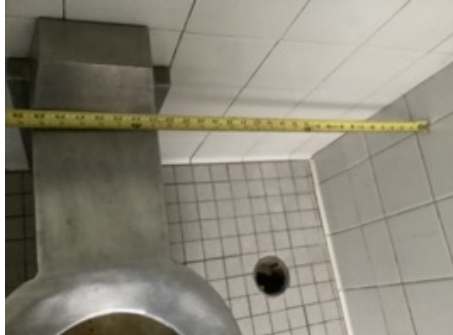
Comment #: PALO-0222

Deficiency: Accessible Toilet Stall - Water Closet - Location

The water closet is not a compliant distance from the adjacent wall.

Measurement: 26 inches

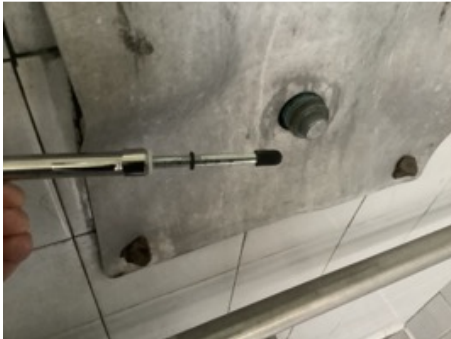
Deficiency: Accessible Toilet Stall - Water Closet - Flush Control Operating Force

Floor/Area: West Side
Room/Spot: Exterior Restrooms
Notes: Men's Restroom

Provided operable parts shall be operable with one hand and shall not require tight grasping, pinching, or twisting of the wrist. The force required to activate operable parts shall be 5 pounds maximum.

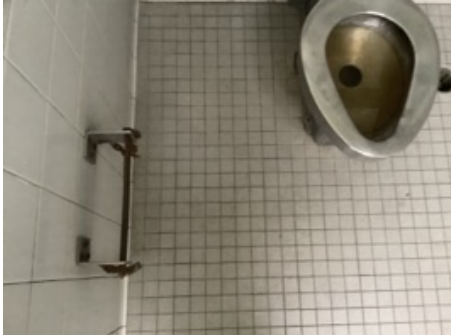
Deficiency: Accessible Toilet Stall - Dispensers - Toilet Paper Location

Floor/Area: West Side
Room/Spot: Exterior Restrooms
Notes: Men's Restroom

This requires relocation of the toilet paper dispenser so that center line is 7" minimum to 9" maximum from face of water closet in front of the water closet measured to the centerline of the dispenser, and located below the grab bar.

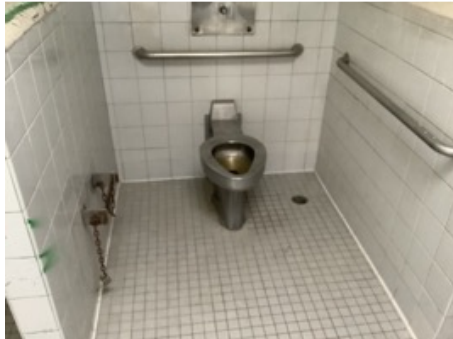
Comment #: PALO-0225

Deficiency: Accessible Toilet Stall - Dispensers - Toilet Paper Below Grab Bar

The toilet paper dispenser is located above the side grab bar.

Measurement: 0 inches

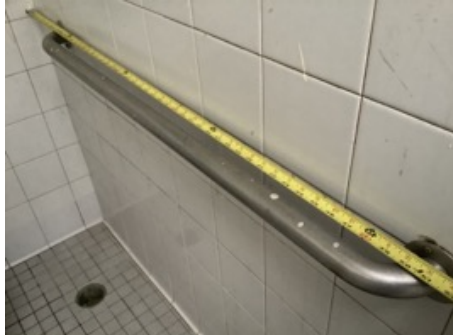
Comment #: PALO-0226

Deficiency: Accessible Toilet Stall - Side Grab Bar - End Distance to Rear Wall

The side grab bar does not extend minimum 54 inches from the rear wall.

Measurement: 51 inches

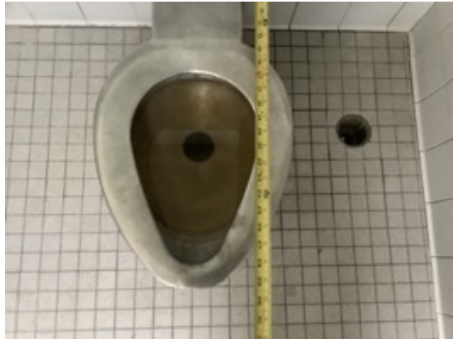
Comment #: PALO-0227

Deficiency: Accessible Toilet Stall - Side Grab Bar - Distance to Water Closet

The side grab bar does not extend 24 inches (610 mm) minimum in front of the water closet.

Measurement: 21.5 inches

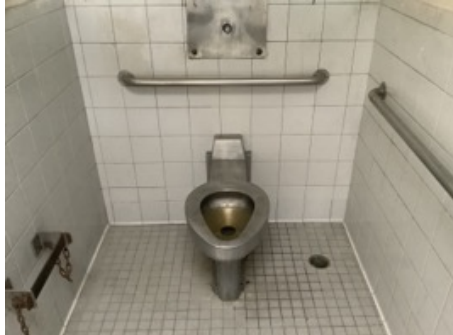
Comment #: PALO-0228

Deficiency: Accessible Toilet Stall - Rear Grab Bar - Open Side Distance From Centerline

The rear grab bar does not extend the full 24 inches past the centerline of the water closet.

Measurement: 18 inches

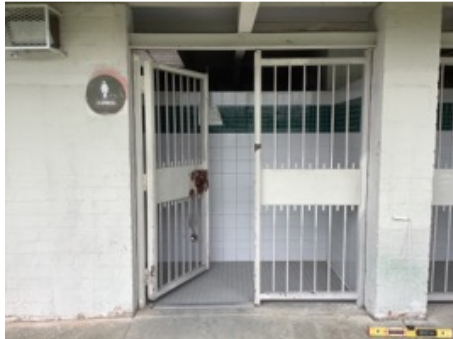
Comment #: PALO-0229

Deficiency: Restroom Doors - Tactile Sign - General

No permanent tactile restroom identification sign has been provided.

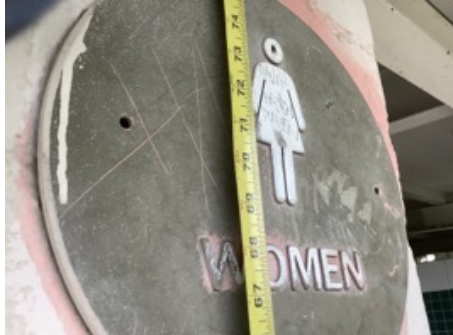
Comment #: PALO-0230

Deficiency: Restroom Doors - Geometric Sign - Height

The geometric sign is not mounted within the allowable height ranges.

Measurement: 71 inches

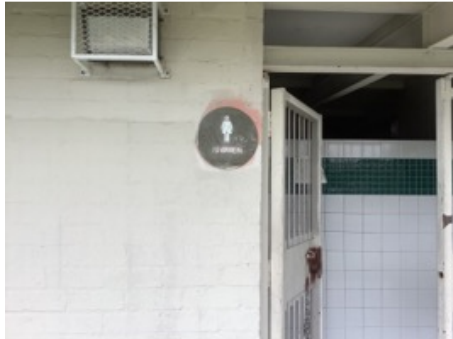
Comment #: PALO-0231

Deficiency: Restroom Doors - Geometric Sign - Color Contrast

The geometric sign provided at the restroom does not contrast with the door.

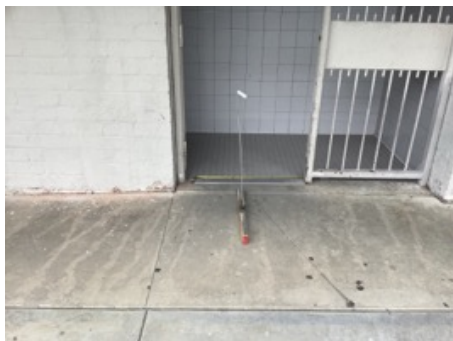
Comment #: PALO-0232

Deficiency: Restroom Doors - Landing - Slopes

The slopes at the door landings exceed the allowable 2.0% grade.

Measurement: 7 % grade

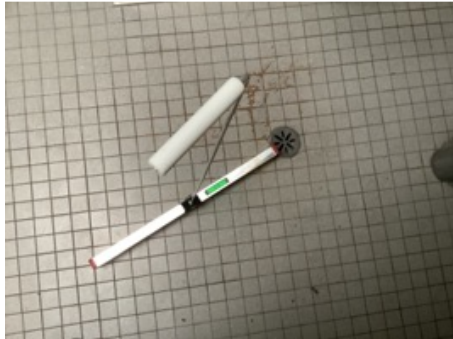
Comment #: PALO-0233

Deficiency: Restroom Interior Space - Floor Surface - Slopes

The floor surface has slopes that exceeds the allowable 1:48 (2%) grade in any direction.

Measurement: 2.3 % grade

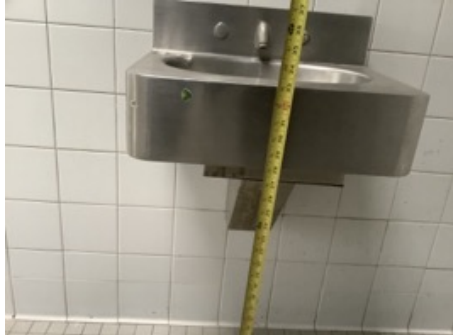
Comment #: PALO-0234

Deficiency: Lavatory - Knee/Toe Clearance - Height

The knee clearance at the lavatory is less than the allowable 29 inches.

Measurement: 28 inches

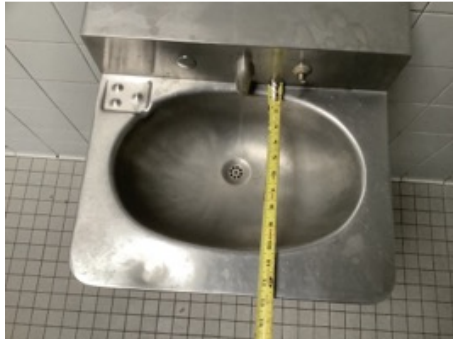
Comment #: PALO-0235

Deficiency: Lavatory - Location - Depth

Lavatory controls are less than 17-inches or more than 19 inches from the face of the lavatory.

Measurement: 12.75 inches

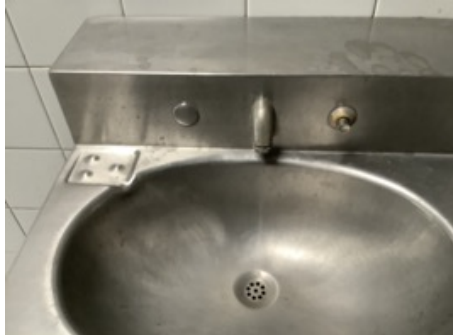
Comment #: PALO-0236

Deficiency: Lavatory - Controls - Operation

The operable parts of the lavatory require tight grasping pinching or twisting to operate.

Measurement: 1 count

Replace with lever operated, push type, or electronically controlled mechanisms, or approved controls with 5 lbf maximum operating force. Self-closing valves shall remain on for at least 10 seconds.

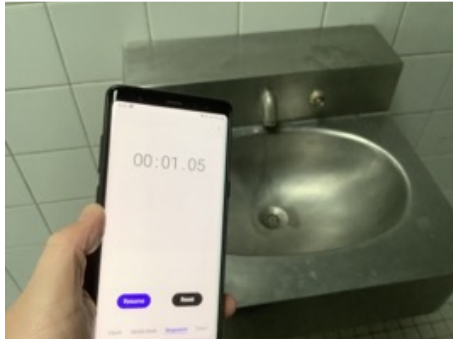
Comment #: PALO-0237

Deficiency: Lavatory - Controls - Self-Closing Valve

At 5 pounds of operating pressure the self-closing sink valve stays on less than the minimum 10 seconds.

Measurement: 1 seconds

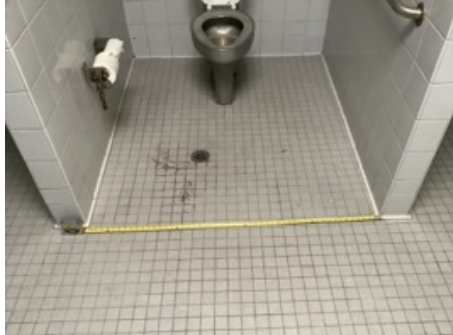
Comment #: PALO-0238

Deficiency: Accessible Toilet Stall - Dimensions - Stall Width

Width of stall is less than 60-inches when measured perpendicular to the side wall.

Measurement: 51 inches

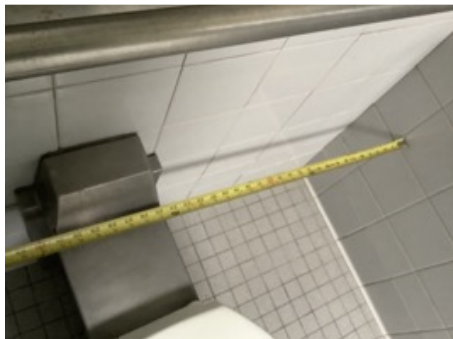
Comment #: PALO-0239

Deficiency: Accessible Toilet Stall - Water Closet - Location

The water closet is not a compliant distance from the adjacent wall.

Measurement: 27.5 inches

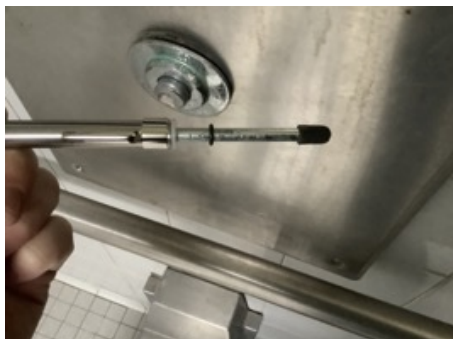
Comment #: PALO-0240

Deficiency: Accessible Toilet Stall - Water Closet - Flush Control Operating Force

The operational force of the flush valve exceeds the allowable 5 lbf.

Measurement: 12 lbf

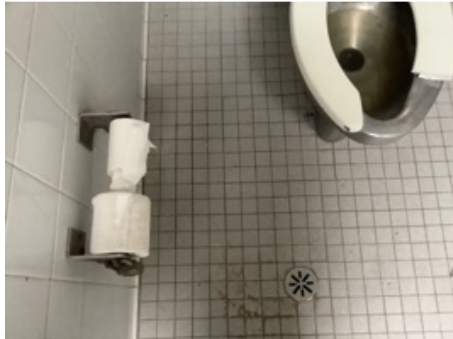
Comment #: PALO-0241

Deficiency: Accessible Toilet Stall - Dispensers - Toilet Paper Location

The toilet paper dispenser is outside of the allowable reach range.

Measurement: 2 inches

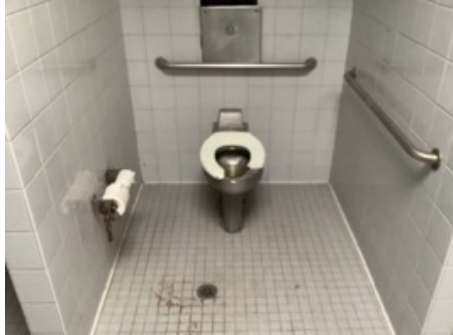
Comment #: PALO-0242

Deficiency: Accessible Toilet Stall - Dispensers - Toilet Paper Below Grab Bar

The toilet paper dispenser is located above the side grab bar.

Measurement: 0 inches

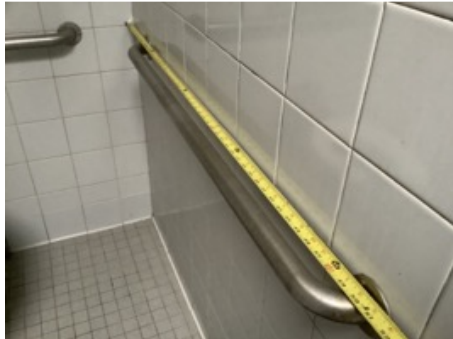
Comment #: PALO-0243

Deficiency: Accessible Toilet Stall - Side Grab Bar - End Distance to Rear Wall

The side grab bar does not extend minimum 54 inches from the rear wall.

Measurement: 50 inches

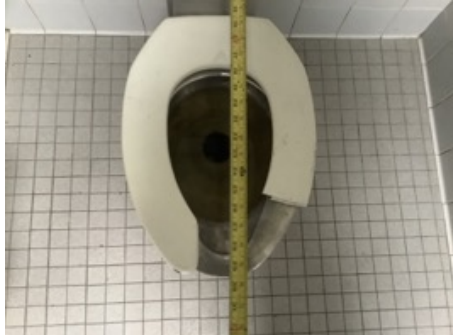
Comment #: PALO-0244

Deficiency: Accessible Toilet Stall - Side Grab Bar - Distance to Water Closet

The side grab bar does not extend 24 inches (610 mm) minimum in front of the water closet.

Measurement: 20.5 inches

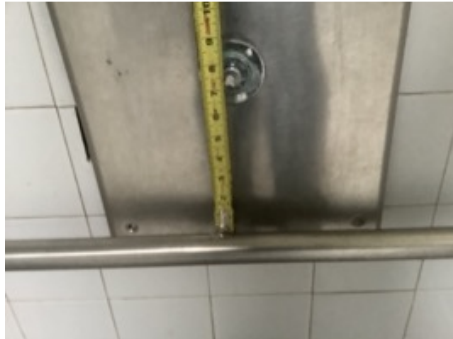
Comment #: PALO-0245

Deficiency: Accessible Toilet Stall - Rear Grab Bar - Above Clearance

The rear grab bar does not have a minimum 12 inch clear space above the grab bar.

Measurement: 7.5 inches

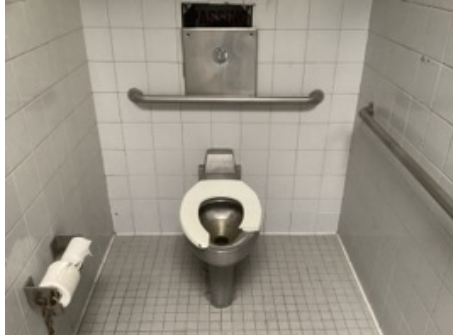
Comment #: PALO-0246

Deficiency: Accessible Toilet Stall - Rear Grab Bar - Open Side Distance From Centerline

The rear grab bar does not extend the full 24 inches past the centerline of the water closet.

Measurement: 18 inches

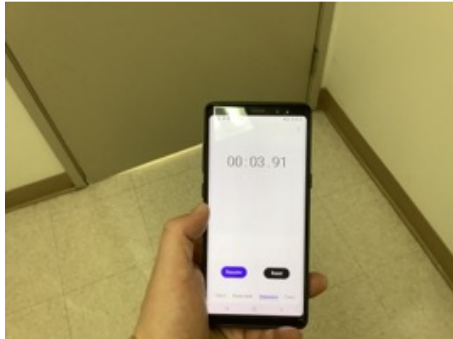
Comment #: PALO-0247

Deficiency: Restroom Doors - Operation - Closing Speed

The door closes faster than the minimum 5 seconds.

Measurement: 3.91 seconds

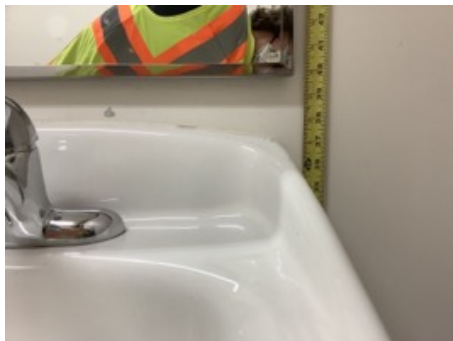
Comment #: PALO-0248

Deficiency: Restroom Interior Space - Amenities - Mirror Height

The mirror height exceeds the allowable 40 inches above the finished floor.

Measurement: 40.25 inches

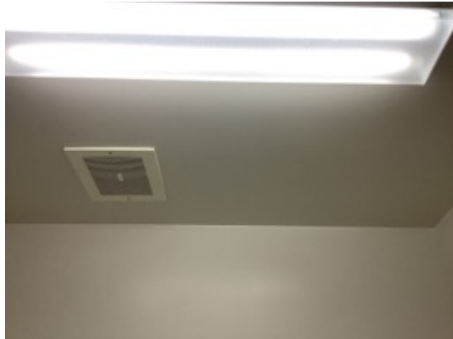
Comment #: PALO-0249

Deficiency: Restroom Interior Space - Fire Strobes - General

No visible alarm notifications are provided.

Measurement: 1 count

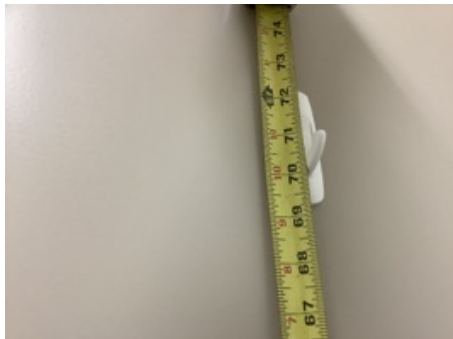
Comment #: PALO-0250

Deficiency: Accessible Toilet Stall - Door Hardware - Coat Hook Height

The operable part of the provided coat hook is higher than the allowable 48 inches AFF.

Measurement: 71 inches

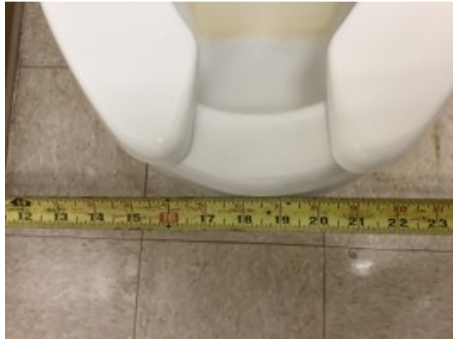
Comment #: PALO-0251

Deficiency: Accessible Toilet Stall - Water Closet - Location

The water closet is not a compliant distance from the adjacent wall.

Measurement: 18.5 inches

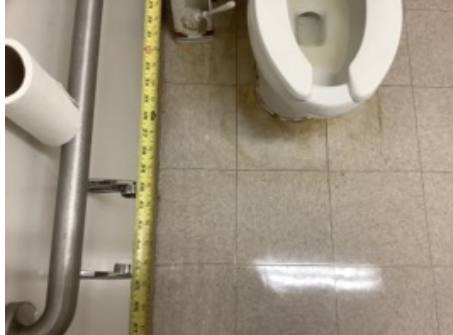
Comment #: PALO-0252

Deficiency: Accessible Toilet Stall - Dispensers - Toilet Paper Location

The toilet paper dispenser is outside of the allowable reach range.

Measurement: 12 inches

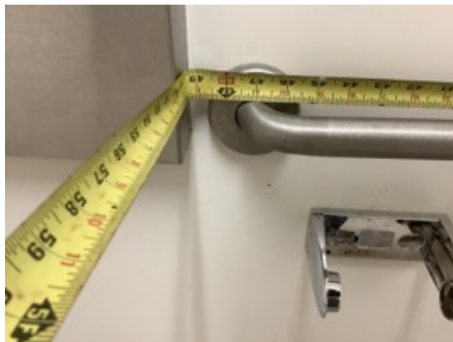
Deficiency: Accessible Toilet Stall - Side Grab Bar - End Distance to Rear Wall

The side wall grab bar shall be 42 inches (1067 mm) long minimum, located 12 inches (305 mm) maximum from the rear wall and extending 54 inches (1372 mm) minimum from the rear wall with the front end positioned 24 inches (610 mm) minimum in front of the water closet.

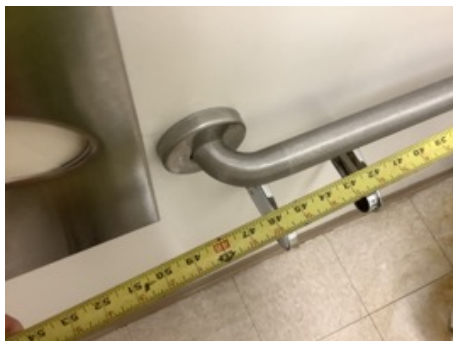
Deficiency: Accessible Toilet Stall - Side Grab Bar - Distance to Water Closet

The side wall grab bar shall be 42 inches (1067 mm) long minimum, located 12 inches (305 mm) maximum from the rear wall and extending 54 inches (1372 mm) minimum from the rear wall with the front end positioned 24 inches (610 mm) minimum in front of the water closet.

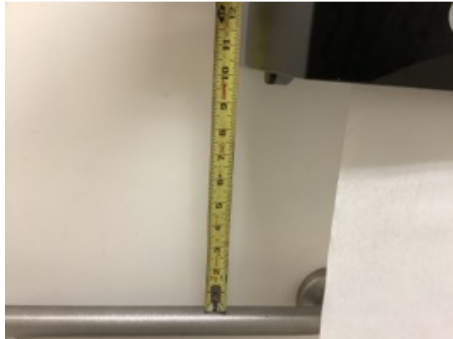
Comment #: PALO-0255

Deficiency: Accessible Toilet Stall - Rear Grab Bar - Above Clearance

The rear grab bar does not have a minimum 12 inch clear space above the grab bar.

Measurement: 10 inches

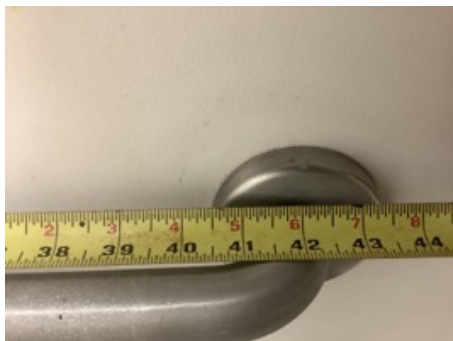
Comment #: PALO-0256

Deficiency: Accessible Toilet Stall - Rear Grab Bar - Open Side Distance From Centerline

The rear grab bar does not extend the full 24 inches past the centerline of the water closet.

Measurement: 23.5 inches

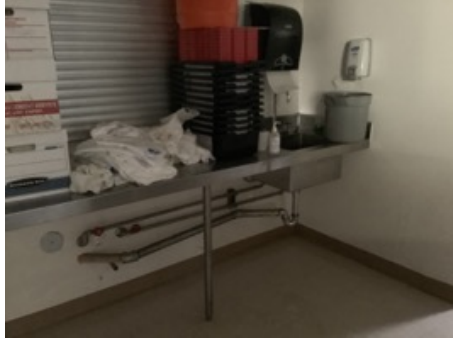
Comment #: PALO-0257

Deficiency: Lavatory - Accessible Count - General

There are more than 1 lavatory provided in the restroom.

Measurement: 0 count

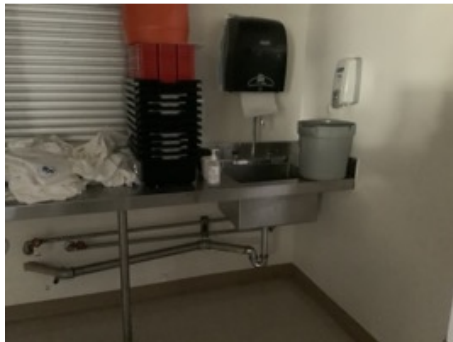
Comment #: PALO-0258

Deficiency: Lavatory - Clear Floor Space - General

There is no clear floor space provided at the lavatory.

Measurement: 15.5 inches

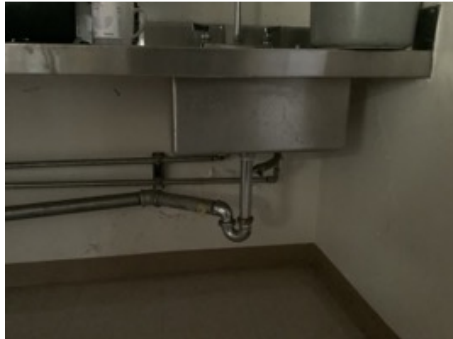
Comment #: PALO-0259

Deficiency: Lavatory - Covered Pipes/Hose Bib - General

The pipe insulation does not cover everything under the sink including water supply lines and hose bib.

Measurement: 0 count

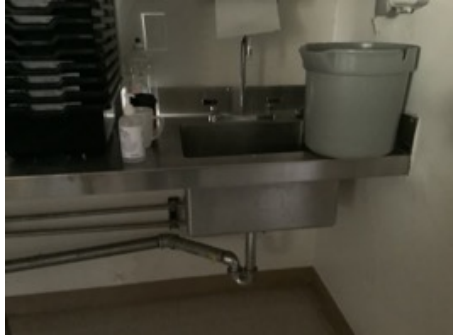
Comment #: PALO-0260

Deficiency: Lavatory - Knee/Toe Clearance - Width

Minimum 30 inch wide knee and toe space is not provided.

Measurement: 0 Inches

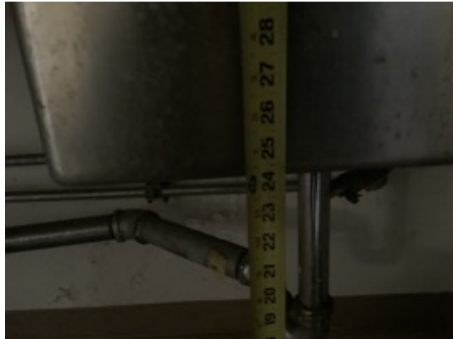
Comment #: PALO-0261

Deficiency: Lavatory - Knee/Toe Clearance - Height

The knee clearance at the lavatory is less than the allowable 29 inches.

Measurement: 24.25 inches

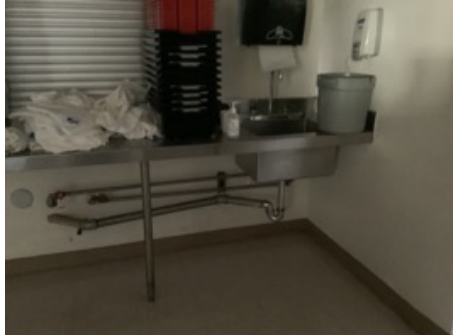
Comment #: PALO-0262

Deficiency: Lavatory - Knee/Toe Clearance - Incremental Depth

The knee clearance at the lavatory does not match the depth to reach the operable parts.

Measurement: 0 inches

Provide knee clearance at the accessible lavatory as noted below.

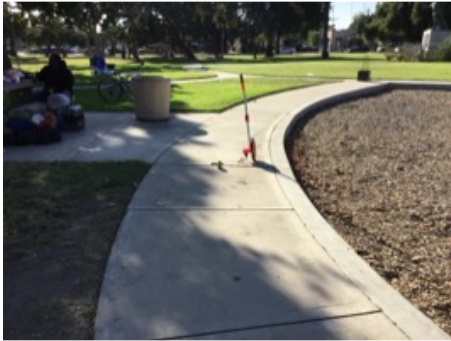
Comment #: GAN-001

Deficiency: Accessible Route - Clear Width - Passing Space

Length of walk exceeds 200' and no 60" x 60" turning space is provided. Walk #3 is 259' long and is over 214' long until the first passing or turning space, located at picnic areas #1 & #2. This length is non Compliant without an added passing area.

Measurement: 1 count

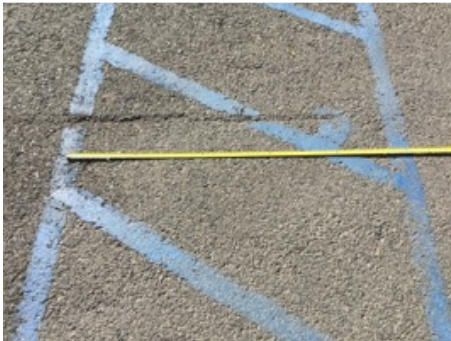
Comment #: GAN-002

Deficiency: Parking - Access Aisle Markings - Width

The marked access aisle is less than 60 inches (5 ft. or 1524 mm) wide for a car stall and/or 144 inches for a van stall.

Measurement: 59 inches

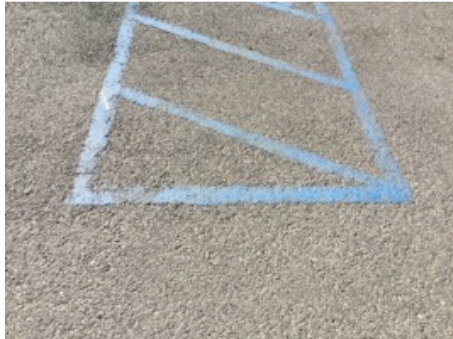
Comment #: GAN-003

Deficiency: Parking - Access Aisle Markings - "No Parking"

Missing 12" white 'No Parking' markings.

Measurement: 1 count

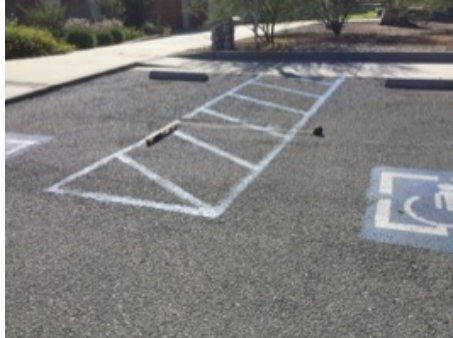
Comment #: GAN-004

Deficiency: Parking - Access Aisle - Slope

The slope of the access aisle in any direction exceeds 1:48 (2.0%) grade.

Measurement: 3.7 % grade

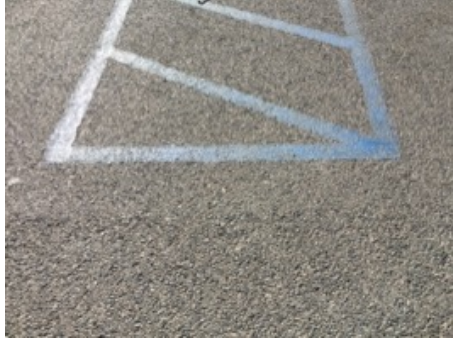
Comment #: GAN-005

Deficiency: Parking - Access Aisle Markings - "No Parking"

Missing 12" white 'No Parking' markings OR Markings are faded and does not discourage parking in the access aisle.

Measurement: 1 count

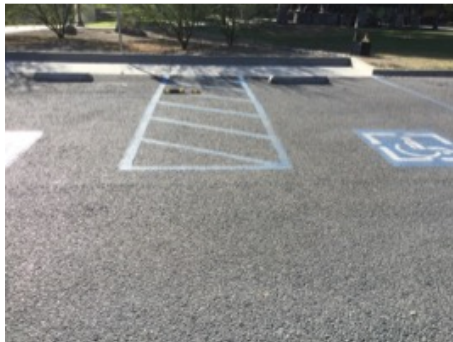
Comment #: GAN-006

Deficiency: Parking - Access Aisle - Slope

The slope of the access aisle in any direction exceeds 1:48 (2.0%) grade.

Measurement: 2.9 % grade

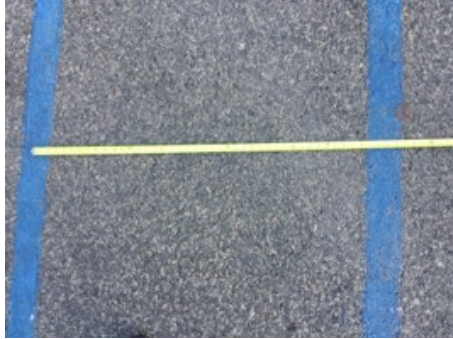
Comment #: GAN-007

Deficiency: Parking - Access Aisle Markings - Hatched Line Spacing

The hatched lines within the border line of the access aisle are spaced greater than 36 inches (914 mm) on center apart.

Measurement: 43 inches

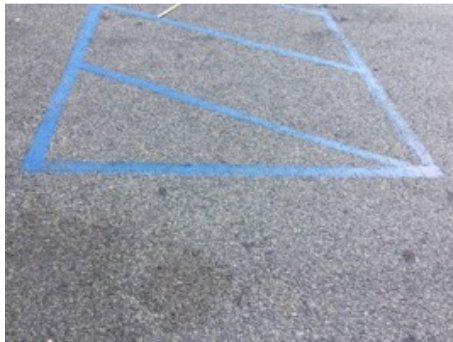
Comment #: GAN-008

Deficiency: Parking - Access Aisle Markings - "No Parking"

"No Parking" is not provided at access aisles.

Measurement: 0 count

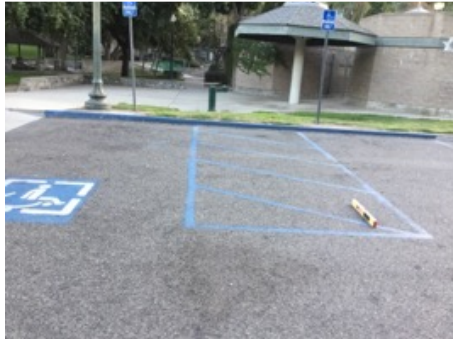
Comment #: GAN-009

Deficiency: Parking - Access Aisle - Slope

The slope of the access aisle in any direction exceeds 1:48 (2.0%) grade.

Measurement: 2.7 % grade

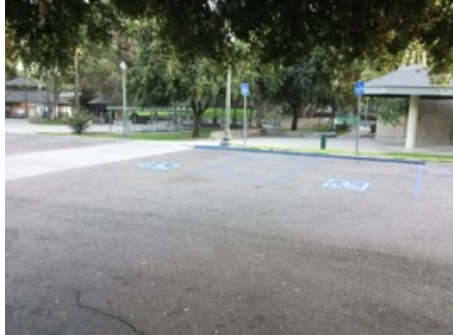
Comment #: GAN-010

Deficiency: Parking - Access Aisle - Arrangement

The access aisle requires persons to pass behind parking stalls that are not their own. User of Stall 5 must pass behind Stall 4 and 5

Measurement: 1 count

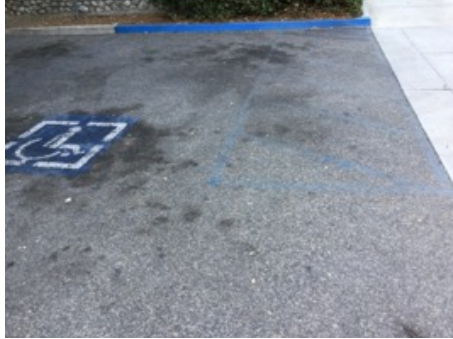
Comment #: GAN-011

Deficiency: Parking - Access Aisle Markings - Width

The marked access aisle is less than 60 inches (5 ft. or 1524 mm) wide for a car stall and/or 144 inches for a van stall.

Measurement: 1 inches

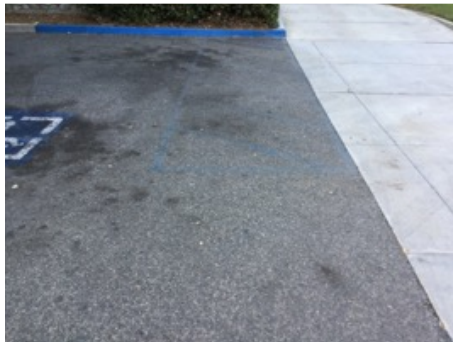
Comment #: GAN-012

Deficiency: Parking - Access Aisle Markings - Border Line Markings

The access aisle is not marked with a blue painted border line around the entire perimeter. Access aisle markings have faded and need to be repainted.

Measurement: 0 count

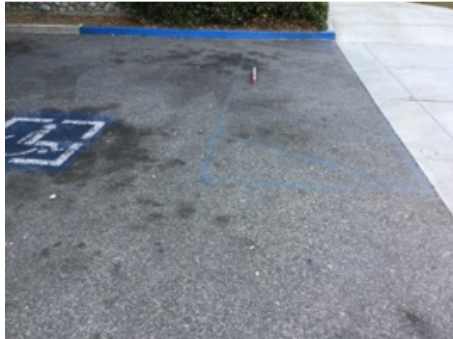
Comment #: GAN-013

Deficiency: Parking - Access Aisle - Slope

The slope of the access aisle in any direction exceeds 1:48 (2.0%) grade.

Measurement: 2.7 % grade

Recommended Remediation:

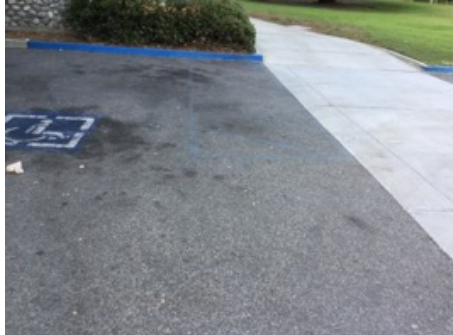
Comment #: GAN-014

Deficiency: Accessible Route - Vehicular Area Boundary - Detectable Warning Surface

Detectable warnings are not provided at the at-grade transitions where the accessible route meets the vehicular way and no curbs are provided.

Recommended Remediation:

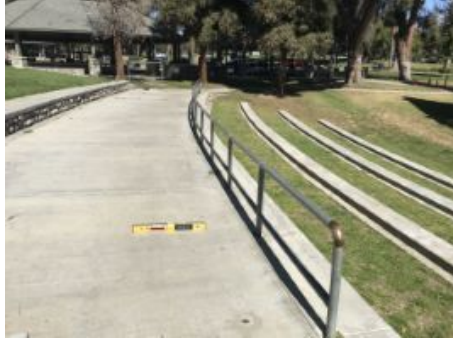
Comment #: GAN-015

Deficiency: Accessible Route - Slopes - Cross Slope

The cross slope of accessible routes exceeds 1:48 (2.0 %). 2.8% to 3.3% cross slope measured along the row for wheelchairs seating at the amphitheater.

Measurement: 3.3 % grade

Recommended Remediation:

Remove and replace walk. Install walk that provides cross slopes at circulation route of 1:48 maximum.
