APPENDIX A

FACILITY ASSESSMENT PHOTO REPORTS

CITY HALL

1.0 Site Assessment

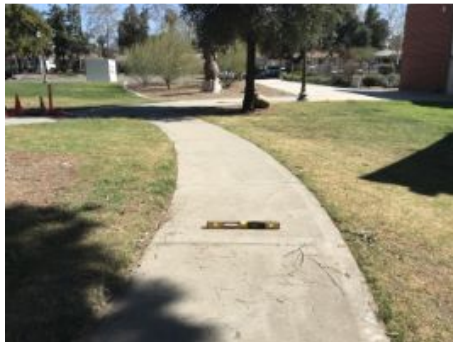
Comment #: GAN-016

Deficiency: Accessible Route - Slopes - Cross Slope

The cross slope of accessible routes exceeds 1:48 (2.0 %). 2.9% to 3.6% cross slope measured along the route from the community center to the amphitheater.

Measurement: 3.6 % grade

Recommended Remediation:

Remove and replace walk. Install walk that provides cross slopes at circulation route of 1:48 maximum.

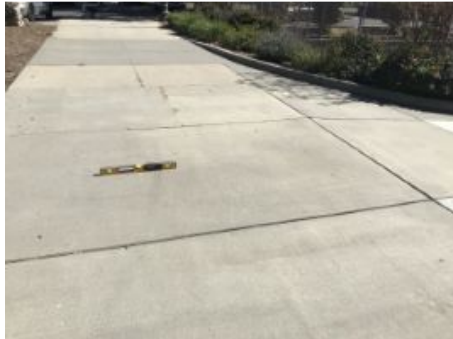
Comment #: GAN-017

Deficiency: Accessible Route - Slopes - Cross Slope

The cross slope of accessible routes exceeds 1:48 (2.0 %). 2.6% to 3.4% cross slope measured along the route to the amphitheater on the north end of the community center.

Measurement: 3.4 % grade

Recommended Remediation:

Remove and replace walk. Install walk that provides cross slopes at circulation route of 1:48 maximum.

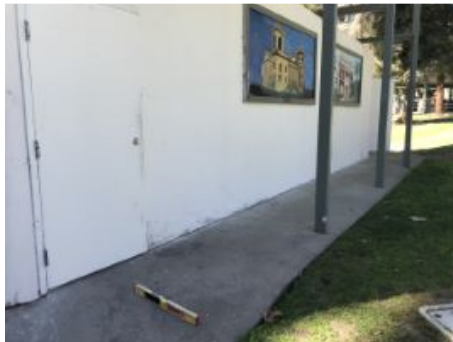
Comment #: GAN-018

Deficiency: Exterior Doors/Doorways/Gates - Clearances: Front - Pull Side Approach

60 inches of maneuvering space beyond the pull side of the door is not provided.

Measurement: 48 inches

Recommended Remediation:

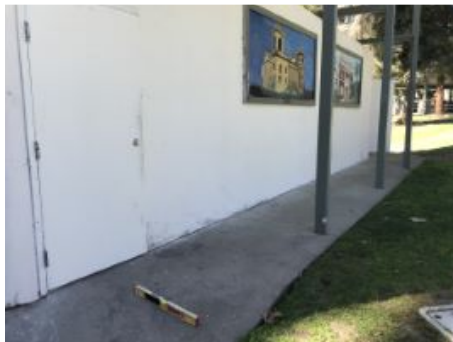
Comment #: GAN-019

Deficiency: Exterior Doors/Doorways/Gates - Landing - Slopes

Slopes more than 1:48 (2%) grade, or changes in elevation are located at door landings. 7.4% cross slope and 8.6% running slope measured in the maneuvering clearance on the pull side of the north amphitheater door.

Measurement: 8.6 % grade

Recommended Remediation:

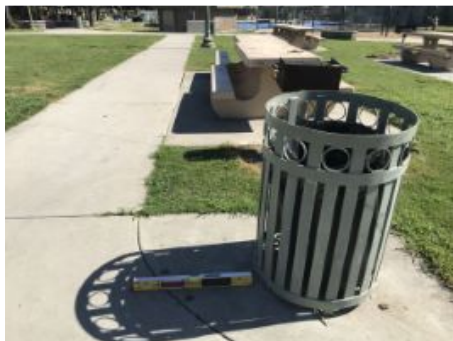
Comment #: GAN-020

Deficiency: Accessible Route - Reach Ranges - Clear Floor Space

30" x 48" level clear ground space is not provided at the operable part. 4.1% to 4.9% cross slope measured in the clear ground space at the trash can.

Measurement: 4.9 % grade

Recommended Remediation:

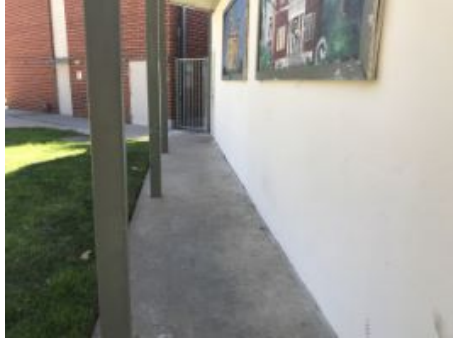
Comment #: GAN-021

Deficiency: Accessible Route - Clear Width - General

Accessible route widths do not provide minimum 48-inches clear. 43-1/2" wide route measured along the route at the north end of the amphitheater at posts.

Measurement: 43.5 inches

Recommended Remediation:

Replace walks to provide a clear width of 48 inches (1219 mm) minimum. When, because of right-of-way restrictions, natural barriers or other existing conditions, the enforcing agency determines that compliance with the 48-inch (1219 mm) clear sidewalk width would create an unreasonable hardship, the clear width may be reduced to 36 inches (914 mm).

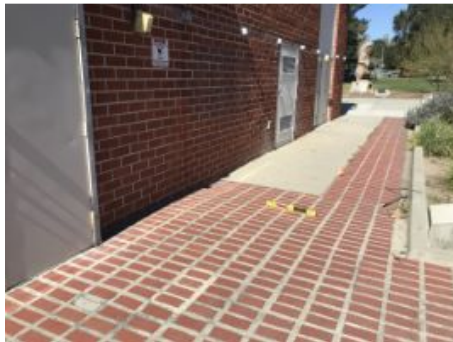
Comment #: GAN-022

Deficiency: Accessible Route - Slopes - Cross Slope

The cross slope of accessible routes exceeds 1:48 (2.0 %). 2.7% to 5.4% cross slope measured along the route to the east entrance to the building.

Measurement: 5.4 % grade

Recommended Remediation:

Remove and replace walk. Install walk that provides cross slopes at circulation route of 1:48 maximum.

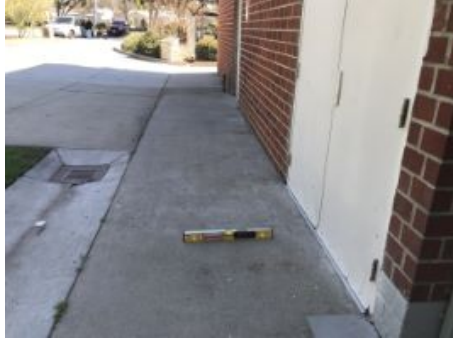
Comment #: GAN-023 **Deficiency:** Exterior Doors/Doorways/Gates - Landing - Slopes

Slopes more than 1:48 (2%) grade, or changes in elevation are located at door landings. 2.8% running slope measured in the maneuvering clearance on the pull side of the north entrance to the community center.

Measurement: 2.8 % grade

Recommended Remediation:

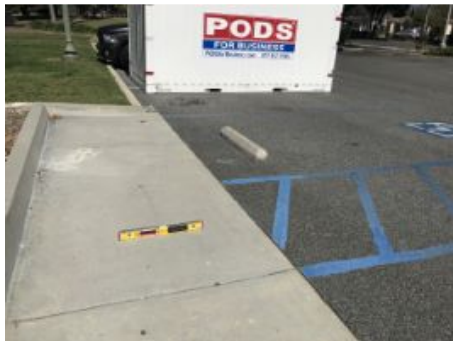
Comment #: GAN-024 **Deficiency:** Accessible Route - Slopes - Cross Slope

The cross slope of accessible routes exceeds 1:48 (2.0 %). 2.7% cross slope measured at turn in route leading to the first accessible parking access aisle. 2.8% cross slope measured at turn in route leading to the second accessible parking access aisle.

Measurement: 2.8 % grade

Recommended Remediation:

Remove and replace walk. Install walk that provides cross slopes at circulation route of 1:48 maximum.

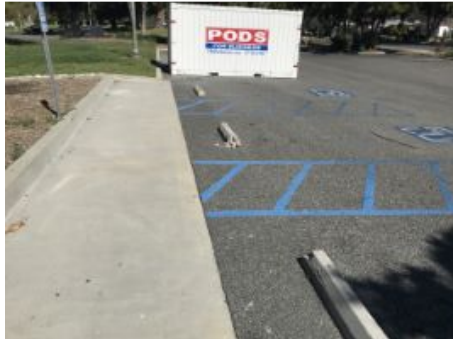
Comment #: GAN-025

Deficiency: Accessible Route - Vehicular Area Boundary - Detectable Warning Surface

Detectable warnings are not provided at the at-grade transitions where the accessible route meets the vehicular way and no curbs are provided. Detectable warnings are not provided where the accessible route from the community center meets the accessible parking stall access aisles.

Measurement: 0 count

Recommended Remediation:

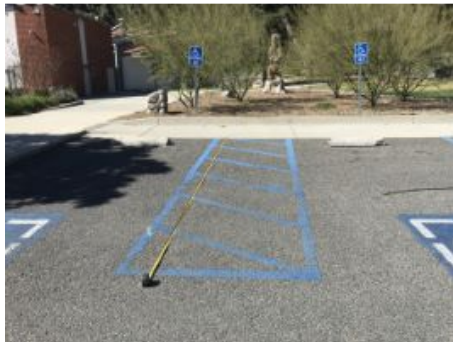
Comment #: GAN-026

Deficiency: Parking - Accessible Stall - Length

The accessible van/car stall is less than 216 inches (18 ft. or 5486 mm) long.

Measurement: 208 inches

Recommended Remediation:

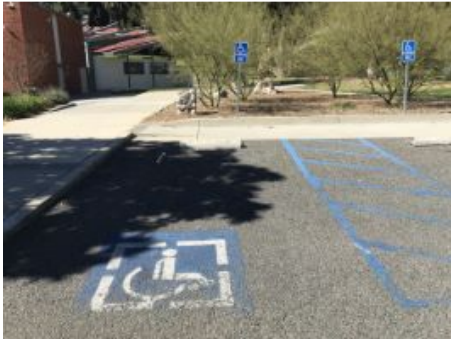
Comment #: GAN-027

Deficiency: Parking - Accessible Stall - Slopes

The slope of the van/car stall in any direction exceeds 1:48 (2.0%) grade. 4.2% running slope measured at the first accessible parking stall. 4.0% running slope measured at the second accessible parking stall. 2.9% cross slope measured at the third accessible parking stall.

Measurement: 4.2 % grade

Recommended Remediation:

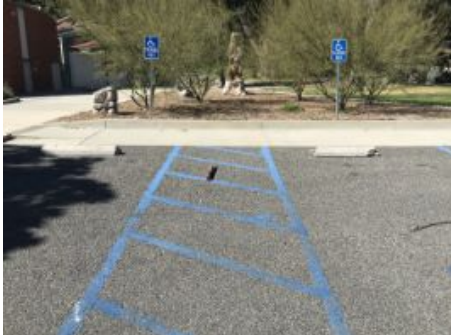
Comment #: GAN-028

Deficiency: Parking - Access Aisle - Slope

The slope of the access aisle in any direction exceeds 1:48 (2.0%) grade. 3.6% running slope measured at the first access aisle. 3.3% cross slope measured at the second access aisle.

Measurement: 3.6 % grade

Recommended Remediation:

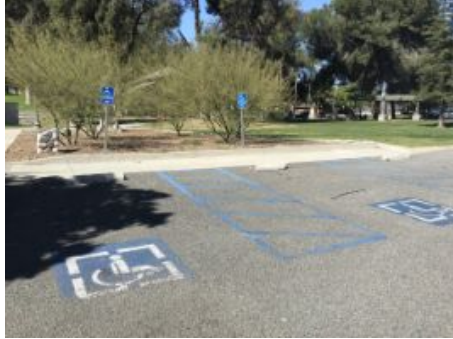
Comment #: GAN-029

Deficiency: Parking - Signage - Minimum Fine

The parking identification sign does not include the text "Minimum Fine \$250" below the ISA. Signage with the International Symbol of Accessibility is not provided at accessible parking stall 3 at the community center.

Measurement: 0 count

Recommended Remediation:

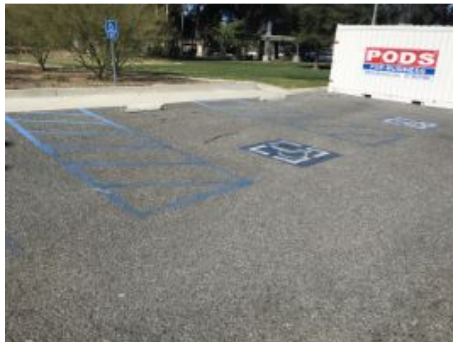
Comment #: GAN-030

Deficiency: Parking - Access Aisle Markings - General

There is no adjacent access aisle marked. The words "No Parking" are not painted on the surface of the parking stall access aisles. The access aisle markings at the pool accessible parking stalls have faded.

Measurement: 0 count

Recommended Remediation:

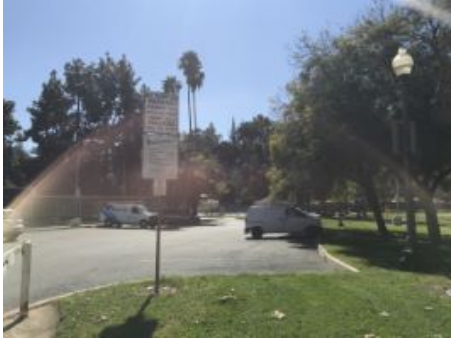
Comment #: GAN-031

Deficiency: Parking - Tow Away Sign - General

There is no "Unauthorized Parking Sign" sign at the entrance to the off-street parking.

Measurement: 0 count

Recommended Remediation:

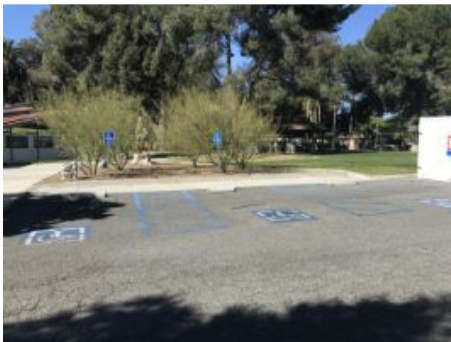
Comment #: GAN-032

Deficiency: Parking - General Parking - Van Stall Space Count

One access space in every six access spaces (or portion of 6) is not van accessible. A van accessible parking spot with compliant access aisle and signage is not provided. A total of 53 parking spaces are provided at the community center parking lot. A minimum of 2 standard and 1 van accessible parking stalls are required. A total of 3 standard parking stalls are provided. A

Measurement: 0 count

Recommended Remediation:

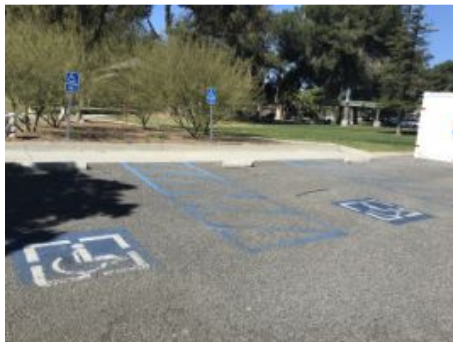
Comment #: GAN-033

Deficiency: Parking - Signage - Van Stall

The van accessible stall is not identified with the words "Van Accessible". A van accessible parking spot with compliant access aisle and signage is not provided. A total of 53 parking spaces are provided at the community center parking lot. A minimum of 2 standard and 1 van accessible parking stalls are required. A total of 3 standard parking stalls are provided. A total of 102

Measurement: 0 count

Recommended Remediation:

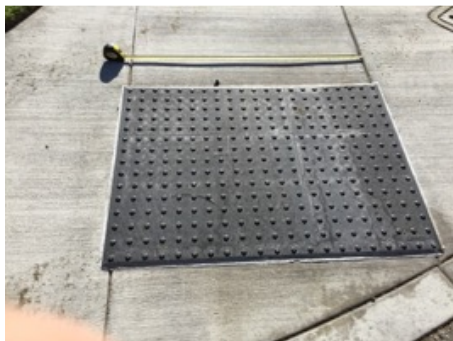
Comment #: GAN-034

Deficiency: At Grade Transitions - Perpendicular Curb Ramp - Clear Width

The clear width of the curb ramp run (excluding any flared sides) is less than 48 inches (1219 mm).

Measurement: 47 inches

Recommended Remediation:

Replace curb ramp and landing. The clear width of curb ramp runs (excluding any flared sides), blended transitions, and turning spaces shall be 48 inches (1219 mm) minimum. The landing clear width shall be at least as wide as the curb ramp, excluding any flared sides, or the blended transition leading to the landing. ADA allows 36-inch minimum width for curb ramp.

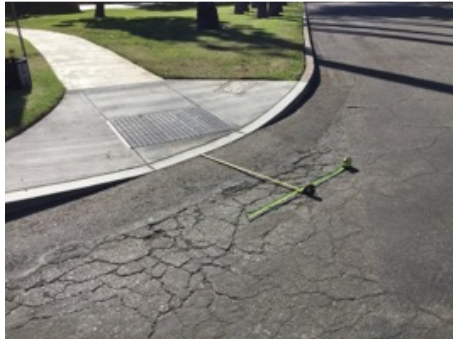
Comment #: GAN-035

Deficiency: At Grade Transitions - Curb Ramp - Clear Space

Bottom of diagonal curb ramps does not provide a clear space 48 inches (1219 mm) minimum outside active traffic lanes of the roadway and within the crosswalk markings. Non compliantly protruding into the street on the west side.

Measurement: 18 inches

Recommended Remediation:

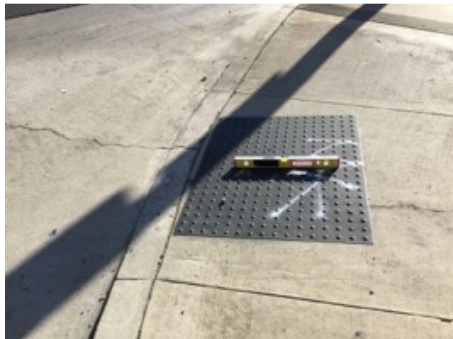
Comment #: GAN-036

Deficiency: At Grade Transitions - Perpendicular Curb Ramp - Running Slope

The running slope of the curb ramp is steeper than 1:12 (8.33%).

Measurement: 9.1 % grade

Recommended Remediation:

Remove and replace the ramp.

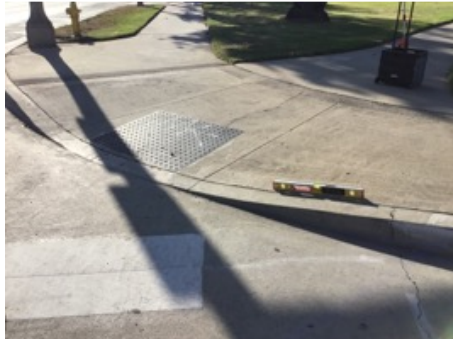
Comment #: GAN-037

Deficiency: At Grade Transitions - Perpendicular Curb Ramp - Flares (Right)

The slopes of the flared sides of the perpendicular ramp are steeper than 1:10 (10%).

Measurement: 10.8 % grade

Recommended Remediation:

Remove and replace the curb ramp so that the provided flares are not steeper than the allowable 1:10 (10%) grade.

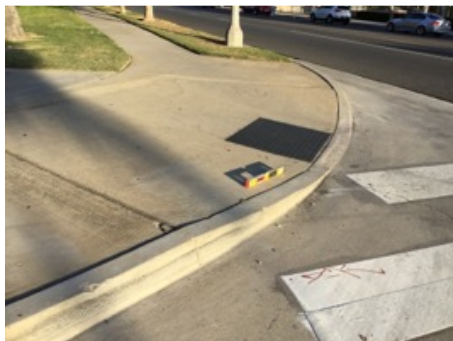
Comment #: GAN-038

Deficiency: At Grade Transitions - Perpendicular Curb Ramp - Flares (Left)

The slopes of the flared sides of the perpendicular ramp are steeper than 1:10 (10%).

Measurement: 11.6 % grade

Recommended Remediation:

Remove and replace the curb ramp so that the provided flares are not steeper than the allowable 1:10 (10%) grade.

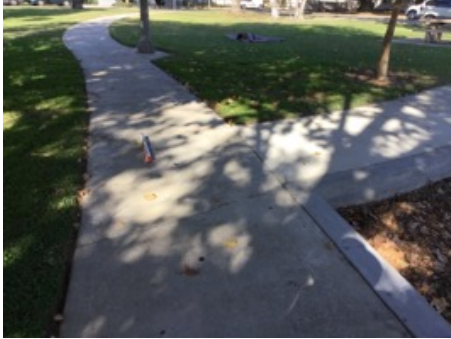
Comment #: GAN-039

Deficiency: Accessible Route - Slopes - Running Slope

The slope in the direction of travel exceeds the allowable 5%.

Measurement: 5.9 % grade

Recommended Remediation:

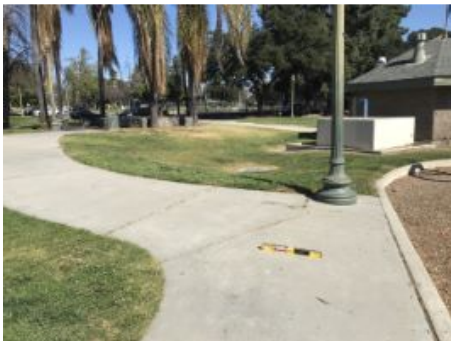
Comment #: GAN-040

Deficiency: Accessible Route - Slopes - Cross Slope

The cross slope of accessible routes exceeds 1:48 (2.0 %). 2.9% cross slope measured at turn in route from the parking lot to the larger playground.

Measurement: 2.9 % grade

Recommended Remediation:

Remove and replace walk. Install walk that provides cross slopes at circulation route of 1:48 maximum.

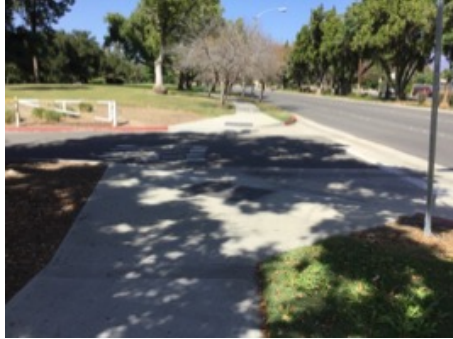
Comment #: GAN-041

Deficiency: Parking - Tow Away Sign - General

There is no "Unauthorized Parking Sign" sign at the entrance to the off-street parking.

Measurement: 0 count

Recommended Remediation:

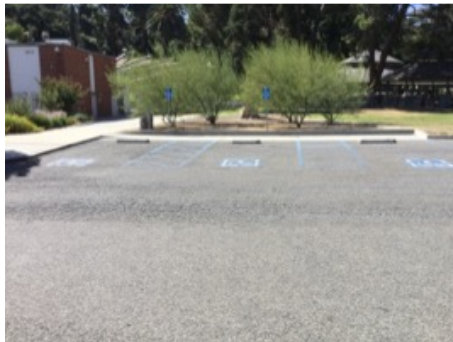
Comment #: GAN-042

Deficiency: Parking - General Parking - Van Stall Space Count

One access space in every six access spaces (or portion of 6) is not van accessible. No van accessible parking at this location.

Measurement: 0 count

Recommended Remediation:

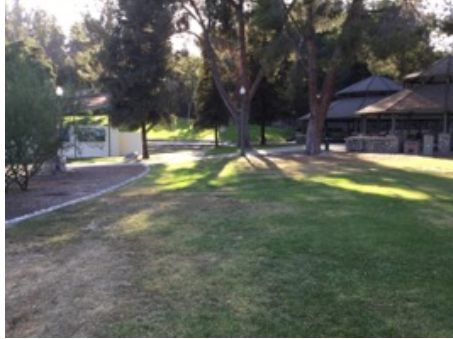
Comment #: GAN-043

Deficiency: Accessible Routes - All Routes - Connect Bldg Route

There is not an accessible route that connects accessible buildings or facility, elements within the same site. There appear to be routes to all areas and buildings within the lower park, however not all routes of access are accessible to the disabled and will be documented on a case by case record basis.

Recommended Remediation:

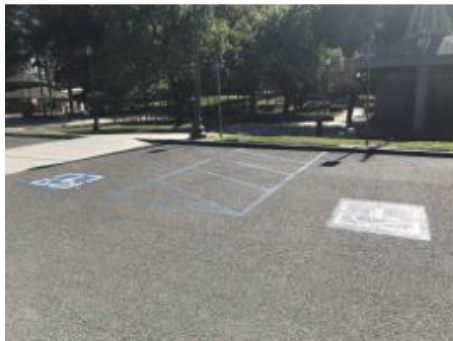
Comment #: GAN-044

Deficiency: Parking - General Parking - Car Stall Space Count

There are not enough accessible parking spaces designated as per Table 11B -208.2. A minimum of one car standard stall and access aisle shall be provided.

Measurement: 0 count

Recommended Remediation:

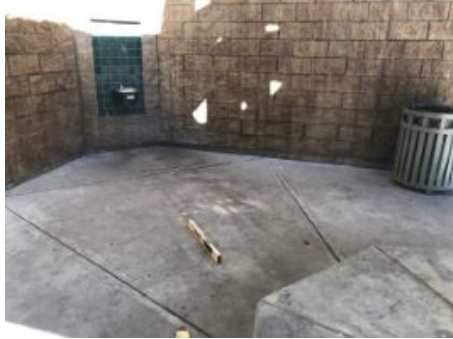
Comment #: GAN-045

Deficiency: Accessible Route - Slopes - Cross Slope

The cross slope of accessible routes exceeds 1:48 (2.0 %). 2.6% slope measured at turn in route leading to the drinking fountain at the park restrooms.

Measurement: 2.6 % grade

Recommended Remediation:

Remove and replace walk. Install walk that provides cross slopes at circulation route of 1:48 maximum.

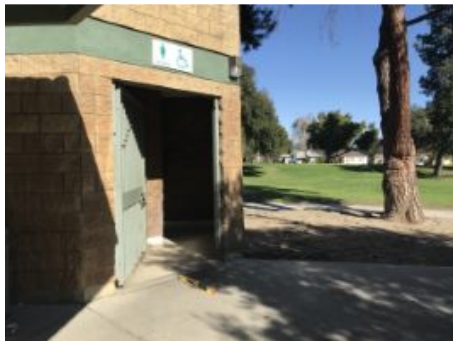
Comment #: GAN-046

Deficiency: Exterior Doors/Doorways/Gates - Landing - Slopes

Slopes more than 1:48 (2%) grade, or changes in elevation are located at door landings. 7.3% running slope measured along the route to the women's restroom.

Measurement: 7.3 % grade

Recommended Remediation:

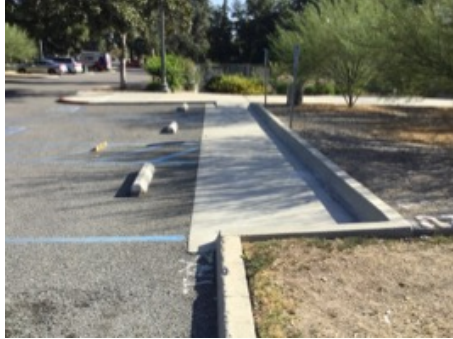
Comment #: GAN-047

Deficiency: Accessible Route - Vehicular Area Boundary - Detectable Warning Surface

Detectable warnings are not provided at the at-grade transitions where the accessible route meets the vehicular way and no curbs are provided. Parking stalls 1, 2 3 and access aisles 1 and 2 all flush with no detectable warnings.

Recommended Remediation:

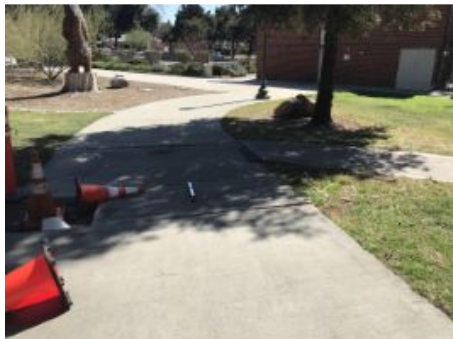
Comment #: GAN-048

Deficiency: Accessible Route - Slopes - Running Slope

The slope in the direction of travel exceeds the allowable 5%. 10.7% running slope measured along the route from the community center to the picnic shelter.

Recommended Remediation:

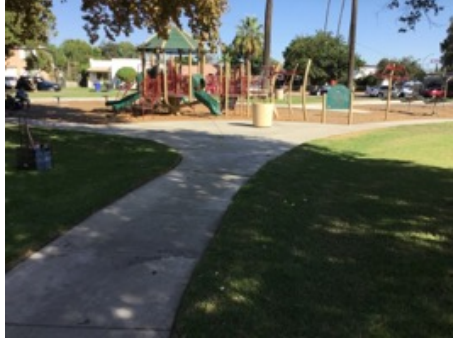
Comment #: GAN-049

Deficiency: Accessible Route - Vertical Displacement - Height

Accessible route has multiple locations where changes in level over 1/4" vertical or 1/2" beveled occur.

Measurement: .7 inches

Recommended Remediation:

Replace/grind locations where changes in elevation occur. Changes in level of 1/4" high maximum shall be permitted to be vertical and without edge treatment. Changes in level between 1/4" high minimum and 1/2" high maximum shall be beveled with a slope not steeper than 1:2. ADA Advisory: Change in level of 1/2" is permitted to be 1/4" vertical plus 1/4" beveled.

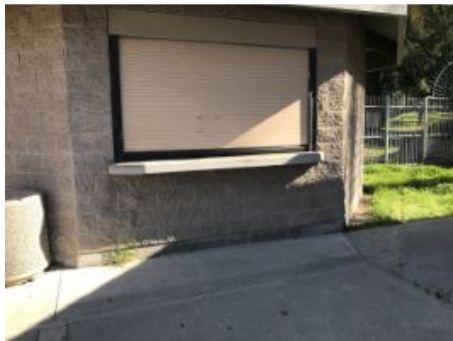
Comment #: GAN-050

Deficiency: Accessible Route - Protrusion - Depth

Objects in the path of travel extend more than 4 inches from the wall with no cane detectable barrier. Concessions counter protrudes 11-1/2" into the accessible route at 38-3/4" above the ground.

Measurement: 11.5 inches

Recommended Remediation:

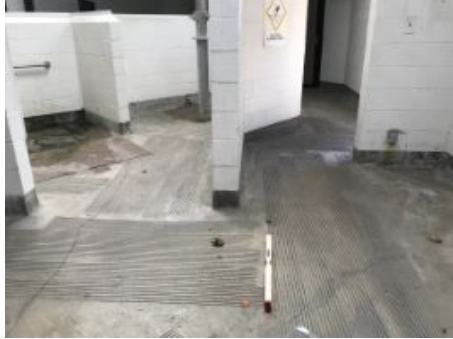
Comment #: GAN-051

Deficiency: Accessible Route - Slopes - Cross Slope

The cross slope of accessible routes exceeds 1:48 (2.0 %). 2.2% to 3.0% slopes measured at the turn in the accessible route to the showers.

Measurement: 3 % grade

Recommended Remediation:

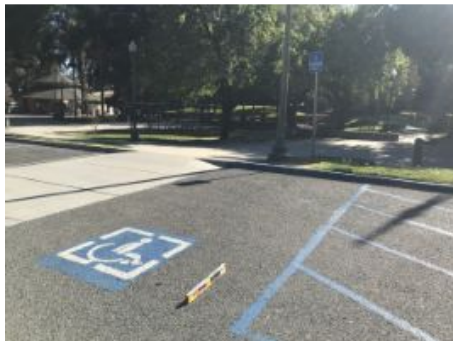
Comment #: GAN-052

Deficiency: Parking - Accessible Stall - Slopes

The slope of the van/car stall in any direction exceeds 1:48 (2.0%) grade. 2.8% to 3.8% running slope measured at the accessible parking stalls.

Measurement: 3.8 % grade

Recommended Remediation:

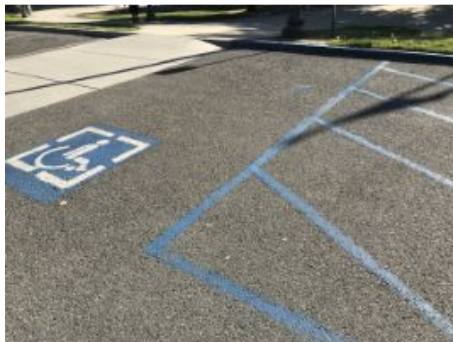
Comment #: GAN-053

Deficiency: Parking - Access Aisle Markings - General

There is no adjacent access aisle marked. Access aisle markings have faded. The words "No Parking" are not painted on the surface of the access aisles.

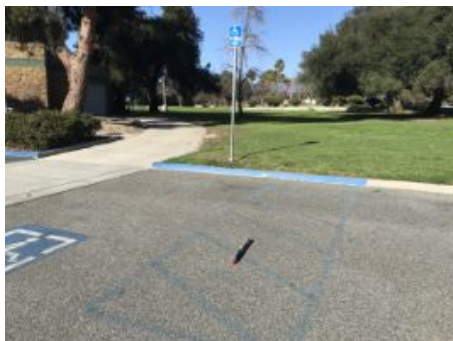
Comment #: GAN-054

Deficiency: Parking - Access Aisle - Slope

The slope of the access aisle in any direction exceeds 1:48 (2.0%) grade. 3.5% to 4.2% running slope measured at the accessible parking stall access aisles.

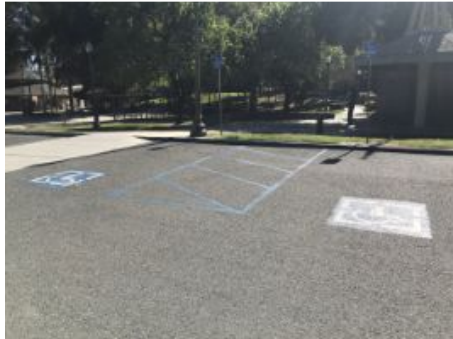
Comment #: GAN-055

Deficiency: Parking - Accessible Route - Adjacent

Parking stalls are positioned so that users of parking stall 2 are required to walk behind parking stall 1 in order to connect to an accessible route.

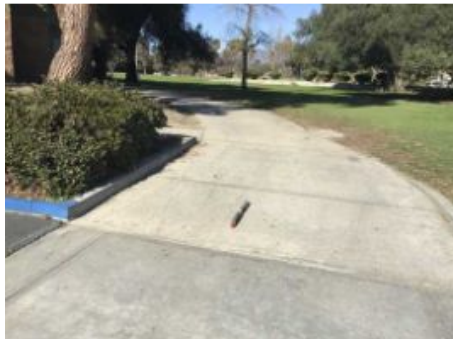
Comment #: GAN-056

Deficiency: Accessible Route - Vehicular Area Boundary - Detectable Warning Surface

Detectable warnings are not provided at the at-grade transitions where the accessible route meets the vehicular way and no curbs are provided. Detectable warnings are not provided at the curb ramps along the parking lot.

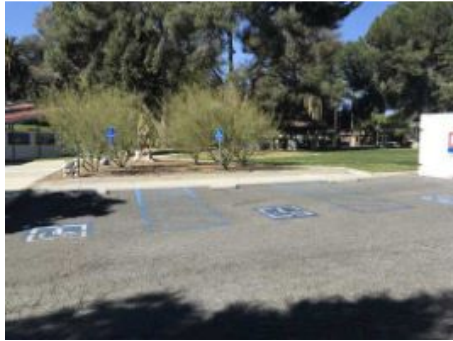
Comment #: GAN-057

Deficiency: Parking - General Parking - Car Stall Space Count

There are not enough accessible parking spaces designated as per Table 11B -208.2. A minimum of one car standard stall and access aisle shall be provided.

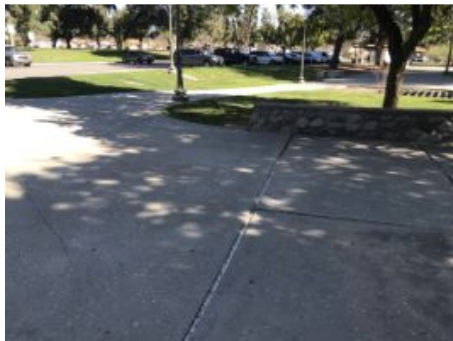
Comment #: GAN-058

Deficiency: Accessible Route - Openings - Width

Accessible route grates / openings exceed 1/2" in the direction of travel. 2" wide gap measured along the route to the swimming pool.

Replace grates, or fill openings, at locations where gratings/openings occur. Openings are allowed a maximum of 1/2" in the direction of travel.

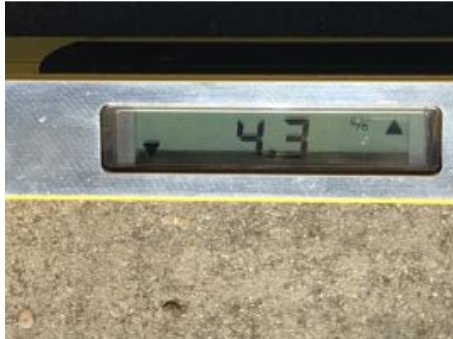
Comment #: GAN-059

Deficiency: Accessible Route - Slopes - Cross Slope

The cross slope of accessible routes exceeds 1:48 (2.0 %). 4.3% cross slope measured at turn in route from the accessible parking stalls to the swimming pool entrance.

Remove and replace walk. Install walk that provides cross slopes at circulation route of 1:48 maximum.

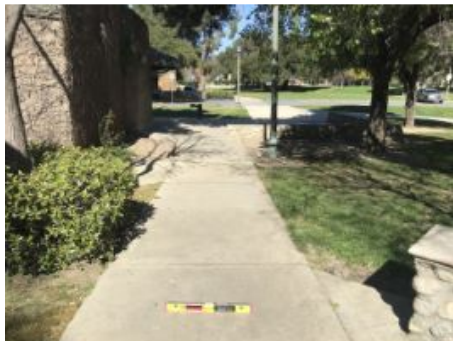
Comment #: GAN-060

Deficiency: Accessible Route - Slopes - Cross Slope

The cross slope of accessible routes exceeds 1:48 (2.0 %). 2.6% to 6.3% cross slope measured along the route from the smaller playground to the swimming pool and parking lot.

Remove and replace walk. Install walk that provides cross slopes at circulation route of 1:48 maximum.

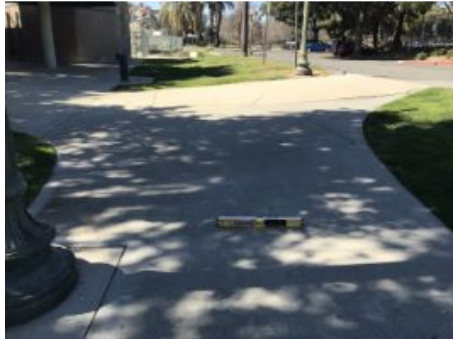
Comment #: GAN-061

Deficiency: Accessible Route - Slopes - Cross Slope

The cross slope of accessible routes exceeds 1:48 (2.0 %). 2.5% to 3.6% cross slope measured along the route from the swimming pool to the picnic shelter.

Remove and replace walk. Install walk that provides cross slopes at circulation route of 1:48 maximum.

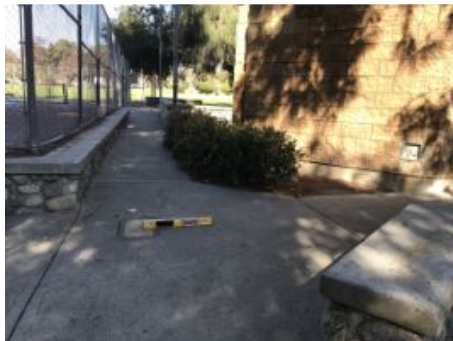
Comment #: GAN-062

Deficiency: Accessible Route - Slopes - Cross Slope

The cross slope of accessible routes exceeds 1:48 (2.0 %). 4.0% to 4.6% slopes measured at turn in route from the tennis courts to the park restrooms.

Remove and replace walk. Install walk that provides cross slopes at circulation route of 1:48 maximum.

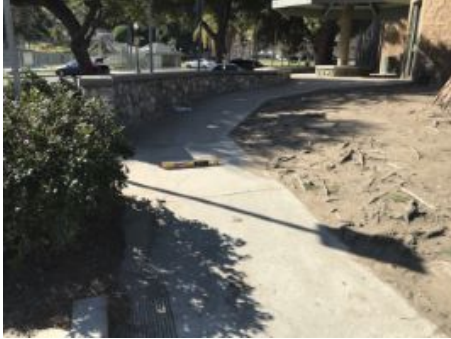
Comment #: GAN-063

Deficiency: Accessible Route - Slopes - Cross Slope

The cross slope of accessible routes exceeds 1:48 (2.0 %). 2.6% cross slope measured along ramp leading to the park restrooms.

Remove and replace walk. Install walk that provides cross slopes at circulation route of 1:48 maximum.

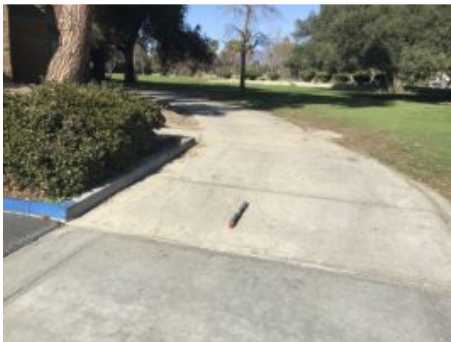
Comment #: GAN-064

Deficiency: Ramps - Slopes - Running Slope

The running slope of the ramp is steeper than 1:12 (8.33%). 9.6% to 10.4% running slope measured along the route from the accessible parking stalls to the park restrooms.

Remove and replace the ramp. The running slope of the curb ramp segments shall be in-line with the direction of sidewalk travel. Ramp runs shall have a running slope not steeper than 1:12.

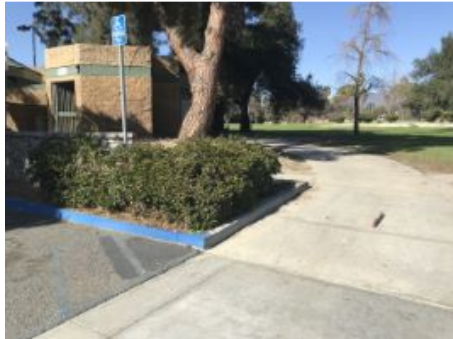
Comment #: GAN-065

Deficiency: Ramps - Slopes - Running Slope

The running slope of the ramp is steeper than 1:12 (8.33%). Slopes range from 9.6% to 10.4% ataroute to park restrooms.

Remove and replace the ramp. The running slope of the curb ramp segments shall be in-line with the direction of sidewalk travel. Ramp runs shall have a running slope not steeper than 1:12.

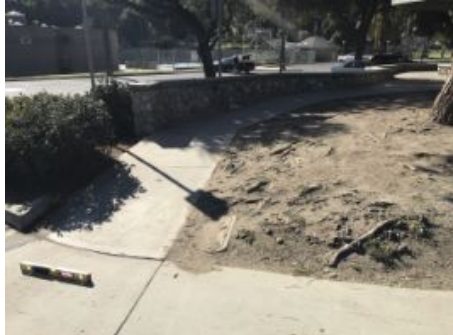
Comment #: GAN-066

Deficiency: Ramps - Landings - Slope

Slopes exceeding the maximum 1:48 in any direction on the landing. 3.9% cross slope measured at the bottom ramp landing.

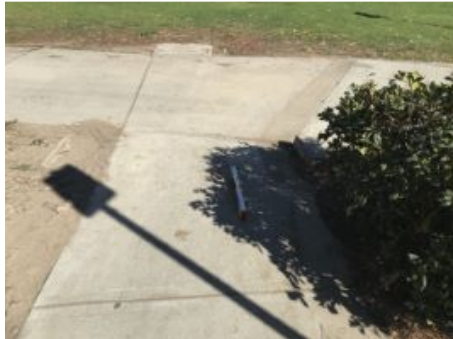
Comment #: **GAN-067**

Deficiency: Ramps - Landings - Change in Direction Length

Ramp does not provide 72-inches landings at changes of direction. Ramp leading to park restrooms is curved and does not have landings at points where the ramp turns.

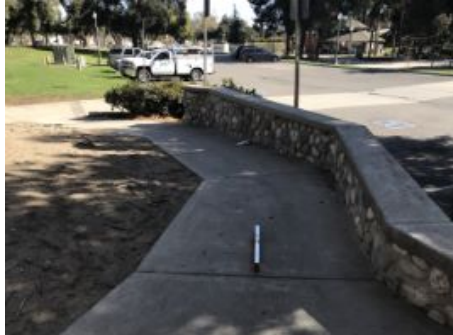
Comment #: **GAN-068**

Deficiency: Ramps - Handrails - Both Sides

Handrails are not provided on both sides of the ramp. Handrails with compliant extensions are not provided at the ramp to the park restrooms. Slopes range from 6.7% to 7.1%.

Install missing handrails so they are provided on both sides of stairs and ramps.

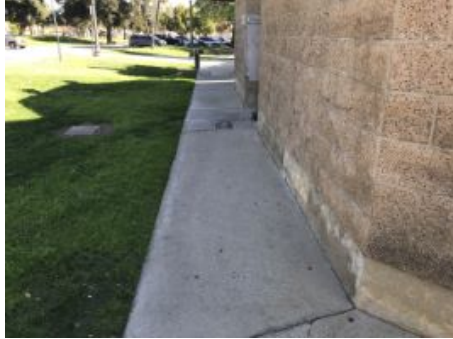
Comment #: GAN-069

Deficiency: Accessible Route - Clear Width - General

Accessible route widths do not provide minimum 48-inches clear.

Replace walks to provide a clear width of 48 inches (1219 mm) minimum. When, because of right-of-way restrictions, natural barriers or other existing conditions, the enforcing agency determines that compliance with the 48-inch (1219 mm) clear sidewalk width would create an unreasonable hardship, the clear width may be reduced to 36 inches (914 mm).

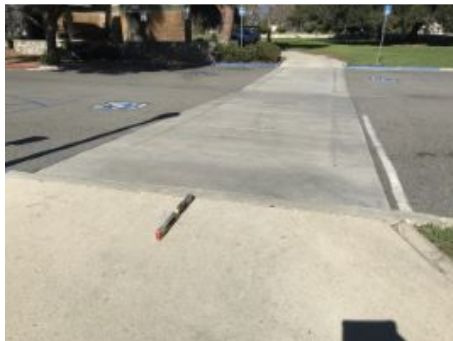
Comment #: GAN-070

Deficiency: Ramps - Slopes - Running Slope

The running slope of the ramp is steeper than 1:12 (8.33%). 7.3% to 10.9% running slope measured along the ramp leading to the accessible parking stalls.

Remove and replace the ramp. The running slope of the curb ramp segments shall be in-line with the direction of sidewalk travel. Ramp runs shall have a running slope not steeper than 1:12.

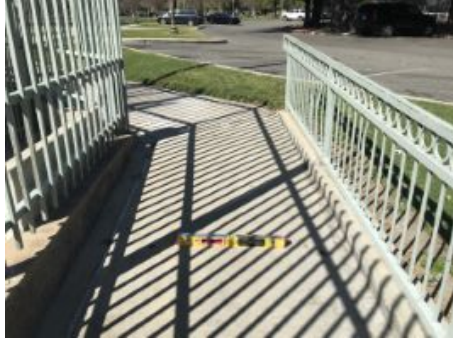
Comment #: GAN-071

Deficiency: Accessible Route - Slopes - Cross Slope

The cross slope of accessible routes exceeds 1:48 (2.0 %). 2.8% to 4.0% cross slope measured along the ramp.

Remove and replace walk. Install walk that provides cross slopes at circulation route of 1:48 maximum.

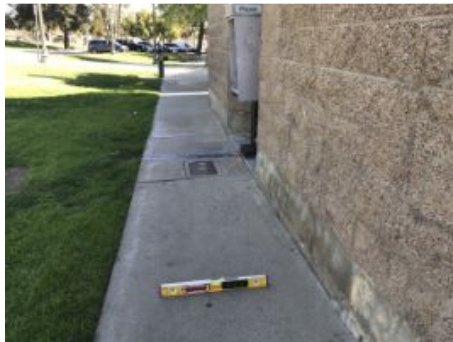
Comment #: GAN-072

Deficiency: Accessible Route - Slopes - Cross Slope

The cross slope of accessible routes exceeds 1:48 (2.0 %). 2.3% to 6.2% cross slope measured along the route from the courts and playground area to the swimming pool entrance.

Remove and replace walk. Install walk that provides cross slopes at circulation route of 1:48 maximum.

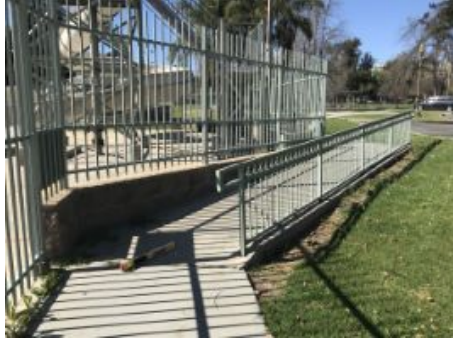
Comment #: GAN-073

Deficiency: Ramps - Landings - Slope

Slopes exceeding the maximum 1:48 in any direction on the landing. 3.9% running slope measured at the bottom ramp landing. 1" gap measured at the bottom landing. Bottom landing has a change in direction. 19" depth measured before change in direction occurs at the landing.

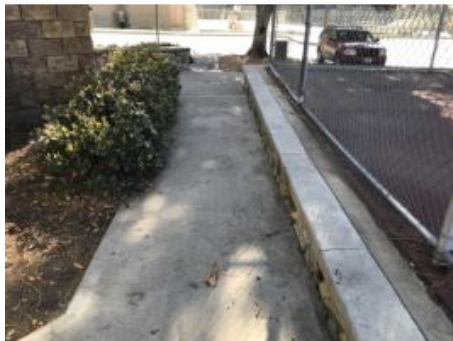
Comment #: GAN-074

Deficiency: Accessible Route - Clear Width - General

Accessible route widths do not provide minimum 48-inches clear. 40" wide route measured to the tennis courts.

Replace walks to provide a clear width of 48 inches (1219 mm) minimum. When, because of right-of-way restrictions, natural barriers or other existing conditions, the enforcing agency determines that compliance with the 48-inch (1219 mm) clear sidewalk width would create an unreasonable hardship, the clear width may be reduced to 36 inches (914 mm).

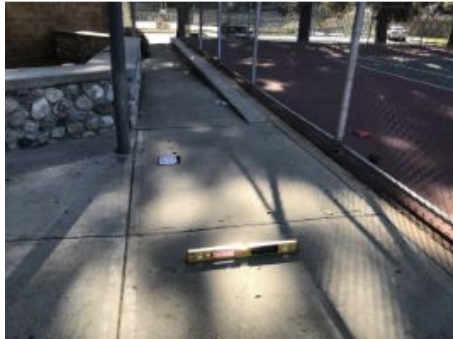
Comment #: GAN-075

Deficiency: Accessible Route - Slopes - Cross Slope

The cross slope of accessible routes exceeds 1:48 (2.0 %). 2.6% to 3.0% cross slope measured along the route to the tennis courts.

Remove and replace walk. Install walk that provides cross slopes at circulation route of 1:48 maximum.

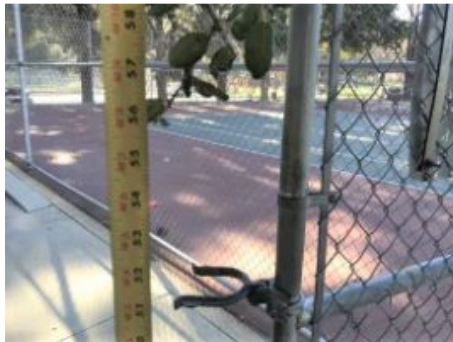
Comment #: GAN-076

Deficiency: Exterior Doors/Doorways/Gates - Hardware - Handle Height

Door hardware is not located 34-inches minimum to 44-inches maximum AFF.

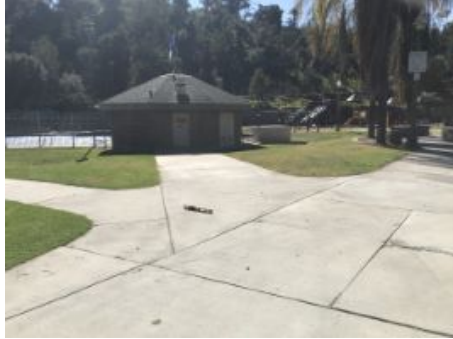
Comment #: GAN-077

Deficiency: Accessible Route - Slopes - Cross Slope

The cross slope of accessible routes exceeds 1:48 (2.0 %). 2.9% cross slope measured at the turn in the accessible route from the courts park area to the swimming pool.

Remove and replace walk. Install walk that provides cross slopes at circulation route of 1:48 maximum.

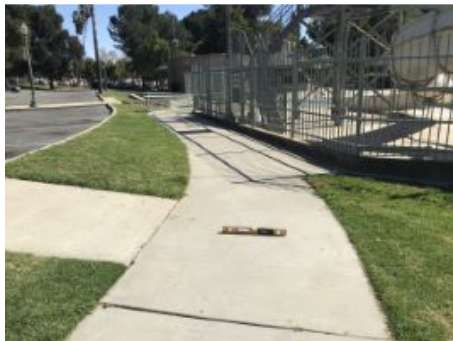
Comment #: GAN-078

Deficiency: Accessible Route - Slopes - Cross Slope

The cross slope of accessible routes exceeds 1:48 (2.0 %). 2.3% to 2.6% cross slope measured along the route from the courts park area to the swimming pool.

Remove and replace walk. Install walk that provides cross slopes at circulation route of 1:48 maximum.

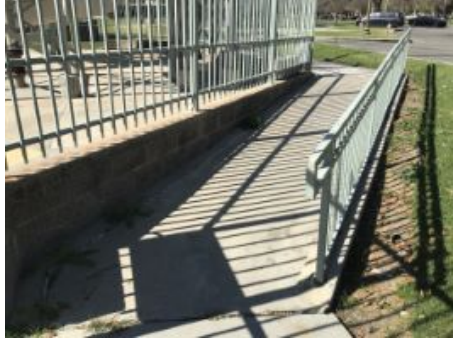
Comment #: GAN-079

Deficiency: Ramps - Handrails - Both Sides

Handrails and extensions are not provided on both sides of the ramp.

Install missing handrails so they are provided on both sides of stairs and ramps.

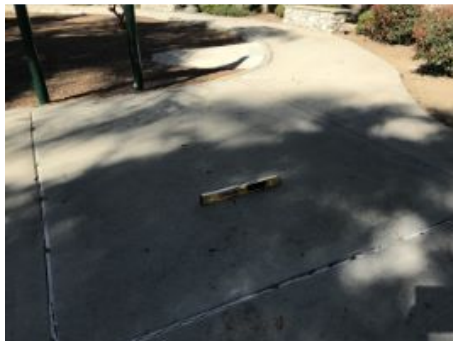
Comment #: GAN-080

Deficiency: Accessible Route - Slopes - Cross Slope

The cross slope of accessible routes exceeds 1:48 (2.0 %). 2.9% to 3.8% slopes measured at turn in accessible to the smaller playground.

Remove and replace walk. Install walk that provides cross slopes at circulation route of 1:48 maximum.

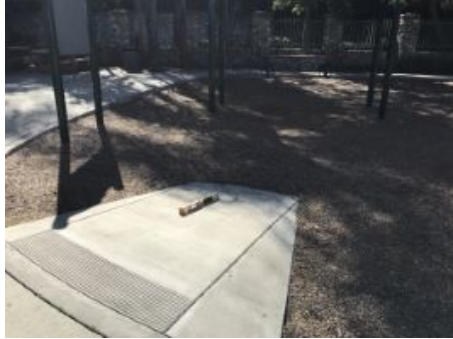
Comment #: GAN-081

Deficiency: Ramps - Slopes - Running Slope

The running slope of the ramp is steeper than 1:12 (8.33%). 9.0% running slope measured at the ramp leading to the smaller playground.

Remove and replace the ramp. The running slope of the curb ramp segments shall be in-line with the direction of sidewalk travel. Ramp runs shall have a running slope not steeper than 1:12.

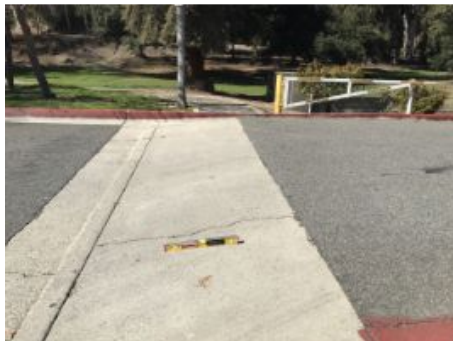
Comment #: GAN-082

Deficiency: Accessible Route - Slopes - Cross Slope

The cross slope of accessible routes exceeds 1:48 (2.0 %). 7.1% to 10.0% cross slope measured where the route runs across the driveway to the community center parking lot.

Remove and replace walk. Install walk that provides cross slopes at circulation route of 1:48 maximum.

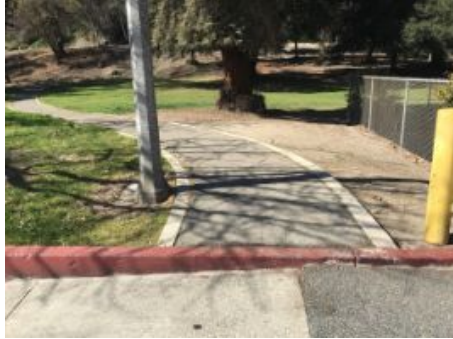
Comment #: GAN-083

Deficiency: At Grade Transitions - Curb Ramp - General

No curb ramp is provided where accessible route crosses a curb. 5" high curb measured where the accessible route enters crosses the driveway to the community center parking lot.

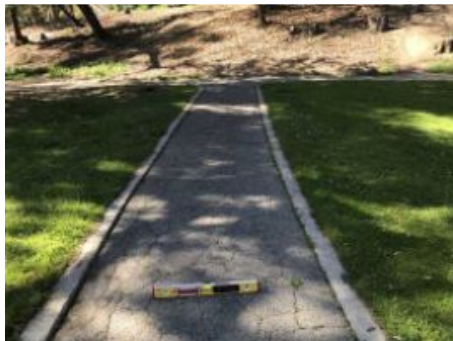
Comment #: GAN-084

Deficiency: Accessible Route - Slopes - Cross Slope

The cross slope of accessible routes exceeds 1:48 (2.0 %). 2.6% to 4.5% cross slope measured along the walking path.

Remove and replace walk. Install walk that provides cross slopes at circulation route of 1:48 maximum.

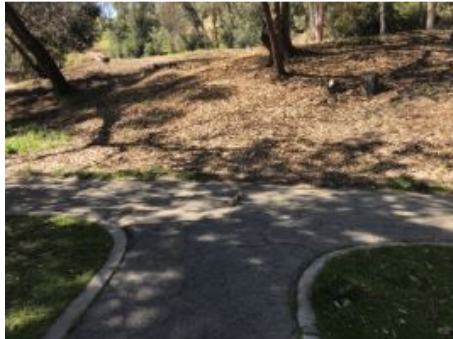
Comment #: **GAN-085**

Deficiency: Accessible Route - Slopes - Cross Slope

The cross slope of accessible routes exceeds 1:48 (2.0 %). 3.3% cross slope measured where the route from the parking lot turns towards the picnic tables.

Remove and replace walk. Install walk that provides cross slopes at circulation route of 1:48 maximum.

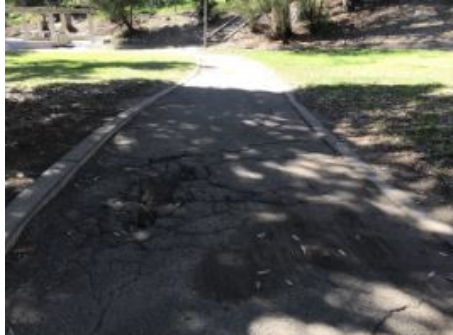
Comment #: **GAN-086**

Deficiency: Accessible Route - Slopes - Cross Slope

The cross slope of accessible routes exceeds 1:48 (2.0 %). 4.7% cross slope measured along the route.

Remove and replace walk. Install walk that provides cross slopes at circulation route of 1:48 maximum.

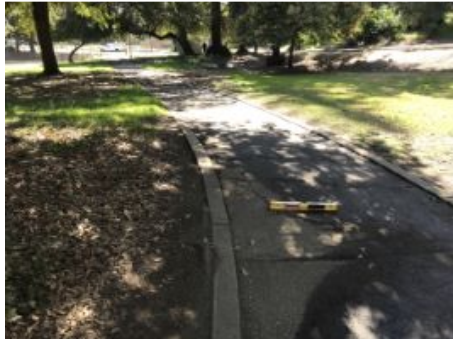
Comment #: **GAN-087**

Deficiency: Accessible Route - Slopes - Cross Slope

The cross slope of accessible routes exceeds 1:48 (2.0 %). 5.0% to 8.1% cross slope measured along the route.

Remove and replace walk. Install walk that provides cross slopes at circulation route of 1:48 maximum.

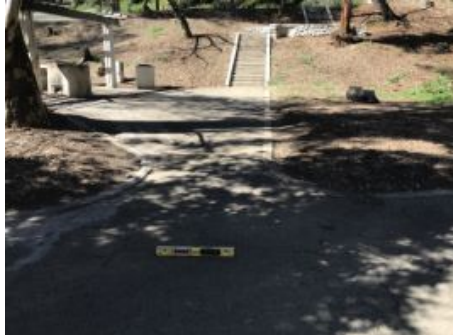
Comment #: **GAN-088**

Deficiency: Accessible Route - Slopes - Cross Slope

The cross slope of accessible routes exceeds 1:48 (2.0 %). 2.7% cross slope measured at the turn in the route to the picnic shelter.

Remove and replace walk. Install walk that provides cross slopes at circulation route of 1:48 maximum.

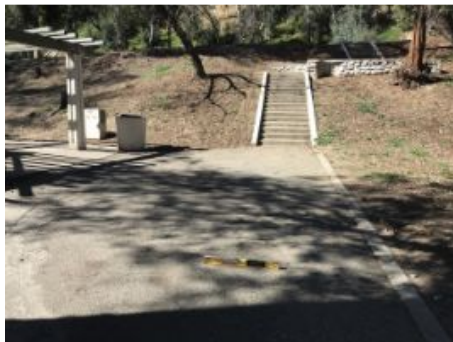
Comment #: GAN-089

Deficiency: Accessible Route - Slopes - Cross Slope

The cross slope of accessible routes exceeds 1:48 (2.0 %). 2.7% to 5.7% cross slope measured along the route to the picnic shelter.

Remove and replace walk. Install walk that provides cross slopes at circulation route of 1:48 maximum.

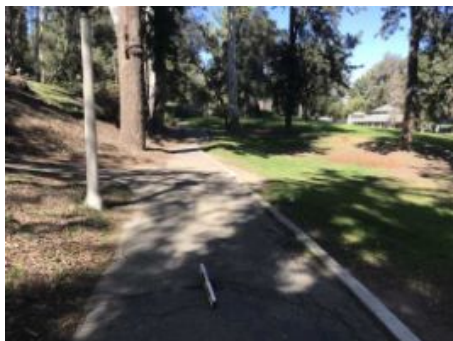
Comment #: GAN-090

Deficiency: Accessible Route - Slopes - Cross Slope

The cross slope of accessible routes exceeds 1:48 (2.0 %). 2.4% to 8.3% cross slope measured along the route to the ramp at the north end of the walking path. 14.4% running slope measured along the route.

Remove and replace walk. Install walk that provides cross slopes at circulation route of 1:48 maximum.

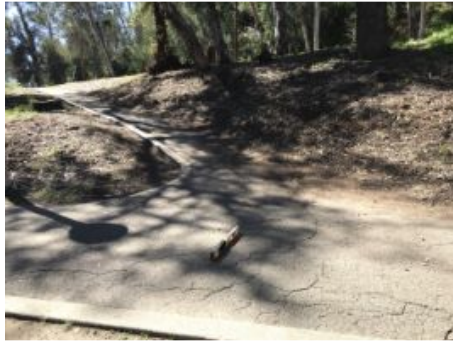
Comment #: GAN-091

Deficiency: Accessible Route - Slopes - Cross Slope

The cross slope of accessible routes exceeds 1:48 (2.0 %). 4.2% cross slope measured at turning space along the route to the ramp at the north end of the walking path.

Remove and replace walk. Install walk that provides cross slopes at circulation route of 1:48 maximum.

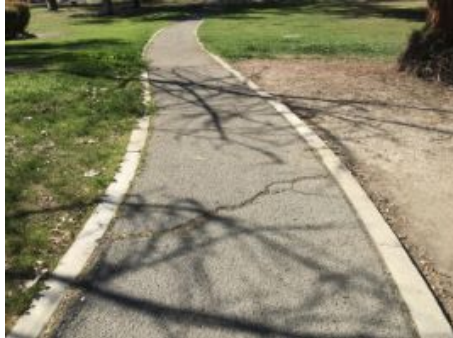
Comment #: GAN-092

Deficiency: Accessible Route - Openings - Width

Accessible route grates / openings exceed 1/2" in the direction of travel. 2" wide gap measured along the walking path.

Replace grates, or fill openings, at locations where gratings/openings occur. Openings are allowed a maximum of 1/2" in the direction of travel.

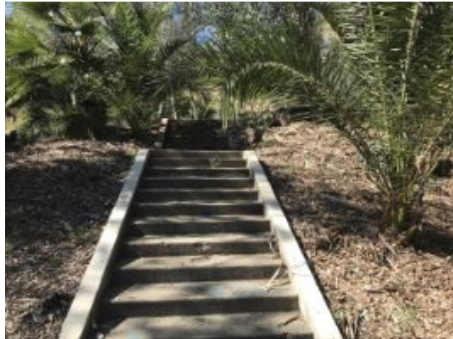
Comment #: GAN-093

Deficiency: Accessible Route - Vertical Clearance - Height

Palm frawns are located in an area where vertical clearance is less than 80- inches minimum. 50" to 63" high vertical clearance measured to the tree branches at the stairs.

Measurement: 50 inches

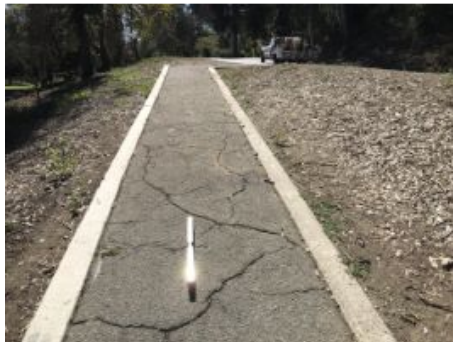
Comment #: GAN-094

Deficiency: Ramps - Slopes - Running Slope

The running slope of the ramp is steeper than 1:12 (8.33%). 12.5% to 14.1% running slope measured along the ramp located at the north end of the walking path.

Measurement: 14.1 % grade

Remove and replace the ramp. The running slope of the curb ramp segments shall be in-line with the direction of sidewalk travel. Ramp runs shall have a running slope not steeper than 1:12.

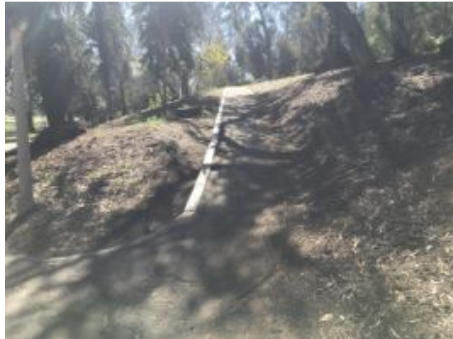
Comment #: GAN-095

Deficiency: Ramps - Handrails - Both Sides

Handrails are not provided on both sides of the ramp.

Install missing handrails so they are provided on both sides of stairs and ramps.

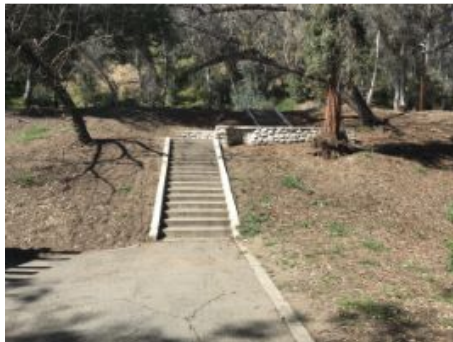
Comment #: GAN-096

Deficiency: Stairs - Contrast Striping - Exterior Stair

A 2-inch minimum to 4-inch maximum clear visual contrast stripe is not provided on each step.

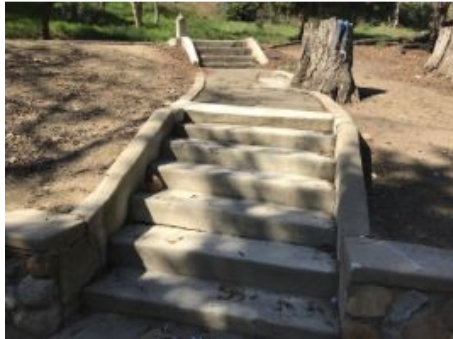
Comment #: GAN-097

Deficiency: Stairs - Risers - Uniformity

All steps on a flight of stairs do not provide uniform riser heights and/or uniform tread depths. 4-3/4" to 7" riser heights measured at the stairs.

Replace steps to provide uniform riser heights.

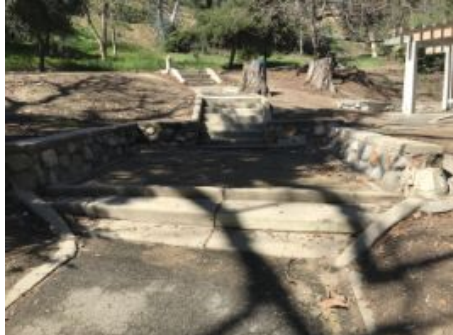
Comment #: GAN-098

Deficiency: Stairs - Handrails - Both Sides

Handrails are not provided on both sides of the staircase.

Install missing handrails so they are provided on both sides of stairs and ramps.

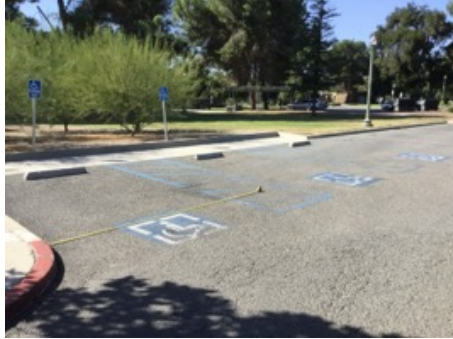
Comment #: GAN-099

Deficiency: Parking - Signage - Van Stall

The van accessible stall is not identified with the words "Van Accessible".

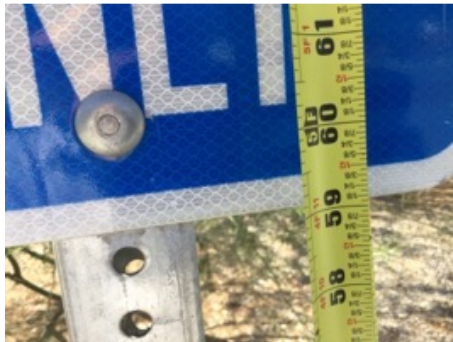
Comment #: GAN-0100

Deficiency: Parking - Signage - Height

The bottom of the sign is lower than 60 inches (1524 mm) above the finished floor.

Measurement: 59 inches

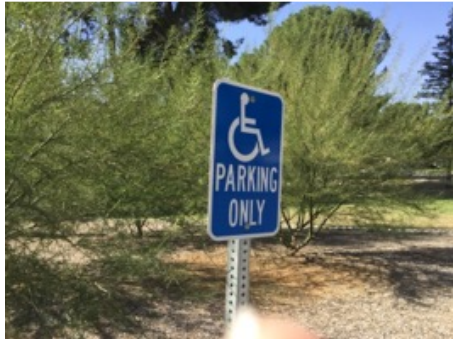
Comment #: GAN-0101

Deficiency: Parking - Signage - Minimum Fine

The parking identification sign does not include the text "Minimum Fine \$250" below the ISA.

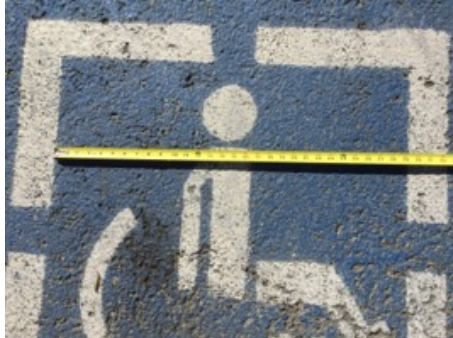
Comment #: GAN-0102

Deficiency: Parking - ISA - Size

The ISA identifying the accessible parking stall is smaller than 36 inches wide by 36 inches high (914 mm x 914 mm).

Measurement: 29.5 inches

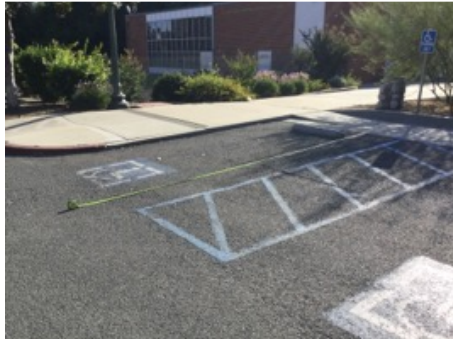
Comment #: GAN-0103

Deficiency: Parking - Accessible Stall - Length

The accessible van/car stall is less than 216 inches (18 ft. or 5486 mm) long.

Measurement: 209 inches

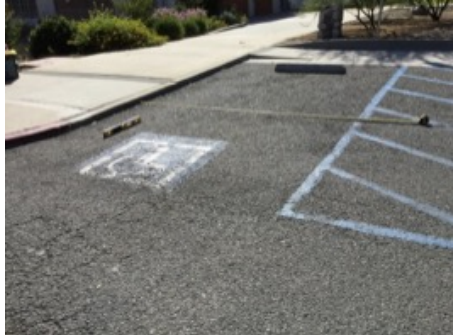
Comment #: GAN-0104

Deficiency: Parking - Accessible Stall - Slopes

The slope of the van/car stall in any direction exceeds 1:48 (2.0%) grade.

Measurement: 3.4 % grade

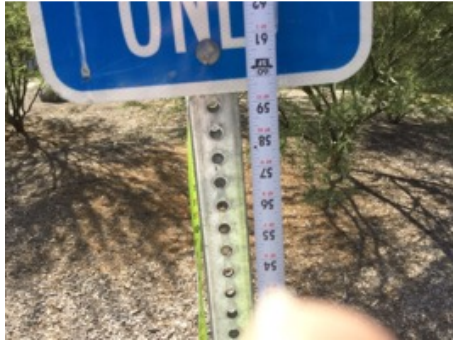
Comment #: GAN-0105

Deficiency: Parking - Signage - Height

The bottom of the sign is lower than 60 inches (1524 mm) above the finished floor.

Measurement: 59.5 inches

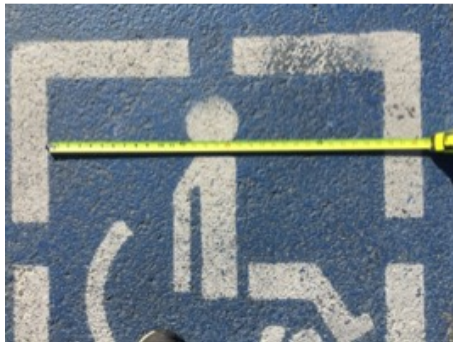
Comment #: GAN-0106

Deficiency: Parking - ISA - Size

The ISA identifying the accessible parking stall is smaller than 36 inches wide by 36 inches high (914 mm x 914 mm).

Measurement: 29.5 inches

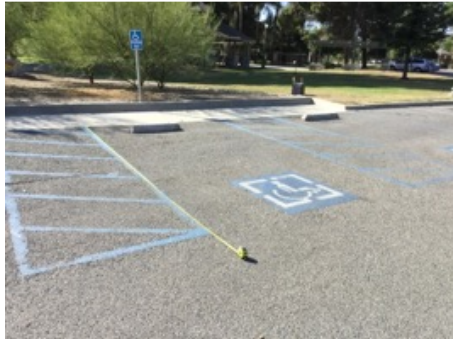
Comment #: GAN-0107

Deficiency: Parking - Accessible Stall - Length

The accessible van/car stall is less than 216 inches (18 ft. or 5486 mm) long.

Measurement: 209 inches

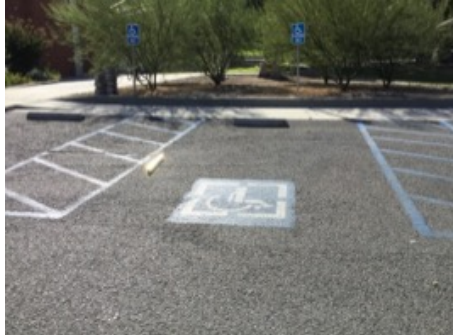
Comment #: GAN-0108

Deficiency: Parking - Accessible Stall - Slopes

The slope of the van/car stall in any direction exceeds 1:48 (2.0%) grade.

Measurement: 4.1 % grade
