APPENDIX A

FACILITY ASSESSMENT PHOTO REPORTS

CITY HALL

1.0 Site Assessment

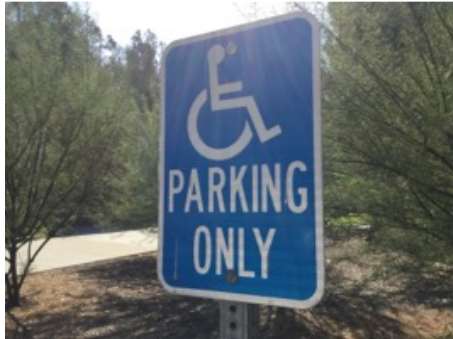
Comment #: GAN-0109

Deficiency: Parking - Signage - Minimum Fine

The parking identification sign does not include the text "Minimum Fine \$250" below the ISA.

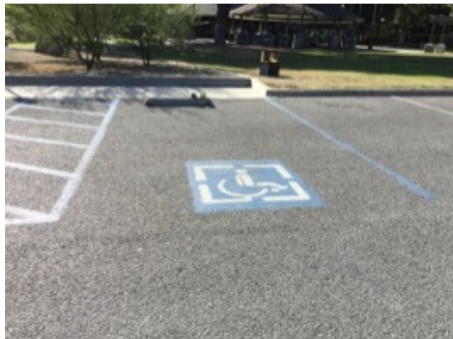
Comment #: GAN-0110

Deficiency: Parking - Signage - Location

The parking identification sign is not installed at parking stall.

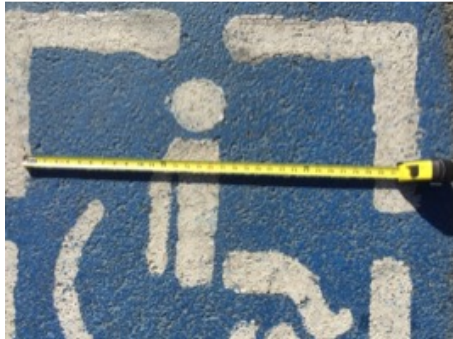
Comment #: GAN-0111

Deficiency: Parking - ISA - Size

The ISA identifying the accessible parking stall is smaller than 36 inches wide by 36 inches high (914 mm x 914 mm).

Measurement: 29.5 inches

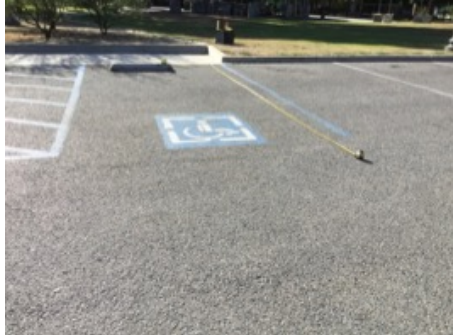
Comment #: GAN-0112

Deficiency: Parking - Accessible Stall - Length

The accessible van/car stall is less than 216 inches (18 ft. or 5486 mm) long.

Measurement: 206 inches

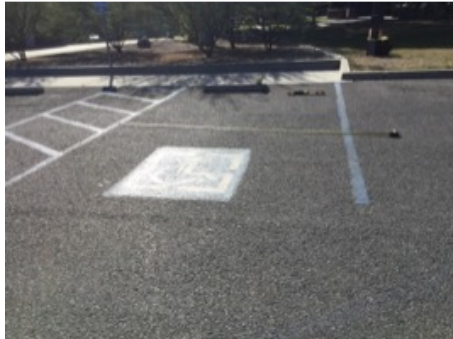
Comment #: GAN-0113

Deficiency: Parking - Accessible Stall - Slopes

The slope of the van/car stall in any direction exceeds 1:48 (2.0%) grade.

Measurement: 2.8 % grade

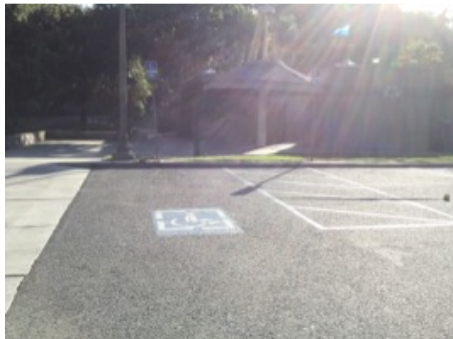
Comment #: GAN-0114

Deficiency: Parking - Signage - Van Stall

The van accessible stall is not identified with the words "Van Accessible".

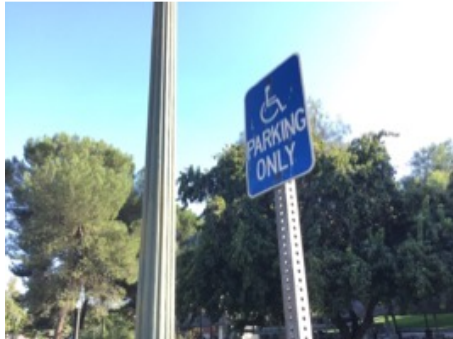
Comment #: GAN-0115

Deficiency: Parking - Signage - Finish

The parking identification sign does not have a reflective finish.

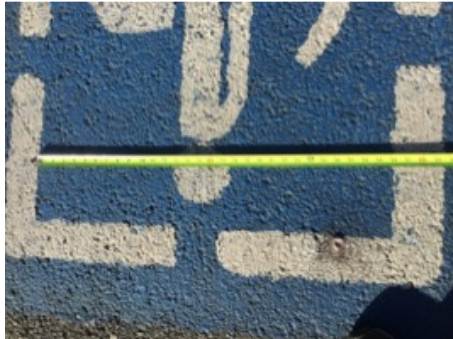
Comment #: GAN-0117

Deficiency: Parking - ISA - Size

The ISA identifying the accessible parking stall is smaller than 36 inches wide by 36 inches high (914 mm x 914 mm).

Measurement: 30 inches

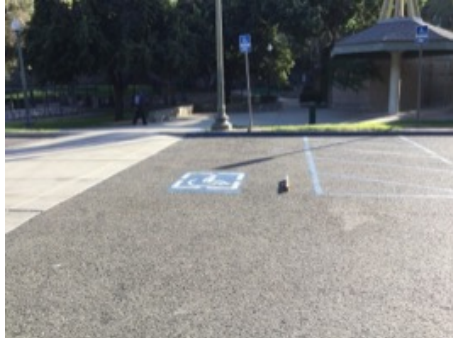
Comment #: GAN-0118

Deficiency: Parking - Accessible Stall - Slopes

The slope of the van/car stall in any direction exceeds 1:48 (2.0%) grade.

Measurement: 3.3 % grade

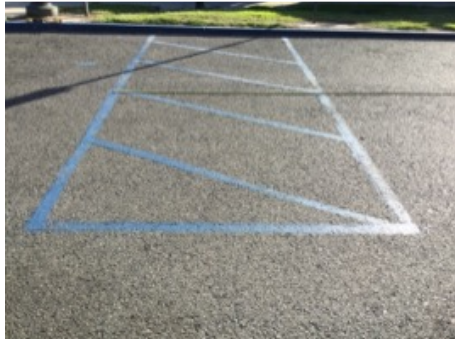
Comment #: GAN-0119

Deficiency: Parking - Access Aisle Markings - Width

The accessible van stall has an adjacent access aisle less than 96 inches (8 ft. or 2438 mm) is less than 144 inches (12 ft. or 3658 mm) wide.

Measurement: 88 inches

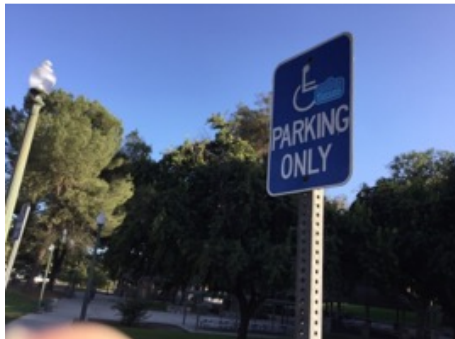
Comment #: GAN-0120

Deficiency: Parking - Signage - Finish

The parking identification sign does not have a reflective finish.

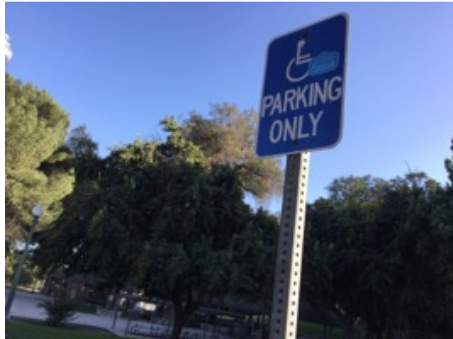
Comment #: GAN-0121

Deficiency: Parking - Signage - Minimum Fine

The parking identification sign does not include the text "Minimum Fine \$250" below the ISA.

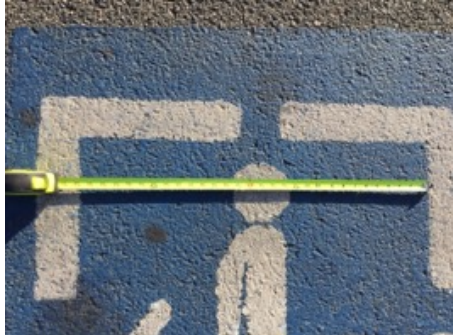
Comment #: GAN-0122

Deficiency: Parking - ISA - Size

The ISA identifying the accessible parking stall is smaller than 36 inches wide by 36 inches high (914 mm x 914 mm).

Measurement: 29.5 inches

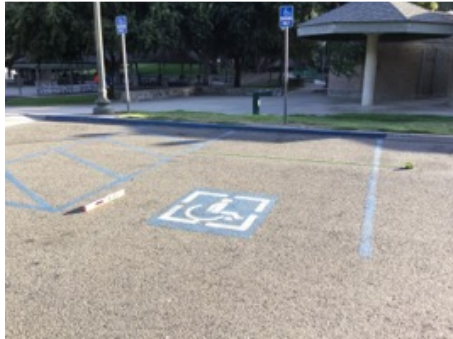
Comment #: GAN-0123

Deficiency: Parking - Accessible Stall - Slopes

The slope of the van/car stall in any direction exceeds 1:48 (2.0%) grade.

Measurement: 2.7 % grade

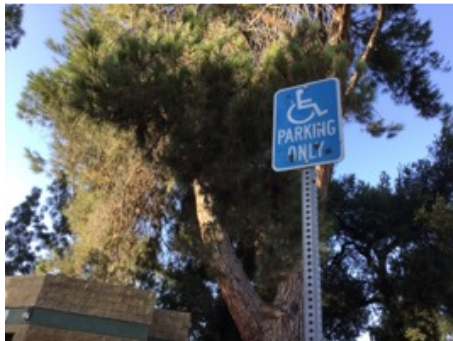
Comment #: GAN-0124

Deficiency: Parking - Signage - Finish

The parking identification sign does not have a reflective finish.

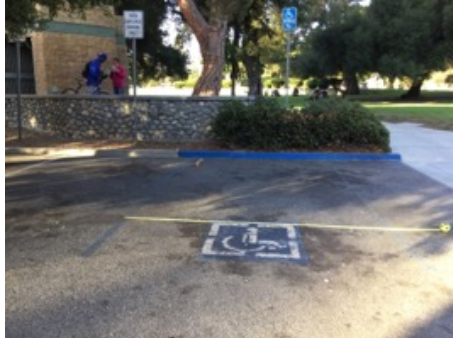
Comment #: GAN-0126

Deficiency: Parking - Accessible Stall - Slopes

The slope of the van/car stall in any direction exceeds 1:48 (2.0%) grade.

Measurement: 3.1 % grade

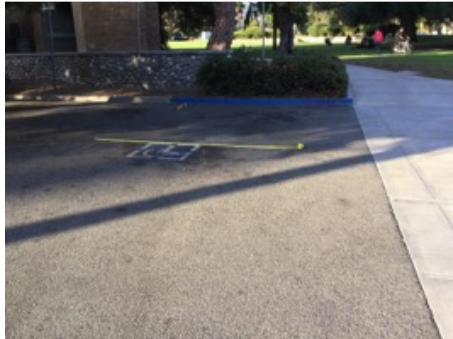
Comment #: GAN-0127

Deficiency: Parking - Access Aisle Markings - General

There is no adjacent access aisle marked.

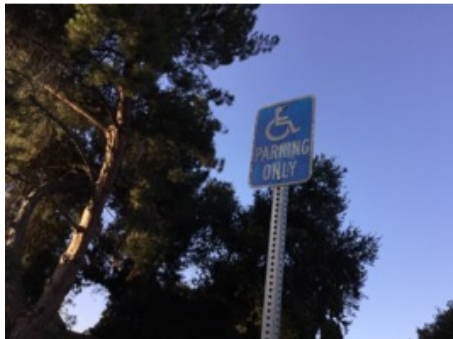
Comment #: GAN-0128

Deficiency: Parking - Signage - Finish

The parking identification sign does not have a reflective finish.

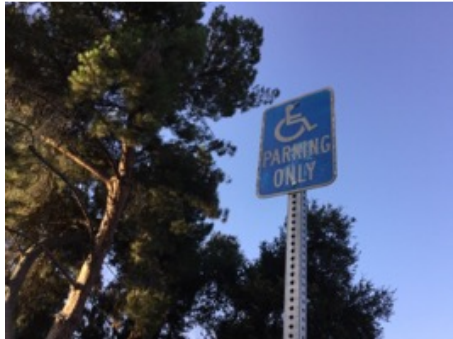
Comment #: GAN-0129

Deficiency: Parking - Signage - Minimum Fine

The parking identification sign does not include the text "Minimum Fine \$250" below the ISA.

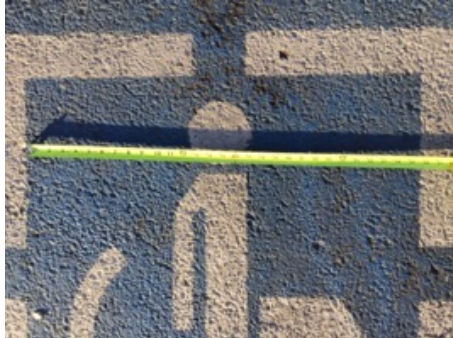
Comment #: GAN-0130

Deficiency: Parking - ISA - Size

The ISA identifying the accessible parking stall is smaller than 36 inches wide by 36 inches high (914 mm x 914 mm).

Measurement: 29.5 inches

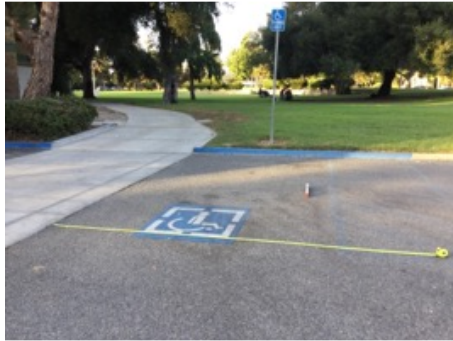
Comment #: GAN-0131

Deficiency: Parking - Accessible Stall - Slopes

The slope of the van/car stall in any direction exceeds 1:48 (2.0%) grade.

Measurement: 3 % grade

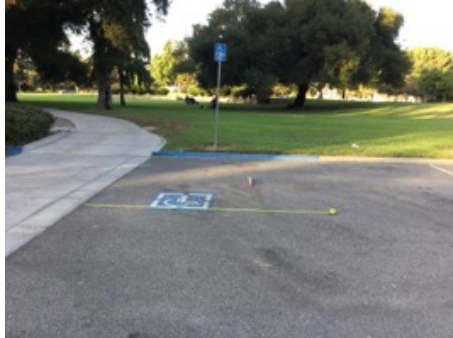
Comment #: GAN-0132

Deficiency: Parking - Access Aisle Markings - General

There is no adjacent access aisle marked. The access aisle is not maintained and not deterring parking within access aisle.

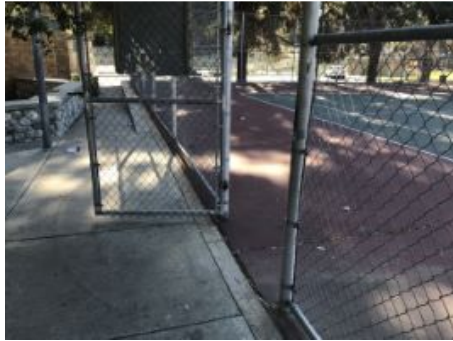
Comment #: GAN-0133

Deficiency: Accessible Route - Openings - Width

Accessible route grates / openings exceed 1/2" in the direction of travel. 1-1/2 inch gap at gate opening.

Measurement: 1.5 inches

Replace grates, or fill openings, at locations where gratings/openings occur. Openings are allowed a maximum of 1/2" in the direction of travel.

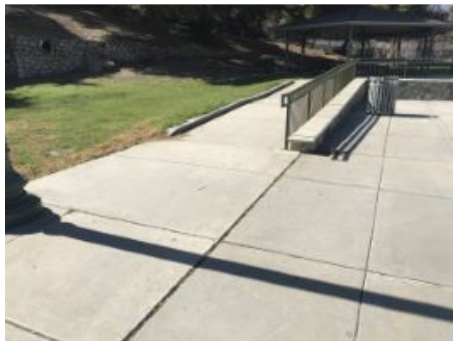
Comment #: GAN-0134

Deficiency: Accessible Route - Openings - Width

Accessible route grates / openings exceed 1/2" in the direction of travel.

Measurement: 1.25 inches

Replace grates, or fill openings, at locations where gratings/openings occur. Openings are allowed a maximum of 1/2" in the direction of travel.

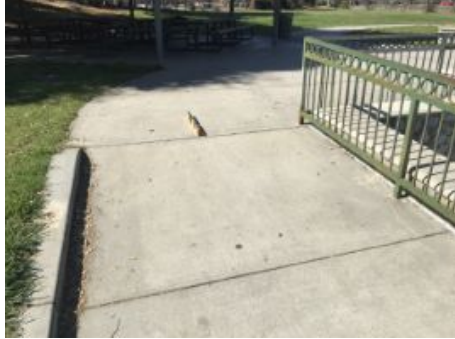
Comment #: GAN-0135

Deficiency: Ramps - Landings - Slope

Slopes exceeding the maximum 1:48 in any direction on the landing. 3.6% running slope measured at the top ramp landing. 2.9% running slope measured at the bottom ramp landing.

Measurement: 3.6 % grade

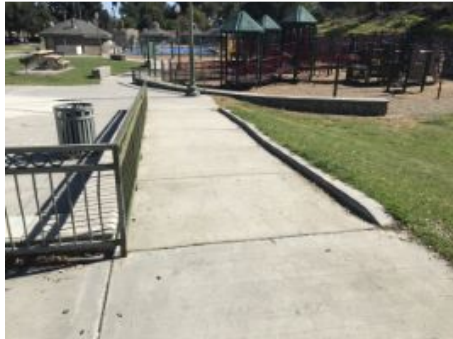
Comment #: GAN-0137

Deficiency: Ramps - Handrails - Both Sides

Handrails and handrail extensions are not provided on both sides of the ramp.

Measurement: 0 count

Install missing handrails so they are provided on both sides of stairs and ramps.

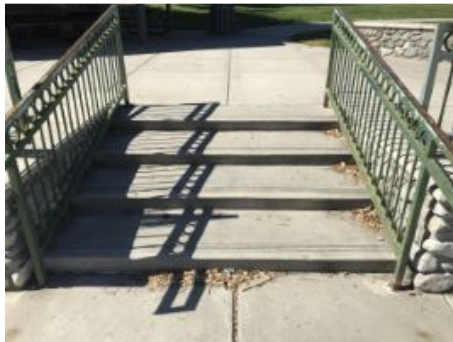
Comment #: GAN-0138

Deficiency: Stairs - Contrast Striping - Exterior Stair

A 2-inch minimum to 4-inch maximum clear visual contrast stripe is not provided on each step.

Measurement: 0 count

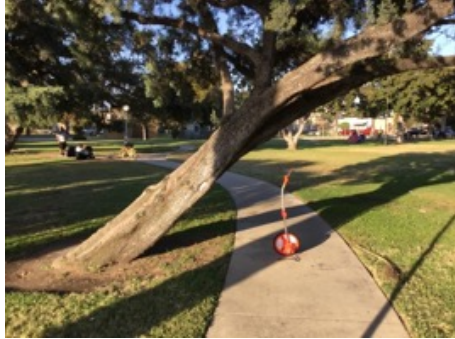
Comment #: GAN-0139

Deficiency: Accessible Route - Protrusion - Height

Objects in the path of travel extend more than 4 inches from the wall with no cane detectable barrier.

Measurement: 49 inches

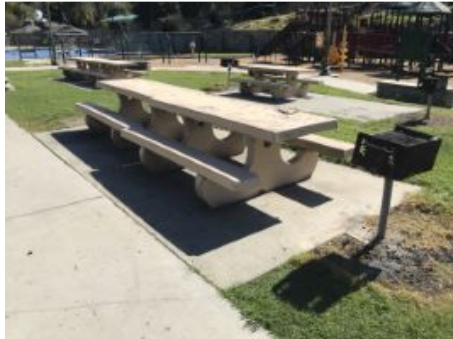
Comment #: GAN-0140

Deficiency: Accessible Route - Clear Width - General

Accessible route widths do not provide minimum 48-inches clear. 27-1/2" deep clear ground space measured at the picnic table. 23-1/2" wide clear ground space measured at the grill.

Measurement: 23.5 inches

Replace walks to provide a clear width of 48 inches (1219 mm) minimum. When, because of right-of-way restrictions, natural barriers or other existing conditions, the enforcing agency determines that compliance with the 48-inch (1219 mm) clear sidewalk width would create an unreasonable hardship, the clear width may be reduced to 36 inches (914 mm).

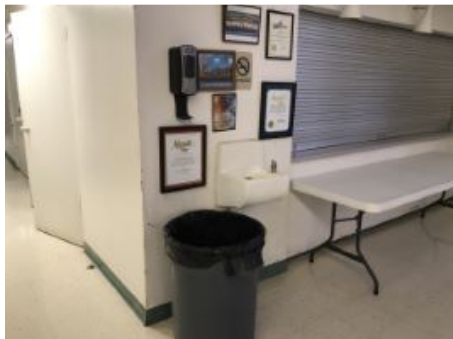
Comment #: GAN-0141

Deficiency: Accessible Route - Reach Ranges - Side Reach Obstructed

Obstructed elements is either deeper than 24" or more than 46-inches maximum AFF when deeper than 10-inches (to a maximum of 24-inches). 54" AFF measured to the antibacterial dispenser control.

Measurement: 54 inches

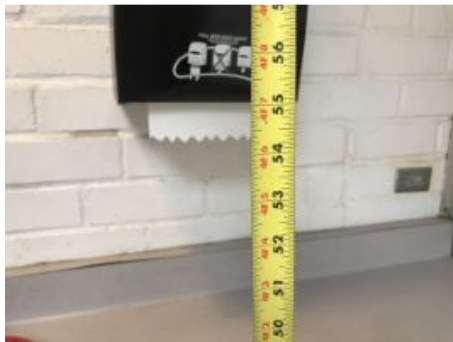
Comment #: GAN-0142

Deficiency: Accessible Route - Reach Ranges - Forward Reach Obstructed

The maximum reach is more than 44" when the depth of reach over an obstruction exceeds 20." 55" AFF measured to the paper towel dispenser in the kitchen.

Measurement: 55 inches

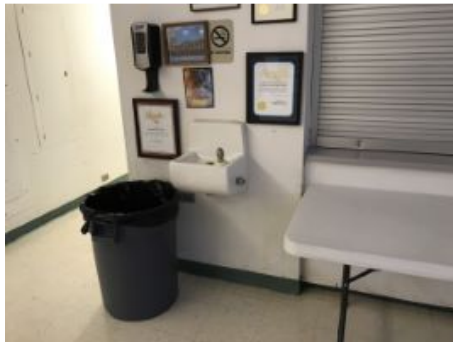
Comment #: GAN-0143

Deficiency: Drinking Fountain - Number Provided - Hi/Lo

One standing and one wheelchair accessible drinking fountain is not provided at each location. A wheelchair height drinking fountain is not provided. 38-1/2" AFF measured to the spout.

Measurement: 1 count

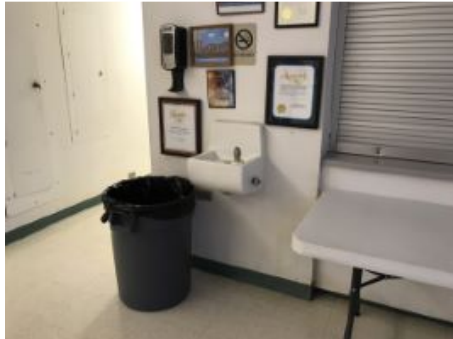
Comment #: GAN-0144

Deficiency: Drinking Fountain - Typical at Both - Pedestrian Protection

Pedestrian protection is not provided at drinking fountains.

Measurement: 0 count

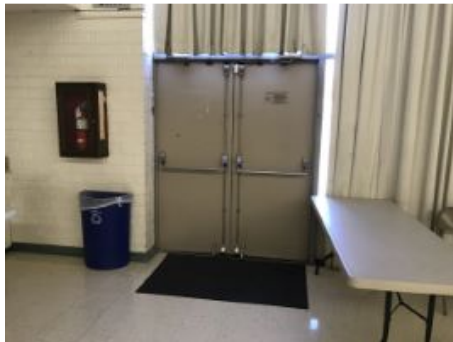
Comment #: GAN-0145

Deficiency: Interior Doors/Doorways/Gates - Hardware - Smooth Surface

Lower 10 inches of door is not smooth.

Measurement: 2 inches

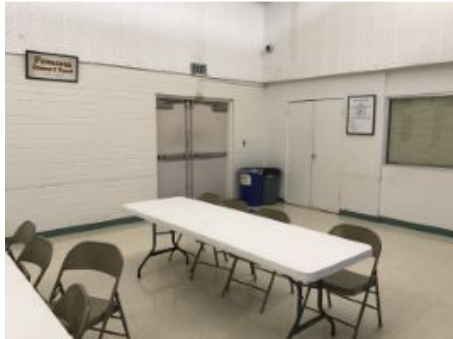
Comment #: GAN-0146

Deficiency: Interior Doors/Doorways/Gates - Tactile Sign - General

No permanent tactile exit sign has been provided.

Measurement: 0 count

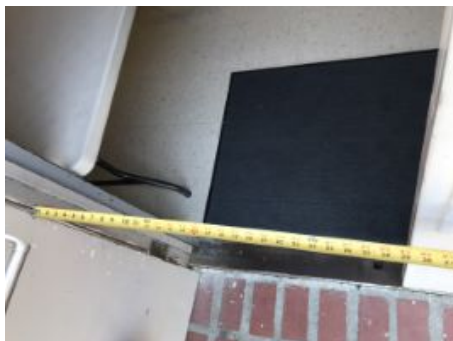
Comment #: GAN-0147

Deficiency: Interior Doors/Doorways/Gates - Dimensions - Width

32-inch clear opening is not provided when door is open at 90 degrees.

Measurement: 29.75 inches

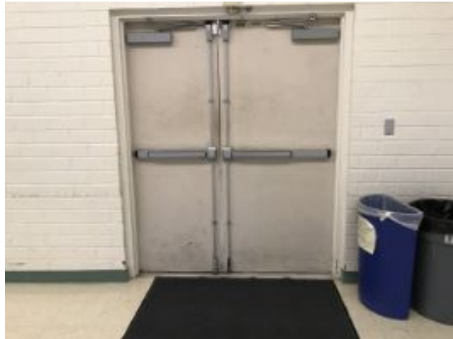
Comment #: GAN-0148

Deficiency: Interior Doors/Doorways/Gates - Operation - Closing Speed

The door closes faster than the minimum 5 seconds. 3.05 to 3.73 seconds closing speed measured at the entry doors.

Measurement: 3.05 seconds

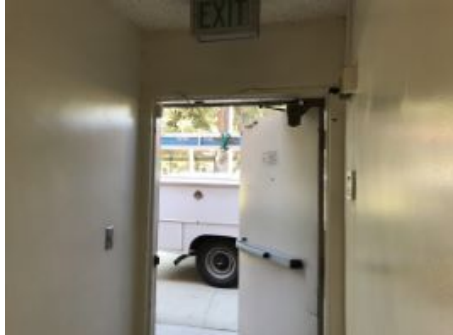
Comment #: GAN-0149

Deficiency: Interior Doors/Doorways/Gates - Clearances: Front - Latch Clearance

18-inches (exterior) not provided at latch side clearances.

Measurement: 3 inches

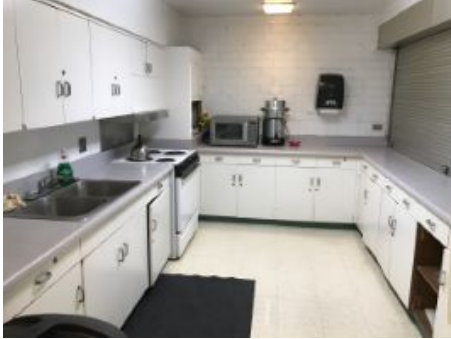
Comment #: GAN-0150

Deficiency: Kitchen - Storage - General

The storage does not have at least 50% of cabinet shelf space within reach ranges (15"-48"; 46" max when shelving is 10" deep) AND/OR with handles that cannot be operated with one hand, and require tight grasping, pinching, or twisting of the wrist, or require more than 5 pounds force to operate, AND/OR without clear floor space. Less than 50% of the storage is provided within

Measurement: 1 count

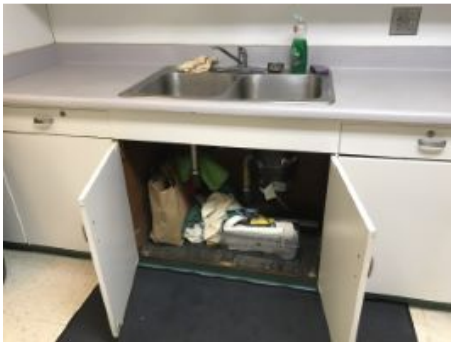
Comment #: GAN-0151

Deficiency: Kitchen - Sink/Counter Surface - Height

The height of the lavatory counter surface exceeds the allowable 34 inches AFF. 36-1/4" AFF measured to the kitchen sink rim. Knee and toe clearances are not provided at the sink.

Measurement: 36.24 inches

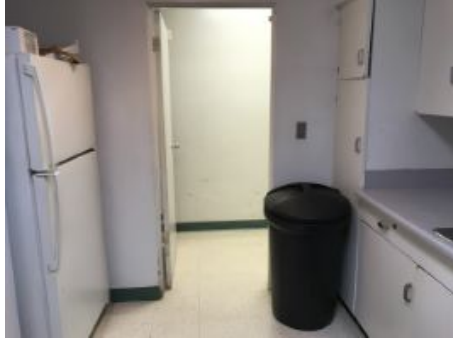
Comment #: GAN-0152

Deficiency: Interior Doors/Doorways/Gates - Dimensions - Width

32-inch clear opening is not provided when door is open at 90 degrees.

Measurement: 29.75 inches

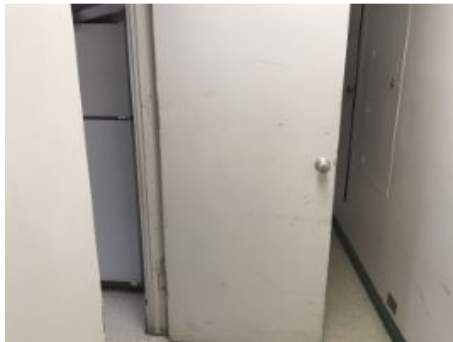
Comment #: GAN-0153

Deficiency: Interior Doors/Doorways/Gates - Hardware - Operation

The operable part requires tight grasping, pinching and/or twisting of the wrist to operate.

Measurement: 2 count

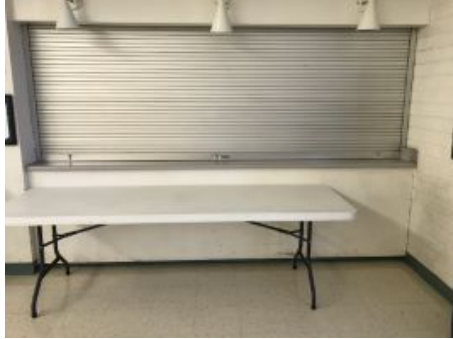
Comment #: GAN-0154

Deficiency: Transaction Counters - Dimensions - Counter Height

The counter surface is higher than the allowable 34 inches above the finished floor.

Measurement: 36 inches

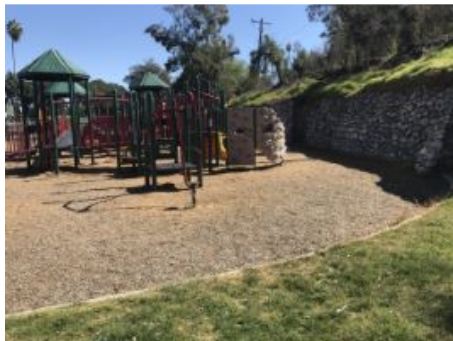
Comment #: GAN-0155

Deficiency: Playgrounds - Ground Surface - Use Zone

The ground surface at the playground is wood chips which are not considered accessible. The 'use zone' ground surfaces does not comply with ASTM F 1292 (1999 edition or 2004 edition).

Measurement: 0 count

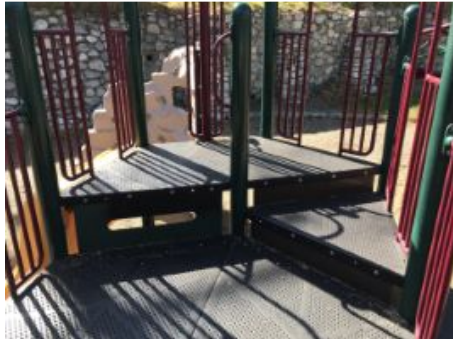
Comment #: GAN-0156

Deficiency: Playgrounds - Transfer System - Contrast Striping

Transfer step does not provide contrast striping, or contrast striping is not compliant.

Measurement: 0 count

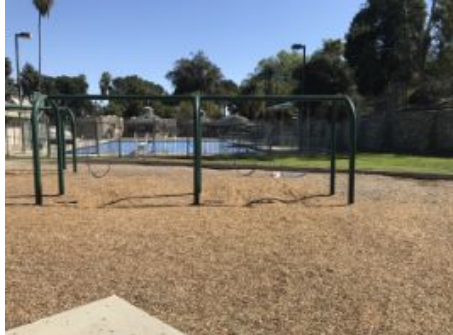
Comment #: GAN-0157

Deficiency: Playgrounds - Transfer System - Transfer Space

A 30" x 48" level transfer space is not provided. 26" to 28" height measured to entry points at the swings and is not level.

Measurement: 28 inches

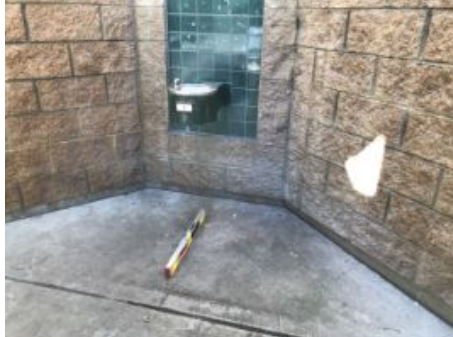
Comment #: GAN-0158

Deficiency: Drinking Fountain - Wheelchair Compliance - Clear Floor Grades

30" x 48" clear floor space slopes exceed 1:48 (2.083%) 3.2% slope measured in clear ground space at the drinking fountain.

Measurement: 3.2 % grade

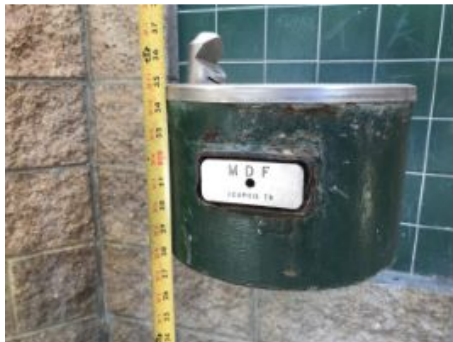
Comment #: GAN-0159

Deficiency: Drinking Fountain - Number Provided - Hi/Lo

One standing and one wheelchair accessible drinking fountain is not provided at each location.

Measurement: 0 count

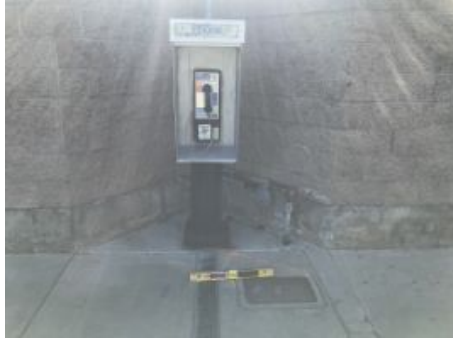
Comment #: GAN-0160

Deficiency: Accessible Route - Reach Ranges - Clear Floor Space

30" x 48" level clear ground space is not provided at the operable part. 3.5% cross slope measured in clear ground space at the pay phone.

Measurement: 3.5 % grade

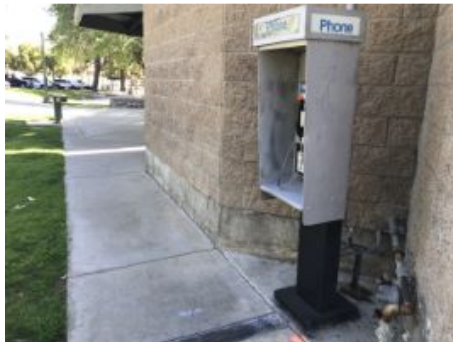
Comment #: GAN-0161

Deficiency: Accessible Route - Reach Ranges - Forward Reach

Element for forward reach is not located within 15-inches minimum to 48-inches maximum AFF. 54-1/2" high reach measured to the highest pay phone control.

Measurement: 54.5 inches

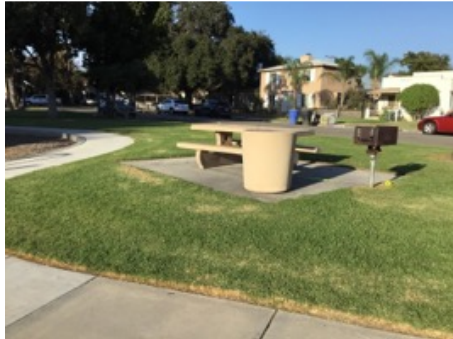
Comment #: GAN-0162

Deficiency: Picnic Tables - Wheelchair seating - Approach

Wheelchair spaces do not adjoin accessible routes. There is a potential disabled seat at the east head of the table, however there is no route of access to the area from walk #3, and no 36" x 60" maneuvering area at the seating location. This table would provide 5% disabled seating, 1 in 9 total, however overall the location is non compliant.

Measurement: 1 count

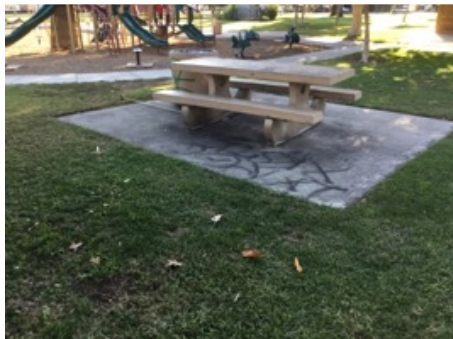
Comment #: GAN-0163

Deficiency: Picnic Tables - Wheelchair seating - Approach

Wheelchair spaces do not adjoin accessible routes. There is a potential disabled seat at the east head of the table, however there is no route of access to the area from walk #3, and no 36" x 60" maneuvering area at the seating location. This table would provide 5% disabled seating, 1 in 9 total, however overall the location is non compliant.

Measurement: 1 count

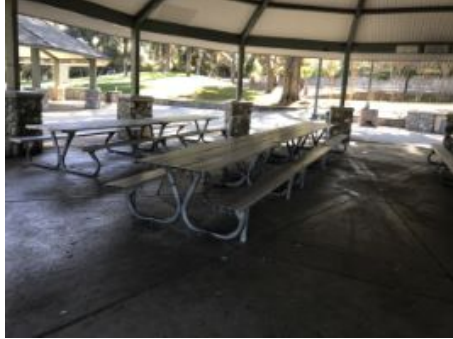
Comment #: GAN-0164

Deficiency: Seating - Picnic Table - Count

There are not a minimum of 5% accessible seats provided at all types of tables. There are 10 tables. The toe and knee clearance at the picnic table is 9-1/2" in depth.

Measurement: 0 count

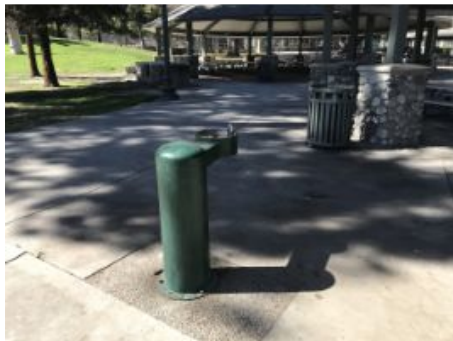
Comment #: GAN-0165

Deficiency: Drinking Fountain - Typical at Both - Pedestrian Protection

Pedestrian protection is not provided at drinking fountains.

Measurement: 0 count

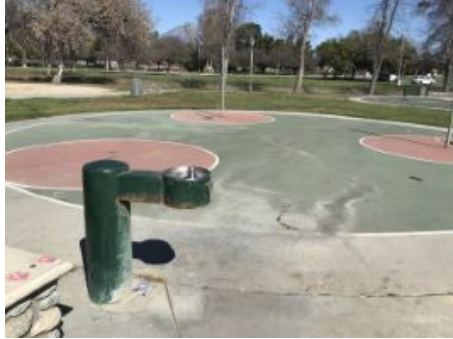
Comment #: GAN-0166

Deficiency: Drinking Fountain - Number Provided - 50 percent

When dispersed, 50% are not compliant for standing and/or 50% are not complaint for wheelchair accessible on the site are .

Measurement: 0 count

Remove/replace so when more than the minimum number of drinking fountains are provided, 50 percent of the total number of drinking fountains shall be provided for standing person, and 50 percent of the total number of drinking fountains shall be provided as wheelchair accessible. Must be evenly distributed for a total of 100% of the drinking fountains. Bottle filling stations will not meet compliance for this item.

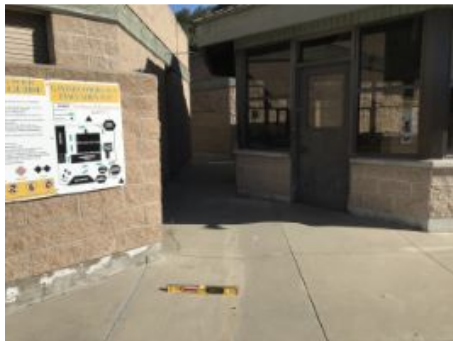
Comment #: GAN-0167

Deficiency: Accessible Route - Slopes - Cross Slope

The cross slope of accessible routes exceeds 1:48 (2.0 %). 2.4% to 5.6% cross slope measured along route from pool to the restrooms.

Measurement: 5.6 % grade

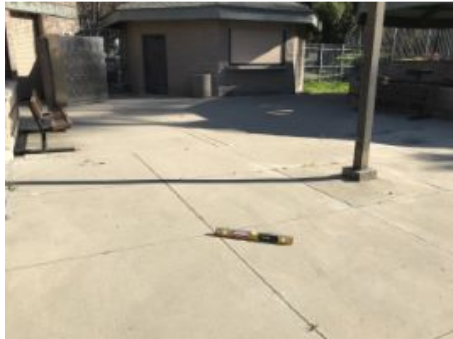
Comment #: GAN-0168

Deficiency: Accessible Route - Slopes - Cross Slope

The cross slope of accessible routes exceeds 1:48 (2.0 %). 2.7% to 4.6% cross slope measured along route from pool to the restrooms.

Measurement: 4.6 % grade

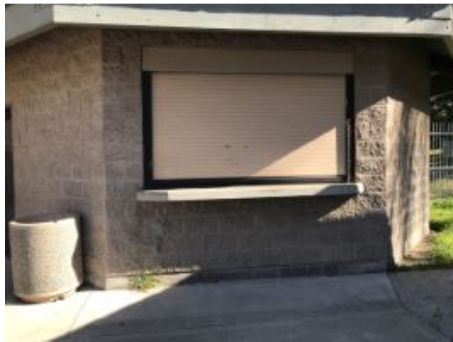
Comment #: GAN-0169

Deficiency: Transaction Counters - Dimensions - Counter Height

The counter surface is higher than the allowable 34 inches above the finished floor. 42-3/4" AFF measured to the concessions counter

Measurement: 42.75 inches

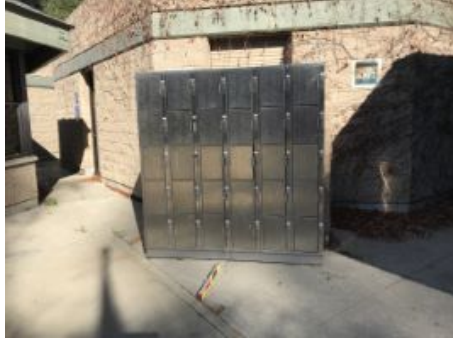
Comment #: GAN-0170

Deficiency: Accessible Route - Slopes - Cross Slope

The cross slope of accessible routes exceeds 1:48 (2.0 %). 3.4% slope measured in the clear ground space at the concessions counter. 4.1% slope measured in the clear ground space at the lockers.

Measurement: 4.1 % grade

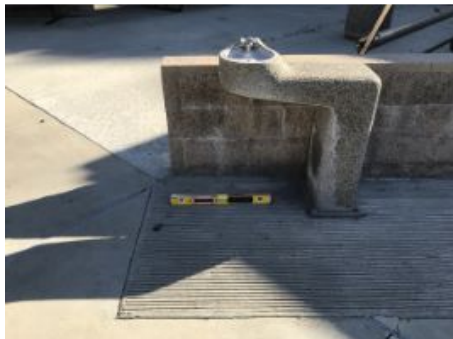
Comment #: GAN-0171

Deficiency: Drinking Fountain - Wheelchair Compliance - Clear Floor Grades

30" x 48" clear floor space slopes exceed 1:48 (2.083%) 3.8% slope measured in clear ground space at the pool drinking fountain.

Measurement: 3.8 % grade

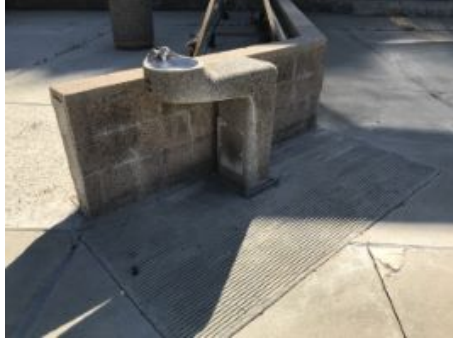
Comment #: GAN-0172

Deficiency: Drinking Fountain - Number Provided - Hi/Lo

One standing and one wheelchair accessible drinking fountain is not provided at each location. Typical two locations.

Measurement: 1 count

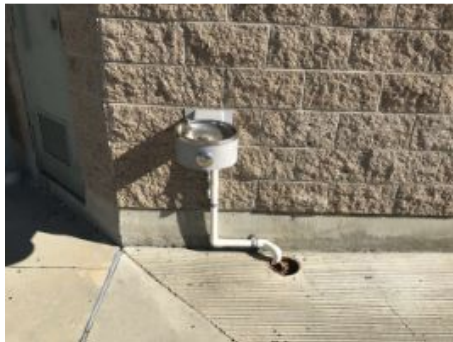
Comment #: GAN-0173

Deficiency: Drinking Fountain - Typical at Both - Pedestrian Protection

Pedestrian protection is not provided at drinking fountains.

Measurement: 0 count

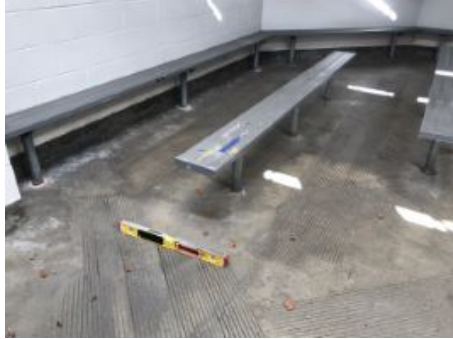
Comment #: GAN-0174

Deficiency: Locker Room - Benches - Clear floor space position

The clear floor space is not positioned for either forward or parallel approach to designated accessible bench. 2.4% to 4.6% slopes measured in the clear floor space at the bench.

Measurement: 0 count

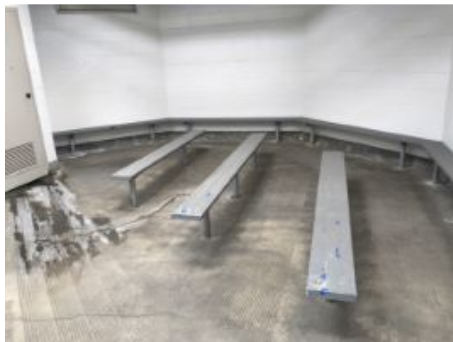
Comment #: GAN-0175

Deficiency: Locker Room - Benches - Bench provided

There is not a bench provided in the locker room. 14-1/4" to 15-1/2" AFF measured to the top of the bench seat. Benches do not have back support.

Measurement: 0 count

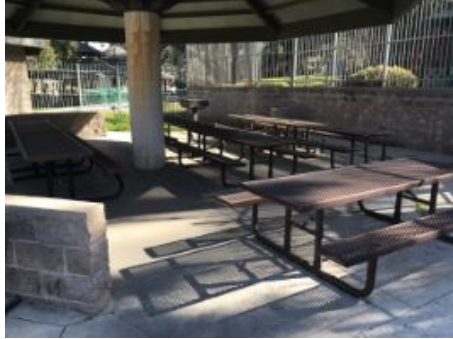
Comment #: GAN-0176

Deficiency: Seating - Picnic Table - Count

There are not a minimum of 5% accessible seats provided at all types of tables. There are 10 tables. The toe and knee clearance at the picnic table is 9-1/2" in depth.

Measurement: 0 count

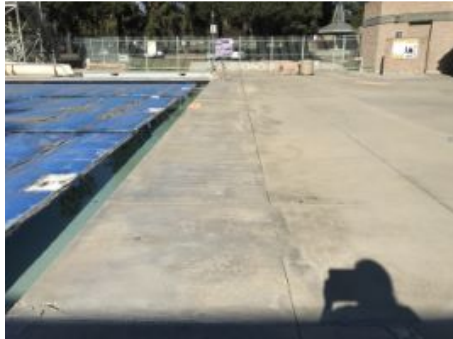
Comment #: GAN-0177

Deficiency: Swimming Pools - Accessible means of entry - Number of means of entry

The pool has more than 300 linear feet of pool wall (perimeter). Two accessible methods of entry are not provided at the swimming pool with more than 300 linear feet of pool wall.

Measurement: 0 count

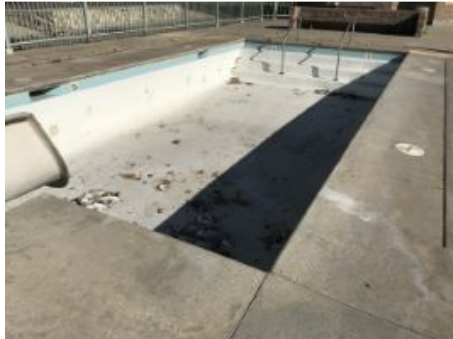
Comment #: GAN-0178

Deficiency: Swimming Pools - Accessible means of entry - Number of means of entry

The pool does not provide an accessible means of entry.

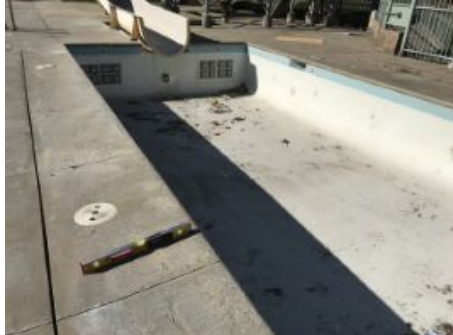
Comment #: GAN-0179

Deficiency: Swimming Pools - Deck Walking Surface - Slope

The running slope is not less than 5.00% (1:20) and/or the cross slope is not less than 2.08% (1:48). 2.6% to 7.0% cross slope measured along the route between the two swimming pools.

Remove and replace surfaces to provide a running slope less than 5.00% (1:20) and a cross slope less than 2.08% (1:48).

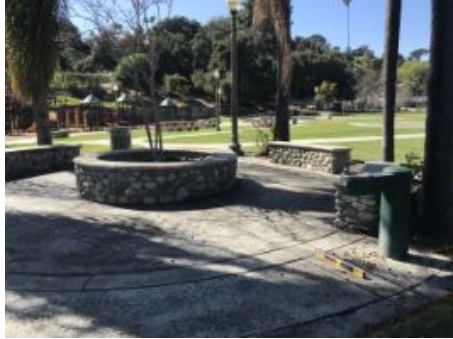
Comment #: GAN-0180

Deficiency: Accessible Route - Slopes - Cross Slope

The cross slope of accessible routes exceeds 1:48 (2.0 %). 2.5% cross slope measured in the clear ground space at the drinking fountain located at the entrance to the park area.

Measurement: 2.5 % grade

Remove and replace walk. Install walk that provides cross slopes at circulation route of 1:48 maximum.

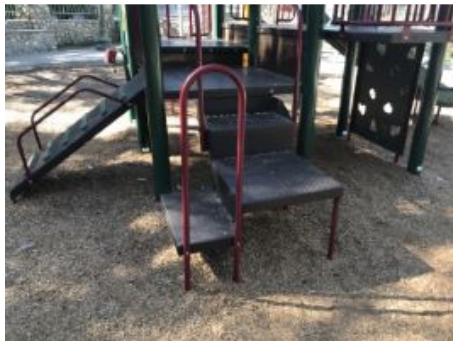
Comment #: GAN-0181

Deficiency: Playgrounds - Transfer System - Contrast Striping

Transfer step does not provide contrast striping, or contrast striping is not compliant.

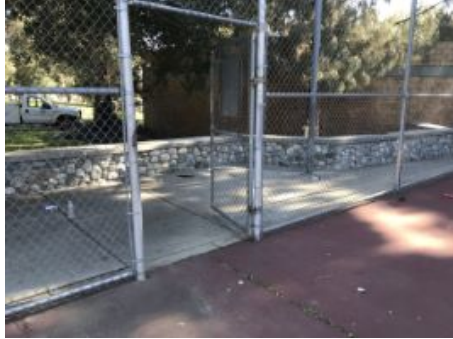
Comment #: GAN-0182

Deficiency: Exterior Doors/Doorways/Gates - Hardware - Smooth Surface

Lower 10 inches of door is not smooth.

Measurement: 2 inches

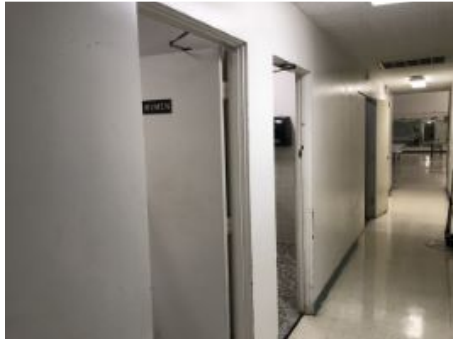
Comment #: GAN-0183

Deficiency: Restroom Doors - Geometric Sign - General

There is no geometric sign on the exterior door to the restrooms.

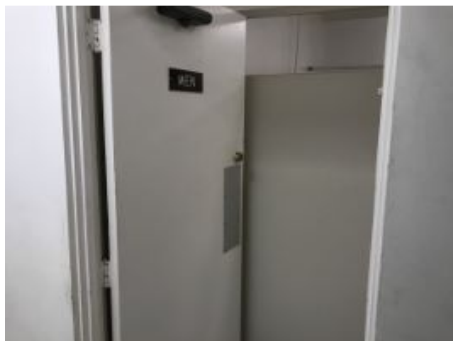
Comment #: GAN-0184

Deficiency: Restroom Doors - Dimensions - Width

The door does not provide a clear open width of minimum 32 inches when open 90 degrees. 30" clear width measured at the men's and women's restroom doors.

Measurement: 30 inches

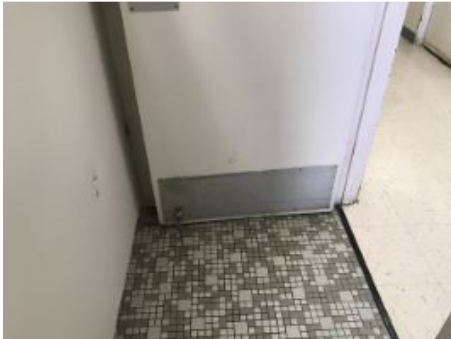
Comment #: GAN-0185

Deficiency: Restroom Doors - Hardware - Smooth Surface

The doorway is not smooth for the bottom ten inches. Door smooth surface blocked by door stops on the push side of the men's and women's restroom doors.

Measurement: 2 inches

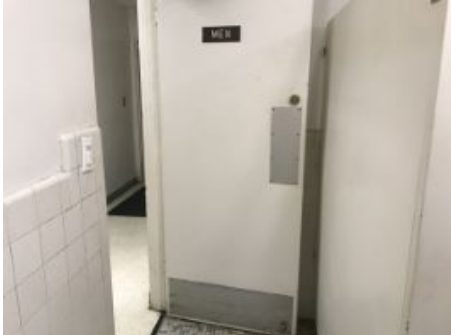
Comment #: GAN-0186

Deficiency: Restroom Doors - Clearances: Front - Pull Side Approach

60 inches of maneuvering space beyond the pull side of the door is not provided. 35" deep maneuvering clearance measured on the pull side of the restroom doors.

Measurement: 35 inches

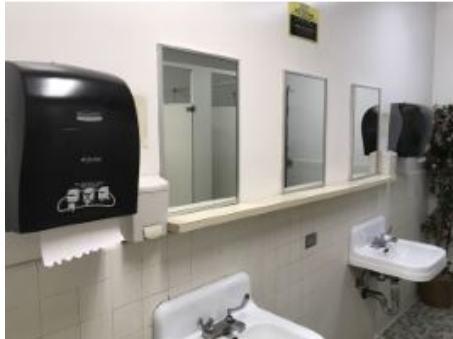
Comment #: GAN-0187

Deficiency: Restroom Interior Space - Amenities - Dispenser Heights

The soap dispenser exceeds the maximum allowable height. 49" AFF measured to the soap dispensers. 54" AFF measured to the paper towel dispensers.

Measurement: 54 inches

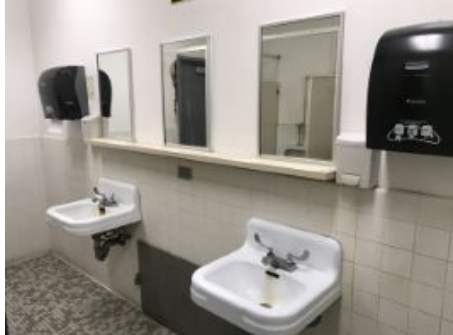
Comment #: GAN-0188

Deficiency: Restroom Interior Space - Amenities - Mirror Height

The mirror height exceeds the allowable 40 inches above the finished floor. 49 -1/2" to 49-3/4" AFF measured to the bottom of the mirror reflective surface.

Measurement: 49.75 inches

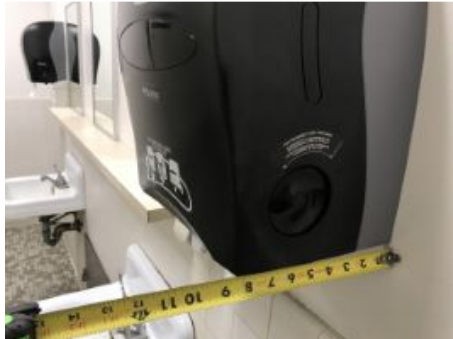
Comment #: GAN-0189

Deficiency: Restroom Interior Space - Protruding Objects - General

Objects in the restroom extend more than 4 inches from the wall with no cane detectable barrier. Paper towel dispenser protrudes 8-1/2" into the accessible route at 54-1/4" AFF. Lavatory protrudes 17-1/2" into the accessible route at 28" AFF.

Measurement: 54.5 inches

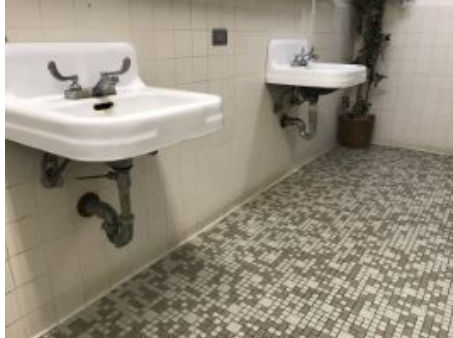
Comment #: GAN-0190

Deficiency: Lavatory - Covered Pipes/Hose Bib - General

The pipe insulation does not cover everything under the sink including water supply lines and hose bib.

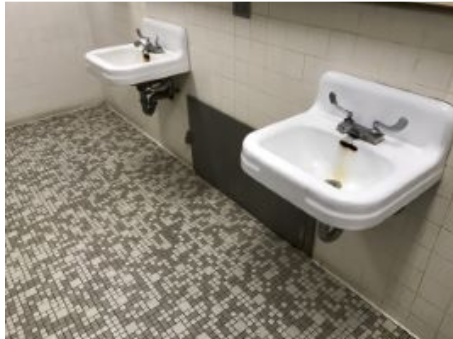
Comment #: GAN-0191

Deficiency: Lavatory - Knee/Toe Clearance - Height

The knee clearance at the lavatory is less than the allowable 29 inches. 25" AFF knee clearance measured at the lavatories. 27" to 27-7/8" AFF measured to the bottom of the front of the lavatories. 17-3/4" deep toe clearance measured at the lavatories.

Measurement: 25 inches

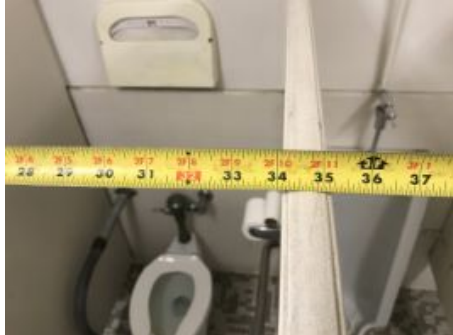
Comment #: GAN-0192

Deficiency: Accessible Toilet Stall - Count - General

Width of stall is less than 60-inches when measured perpendicular to the side wall. A wheelchair accessible stall is not provided in the multi-user restrooms. 34" x 55-3/4" interior dimensions measured at the men's restroom stall. 31-1/4" x 55-1/2" interior dimensions measured at the women's restroom stall.

Compliant grab bars are not provided at the restroom stalls. A door is not

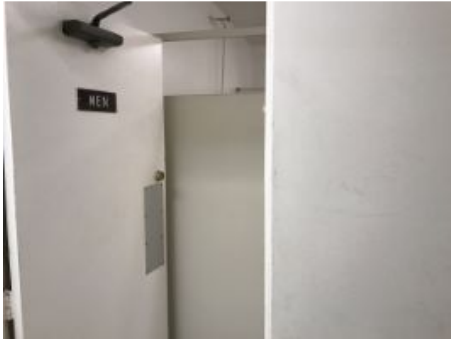
Comment #: GAN-0193

Deficiency: Restroom Doors - Tactile Sign - General

No permanent tactile restroom identification sign has been provided.

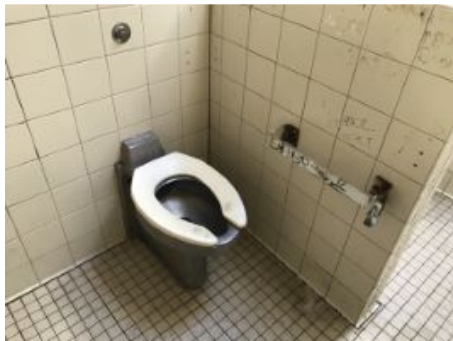
Comment #: GAN-0194

Deficiency: Accessible Toilet Stall - Dispensers - Toilet Paper Location

The toilet paper dispenser is outside of the allowable reach range. Toilet paper dispenser is located behind the front edge of the water closet.

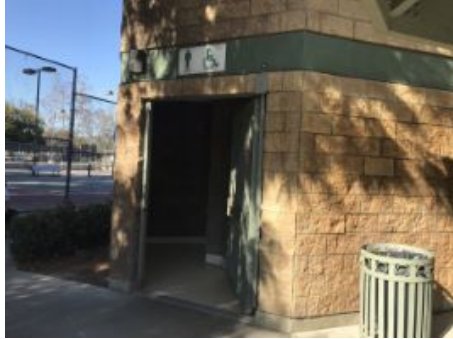
Comment #: GAN-0195

Deficiency: Restroom Doors - Geometric Sign - General

There is no geometric sign on the exterior door to the restrooms.

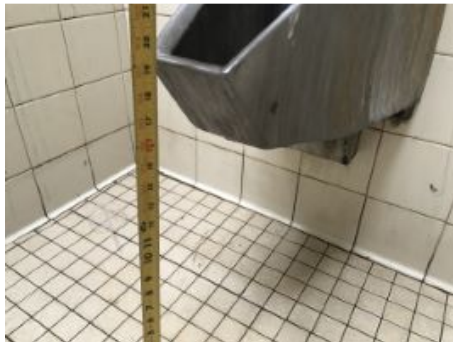
Comment #: GAN-0196

Deficiency: Urinal - Rim Dimensions - Height

The urinal rim height is greater than the allowable 17 inches AFF.

Measurement: 19.5 inches

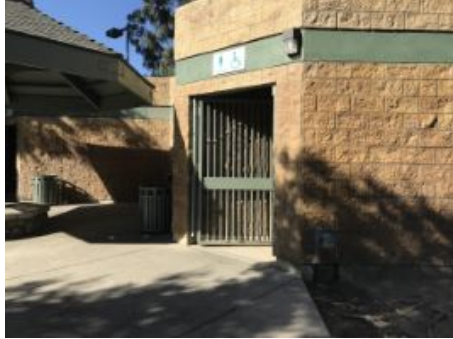
Comment #: GAN-0197

Deficiency: Restroom Doors - Tactile Sign - General

No permanent tactile and braille restroom identification sign has been provided with ISA.

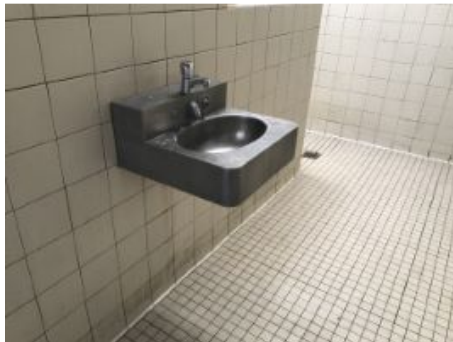
Comment #: GAN-0198

Deficiency: Restroom Interior Space - Protruding Objects - General

Objects in the restroom extend more than 4 inches from the wall with no cane detectable barrier. Lavatories protrude 17-3/4" into the accessible route at 29 -1/4" AFF.

Measurement: 17.75 inches

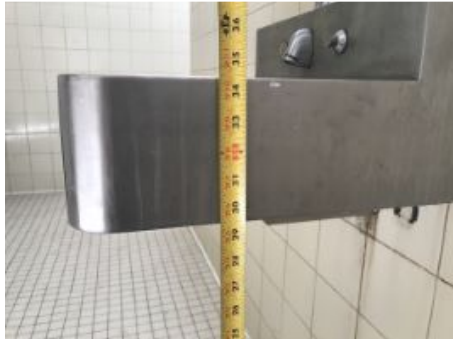
Comment #: GAN-0199

Deficiency: Lavatory - Height - General

The height of the lavatory counter surface exceeds the allowable 34 inches AFF.

Measurement: 34.25 inches

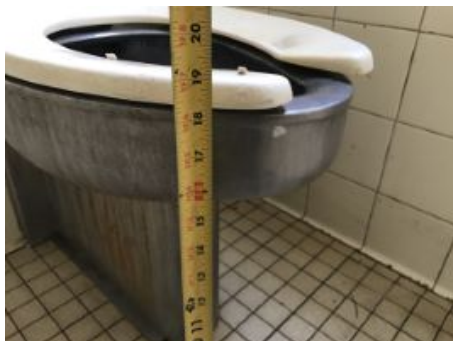
Comment #: GAN-0200

Deficiency: Accessible Toilet Stall - Water Closet - Height

The toilet seat exceeds the allowable 17 - 19 inches AFF measured to the top of the seat.

Measurement: 19.25 inches

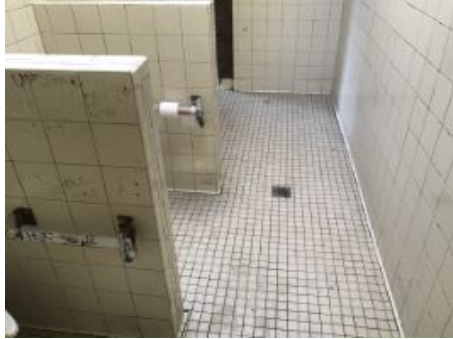
Comment #: GAN-0201

Deficiency: Restroom Access - Dimensions - Width

The clear width to the accessible stall is less than 44-inches clear.

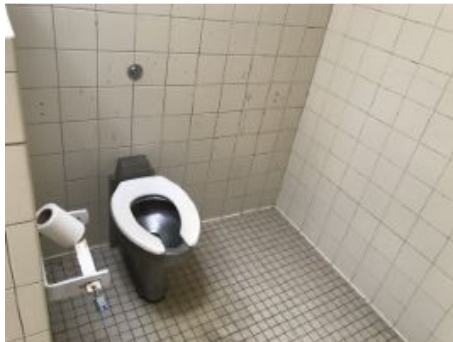
Comment #: GAN-0202

Deficiency: Accessible Toilet Stall - Dimensions - No Partitions

The accessible stall does not provide toe clearance and/or the minimum allowable clear width. 58-1/4" wide clearance measured at the wheelchair accessible stalls.

Measurement: 58.25 inches

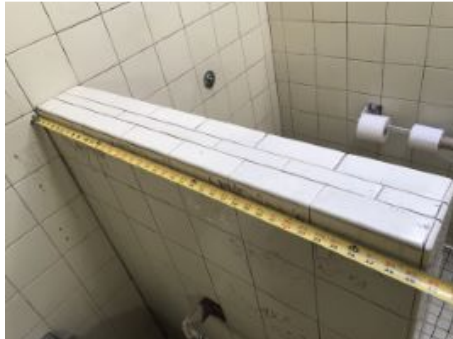
Comment #: GAN-0203

Deficiency: Accessible Toilet Stall - Grab Bars - General

No side wall grab bar is installed. Side wall partition extends 39-1/2" from the rear wall. Side wall does not extend far enough for a grab bar to be installed a minimum of 54" from the rear wall.

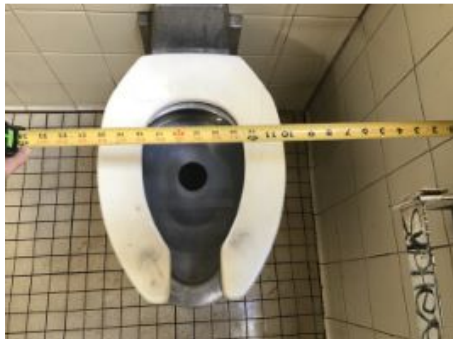
Comment #: GAN-0204

Deficiency: Accessible Toilet Stall - Water Closet - Location

The water closet is not a compliant distance from the adjacent wall. Water closet centerlines measured 15-1/4" and 19-1/4" from the side wall.

Measurement: 15.25 inches

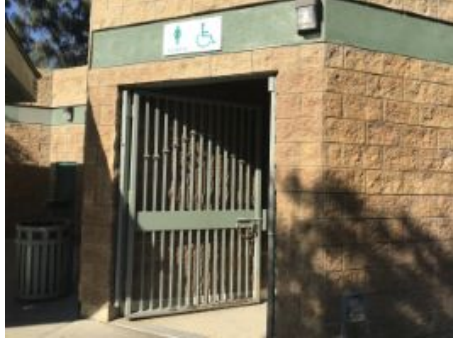
Comment #: GAN-0205

Deficiency: Restroom Doors - Geometric Sign - General

There is no geometric sign on the exterior door to the restrooms.

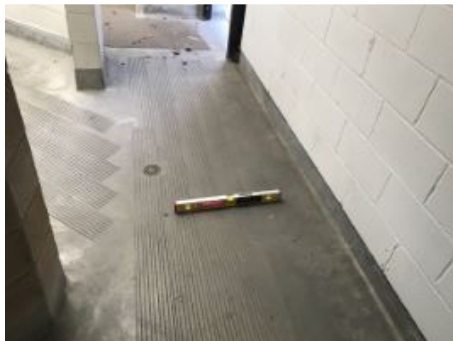
Comment #: GAN-0206

Deficiency: Restroom Interior Space - Floor Surface - Slopes

The floor surface has slopes that exceeds the allowable 1:48 (2%) grade in any direction. 2.7% to 3.3% cross slope measured along the route from the restroom entrance to the showers and lavatories.

Measurement: 3.3 % grade

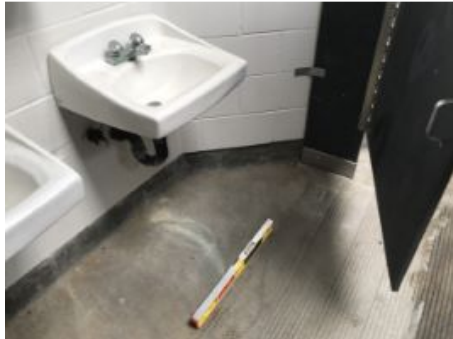
Comment #: GAN-0207

Deficiency: Lavatory - Clear Floor Space - General

Clear floor space provided at the lavatory is not level. 3.2% to 3.7% slopes measured in the clear floor space at the accessible lavatory.

Measurement: 3.7 % grade

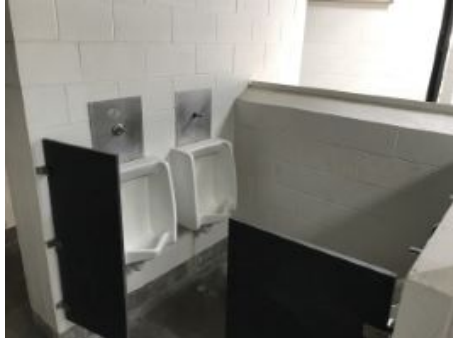
Comment #: GAN-0208

Deficiency: Urinal - Clear Floor Space - General

A clear floor space minimum 30 inches by 48 inches is not provided at the urinal.

Measurement: 21.5 inches

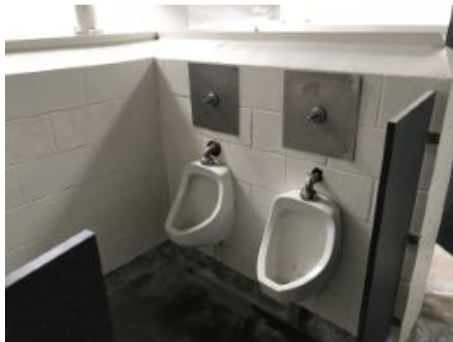
Comment #: GAN-0209

Deficiency: Urinal - Rim Dimensions - Height

The urinal rim height is greater than the allowable 17 inches AFF. 21-1/2" AFF measured to the urinal rim.

Measurement: 21.5 inches

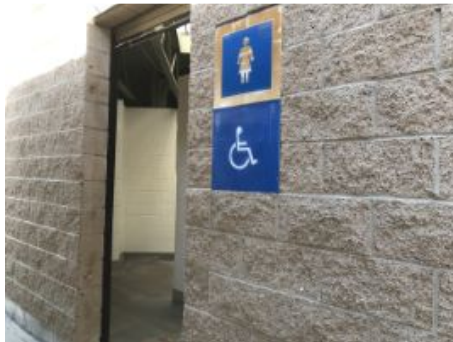
Comment #: GAN-0210

Deficiency: Restroom Doors - Tactile Sign - General

No permanent tactile restroom identification sign has been provided.

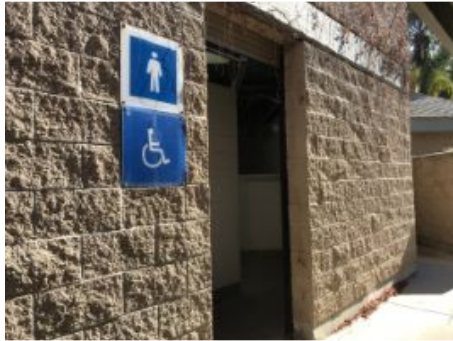
Comment #: GAN-0211

Deficiency: Restroom Doors - Geometric Sign - General

There is no geometric sign on the exterior door to the restrooms.

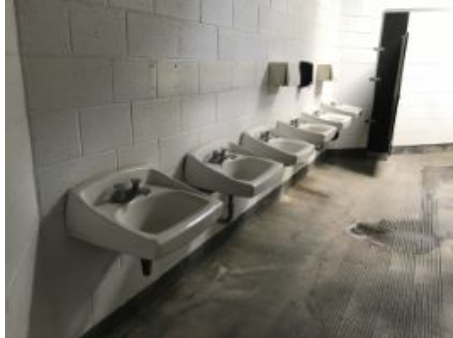
Comment #: GAN-0212

Deficiency: Restroom Interior Space - Amenities - Soap Dispenser Height

The soap dispenser exceeds the maximum allowable height. Also exceeds ADA forward approach with 44-inches minimum reach over lavatory.

Measurement: 45.5 inches

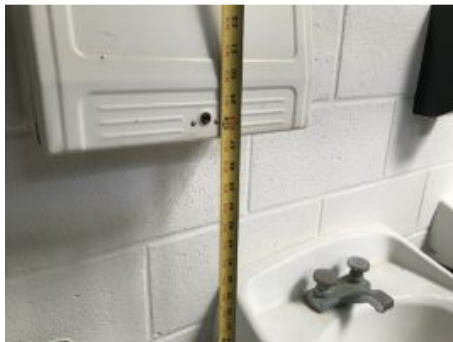
Comment #: GAN-0213

Deficiency: Restroom Interior Space - Amenities - Paper Towel Height

The paper towel dispenser exceeds the maximum allowable height.

Measurement: 45.5 inches

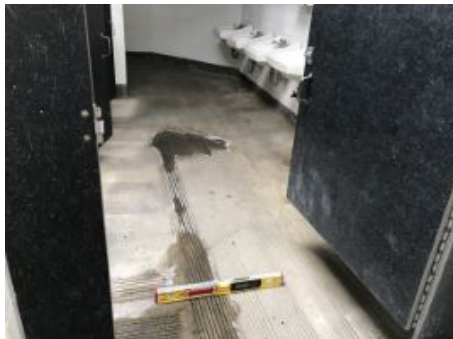
Comment #: GAN-0214

Deficiency: Restroom Interior Space - Floor Surface - Slopes

The floor surface has slopes that exceeds the allowable 1:48 (2%) grade in any direction. 2.4% to 7.2% cross slope measured along the floor surface in front of the lavatories.

Measurement: 7.2 % grade
