APPENDIX A

FACILITY ASSESSMENT PHOTO REPORTS

CITY HALL

1.0 Site Assessment

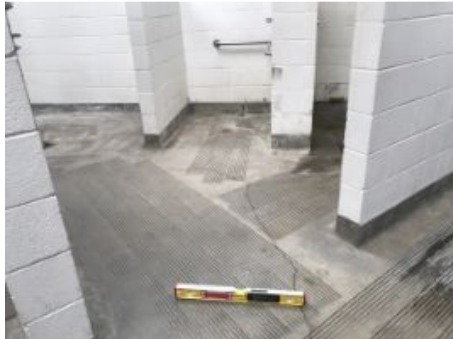
Comment #: GAN-0215

Deficiency: Restroom Interior Space - Floor Surface - Slopes

The floor surface has slopes that exceeds the allowable 1:48 (2%) grade in any direction. 3.0% to 4.2% cross slope measured along the route to the showers.

Measurement: 4.2 % grade

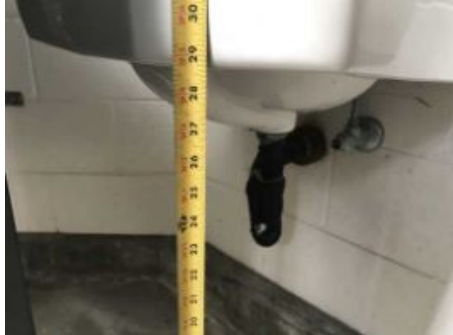
Comment #: GAN-0216

Deficiency: Lavatory - Knee/Toe Clearance - Height

The knee clearance at the lavatory is less than the allowable 29 inches. 25" to 26" AFF knee clearance measured at the lavatory. 28-3/4" AFF to the bottom of the lavatory.

Measurement: 28.75 inches

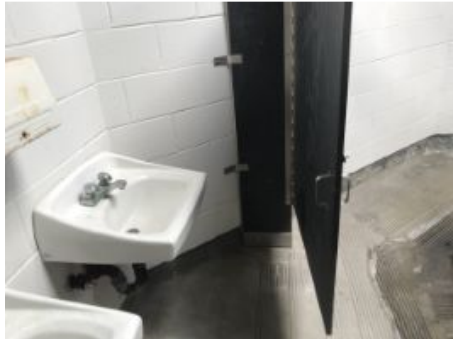
Comment #: GAN-0217

Deficiency: Accessible Toilet Stall - Door Clearances - Clear Floor Space

Door swings into clear floor space of lavatory.

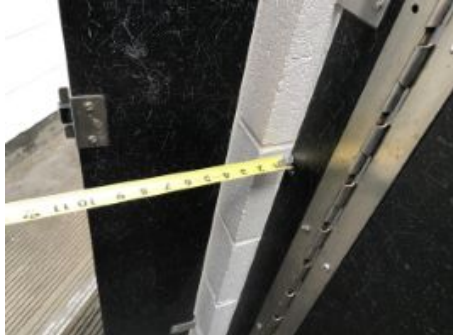
Comment #: GAN-0218

Deficiency: Accessible Toilet Stall - Door Pull Side - Strike Side

The accessible stall door does not provide 18-inch strike side clearance for a depth of 60-inches minimum on pull side of stall door.

Measurement: 10 inches

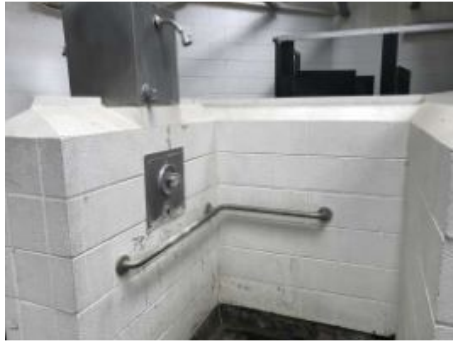
Comment #: GAN-0219

Deficiency: Accessible Shower - Controls - Location

Shower controls are not located in correct location. The shower spray unit does not include a 59" long hose. Shower controls require tight grasping and twisting of the wrist to operate.

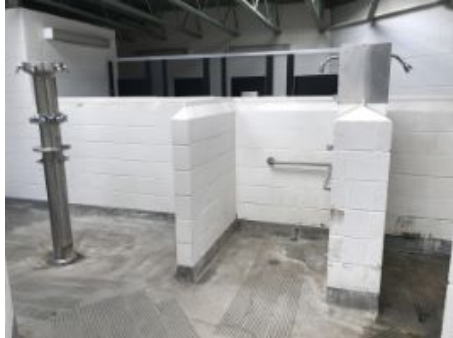
Comment #: GAN-0220

Deficiency: Accessible Shower - Roll-In - General

An accessible shower is not provided. 41-3/4" x 47-1/2" interior dimensions measured at the roll-in shower.

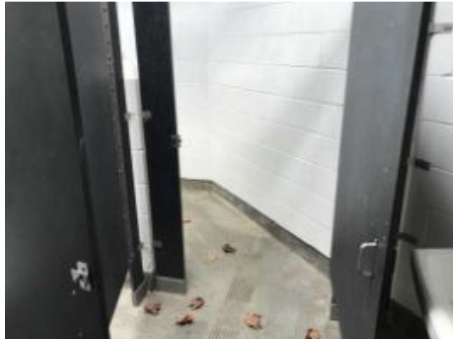
Comment #: GAN-0221

Deficiency: Accessible Toilet Stall - Count - General

A wheelchair stall is not provided in a multi-user restroom. A compliant wheelchair accessible stall is not provided in the restroom. Wheelchair stall is 48" deep before it begins narrowing to a point. 10" maneuvering clearance measured adjacent to the latch on the pull side of the men's wheelchair stall.

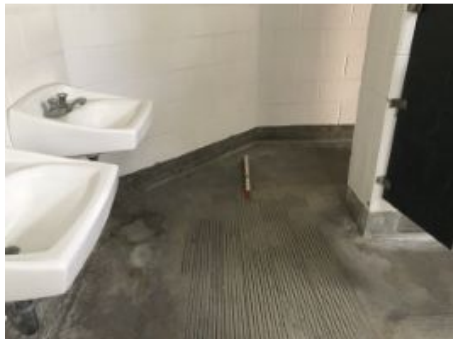
Comment #: GAN-0222

Deficiency: Restroom Interior Space - Floor Surface - Slopes

The floor surface has slopes that exceeds the allowable 1:48 (2%) grade in any direction. 2.5% cross slope measured in turn along the route to the lavatories.

Measurement: 2.5 % grade

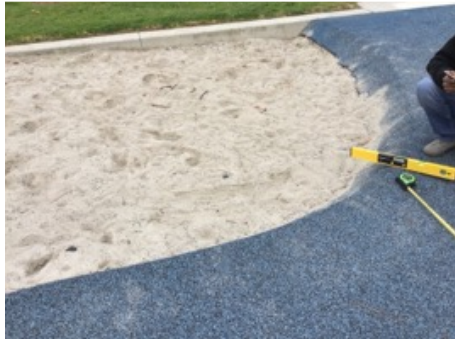
Comment #: TGP-01

Deficiency: Accessible Route - Change in Level - Warning Curbs

Warning curb / guide rail is not installed at locations where there is an elevation change of more than 4" above finish grade.

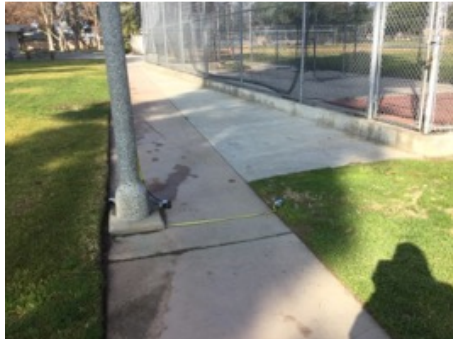
Comment #: TGP-03

Deficiency: Accessible Route - Clear Width - General

Accessible route widths do not provide minimum 48-inches clear.

Measurement: 40 inches

Replace walks to provide a clear width of 48 inches (1219 mm) minimum. When, because of right-of-way restrictions, natural barriers or other existing conditions, the enforcing agency determines that compliance with the 48-inch (1219 mm) clear sidewalk width would create an unreasonable hardship, the clear width may be reduced to 36 inches (914 mm).

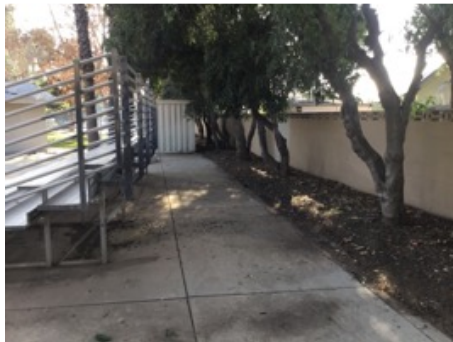
Comment #: TGP-04

Deficiency: Accessible Route - Protrusion - Height

Objects in the path of travel extend more than 4 inches from the wall with no cane detectable barrier.

Measurement: 59 inches

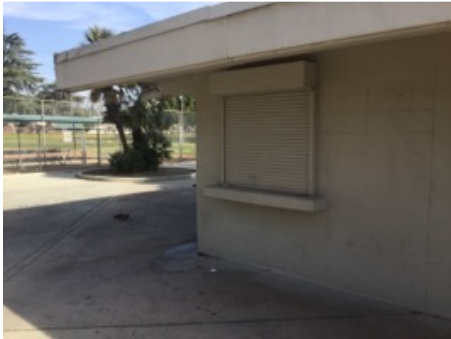
Comment #: TGP-05

Deficiency: Accessible Route - Protrusion - Depth

Objects in the path of travel extend more than 4 inches from the wall with no cane detectable barrier.

Measurement: 11 inches

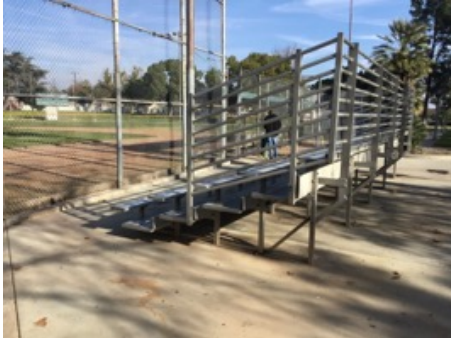
Comment #: TGP-06

Deficiency: Accessible Route - Protrusion - Height

Objects in the path of travel extend more than 4 inches from the wall with no cane detectable barrier.

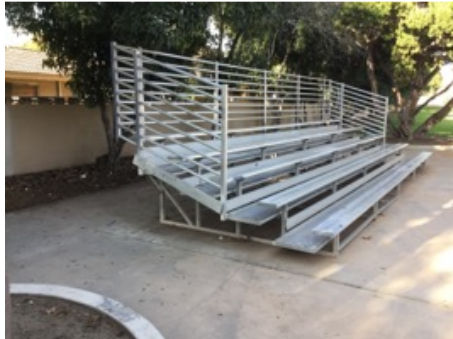
Comment #: TGP-07

Deficiency: Accessible Route - Protrusion - Height

Objects in the path of travel extend more than 4 inches from the wall with no cane detectable barrier.

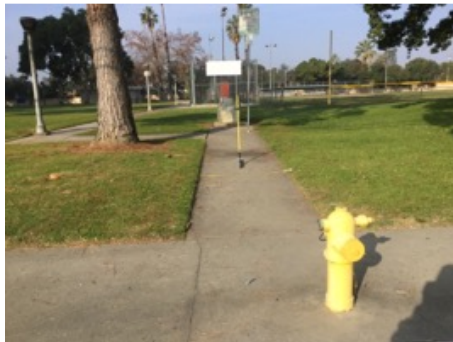
Comment #: TGP-08

Deficiency: Accessible Route - Slopes - Running Slope

The slope in the direction of travel exceeds the allowable 5%.

Measurement: 5.8 % grade

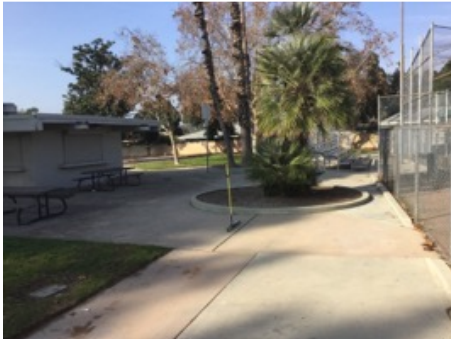
Comment #: TGP-09

Deficiency: Accessible Route - Slopes - Running Slope

The slope in the direction of travel exceeds the allowable 5%.

Measurement: 7 % grade

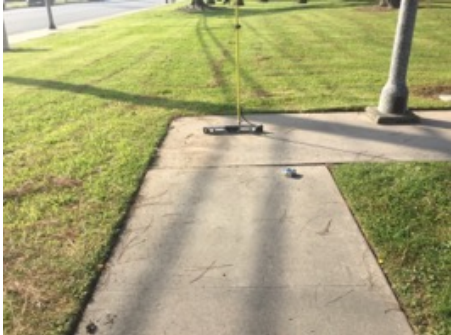
Comment #: TGP-10

Deficiency: Accessible Route - Slopes - Cross Slope

The cross slope of accessible routes exceeds 1:48 (2.0 %).

Measurement: 2.8 % grade

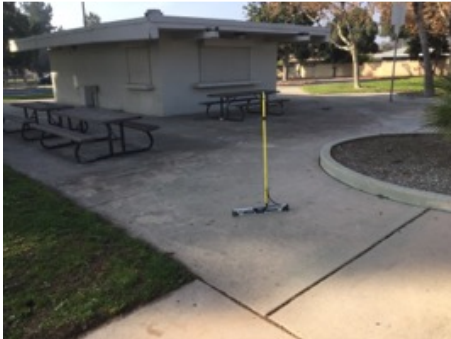
Comment #: TGP-11

Deficiency: Accessible Route - Slopes - Cross Slope

The cross slope of accessible routes exceeds 1:48 (2.0 %).

Measurement: 4.2 % grade

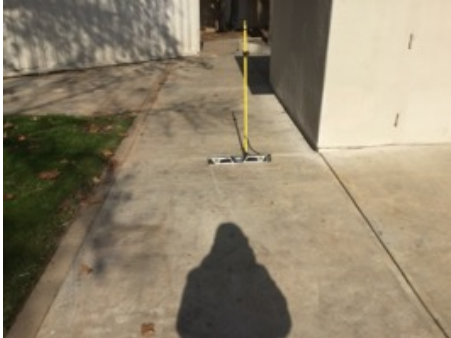
Comment #: TGP-12

Deficiency: Accessible Route - Slopes - Cross Slope

The cross slope of accessible routes exceeds 1:48 (2.0 %).

Measurement: 4 % grade

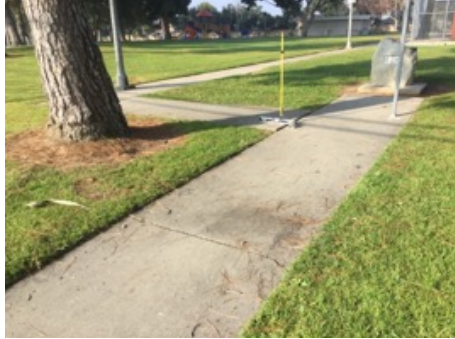
Comment #: TGP-13

Deficiency: Accessible Route - Vertical Displacment - Height

Accessible route has multiple locations where changes in level over ¼” vertical or ½” beveled occur.

Measurement: .75 inches

Replace/grind locations where changes in elevation occur. Changes in level of ¼” high maximum shall be permitted to be vertical and without edge treatment.

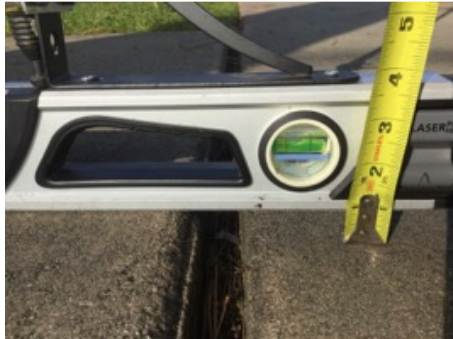
Comment #: TGP-15

Deficiency: Accessible Route - Vertical Displacement - Bevelment Slope

Accessible route has multiple locations where changes in level over 1/4" vertical or 1/2" beveled occur.

Measurement: .75 inches

Replace/grind locations where changes in elevation occur. Changes in level of 1/4" high maximum shall be permitted to be vertical and without edge treatment.

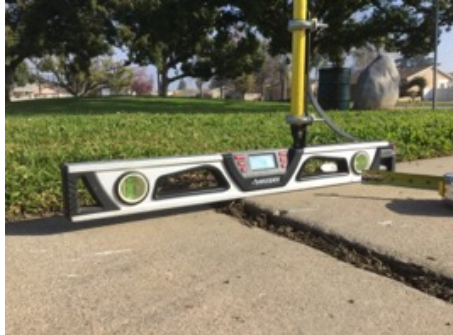
Comment #: TGP-16

Deficiency: Accessible Route - Vertical Displacement - Bevelment Slope

Accessible route has multiple locations where changes in level over 1/4" vertical or 1/2" beveled occur.

Measurement: .75 inches

Replace/grind locations where changes in elevation occur. Changes in level of 1/4" high maximum shall be permitted to be vertical and without edge treatment.

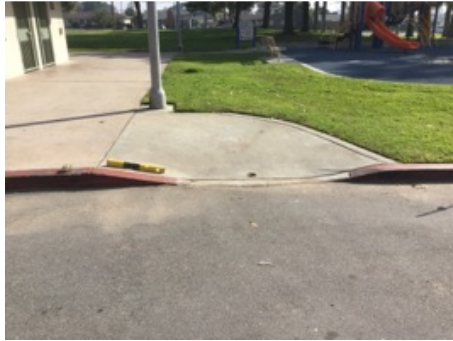
Comment #: TGP-17

Deficiency: At Grade Transitions - Perpendicular Curb Ramp - Flares (Left)

The slopes of the flared sides of the perpendicular ramp are steeper than 1:10 (10%).

Measurement: 18.6 % grade

Remove and replace the curb ramp so that the provided flares are not steeper than the allowable 1:10 (10%) grade.

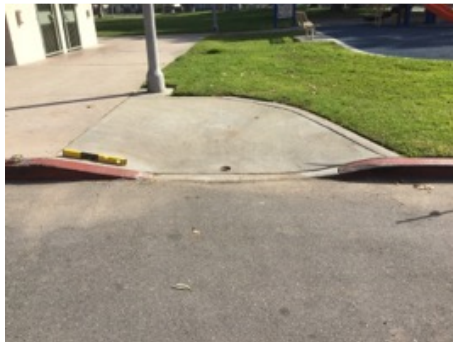
Deficiency: At Grade Transitions - Perpendicular Curb Ramp - Detectable Warning Surface

Install detectable warnings at all curb ramps where missing.

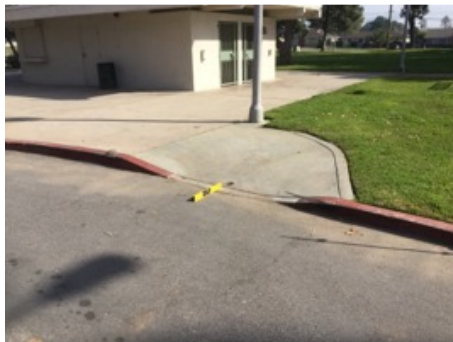
Comment #: TGP-19

Deficiency: At Grade Transitions - Perpendicular Curb Ramp - Grade Breaks

The grade breaks at both the top and bottom of the curb ramp run are not flush.

Measurement: 4 count

Replace curb ramp.

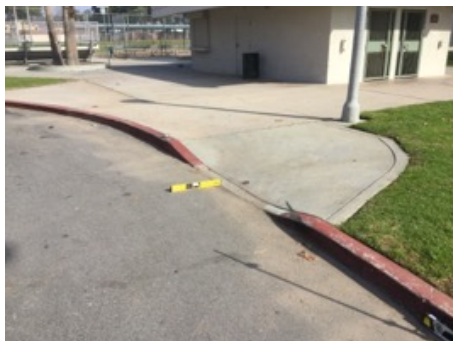
Comment #: TGP-20

Deficiency: At Grade Transitions - Perpendicular Curb Ramp - Counter Slope

The counter slope of the adjoining gutter/road adjacent to and within 24 inches (610 mm) of the curb ramp is steeper than 1:20 (5.0 % grade).

Measurement: 5.9 % grade

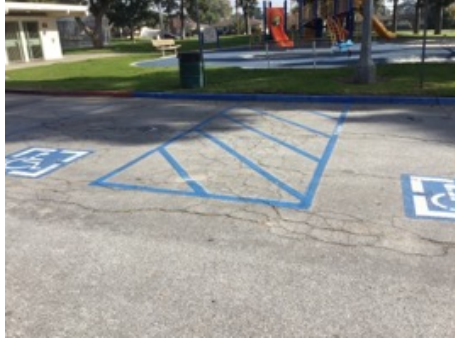
Comment #: TGP-21

Deficiency: Parking - Access Aisle Markings - Width

The marked access aisle is less than 60 inches (5 ft. or 1524 mm) wide for a car stall and/or 144 inches for a van stall.

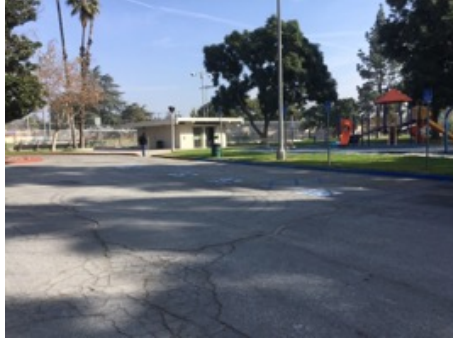
Comment #: TGP-23

Deficiency: Parking - Accessible Route - Adjacent

Access aisle is not located to an accessible route.

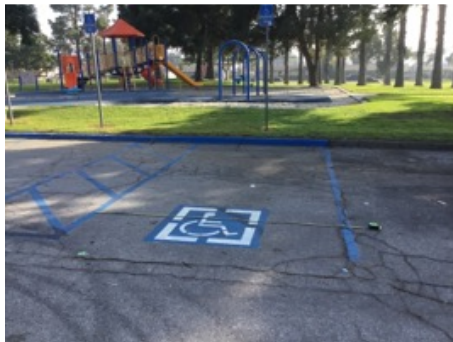
Comment #: TGP-24

Deficiency: Parking - Accessible Stall - Length

The accessible van/car stall is less than 216 inches (18 ft. or 5486 mm) long.

Measurement: 218 inches

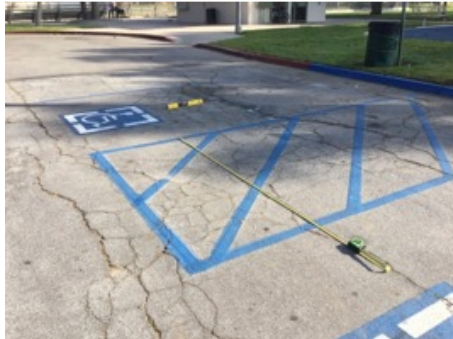
Comment #: TGP-25

Deficiency: Parking - Accessible Stall - Van Stall Width

The van stall is not a minimum 144 inches wide, OR 108 inches when the adjacent access aisle is minimum 96 inches wide.

Measurement: 91 inches

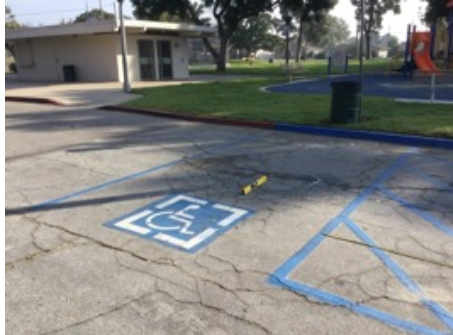
Comment #: TGP-26

Deficiency: Parking - Accessible Stall - Slopes

The slope of the van/car stall in any direction exceeds 1:48 (2.0%) grade.

Measurement: 2.8 % grade

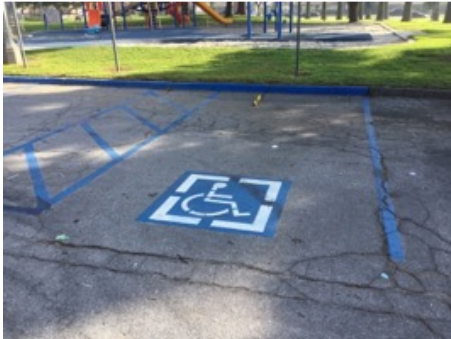
Comment #: TGP-29

Deficiency: Parking - Accessible Stall - Slopes

The slope of the van/car stall in any direction exceeds 1:48 (2.0%) grade.

Measurement: 3.1 % grade

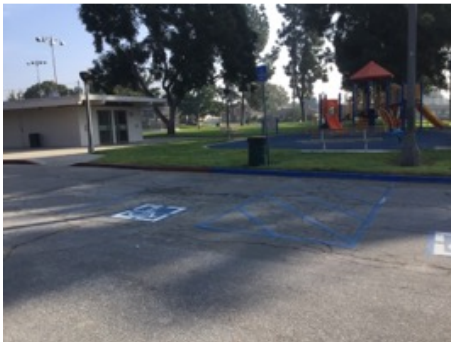
Comment #: TGP-30

Deficiency: Parking - General Parking - Van Stall Space Count

One access space in every six access spaces (or portion of 6) is not van accessible.

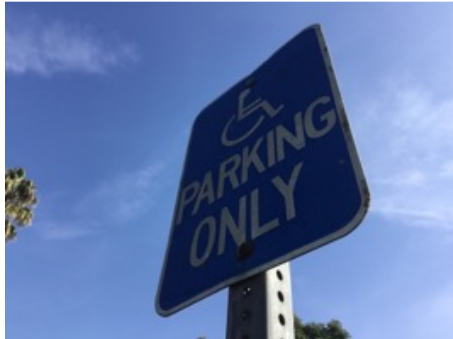
Comment #: TGP-33

Deficiency: Parking - Signage - Finish

The parking identification sign does not have a reflective finish.

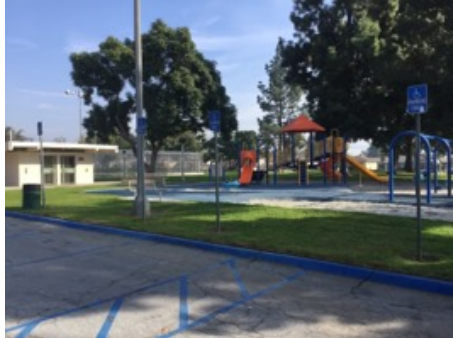
Comment #: TGP-34

Deficiency: Parking - Signage - Minimum Fine

The parking identification sign does not includes the text "Minimum Fine \$250" below the ISA.

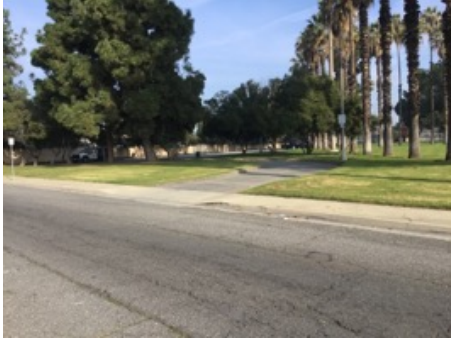
Comment #: TGP-35

Deficiency: Parking - Tow Away Sign - General

There is no "Unauthorized Parking Sign" sign at the entrance to the off-street parking.

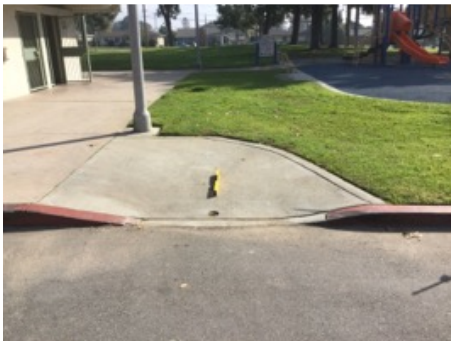
Comment #: TGP-36

Deficiency: Ramps - Slopes - Running Slope

The running slope of the ramp is steeper than 1:12 (8.33%).

Measurement: 6.4 % grade

Remove and replace the ramp. The running slope of the curb ramp segments shall be in-line with the direction of sidewalk travel. Ramp runs shall have a running slope not steeper than 1:12.

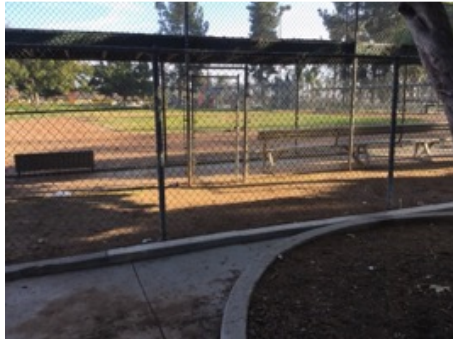
Comment #: TGP-37

Deficiency: Area of Sport Activity - Accessible Route - Connection

An accessible route is not provided to the boundary of each area of sport activity.

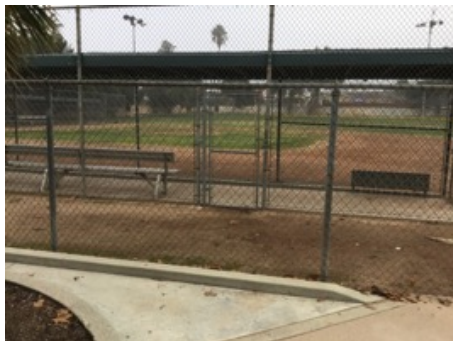
Comment #: TGP-38

Deficiency: Area of Sport Activity - Accessible Route - Connection

An accessible route is not provided to the boundary of each area of sport activity.

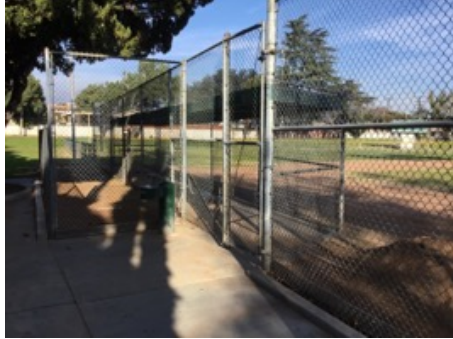
Comment #: TGP-39

Deficiency: Area of Sport Activity - Team or player seating - Accessible Route

An accessible routes to team or player seating areas serving areas of sport activity is not provided.

While the use of platform lifts is allowed, ramps are recommended to provide access to player seating areas serving an area of sport activity.

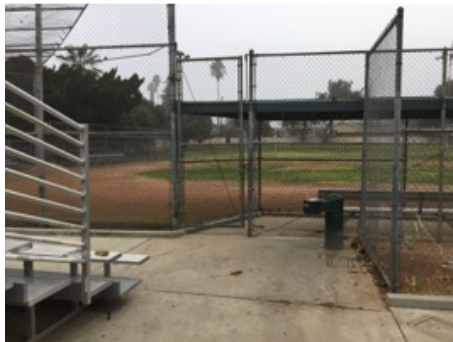
Comment #: TGP-40

Deficiency: Area of Sport Activity - Team or player seating - Accessible Route

An accessible routes to team or player seating areas serving areas of sport activity is not provided.

While the use of platform lifts is allowed, ramps are recommended to provide access to player seating areas serving an area of sport activity.

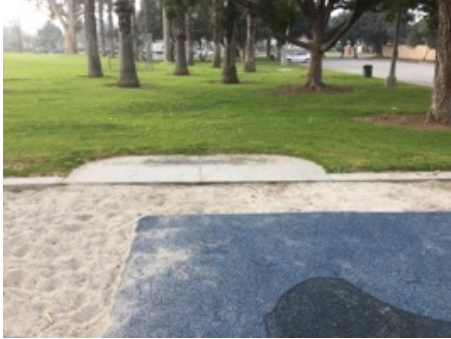
Comment #: TGP-43

Deficiency: Playgrounds - Accessible Route - Site Amenities

An accessible path of travel from the playground is not provided to restrooms, drinking fountains, other accessible areas, and public telephones (if available) on site.

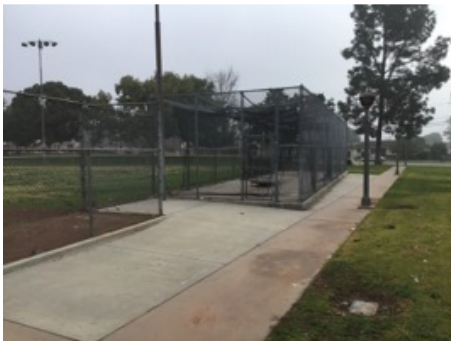
Comment #: TGP-44

Deficiency: Area of Sport Activity - Accessible Route - Connection

An accessible route is not provided to the boundary of each area of sport activity.

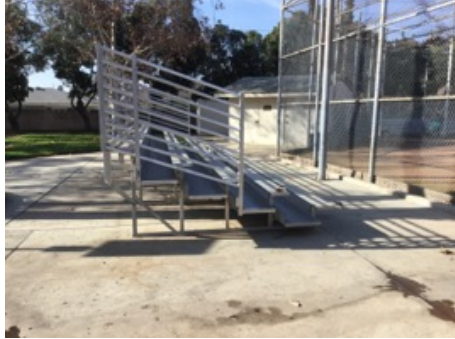
Comment #: TGP-45

Deficiency: Bleachers - Wheelchair Seating - Location

Wheelchair spaces are not an integral part of bleacher seating.

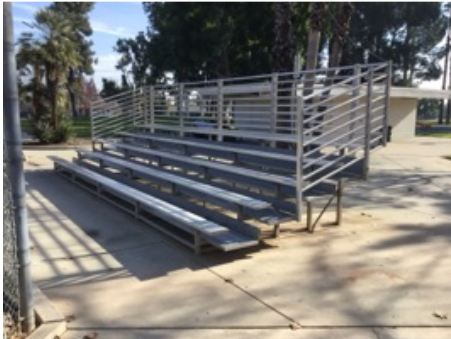
Comment #: TGP-47

Deficiency: Bleachers - Wheelchair Seating - Count

There are not sufficient # of wheelchair spaces at each set of bleachers.

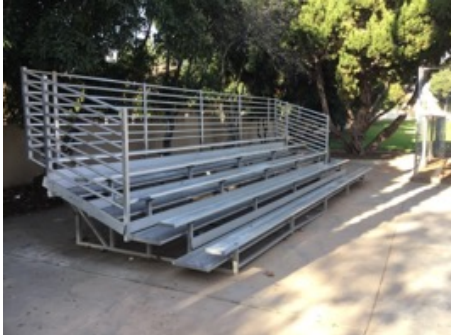
Comment #: TGP-48

Deficiency: Bleachers - Wheelchair Seating - Count

There are not sufficient # of wheelchair spaces at each set of bleachers.

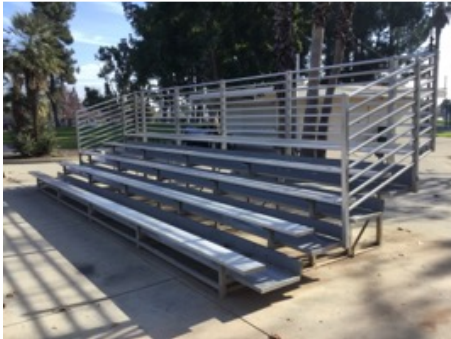
Comment #: TGP-49

Deficiency: Bleachers - Wheelchair Seating - Companion Seats

Companion seats are provided adjacent to each wheelchair space.

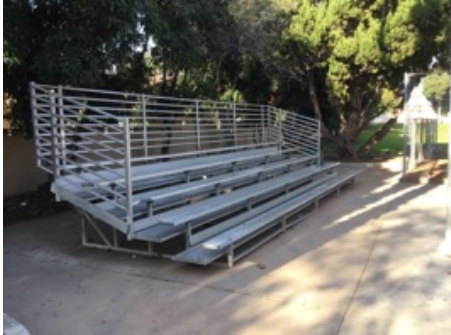
Comment #: TGP-50

Deficiency: Bleachers - Wheelchair Seating - Companion Seats

Companion seats are provided adjacent to each wheelchair space.

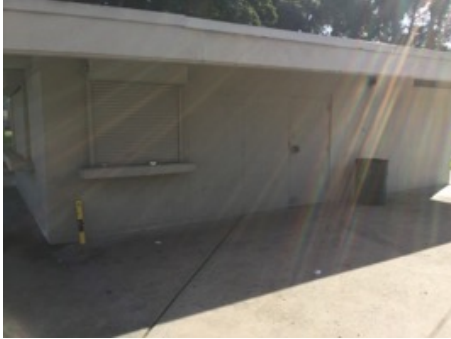
Comment #: TGP-51

Deficiency: Condiments/Amenities - Condiments Counter - Counter Height

The counter surface is higher than the allowable 34 inches above the finished floor.

Measurement: 40 inches

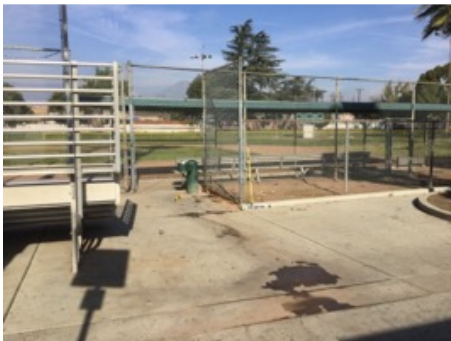
Comment #: TGP-52

Deficiency: Drinking Fountain - Number Provided - Hi/Lo

One standing and one wheelchair accessible drinking fountain is not provided at each location.

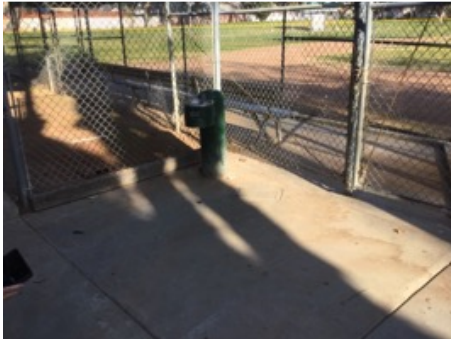
Comment #: TGP-53

Deficiency: Drinking Fountain - Number Provided - Hi/Lo

One standing and one wheelchair accessible drinking fountain is not provided at each location.

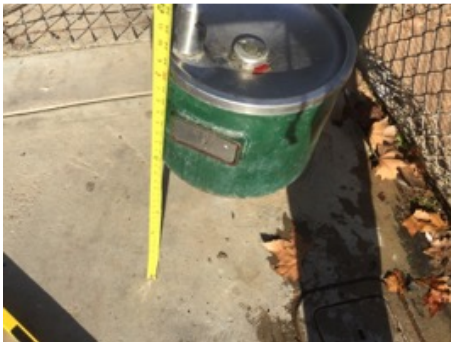
Comment #: TGP-54

Deficiency: Drinking Fountain - Standing Person Unit - Height

Spout outlets of drinking fountains for standing persons is not located between 38" minimum and 43 " maximum above the finish floor or ground.

Measurement: 34 inches

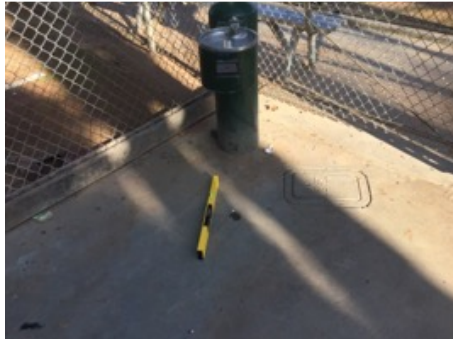
Comment #: TGP-57

Deficiency: Drinking Fountain - Wheelchair Compliance - Clear Floor Grades

30" x 48" clear floor space slopes exceed 1:48 (2.083%)

Measurement: 2.1 % grade

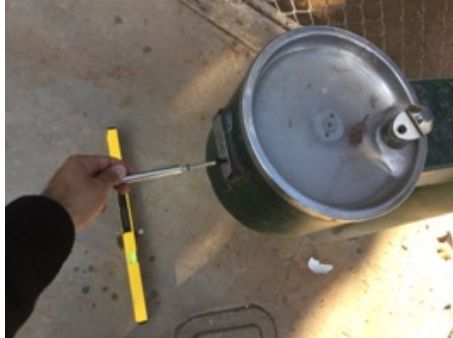
Comment #: TGP-58

Deficiency: Drinking Fountain - Wheelchair Compliance - Operable Parts-Force

Is the force required to activate operable parts 5 pounds maximum?

Measurement: 7.5 pound

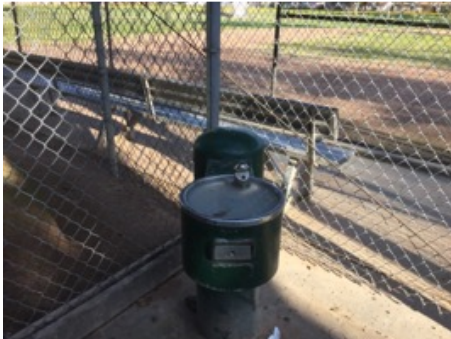
Comment #: TGP-59

Deficiency: Drinking Fountain - Wheelchair Compliance - Water Flow

The spout does not provide a flow of water 4 high minimum.

Measurement: 3 inches

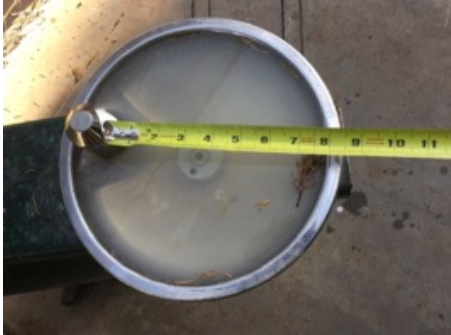
Comment #: TGP-60

Deficiency: Drinking Fountain - Wheelchair Compliance - Operable Part-Location

The flow of water is not activated by a front or side mounted manually operated system that is located within 6" of the front edge of the fountain or an automatic electronically controlled device?

Measurement: 8.5 inches

Replace unit with on that allows the flow of water to be activated by a manually operated system that is front mounted or side mounted and located within 6 inches (152 mm) of the front edge of the fountain or an automatic electronically controlled device.

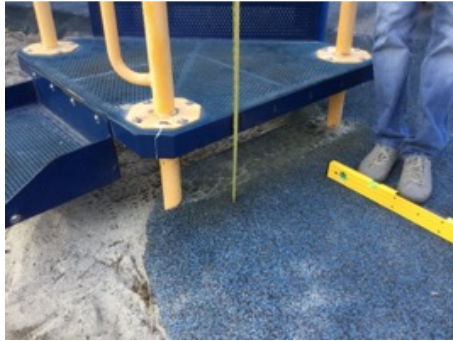
Comment #: TGP-63

Deficiency: Playgrounds - Transfer System - Transfer Platform-Height

Transfer platform exceeds maximum 11" and does not provide a level 30" x 48" clear floor space centered 24" for a parallel approach.

Measurement: 12

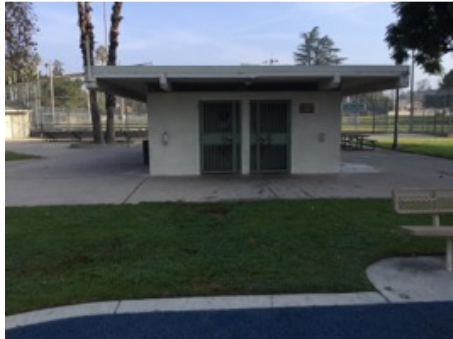
Comment #: TGP-64

Deficiency: Restroom Access - Dimensions - Width

The clear width to the accessible stall is less than 44-inches clear.

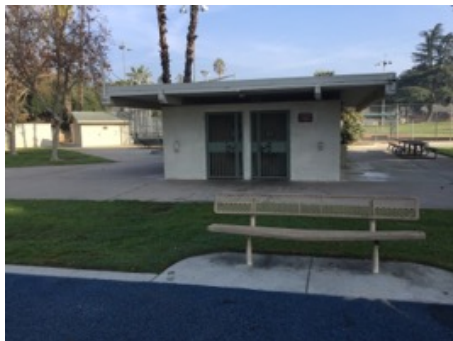
Comment #: TGP-65

Deficiency: Restroom Access - Dimensions - Width

The clear width to the accessible stall is less than 44-inches clear.

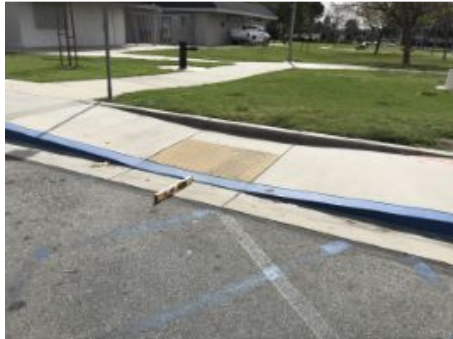
Comment #: PHIL-01

Deficiency: At Grade Transitions - Parallel Curb Ramp - Counter Slope

The counter slope of the adjoining gutter/road adjacent to and within 24 inches (610 mm) of the curb ramp is steeper than 1:20 (5.0 % grade). 7.3% counter slope measured at the curb ramp.

Measurement: 7.3 % grade

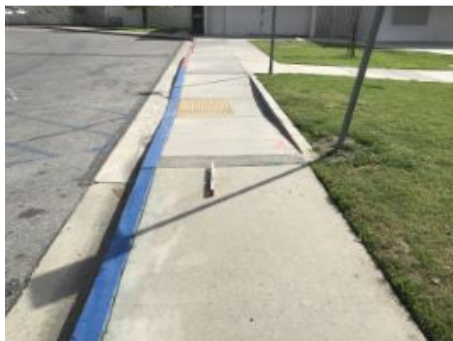
Comment #: PHIL-02

Deficiency: At Grade Transitions - Parallel Curb Ramp - Cross Slope

2.8% cross slope measured at the bottom ramp landing.

Measurement: 2.8 % grade

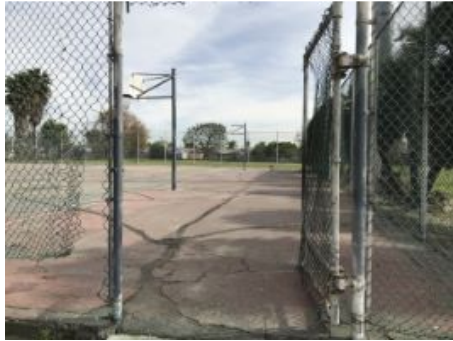
Comment #: PHIL-03

Deficiency: Exterior Doors/Doorways/Gates - Hardware - Smooth Surface

Lower 10 inches of door is not smooth.

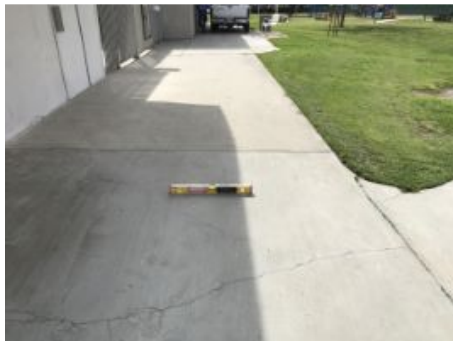
Comment #: PHIL-04

Deficiency: Accessible Route - Slopes - Cross Slope

The cross slope of accessible routes exceeds 1:48 (2.0 %). 2.3% to 4.8% cross slope measured along the route that runs along the community center.

Measurement: 4.8 % grade

Remove and replace walk. Install walk that provides cross slopes at circulation route of 1:48 maximum.

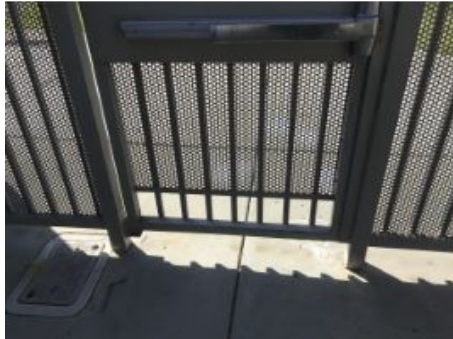
Comment #: PHIL-05

Deficiency: Exterior Doors/Doorways/Gates - Hardware - Smooth Surface

Lower 10 inches of door is not smooth on push side of gate.

Measurement: 2 inches

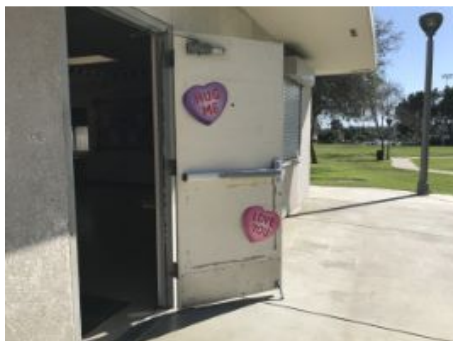
Comment #: PHIL-06

Deficiency: Exterior Doors/Doorways/Gates - Operation - Closing Speed

The door closes faster than the minimum 5 seconds. 2.78 to 2.99 seconds closing speed measured at the community center doors.

Measurement: 2.78 seconds

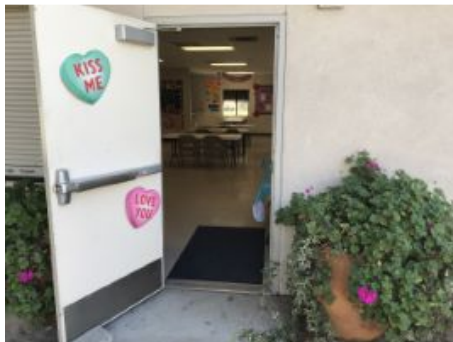
Comment #: PHIL-07

Deficiency: Exterior Doors/Doorways/Gates - Clearances: Front - Latch Clearance

24-inches (exterior) not provided at latch side clearances. 9" maneuvering clearance measured adjacent to the latch on the pull side of the door.

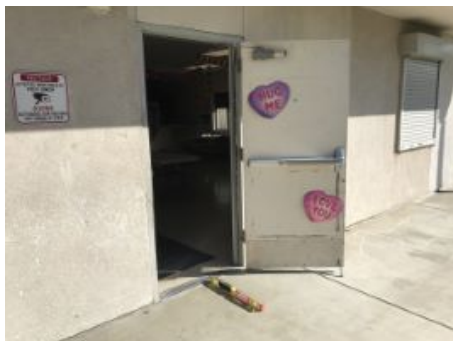
Comment #: PHIL-08

Deficiency: Exterior Doors/Doorways/Gates - Landing - Slopes

Slopes more than 1:48 (2%) grade, or changes in elevation are located at door landings. 3.4% running slope measured in the maneuvering clearance on the pull side of the entry door.

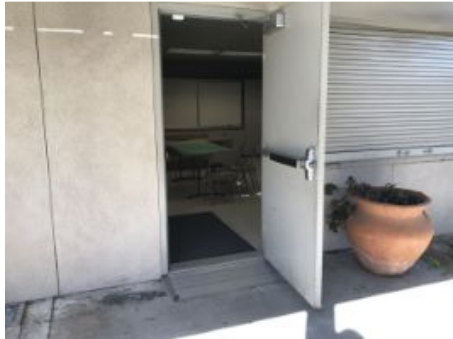
Comment #: PHIL-09

Deficiency: Exterior Doors/Doorways/Gates - Landing - Slopes

Slopes more than 1:48 (2%) grade, or changes in elevation are located at door landings. 2.7% to 10.2% running slope measured in the maneuvering clearance on the pull side of the entry door.

Measurement: 10.2 % grade

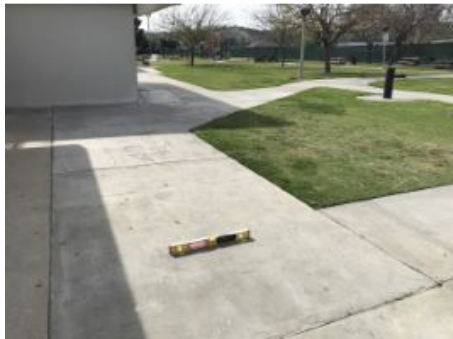
Comment #: PHIL-10

Deficiency: Accessible Route - Slopes - Cross Slope

The cross slope of accessible routes exceeds 1:48 (2.0 %). 2.2% to 4.6% cross slope measured along the park route.

Measurement: 4.6 % grade

Remove and replace walk. Install walk that provides cross slopes at circulation route of 1:48 maximum.

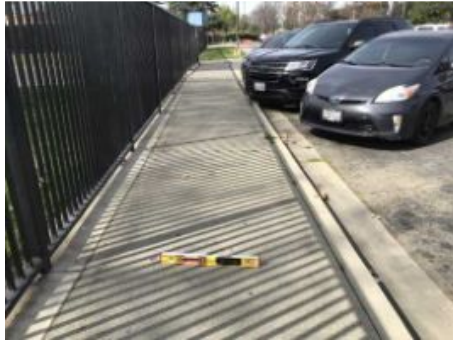
Comment #: PHIL-11

Deficiency: Accessible Route - Slopes - Cross Slope

The cross slope of accessible routes exceeds 1:48 (2.0 %). 2.3% to 3.8% cross slope measured along the route from the park entrance to the school entrance.

Measurement: 3.8 % grade

Remove and replace walk. Install walk that provides cross slopes at circulation route of 1:48 maximum.

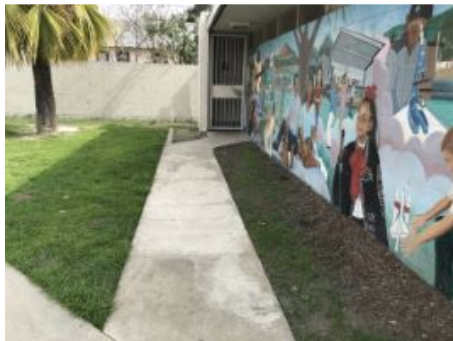
Comment #: PHIL-12

Deficiency: Accessible Route - Clear Width - General

Accessible route widths do not provide minimum 48-inches clear. 40" wide route measured along the route to the men's restroom.

Measurement: 40 inches

Replace walks to provide a clear width of 48 inches (1219 mm) minimum. When, because of right-of-way restrictions, natural barriers or other existing conditions, the enforcing agency determines that compliance with the 48-inch (1219 mm) clear sidewalk width would create an unreasonable hardship, the clear width may be reduced to 36 inches (914 mm).

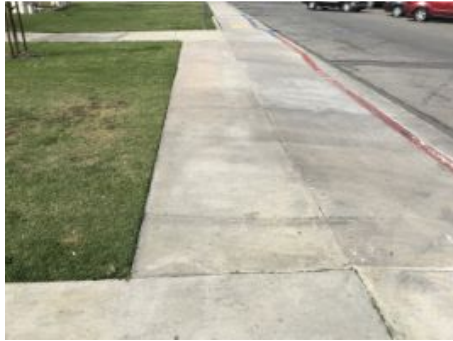
Comment #: PHIL-13

Deficiency: Accessible Route - Clear Width - General

Accessible route widths do not provide minimum 48-inches clear. 47" wide route measured where the accessible route runs along the fire lane driveway.

Measurement: 47 inches

Replace walks to provide a clear width of 48 inches (1219 mm) minimum. When, because of right-of-way restrictions, natural barriers or other existing conditions, the enforcing agency determines that compliance with the 48-inch (1219 mm) clear sidewalk width would create an unreasonable hardship, the clear width may be reduced to 36 inches (914 mm).

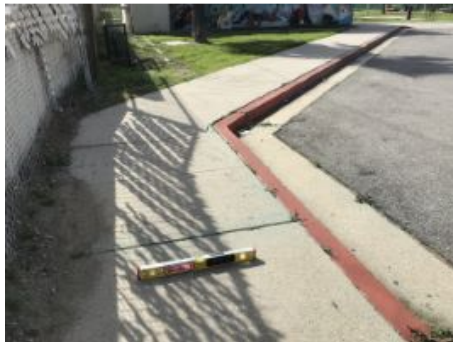
Comment #: PHIL-14

Deficiency: Accessible Route - Slopes - Cross Slope

The cross slope of accessible routes exceeds 1:48 (2.0 %). 2.2% to 3.7% cross slope measured along the route from the northeast public sidewalk to the accessible parking stalls at the park entrance.

Measurement: 3.7 % grade

Remove and replace walk. Install walk that provides cross slopes at circulation route of 1:48 maximum.

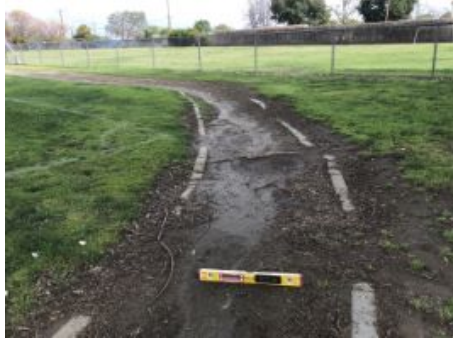
Comment #: PHIL-15

Deficiency: Accessible Routes - All Routes - Connect Bldg Route

There is not an accessible route that connects accessible buildings or facility, elements within the same site. An accessible route is not provided around the soccer fields to the south park entrance. Current ground surface is grass and mud, which is not compliant. 6.6% to 9.3% cross slope measured along the route.

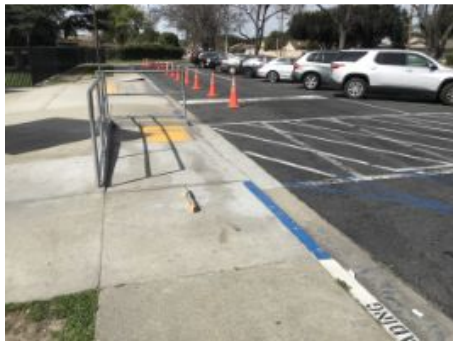
Comment #: PHIL-16

Deficiency: Accessible Route - Slopes - Cross Slope

The cross slope of accessible routes exceeds 1:48 (2.0 %). 2.9% running slope measured at the top ramp landing. This is also a turning space requiring 1:48 maximum cross slope in both directions.

Measurement: 2.9 % grade

Remove and replace walk. Install walk that provides cross slopes at circulation route of 1:48 maximum.

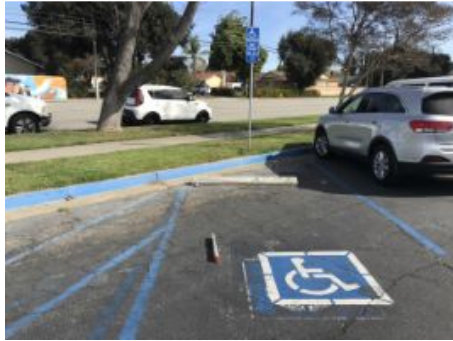
Comment #: PHIL-17

Deficiency: Parking - Accessible Stall - Slopes

The slope of the accessible car stall in any direction exceeds 1:48 (2.0%) grade. 3.0% to 3.5% running slope measured at the standard parking stall.

Measurement: 3.5 % grade

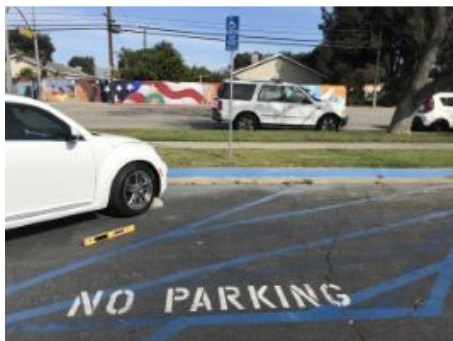
Comment #: PHIL-18

Deficiency: Parking - Accessible Stall - Slopes

The slope of the van/car stall in any direction exceeds 1:48 (2.0%) grade. 2.4% running slope measured at the van accessible parking stall.

Measurement: 2.4 % grade

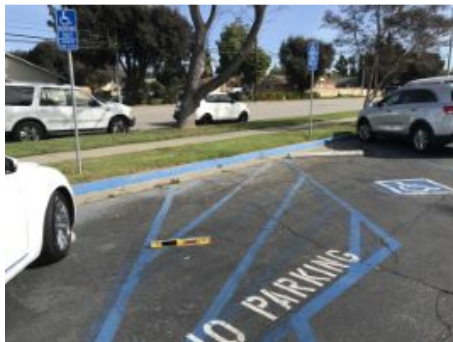
Comment #: PHIL-19

Deficiency: Parking - Access Aisle - Slope

The slope of the access aisle in any direction exceeds 1:48 (2.0%) grade. 2.7% running slope measured at the access aisle. 2.9% cross slope measured at the access aisle.

Measurement: 2.9 % grade

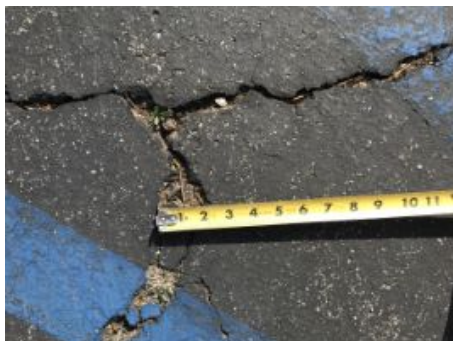
Comment #: PHIL-20

Deficiency: Parking - Access Aisle - Gaps

Accessible route grates / openings exceed 1/2" in the direction of travel.

Measurement: 2.25 inches

Replace grates, or fill openings, at locations where gratings/openings occur. Openings are allowed a maximum of 1/2" in the direction of travel.

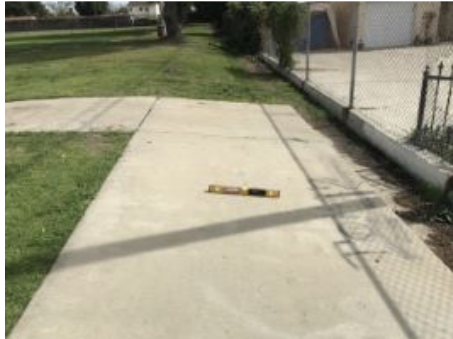
Comment #: PHIL-21

Deficiency: Accessible Route - Slopes - Cross Slope

The cross slope of accessible routes exceeds 1:48 (2.0 %). 9.6% to 12.7% cross slope measured along the route at the south park entrance.

Measurement: 12.7 % grade

Remove and replace walk. Install walk that provides cross slopes at circulation route of 1:48 maximum.

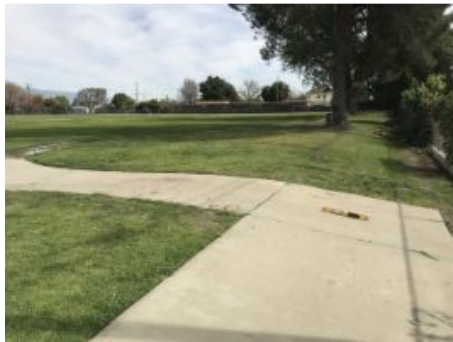
Comment #: PHIL-22

Deficiency: Accessible Route - Slopes - Cross Slope

The cross slope of accessible routes exceeds 1:48 (2.0 %). 13.9% cross slope measured measured at the turn in the route from the south park entrance.

Measurement: 13.9 % grade

Remove and replace walk. Install walk that provides cross slopes at circulation route of 1:48 maximum.

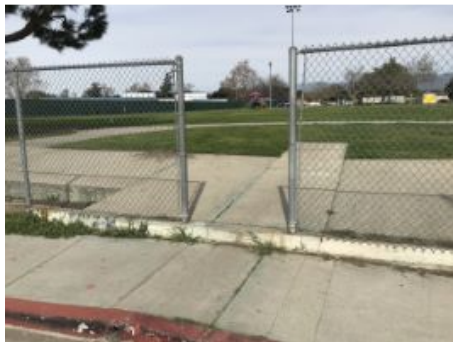
Comment #: PHIL-23

Deficiency: Accessible Route - Site Arrival Points - General

No accessible connections from provided from site arrival points. 6" high curb measured at the south park entrance. A curb ramp is not provided at the entrance.

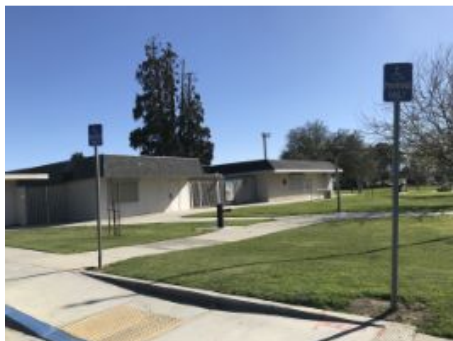
Comment #: PHIL-24

Deficiency: Parking - Signage - Minimum Fine

The parking identification sign does not includes the text "Minimum Fine \$250" below the ISA.

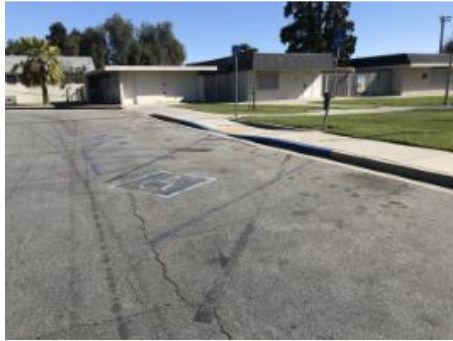
Comment #: PHIL-25

Deficiency: Parking - Accessible Stall - Markings

Markings have faded for accessible parking stalls.

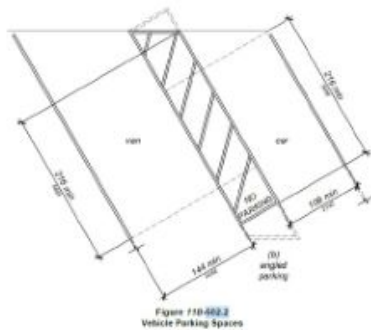
Comment #: PHIL-26

Deficiency: Parking - Access Aisle Markings - Angled Parking

Angled parking stall access aisle does not extend the full required length of the parking stall(s) served on both sides.

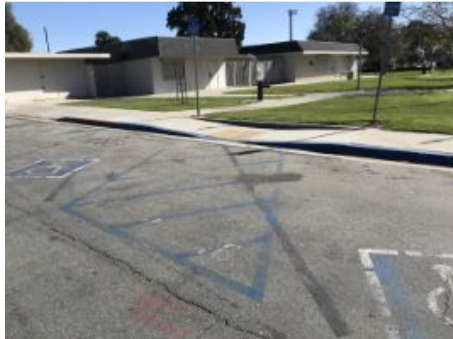
Comment #: PHIL-27

Deficiency: Parking - Access Aisle Markings - "No Parking"

Markings are faded and does not discourage parking in the access aisle.

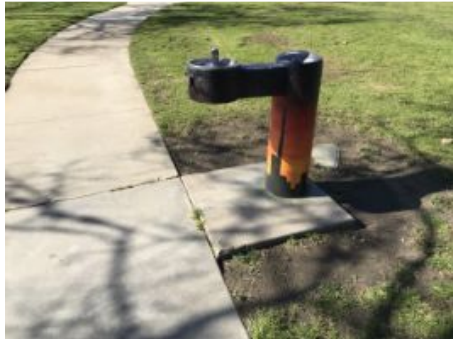
Comment #: PHIL-28

Deficiency: Accessible Route - Vertical Displacement - Height

Accessible route has multiple locations where changes in level over 1/4" vertical or 1/2" beveled occur.

Replace/grind locations where changes in elevation occur. Changes in level of 1/4" high maximum shall be permitted to be vertical and without edge treatment.

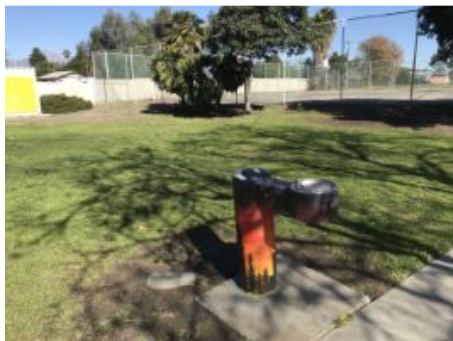
Comment #: PHIL-29

Deficiency: Drinking Fountain - Number Provided - 50 percent

When dispersed, 50% are not compliant for standing and/or 50% are not complaint for wheelchair accessible on the site are. A standing height drinking fountain is not provided.

Remove/replace so when more than the minimum number of drinking fountains are provided, 50 percent of the total number of drinking fountains shall be provided for standing person, and 50 percent of the total number of drinking fountains shall be provided as wheelchair accessible. Must be evenly distributed for a total of 100% of the drinking fountains.

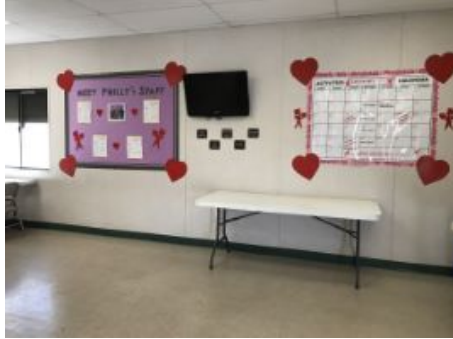
Comment #: PHIL-30

Deficiency: Accessible Route - Protrusion - Depth

Objects in the path of travel extend more than 4 inches from the wall with no cane detectable barrier. TV protrudes 8" into the accessible route at 79" AFF.

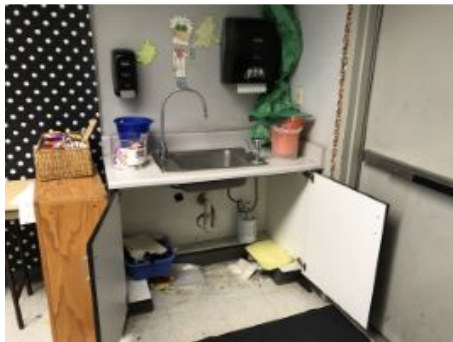
Comment #: PHIL-31

Deficiency: Accessible Route - Reach Ranges - Forward Reach Obstructed

The maximum reach is more than 44" when the depth of reach over an obstruction exceeds 20." 49" measured to the soap dispenser sink. 51" AFF measured to the paper towel dispenser at the sink.

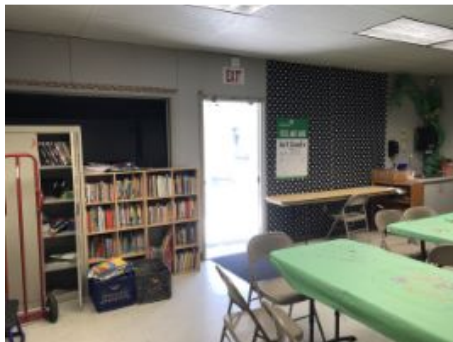
Comment #: PHIL-32

Deficiency: Interior Doors/Doorways/Gates - Tactile Sign - General

No permanent tactile exit sign has been provided.

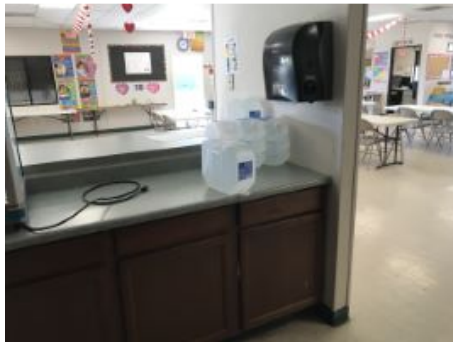
Comment #: PHIL-33

Deficiency: Accessible Route - Reach Ranges - Side Reach

Element for side reach is not located within 15-inches minimum to 48-inches maximum AFF (to a 10-inch depth). 55" AFF measured to the paper towel dispenser control.

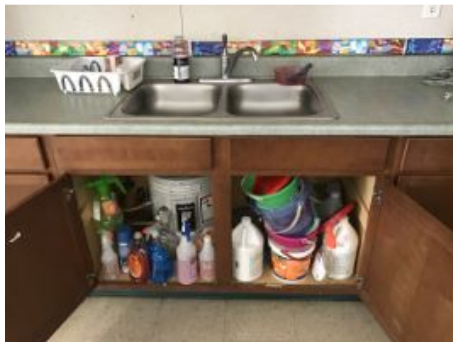
Comment #: PHIL-34

Deficiency: Kitchen - Counter Surface/Sink - Height

The height of the lavatory counter surface exceeds the allowable 34 inches AFF. 36" AFF measured to the sink rim. Knee and toe clearances are not provided at the sink.

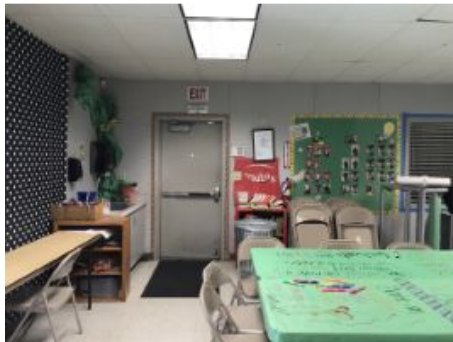
Comment #: PHIL-35

Deficiency: Interior Doors/Doorways/Gates - Hardware - Smooth Surface

Lower 10 inches of door is not smooth. Door stop installed at bottom of door.

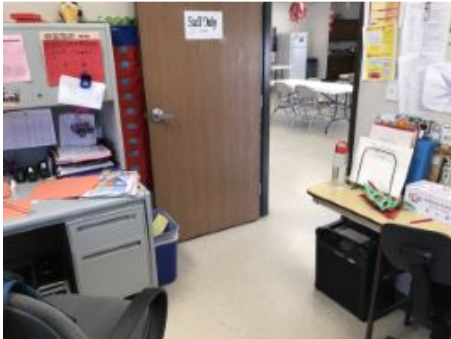
Deficiency: Interior Doors/Doorways/Gates - Clearances: Front - Latch Clearance

Extend landing to provide 18-inch strike side clearance at latch side of door.

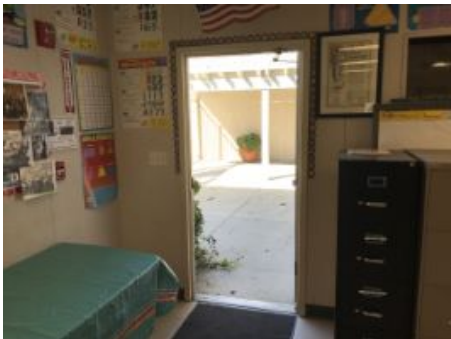
Deficiency: Interior Doors/Doorways/Gates - Clearances: Front - Latch Clearance

Rearrange furniture to provide 18-inch strike side clearance for a depth of 60-inches.

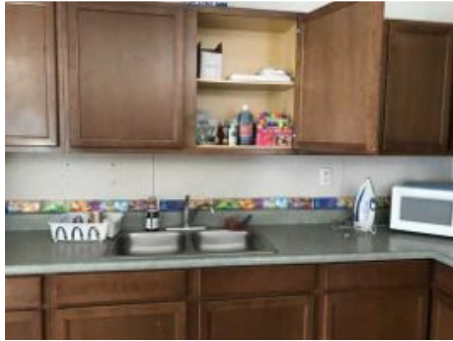
Comment #: PHIL-38

Deficiency: Kitchen - Storage - General

The storage does not have at least 50% of cabinet shelf space within reach ranges (15"-48"; 46" max when shelving is 10" deep) AND/OR with handles that cannot be operated with one hand, and require tight grasping, pinching, or twisting of the wrist, or require more than 5 pounds force to operate, AND/OR without clear floor space. Less than 50% of the storage is provided within

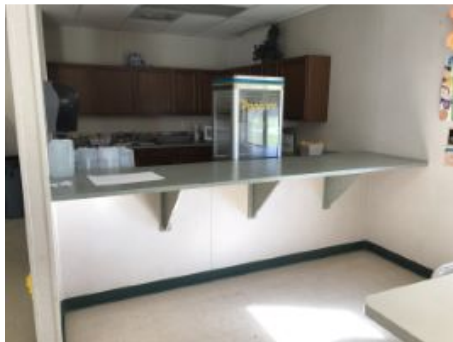
Comment #: PHIL-39

Deficiency: Transaction Counters - Dimensions - Counter Height

The counter surface is higher than the allowable 34 inches above the finished floor.

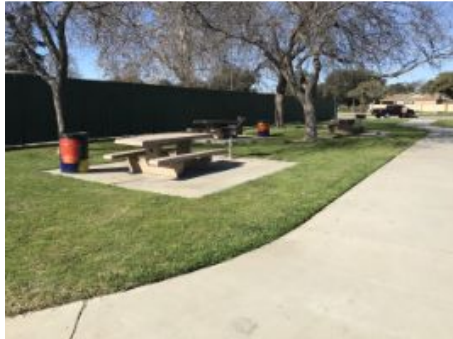
Comment #: PHIL-40

Deficiency: Accessible Route - Surface - Continuity

Accessible route does not provide a firm, stable and slip resistant surface. A compliant accessible route is not provided to a picnic area. Current ground surface is grass, which is not considered accessible.

Replace and provide floor and/or ground surfaces that is stable, firm, and slip resistant

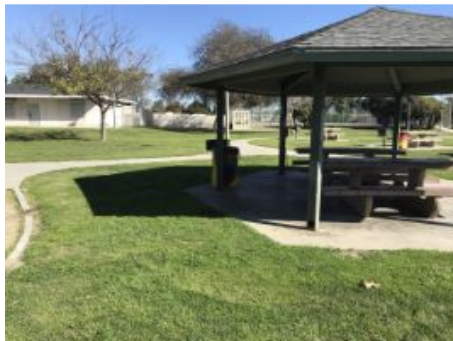
Comment #: PHIL-41

Deficiency: Accessible Route - Surface - Continuity

A compliant accessible route is not provided to the picnic shelter.

Replace and provide floor and/or ground surfaces that is stable, firm, and slip resistant

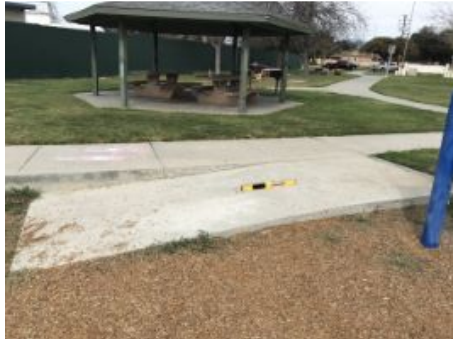
Comment #: PHIL-42

Deficiency: Playgrounds - Accessible Route - Site Amenities

An accessible path of travel from the playground is not provided to restrooms, drinking fountains, other accessible areas, and public telephones (if available) on site. Ramp has slopes of 9.5%, no handrails and no landings.
