APPENDIX A

FACILITY ASSESSMENT PHOTO REPORTS

CITY HALL

1.0 Site Assessment

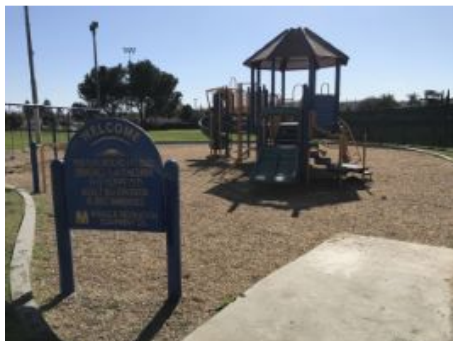
Comment #: PHIL-43

Deficiency: Playgrounds - Ground Surface - Use Zone

It is unknown if the 'use zone' ground surfaces comply with ASTM F 1292 (1999 edition or 2004 edition).

This will need to be verified with the client.

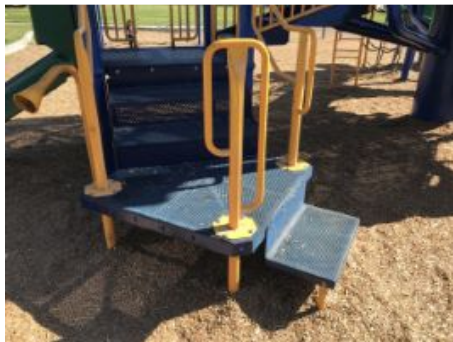
Comment #: PHIL-44

Deficiency: Playgrounds - Transfer System - Contrast Striping

Transfer step does not provide contrast striping, or contrast striping is not compliant.

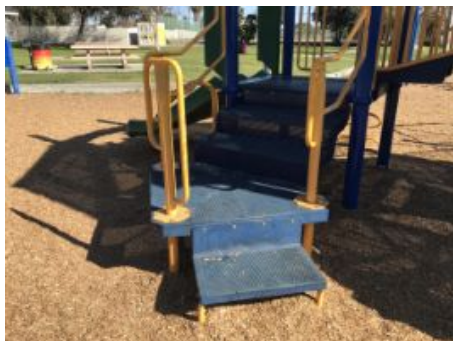
Comment #: PHIL-45

Deficiency: Playgrounds - Transfer System - Transfer Platform-Height

Transfer platform exceeds maximum 11" and does not provide a level 30" x 48" clear floor space centered 24" for a parallel approach.

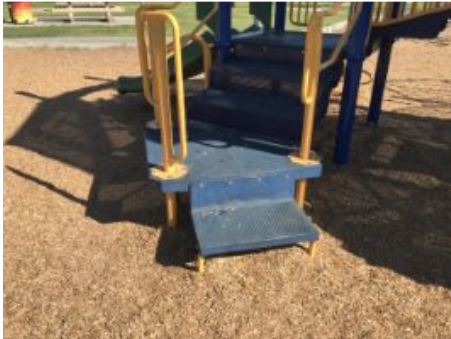
Comment #: PHIL-46

Deficiency: Playgrounds - Transfer System - Transfer Steps - Size

Transfer steps exceed maximum height allowed.

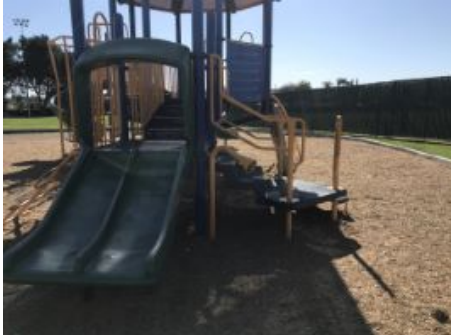
Comment #: PHIL-47

Deficiency: Playgrounds - Ground Level Components - Quantity

The number of existing ground level components is less than the required minimum. The minimum number of ground level play components is not provided.

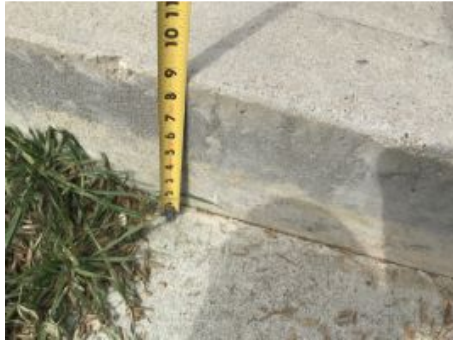
Comment #: PHIL-48

Deficiency: Accessible Route - Change in Level - Warning Curbs

Warning curb / guide rail is not installed at locations where there is an elevation change of more than 4" above finish grade.

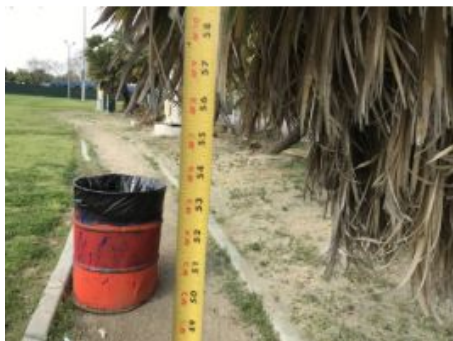
Comment #: PHIL-49

Deficiency: Accessible Route - Protrusion - Depth

Objects in the path of travel extend more than 4 inches from the wall with no cane detectable barrier. 56" high vertical clearance measured to the tree branches that hang over the accessible route.

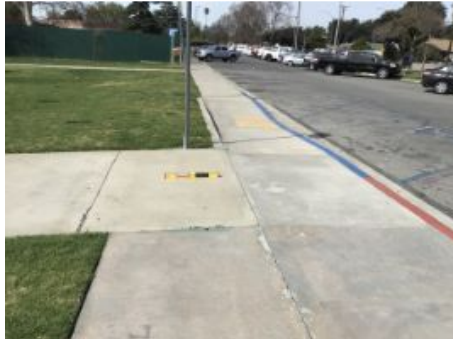
Comment #: PHIL-50

Deficiency: Accessible Route - Slopes - Cross Slope

The cross slope of accessible routes exceeds 1:48 (2.0 %). 2.8% cross slope measured at the turn in the accessible route.

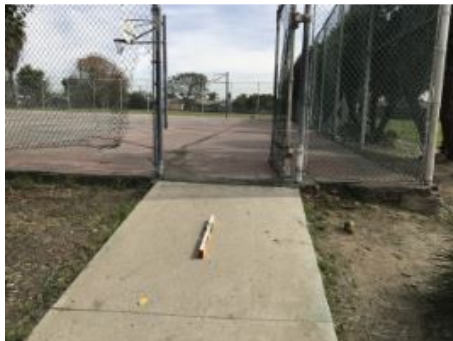
Comment #: PHIL-51

Deficiency: Accessible Route - Slopes - Running Slope

The slope in the direction of travel exceeds the allowable 5%. 10.8% to 13.1% running slope measured along the route to the basketball courts.

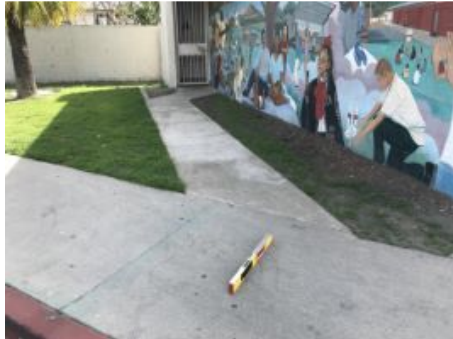
Comment #: PHIL-52

Deficiency: Accessible Route - Slopes - Cross Slope

The cross slope of accessible routes exceeds 1:48 (2.0 %). 3.5% cross slope measured at the turn in the accessible route leading to the men's restroom.

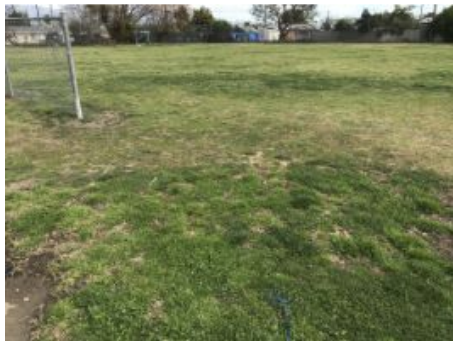
Comment #: PHIL-53

Deficiency: Sport Activity - Accessible Route - Boundary Connection

A minimum of one accessible route a minimum of 48-inches wide is not provided to the boundary to the soccer fields.

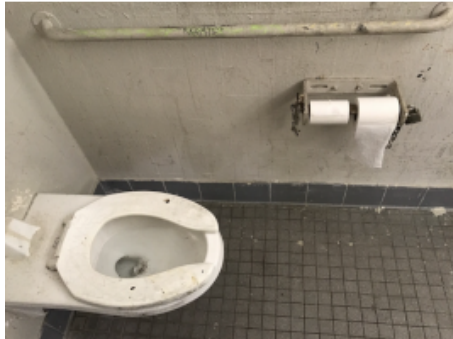
Comment #: PHIL-54

Deficiency: Accessible Toilet Stall - Dispensers - Toilet Paper Location

The toilet paper dispenser is outside of the allowable reach range.

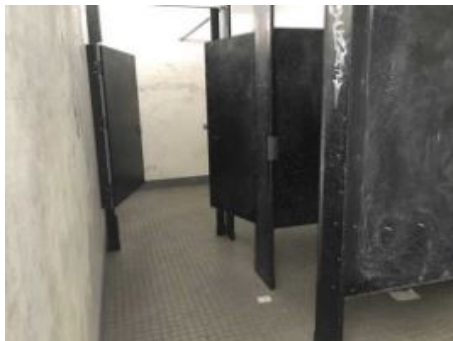
Comment #: PHIL-55

Deficiency: Accessible Toilet Stall - Door - Self-Closing Door

The stall door is not self closing.

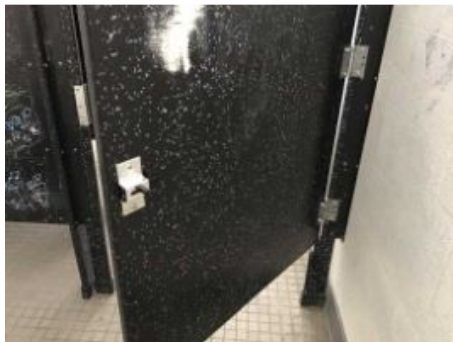
Comment #: PHIL-56

Deficiency: Accessible Toilet Stall - Door Hardware - Handle Both Sides

There is no pull handle on the interior side of the stall door.

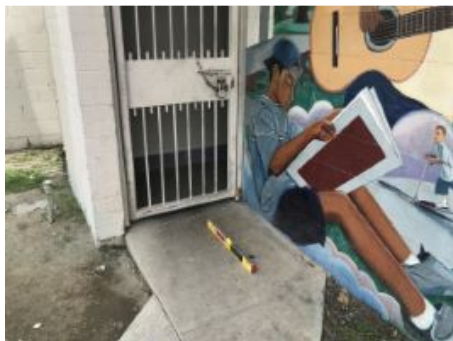
Comment #: PHIL-57

Deficiency: Restroom Doors - Clearances: Front - Latch Clearance

24-inches (exterior) not provided at latch side clearances.

Recommend reversing door and extending the landing to provide 24-inches at latch side clearances.

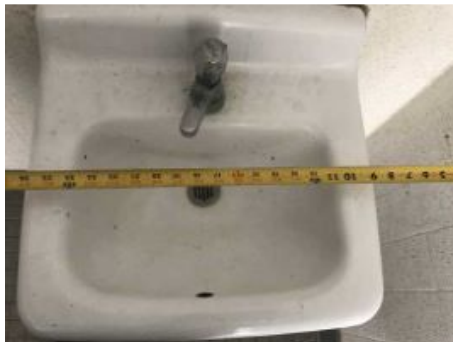
Comment #: PHIL-59

Deficiency: Lavatory - Location - Centerline Distance

The lavatory is not located so that the distance to the adjacent side wall is minimum 18 inches.

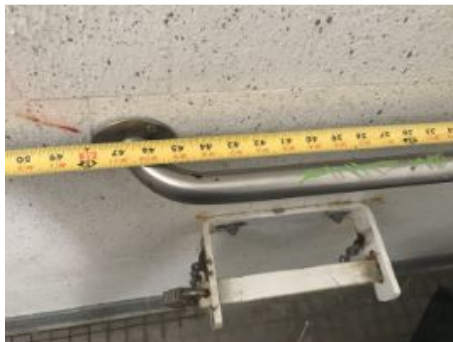
Comment #: PHIL-60

Deficiency: Accessible Toilet Stall - Side Grab Bar - Rear Distance to Rear Wall

The side grab bar does not extend minimum 54 inches from the rear wall.

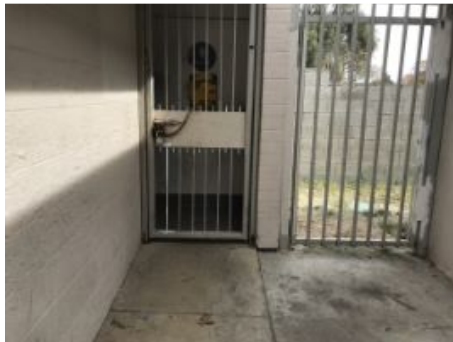
Comment #: PHIL-61

Deficiency: Restroom Doors - Clearances: Front - Latch Clearance

Latch side clearance is not provided at the pull side of the door and 6.6% slopes.

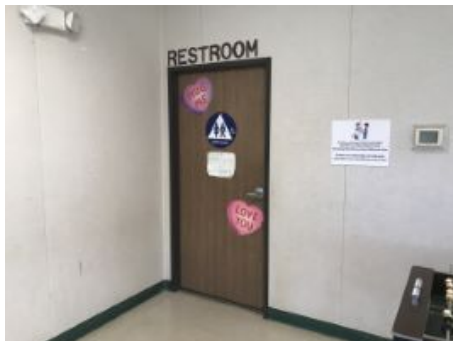
Comment #: PHIL-63

Deficiency: Restroom Doors - Tactile Sign - General

No permanent tactile restroom identification sign has been provided. Signage with the International Symbol of Accessibility, tactile lettering, and Braille is not provided adjacent to the latch side of the restroom door.

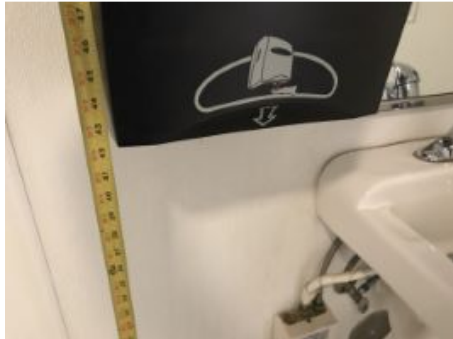
Comment #: PHIL-64

Deficiency: Restroom Interior Space - Amenities - Paper Towel Height

The paper towel dispenser exceeds the maximum allowable height. 43" AFF measured to the paper towel dispenser. 47" AFF measured to the soap dispenser.

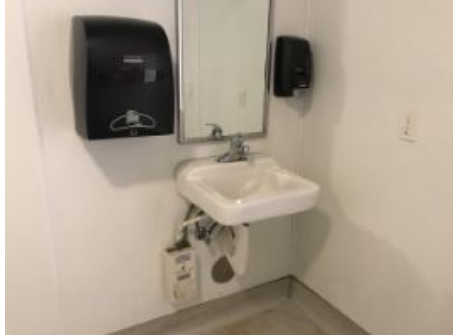
Comment #: PHIL-65

Deficiency: Restroom Interior Space - Amenities - Mirror Height

The mirror height exceeds the allowable 40 inches above the finished floor.

Measurement: 40.5 inches

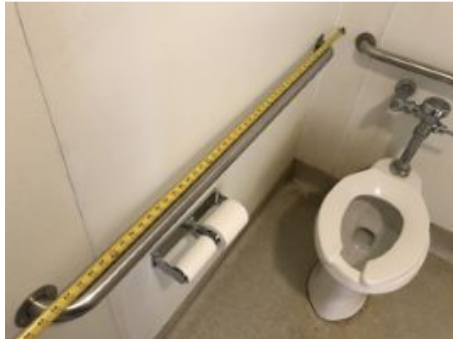
Comment #: PHIL-66

Deficiency: Accessible Toilet Stall - Side Grab Bar - Rear Distance to Rear Wall

The side grab bar does not extend minimum 54 inches from the rear wall.

Measurement: 53.5 inches

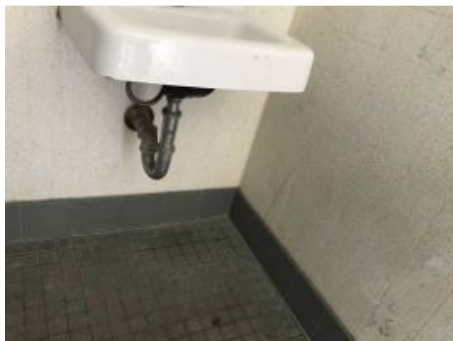
Comment #: PHIL-67

Deficiency: Lavatory - Covered Pipes/Hose Bib - General

The pipe insulation does not cover everything under the sink including water supply lines and hose bib.

Measurement: 0 count

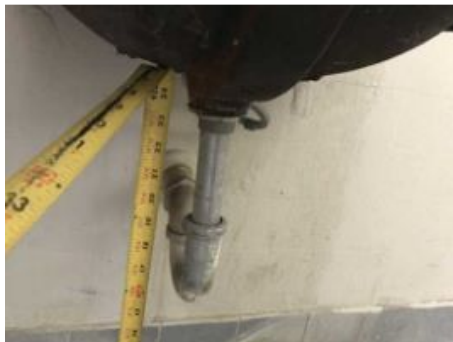
Comment #: PHIL-68

Deficiency: Lavatory - Knee/Toe Clearance - Height

The knee clearance at the lavatory is less than the allowable 29 inches. 16-1/2" deep toe clearance measured at the lavatories. 27-1/2" to 28-1/2" AFF clearance measured to the bottom edge of the lavatories. 25" to 26" AFF knee clearance measured at the lavatories.

Measurement: 25 inches

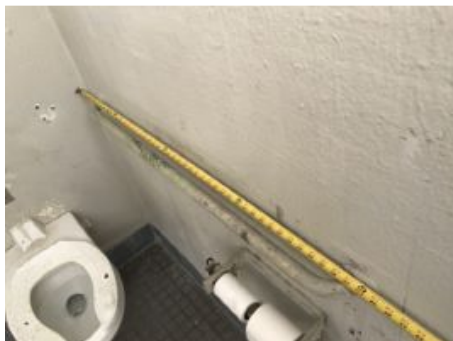
Comment #: PHIL-69

Deficiency: Accessible Toilet Stall - Side Grab Bar - Rear Distance to Rear Wall

The side grab bar does not extend minimum 54 inches from the rear wall.

Measurement: 48 inches

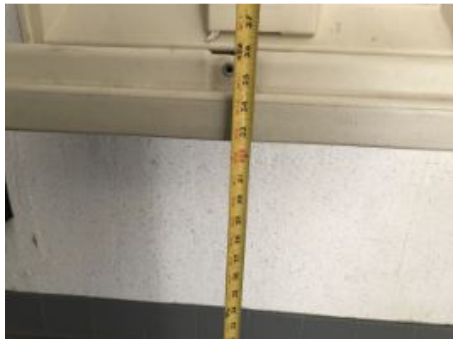
Comment #: PHIL-71

Deficiency: Baby Changing Station - Operable Parts - Height

The operable part exceeds 48 inches height. 36" AFF measured to the top of the changing surface.

Measurement: 36 inches

Provided operable parts shall be operable with one hand and shall not require tight grasping, pinching, or twisting of the wrist. The force required to activate operable parts shall be 5 pounds maximum. Recommend installing a strap for the opening with a circular handle that does not require grasping.

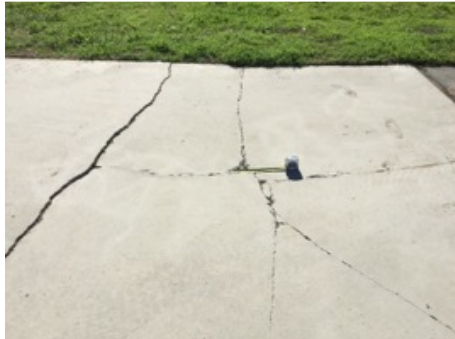
Comment #: JFK-001

Deficiency: Accessible Route - Openings - Width

Accessible route grates / openings exceed 1/2" in the direction of travel.

Measurement: 6 inches

Replace grates, or fill openings, at locations where gratings/openings occur. Openings are allowed a maximum of 1/2" in the direction of travel.

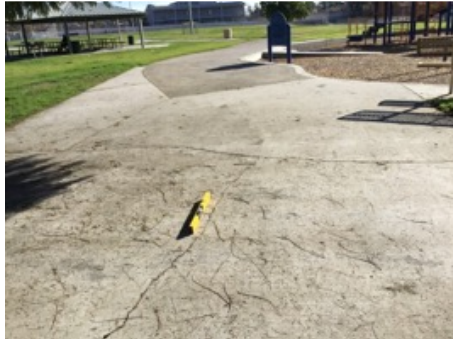
Comment #: JFK-003

Deficiency: Accessible Route - Slopes - Running Slope

The slope in the direction of travel exceeds the allowable 5%.

Measurement: 5.2 % grade

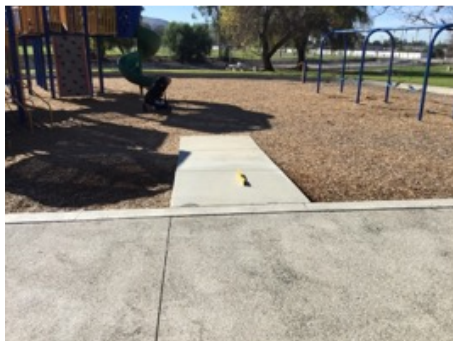
Comment #: JFK-004

Deficiency: Accessible Route - Slopes - Running Slope

The slope in the direction of travel exceeds the allowable 5%.

Measurement: 6.6 % grade

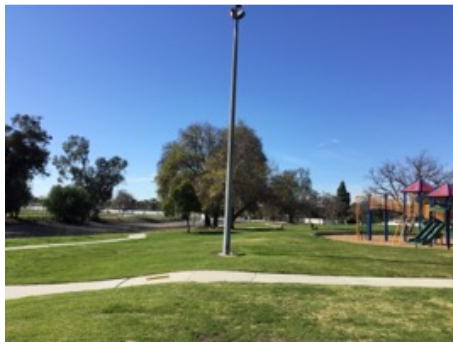
Comment #: JFK-005

Deficiency: Accessible Route - Slopes - Running Slope

The slope in the direction of travel exceeds the allowable 5%. Running slopes of 13.7% and cross slopes of 3.8% at this location.

Measurement: 13.7 % grade

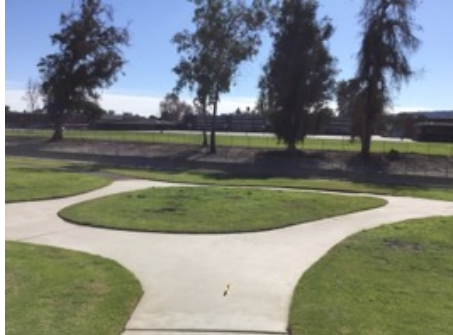
Comment #: JFK-006

Deficiency: Accessible Route - Slopes - Running Slope

The slope in the direction of travel exceeds the allowable 5%. Running slopes of 11.4% and cross slopes of 5.7% at this location.

Measurement: 11.4 % grade

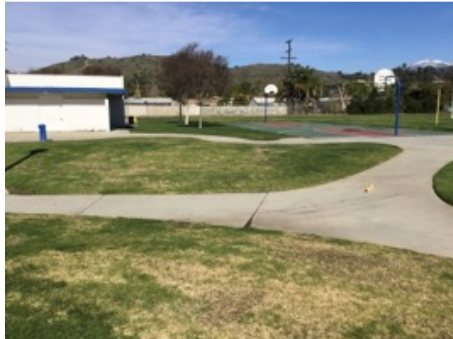
Comment #: JFK-007

Deficiency: Accessible Route - Slopes - Running Slope

The slope in the direction of travel exceeds the allowable 5%.

Measurement: 5.1 % grade

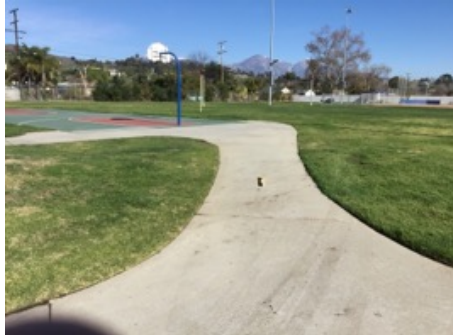
Comment #: JFK-008

Deficiency: Accessible Route - Slopes - Running Slope

The slope in the direction of travel exceeds the allowable 5%. Running slopes of 4.9% and cross slopes of 2.8% at this location.

Measurement: 4.9 % grade

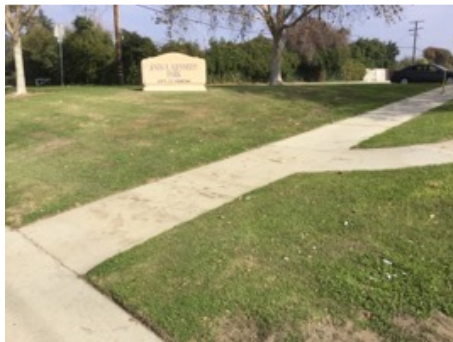
Comment #: JFK-009

Deficiency: Accessible Route - Slopes - Running Slope

The slope in the direction of travel exceeds the allowable 5%.

Measurement: 8 % grade

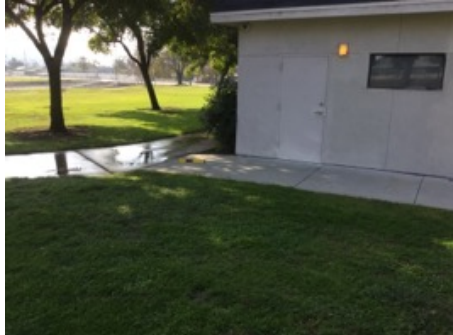
Comment #: JFK-010

Deficiency: Accessible Route - Slopes - Running Slope

The slope in the direction of travel exceeds the allowable 5%.

Measurement: 7.1 % grade

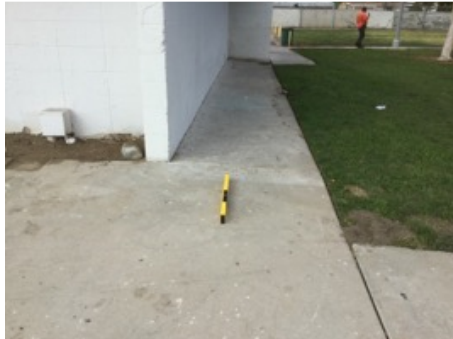
Comment #: JFK-011

Deficiency: Accessible Route - Slopes - Running Slope

The slope in the direction of travel exceeds the allowable 5%.

Measurement: 6.5 % grade

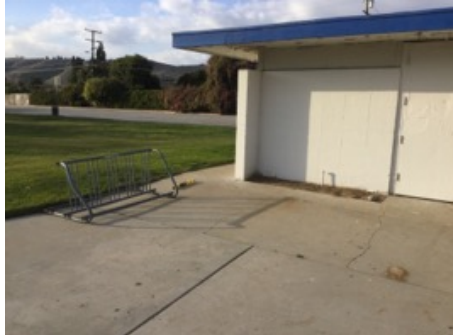
Comment #: JFK-012

Deficiency: Accessible Route - Slopes - Running Slope

The slope in the direction of travel exceeds the allowable 5%.

Measurement: 6.9 % grade

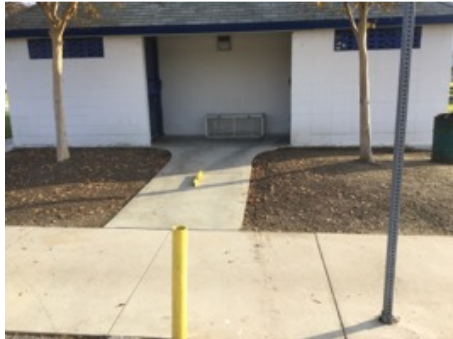
Comment #: JFK-013

Deficiency: Accessible Route - Slopes - Running Slope

The slope in the direction of travel exceeds the allowable 5%.

Measurement: 7.2 % grade

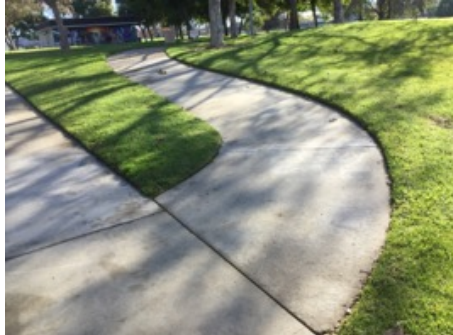
Comment #: JFK-014

Deficiency: Accessible Route - Slopes - Running Slope

The slope in the direction of travel exceeds the allowable 5% Running slopes of 9.1% with cross slopes of 4.5%.

Measurement: 9.1 % grade

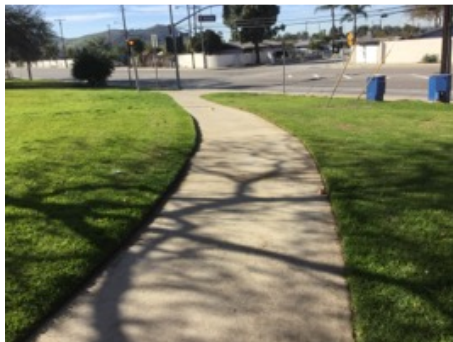
Comment #: JFK-015

Deficiency: Accessible Route - Slopes - Running Slope

The slope in the direction of travel exceeds the allowable 5%.

Measurement: 6.4 % grade

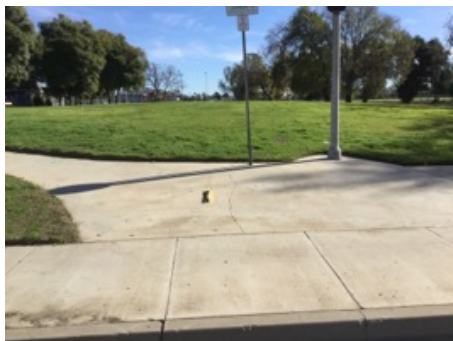
Comment #: JFK-016

Deficiency: Accessible Route - Slopes - Running Slope

The slope in the direction of travel exceeds the allowable 5%.

Measurement: 8.9 % grade

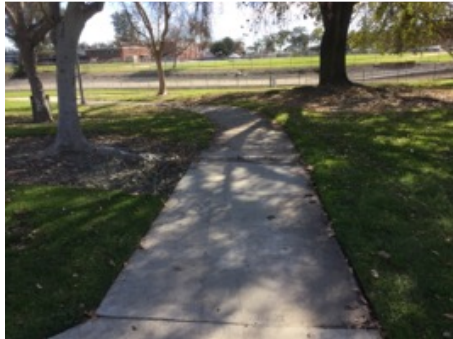
Comment #: JFK-017

Deficiency: Accessible Route - Slopes - Running Slope

The slope in the direction of travel exceeds the allowable 5%. Running slopes of 7.3% and cross slopes of 4.1%.

Measurement: 7.3 % grade

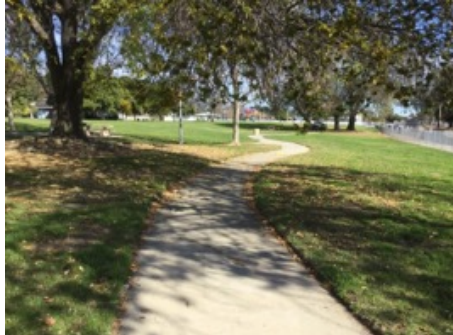
Comment #: JFK-018

Deficiency: Accessible Route - Slopes - Running Slope

The slope in the direction of travel exceeds the allowable 5%. 7.1% running slopes with 3.8% cross slopes.

Measurement: 7.1 % grade

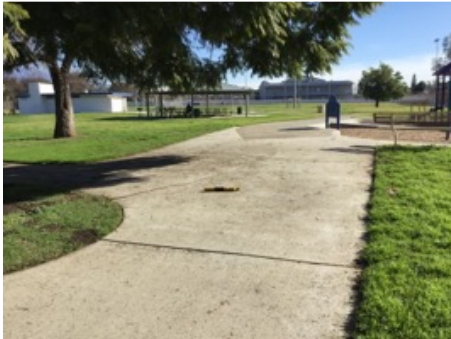
Comment #: JFK-019

Deficiency: Accessible Route - Slopes - Cross Slope

The cross slope of accessible routes exceeds 1:48 (2.0 %).

Measurement: 3.5 % grade

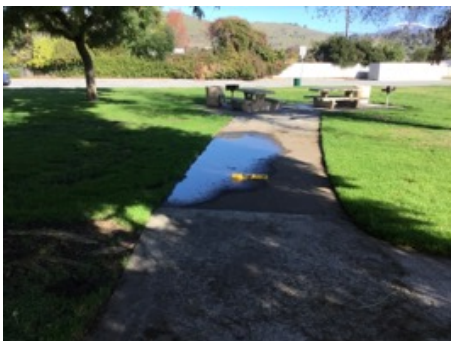
Comment #: JFK-020

Deficiency: Accessible Route - Slopes - Cross Slope

The cross slope of accessible routes exceeds 1:48 (2.0 %).

Measurement: 2.4 % grade

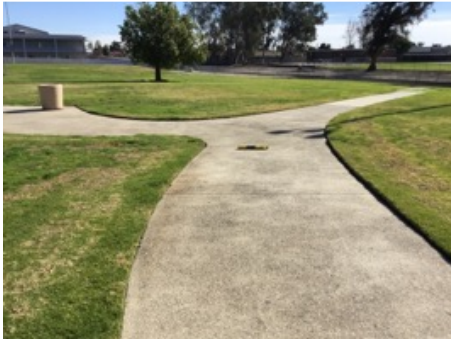
Comment #: JFK-021

Deficiency: Accessible Route - Slopes - Cross Slope

The cross slope of accessible routes exceeds 1:48 (2.0 %).

Measurement: 2.5 % grade

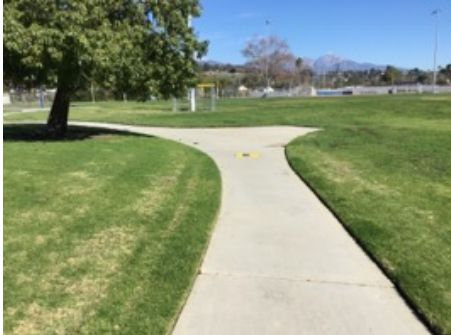
Comment #: JFK-022

Deficiency: Accessible Route - Slopes - Cross Slope

The cross slope of accessible routes exceeds 1:48 (2.0 %).

Measurement: 8.4 % grade

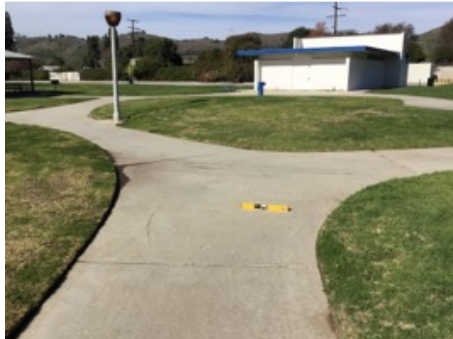
Comment #: JFK-023

Deficiency: Accessible Route - Slopes - Cross Slope

The cross slope of accessible routes exceeds 1:48 (2.0 %).

Measurement: 2.8 % grade

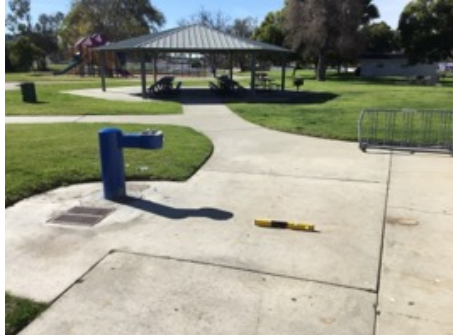
Comment #: JFK-024

Deficiency: Accessible Route - Slopes - Cross Slope

The cross slope of accessible routes exceeds 1:48 (2.0 %).

Measurement: 3.8 % grade

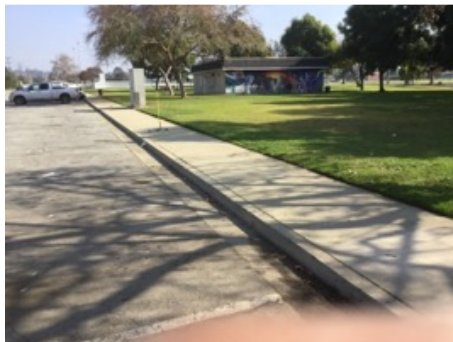
Comment #: JFK-025

Deficiency: Accessible Route - Slopes - Cross Slope

The cross slope of accessible routes exceeds 1:48 (2.0 %). Cross slope for walkway of 120 feet long and 5.5 wide is over 2%, this starts near the first parking stall and continues out of compliance until the walkway that leads to Community Center Building Entrance.

Measurement: 3.5 % grade

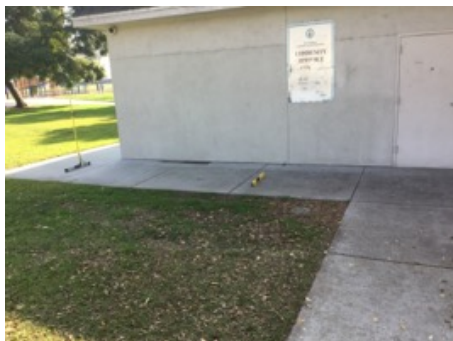
Comment #: JFK-026

Deficiency: Accessible Route - Slopes - Cross Slope

The cross slope of accessible routes exceeds 1:48 (2.0 %).

Measurement: 3 % grade

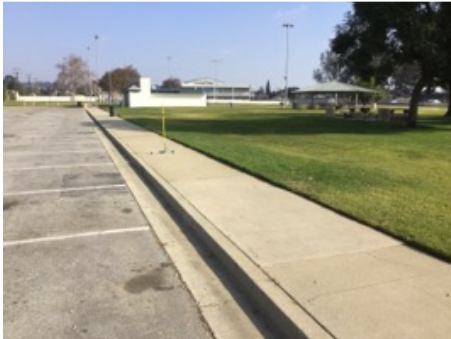
Comment #: JFK-027

Deficiency: Accessible Route - Slopes - Cross Slope

The cross slope of accessible routes exceeds 1:48 (2.0 %).

Measurement: 2.6 % grade

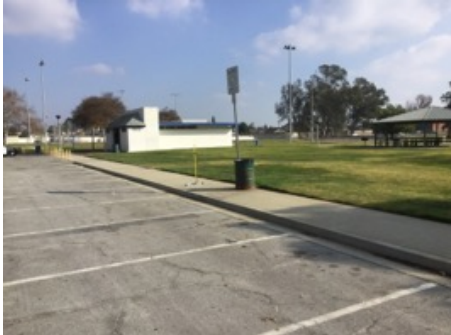
Comment #: JFK-028

Deficiency: Accessible Route - Slopes - Cross Slope

The cross slope of accessible routes exceeds 1:48 (2.0 %).

Measurement: 3.7 % grade

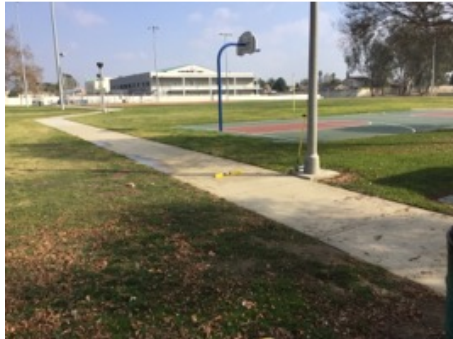
Comment #: JFK-029

Deficiency: Accessible Route - Slopes - Cross Slope

The cross slope of accessible routes exceeds 1:48 (2.0 %).

Measurement: 3 % grade

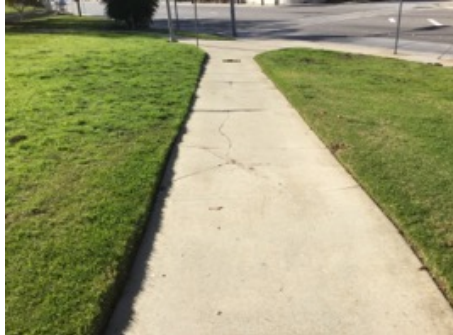
Comment #: JFK-030

Deficiency: Accessible Route - Slopes - Cross Slope

The cross slope of accessible routes exceeds 1:48 (2.0 %).

Measurement: 7.3 % grade

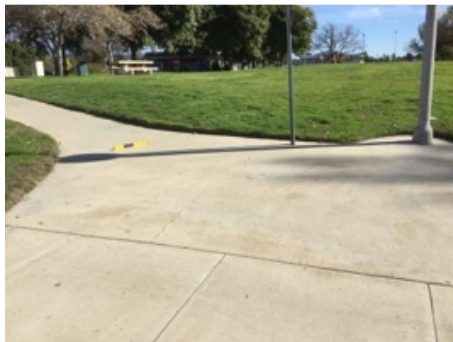
Comment #: JFK-031

Deficiency: Accessible Route - Slopes - Cross Slope

The cross slope of accessible routes exceeds 1:48 (2.0 %).

Measurement: 7.6 % grade

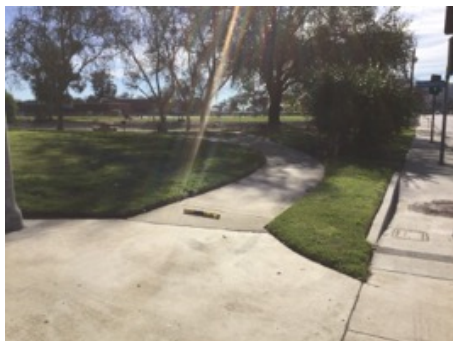
Comment #: JFK-032

Deficiency: Accessible Route - Slopes - Cross Slope

The cross slope of accessible routes exceeds 1:48 (2.0 %).

Measurement: 7 % grade

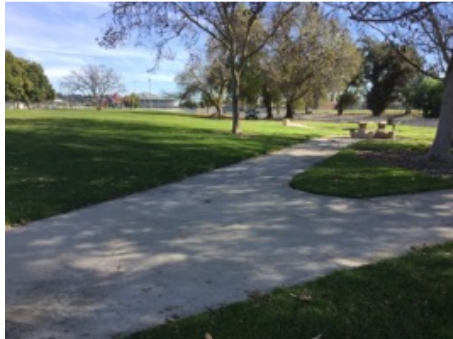
Comment #: JFK-033

Deficiency: Accessible Route - Slopes - Cross Slope

The cross slope of accessible routes exceeds 1:48 (2.0 %).

Measurement: 7.5 % grade

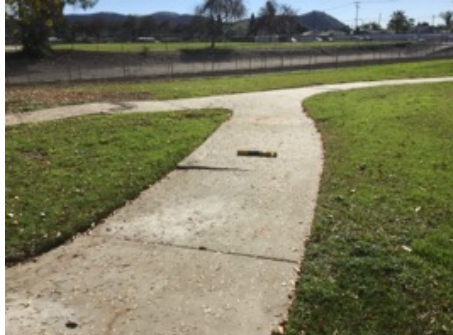
Comment #: JFK-034

Deficiency: Accessible Route - Slopes - Cross Slope

The cross slope of accessible routes exceeds 1:48 (2.0 %). 6.1 Running slopes and 3.1% cross slopes with changes of elevations of 2-1/2".

Measurement: 3.1 % grade

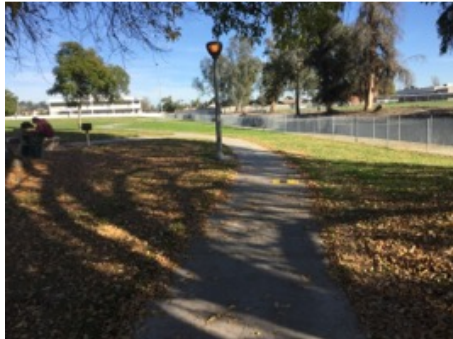
Comment #: JFK-035

Deficiency: Accessible Route - Slopes - Cross Slope

The cross slope of accessible routes exceeds 1:48 (2.0 %).

Measurement: 9.1 % grade

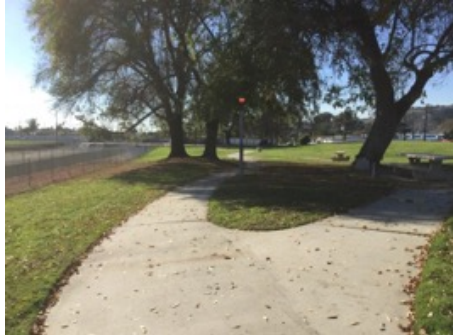
Comment #: JFK-036

Deficiency: Accessible Route - Slopes - Cross Slope

The cross slope of accessible routes exceeds 1:48 (2.0 %).

Measurement: 6.5 % grade

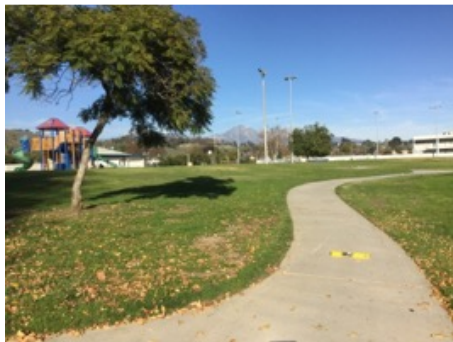
Comment #: JFK-037

Deficiency: Accessible Route - Slopes - Cross Slope

The cross slope of accessible routes exceeds 1:48 (2.0 %).

Measurement: 4.9 % grade

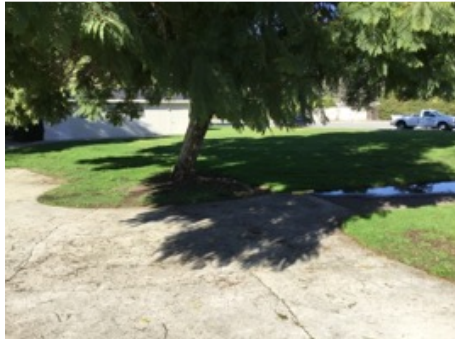
Comment #: JFK-039

Deficiency: Accessible Route - Vertical Displacement - Height

Accessible route has multiple locations where changes in level over 1/4" vertical or 1/2" beveled occur.

Measurement: 1.75 inches

Replace/grind locations where changes in elevation occur. Changes in level of 1/4" high maximum shall be permitted to be vertical and without edge treatment.

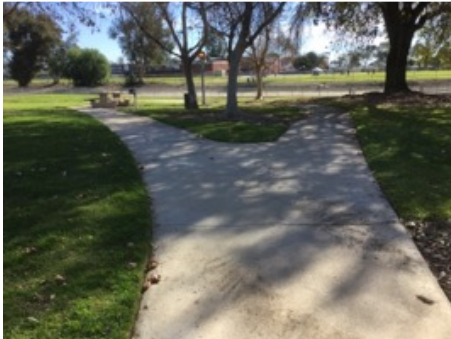
Comment #: JFK-043

Deficiency: Accessible Route - Vertical Displacement - Height

Accessible route has multiple locations where changes in level over 1/4" vertical or 1/2" beveled occur.

Measurement: 1 inches

Replace/grind locations where changes in elevation occur. Changes in level of 1/4" high maximum shall be permitted to be vertical and without edge treatment.

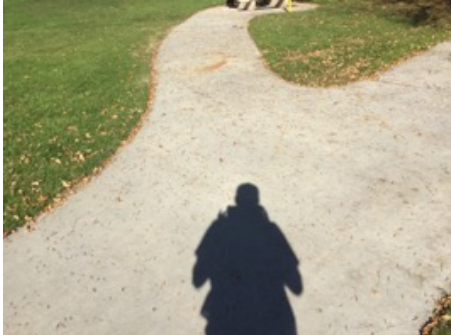
Comment #: JFK-044

Deficiency: Accessible Route - Vertical Displacement - Height

Accessible route has multiple locations where changes in level over 1/4" vertical or 1/2" beveled occur.

Measurement: 1.5 inches

Replace/grind locations where changes in elevation occur. Changes in level of 1/4" high maximum shall be permitted to be vertical and without edge treatment.

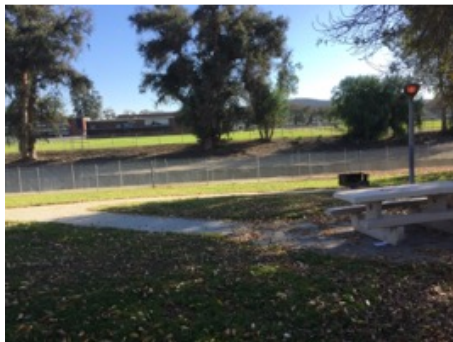
Comment #: JFK-045

Deficiency: Accessible Route - Vertical Displacement - Height

Accessible route has multiple locations where changes in level over 1/4" vertical or 1/2" beveled occur.

Measurement: .5 inches

Replace/grind locations where changes in elevation occur. Changes in level of 1/4" high maximum shall be permitted to be vertical and without edge treatment.

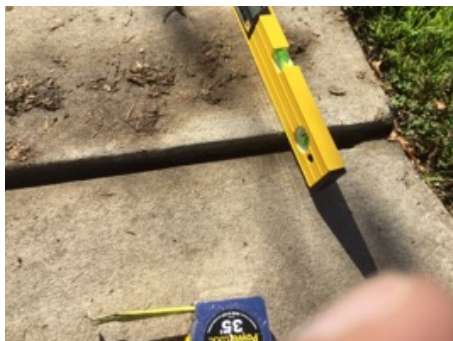
Comment #: JFK-046

Deficiency: Accessible Route - Vertical Displacement - Bevelment Slope

Accessible route has multiple locations where changes in level over 1/4" vertical or 1/2" beveled occur.

Measurement: 0 inches

Replace/grind locations where changes in elevation occur. Changes in level of 1/4" high maximum shall be permitted to be vertical and without edge treatment.

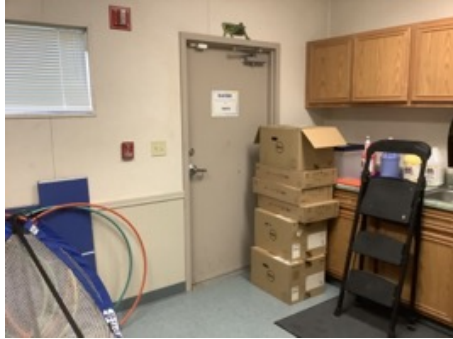
Comment #: JFK-047

Deficiency: Exterior Doors/Doorways/Gates - ISA - All Entrances

The International Symbol of Accessibility (ISA) is missing at this door.

Recommendation would be to add a sticker with the ISA to the second door, or remove the sticker from the other door.

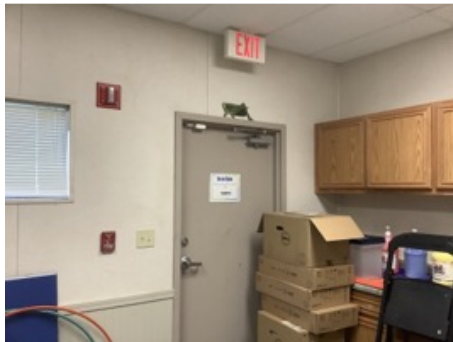
Comment #: JFK-048

Deficiency: Exterior Doors/Doorways/Gates - Tactile Sign - General

No permanent tactile exit sign has been provided.

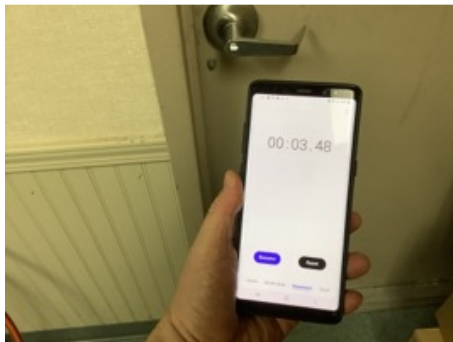
Comment #: JFK-051

Deficiency: Exterior Doors/Doorways/Gates - Operation - Closing Speed

The door closes faster than the minimum 5 seconds.

Measurement: 3.48 seconds

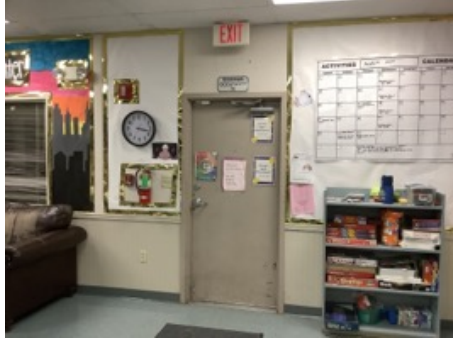
Comment #: JFK-053

Deficiency: Exterior Doors/Doorways/Gates - ISA - All Entrances

The International Symbol of Accessibility (ISA) is missing at this door.

Recommendation would be to add a sticker with the ISA to the second door, or remove the sticker from the other door.

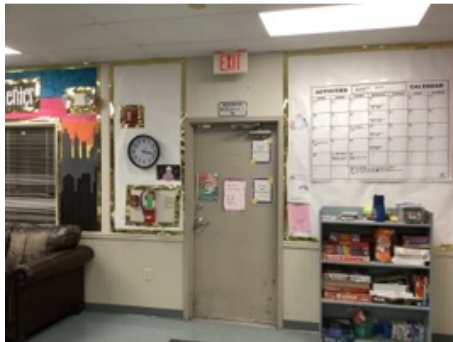
Comment #: JFK-054

Deficiency: Exterior Doors/Doorways/Gates - Tactile Sign - General

No permanent tactile exit sign has been provided.

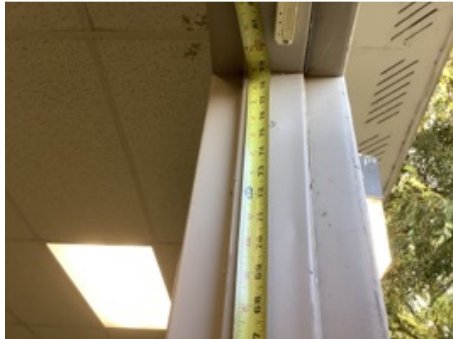
Comment #: JFK-055

Deficiency: Exterior Doors/Doorways/Gates - Dimensions - Clear Height

80" vertical clearance at door is not provided, and 78-inches is not provided at door closers or door stops?

Measurement: 79 inches

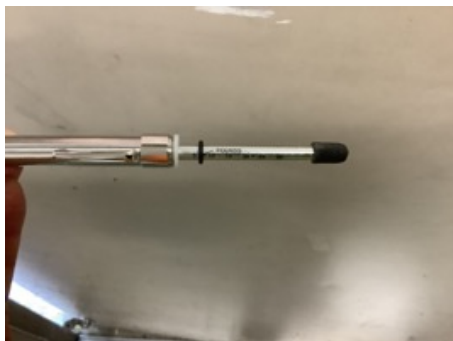
Comment #: JFK-056

Deficiency: Exterior Doors/Doorways/Gates - Operation - Opening Force

The force required to operate the door exceeds the allowable 5 lbf.

Measurement: 7 lbf

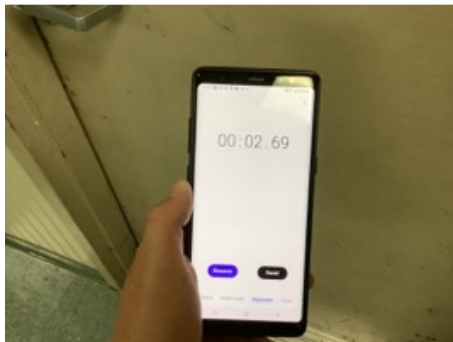
Comment #: JFK-057

Deficiency: Exterior Doors/Doorways/Gates - Operation - Closing Speed

The door closes faster than the minimum 5 seconds.

Measurement: 2.69 seconds

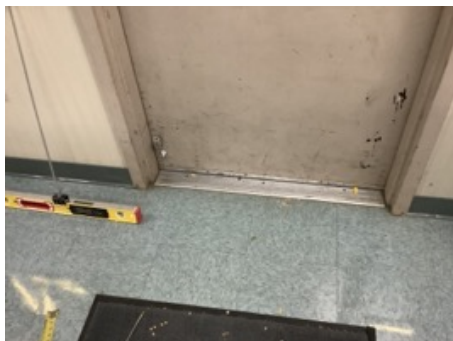
Comment #: JFK-058

Deficiency: Exterior Doors/Doorways/Gates - Hardware - Smooth Surface

Lower 10 inches of door is not smooth.

Measurement: 1 inches

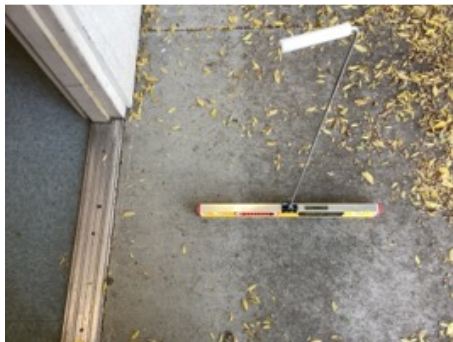
Comment #: JFK-059

Deficiency: Exterior Doors/Doorways/Gates - Landing - Slopes

Slopes more than 1:48 (2%) grade, or changes in elevation are located at door landings.

Measurement: 2.3 % grade

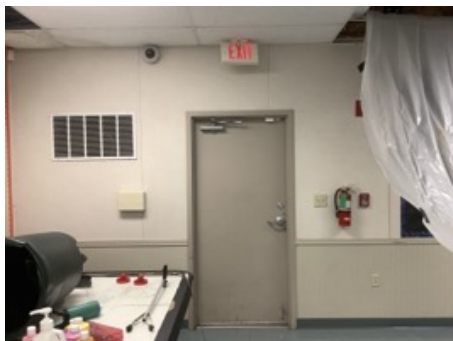
Comment #: JFK-060

Deficiency: Exterior Doors/Doorways/Gates - ISA - All Entrances

The International Symbol of Accessibility (ISA) is missing at this door.

Recommendation would be to add a sticker with the ISA to the second door, or remove the sticker from the other door.

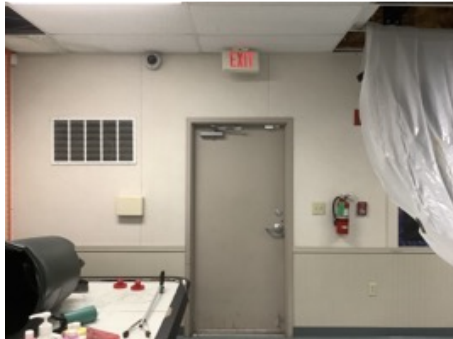
Comment #: JFK-061

Deficiency: Exterior Doors/Doorways/Gates - Tactile Sign - General

No permanent tactile exit sign has been provided.

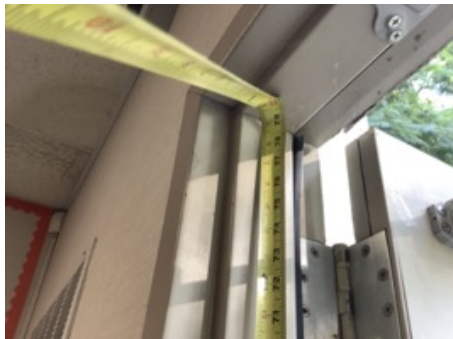
Comment #: JFK-062

Deficiency: Exterior Doors/Doorways/Gates - Dimensions - Clear Height

80" vertical clearance at door is not provided, and 78-inches is not provided at door closers or door stops?

Measurement: 78.5 inches

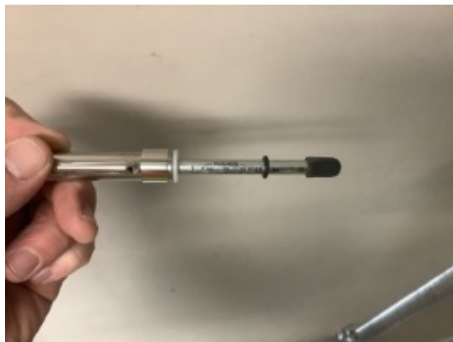
Comment #: JFK-063

Deficiency: Exterior Doors/Doorways/Gates - Operation - Opening Force

The force required to operate the door exceeds the allowable 5 lbf.

Measurement: 27 lbf

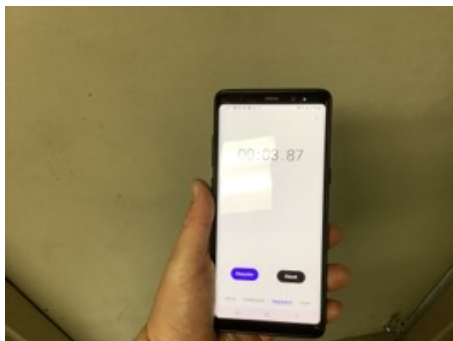
Comment #: JFK-064

Deficiency: Exterior Doors/Doorways/Gates - Operation - Closing Speed

The door closes faster than the minimum 5 seconds.

Measurement: 3.87 seconds

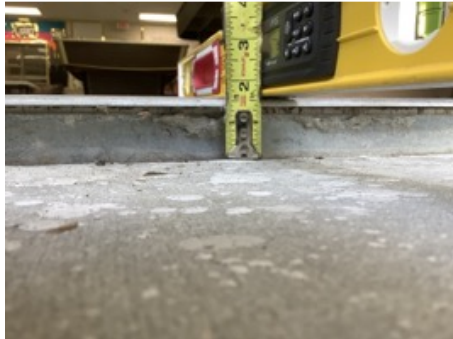
Comment #: JFK-065

Deficiency: Exterior Doors/Doorways/Gates - Threshold - Height

The threshold height exceeds the allowable tolerances.

Measurement: 1.75 inches

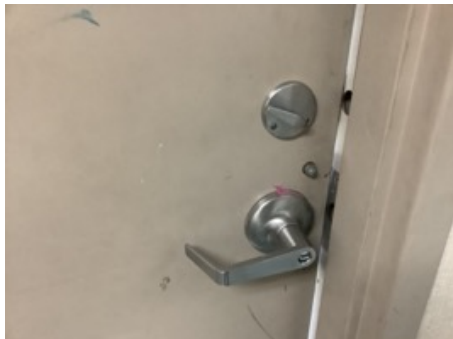
Comment #: JFK-066

Deficiency: Exterior Doors/Doorways/Gates - Hardware - Operation

The operable part requires tight grasping, pinching and/or twisting of the wrist to operate.

Measurement: 2 count

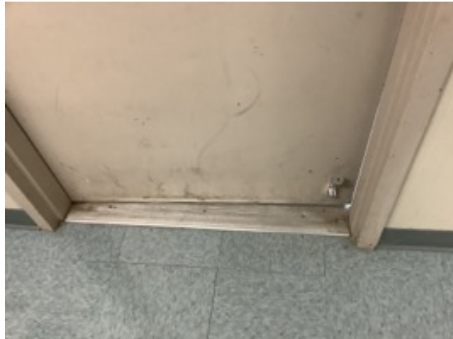
Comment #: JFK-067

Deficiency: Exterior Doors/Doorways/Gates - Hardware - Smooth Surface

Lower 10 inches of door is not smooth.

Measurement: 1 inches

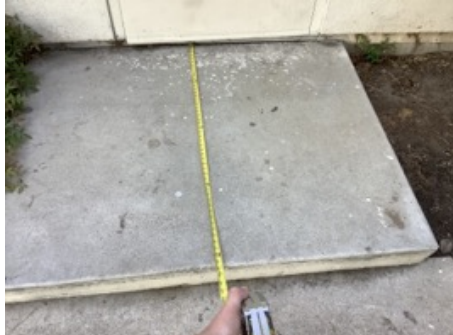
Comment #: JFK-068

Deficiency: Exterior Doors/Doorways/Gates - Clearances: Front - Pull Side Approach

60 inches of maneuvering space beyond the pull side of the door is not provided.

Measurement: 49 inches

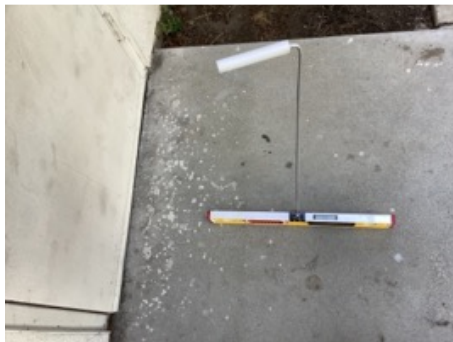
Comment #: JFK-071

Deficiency: Exterior Doors/Doorways/Gates - Landing - Slopes

Slopes more than 1:48 (2%) grade, or changes in elevation are located at door landings.

Measurement: 2.6 % grade

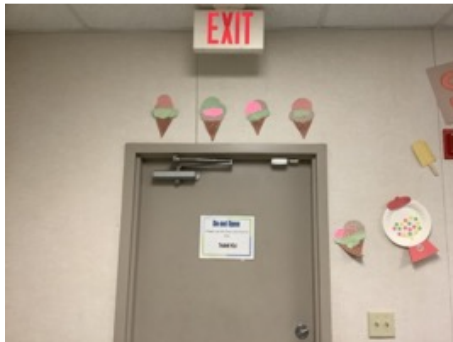
Comment #: JFK-072

Deficiency: Exterior Doors/Doorways/Gates - ISA - All Entrances

The International Symbol of Accessibility (ISA) is missing at this door.

Recommendation would be to add a sticker with the ISA to the second door, or remove the sticker from the other door.

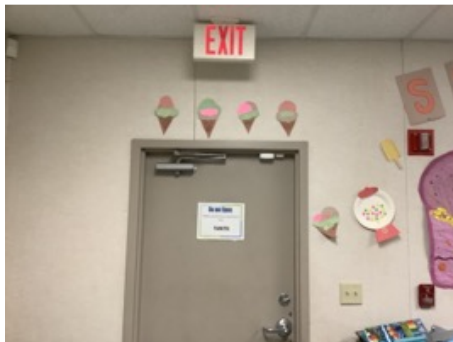
Comment #: JFK-073

Deficiency: Exterior Doors/Doorways/Gates - Tactile Sign - General

No permanent tactile exit sign has been provided.

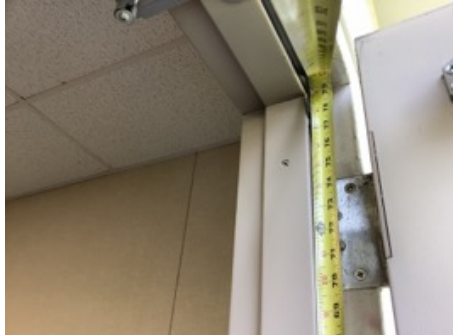
Comment #: JFK-074

Deficiency: Exterior Doors/Doorways/Gates - Dimensions - Clear Height

80" vertical clearance at door is not provided, and 78-inches is not provided at door closers or door stops?

Measurement: 78.5 inches

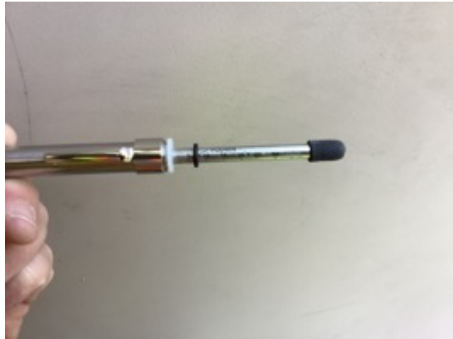
Comment #: JFK-075

Deficiency: Exterior Doors/Doorways/Gates - Operation - Opening Force

The force required to operate the door exceeds the allowable 5 lbf.

Measurement: 7 lbf

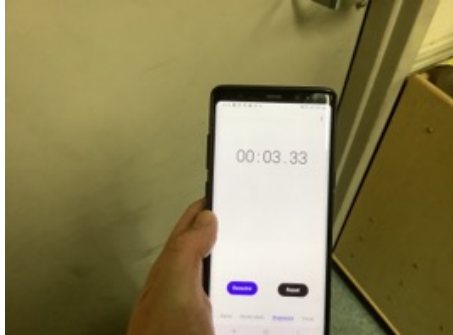
Comment #: JFK-076

Deficiency: Exterior Doors/Doorways/Gates - Operation - Closing Speed

The door closes faster than the minimum 5 seconds.

Measurement: 3.33 seconds

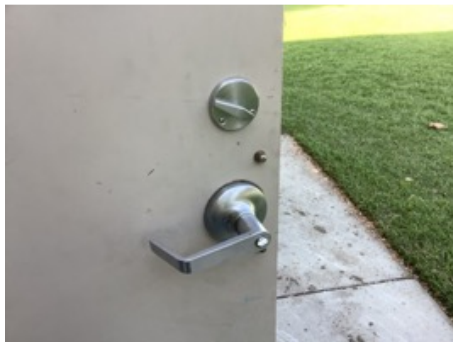
Comment #: JFK-077

Deficiency: Exterior Doors/Doorways/Gates - Hardware - Operation

The operable part requires tight grasping, pinching and/or twisting of the wrist to operate.

Measurement: 2 count

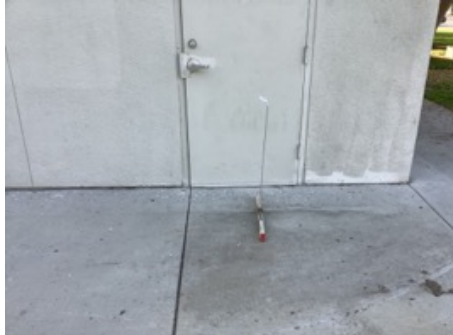
Comment #: JFK-078

Deficiency: Exterior Doors/Doorways/Gates - Landing - Slopes

Slopes more than 1:48 (2%) grade, or changes in elevation are located at door landings.

Measurement: 2.3 % grade

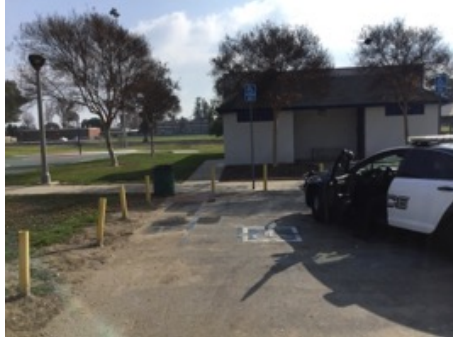
Comment #: JFK-081

Deficiency: Parking - General Parking - Van Stall Space Count

One access space in every six access spaces (or portion of 6) is not van accessible.

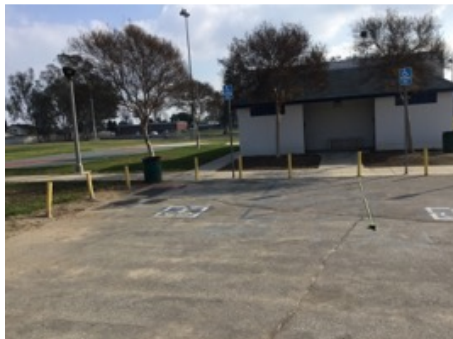
Comment #: JFK-082

Deficiency: Parking - Signage - Van Stall

The van accessible stall is not identified with the words "Van Accessible".

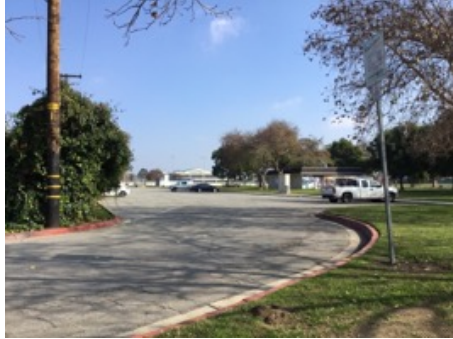
Comment #: JFK-083

Deficiency: Parking - Tow Away Sign - Verbiage

No "tow-away" sign is provided.

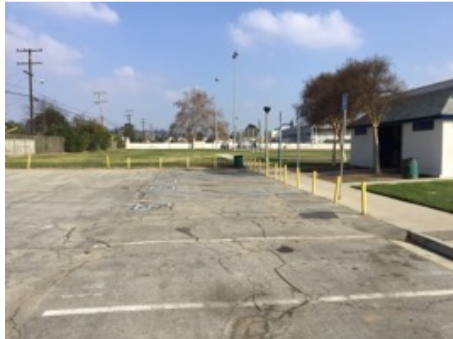
Comment #: JFK-084

Deficiency: Accessible Route - Hazardous Vehicular Areas - Detectable Warning

The detectable warning surface is not installed at hazardous vehicular area boundary.

Measurement: 0 count

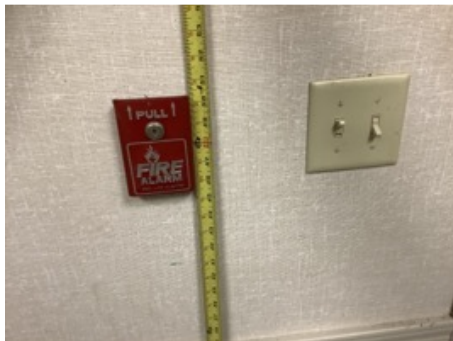
Comment #: JFK-085

Deficiency: Manual Fire Alarm Box - Reach Ranges - Side Reach

Fire alarm exceed 48-inches maximum AFF in the process of having to lift the handle. This also requires more than one motion to set off fire alarm.

Measurement: 50 inches

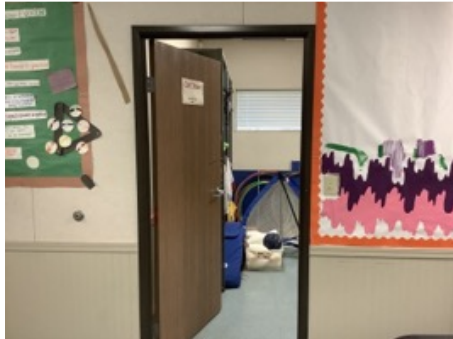
Comment #: JFK-086

Deficiency: Interior Doors/Doorways/Gates - Tactile Sign - General

No permanent tactile exit sign has been provided.

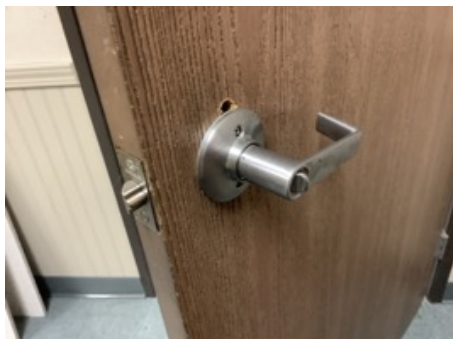
Comment #: JFK-087

Deficiency: Interior Doors/Doorways/Gates - Hardware - Operation

The operable part requires tight grasping, pinching and/or twisting of the wrist to operate.

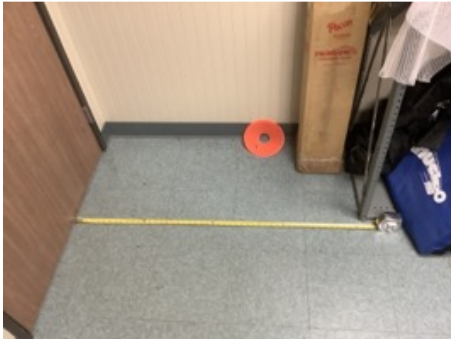
Deficiency: Interior Doors/Doorways/Gates - Clearances: Front - Pull Side Approach

Reconfigure doorway landing to provide a minimum 60-inch door maneuvering space.

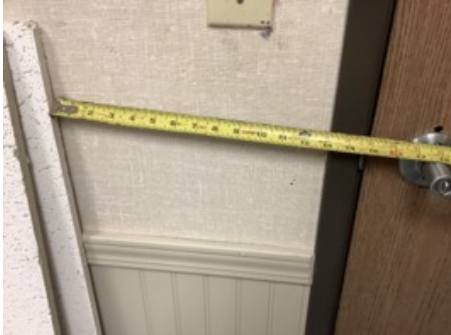
Deficiency: Interior Doors/Doorways/Gates - Clearances: Front - Latch Clearance

Extend landing to provide 18-inch strike side clearance at latch side of door.

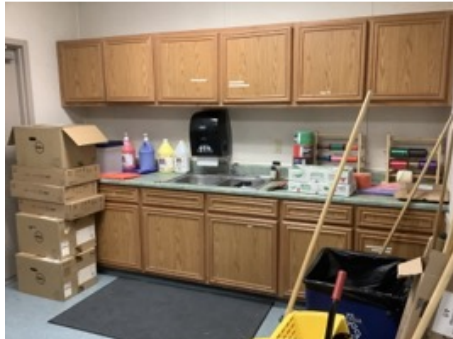
Comment #: JFK-090

Deficiency: Counter - Dimensions - Counter Height

The counter surface is higher than the allowable 34 inches above the finished floor. there is no knee and toe clearances provided at the sink. Floor clutter prohibits access to working surface.

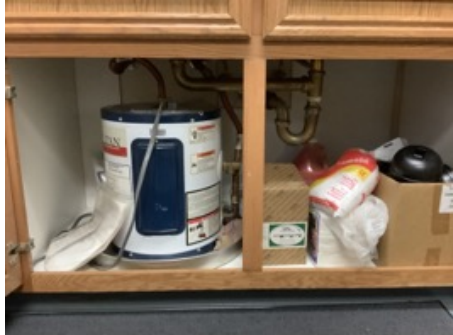
Comment #: JFK-091

Deficiency: Sink - Covered Pipes/Hose Bib - General

The pipe insulation does not cover everything under the sink including water supply lines and hose bib.

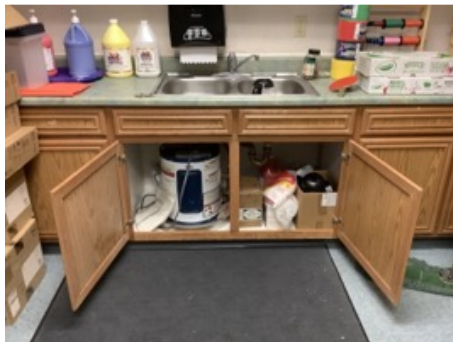
Comment #: JFK-092

Deficiency: Sink - Knee/Toe Clearance - Width

Minimum 30 inch wide knee and toe space is not provided.

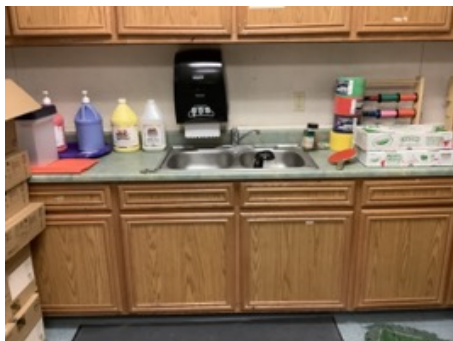
Comment #: JFK-093

Deficiency: Sink - Knee/Toe Clearance - Height

The knee clearance at the lavatory is less than the allowable 29 inches.

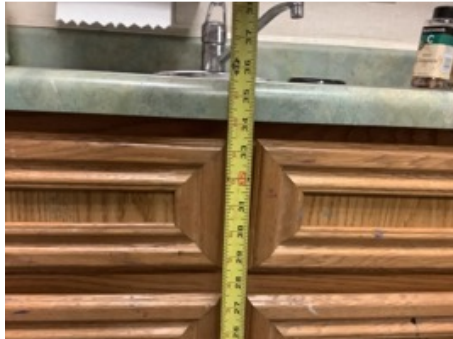
Comment #: JFK-094

Deficiency: Sink - Counter Surface - Height

The height of the lavatory counter surface exceeds the allowable 34 inches AFF.

Measurement: 35.5 inches
