APPENDIX A

FACILITY ASSESSMENT PHOTO REPORTS

CITY HALL

1.0 Site Assessment

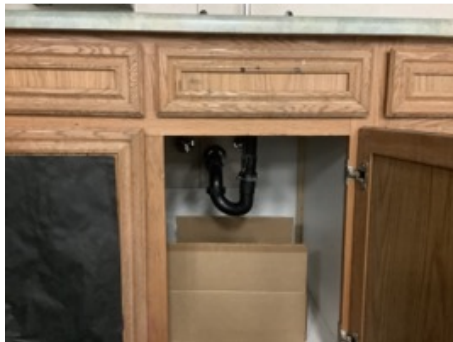
Comment #: JFK-095

Deficiency: Sink - Covered Pipes/Hose Bib - General

The pipe insulation does not cover everything under the sink including water supply lines and hose bib.

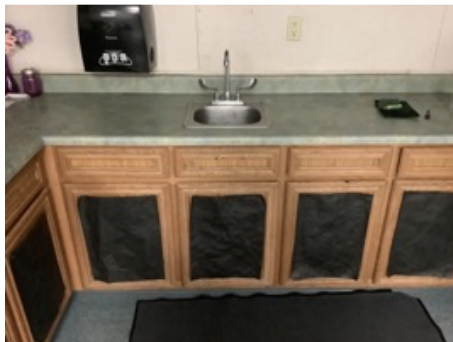
Comment #: JFK-096

Deficiency: Sink - Knee/Toe Clearance - Width

Minimum 30 inch wide knee and toe space is not provided.

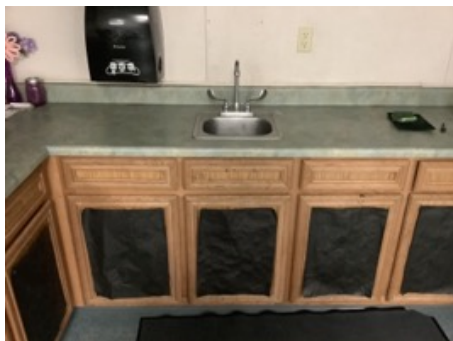
Comment #: JFK-097

Deficiency: Sink - Knee/Toe Clearance - Height

The knee clearance at the lavatory is less than the allowable 29 inches.

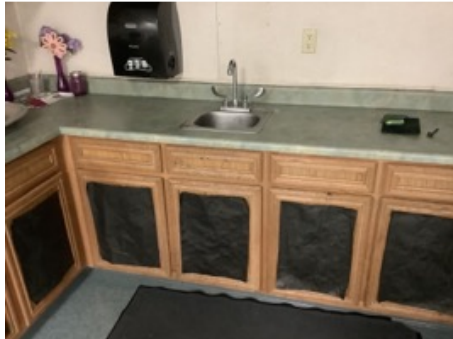
Comment #: JFK-098

Deficiency: Sink - Knee/Toe Clearance - Incremental Depth

The knee clearance at the lavatory does not match the depth to reach the operable parts.

Provide knee clearance at the accessible lavatory as noted below.

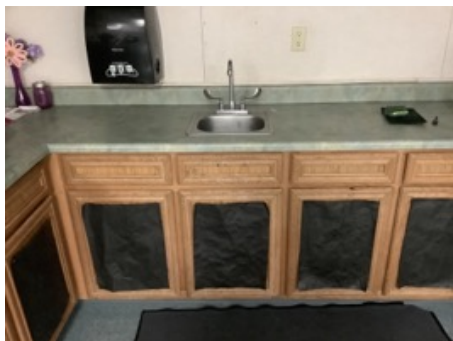
Comment #: JFK-099

Deficiency: Sink - Knee/Toe Clearance - Max Depth 19 Inches

The max depth of the lavatory exceeds the allowable 19 inches.

Provide knee clearance at the accessible lavatory as noted below.

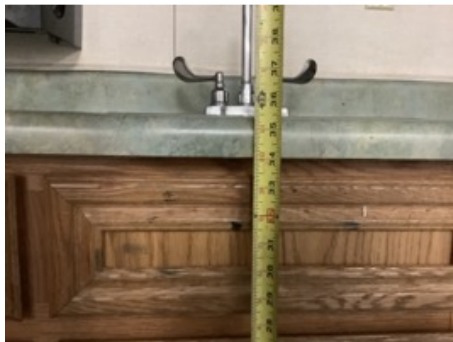
Comment #: JFK-0100

Deficiency: Sink - Counter Surface - Height

The height of the lavatory counter surface exceeds the allowable 34 inches AFF.

Measurement: 35.5 inches

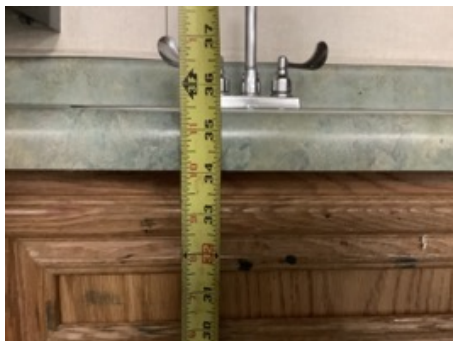
Comment #: JFK-0101

Deficiency: Sink - Height - General

The height of the lavatory counter surface exceeds the allowable 34 inches AFF.

Measurement: 35.5 inches

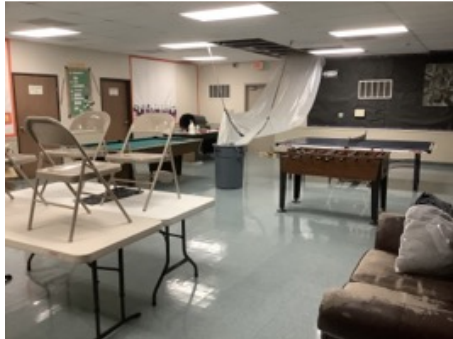
Comment #: JFK-0102

Deficiency: Work Surface - Dimensions - Height

Depending on the age range of the room it may be compliant. Tables for adults do not provide knee clearance.

Measurement: 26 inches

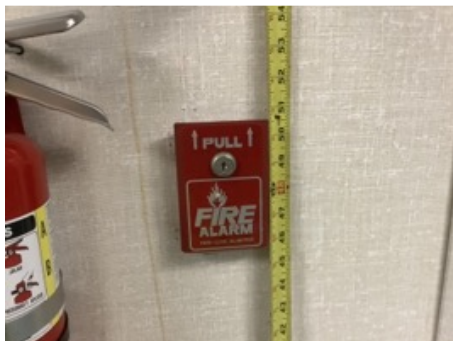
Comment #: JFK-0103

Deficiency: Manual Fire Alarm Box - Reach Ranges - Side Reach

Fire alarm exceed 48-inches maximum AFF in the process of having to lift the handle. This also requires more than one motion to set off fire alarm.

Measurement: 50 inches

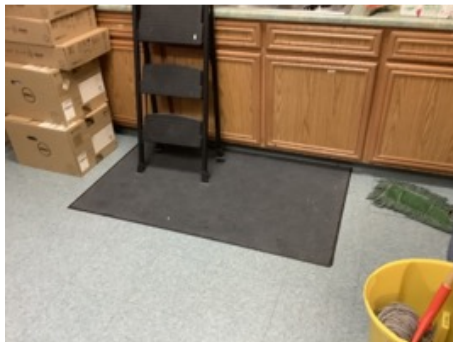
Comment #: JFK-0104

Deficiency: Interior Space - Mat - General

Carpet or carpet tile is not securely attached and is not fastened to the floor surface at edges.

Measurement: 3 count

Mat may cause tripping hazard due to not being securely attached. Carpet or carpet tile shall be securely attached and shall have a firm cushion, pad, or backing or no cushion or pad. Carpet or carpet tile shall have a level loop, textured loop, level cut pile, or level cut/uncut pile texture. Pile height shall be 1/2 inch maximum. Exposed edges of carpet shall be fastened to floor surfaces and shall have trim on the entire length of the exposed edge. Carpet edge trim shall not exceed 1/4" vertical or 1/2" maximum if beveled 2:1.

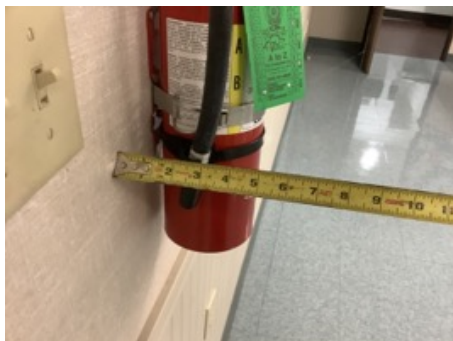
Comment #: JFK-0105

Deficiency: Accessible Route - Protrusion - Depth

Objects in the path of travel extend more than 4 inches from the wall with no cane detectable barrier.

Measurement: 4.5 inches

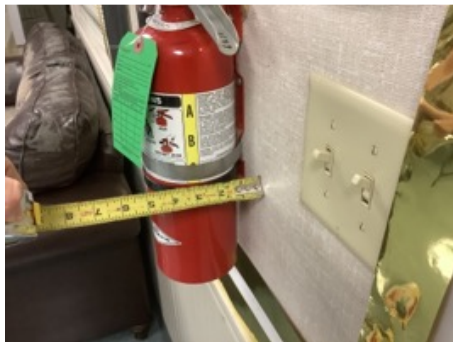
Comment #: JFK-0106

Deficiency: Accessible Route - Protrusion - Depth

Objects in the path of travel extend more than 4 inches from the wall with no cane detectable barrier.

Measurement: 5.5 inches

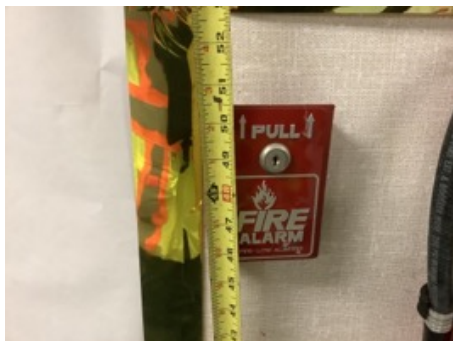
Comment #: JFK-0107

Deficiency: Manual Fire Alarm Box - Reach Ranges - Side Reach

Fire alarm exceed 48-inches maximum AFF in the process of having to lift the handle. This also requires more than one motion to set off fire alarm.

Measurement: 50 inches

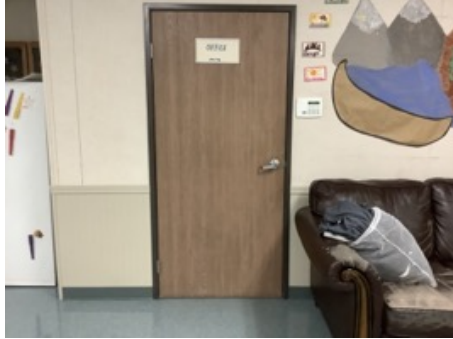
Comment #: JFK-0108

Deficiency: Interior Doors/Doorways/Gates - Clearances: Front - Latch Clearance

18-inches (exterior) not provided at latch side clearances.

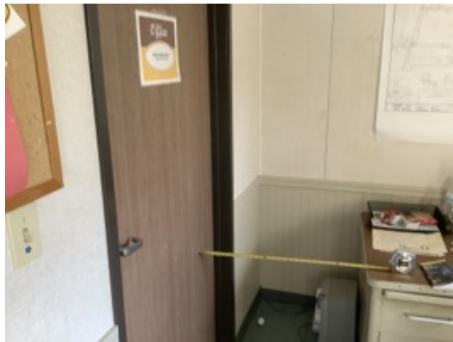
Comment #: JFK-0109

Deficiency: Interior Doors/Doorways/Gates - Clearances: Front - Push Side Approach

48-inches is not provided perpendicular to the pull side of door.

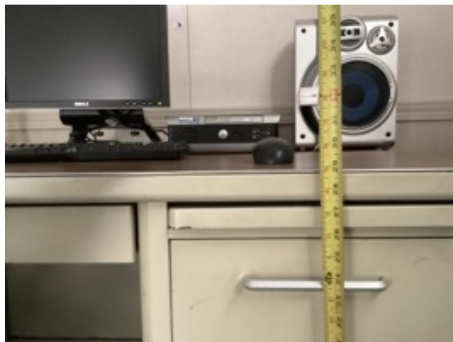
Comment #: JFK-0110

Deficiency: Work Surface - Clearances - General

The desk does not provide knee clearance of minimum 27 inches AFF.

Measurement: 24.5 inches

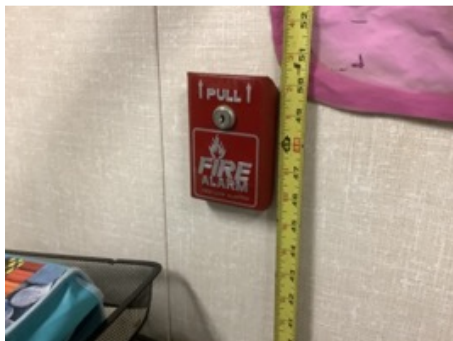
Comment #: JFK-0111

Deficiency: Manual Fire Alarm Box - Reach Ranges - Side Reach

Fire alarm exceed 48-inches maximum AFF in the process of having to lift the handle. This also requires more than one motion to set off fire alarm.

Measurement: 50 inches

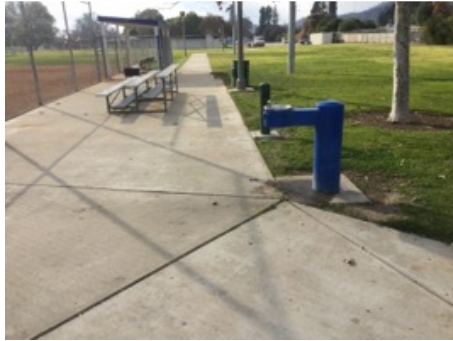
Comment #: JFK-0112

Deficiency: Drinking Fountain - Number Provided - Hi/Lo

One standing and one wheelchair accessible drinking fountain is not provided at each location.

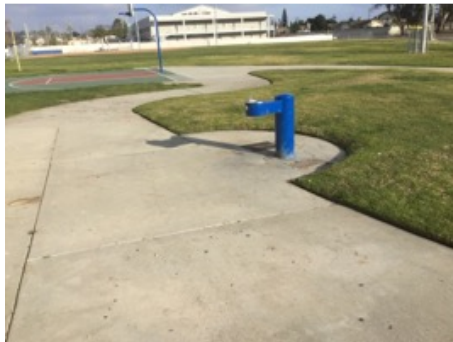
Comment #: JFK-0113

Deficiency: Drinking Fountain - Number Provided - Hi/Lo

One standing and one wheelchair accessible drinking fountain is not provided at each location.

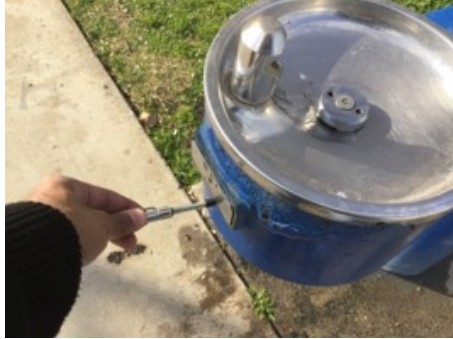
Comment #: JFK-0114

Deficiency: Drinking Fountain - Wheelchair Compliance - Operable Parts-Force

Is the force required to activate operable parts 5 pounds maximum?

Measurement: 10 pound

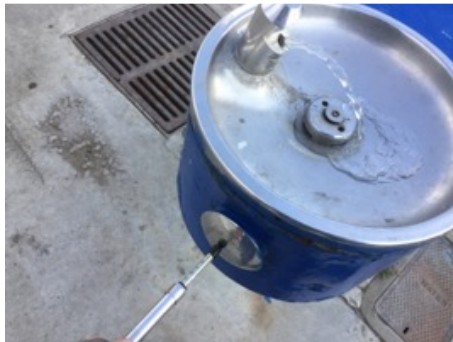
Comment #: JFK-0115

Deficiency: Drinking Fountain - Wheelchair Compliance - Operable Parts-Force

Is the force required to activate operable parts 5 pounds maximum?

Measurement: 10 pound

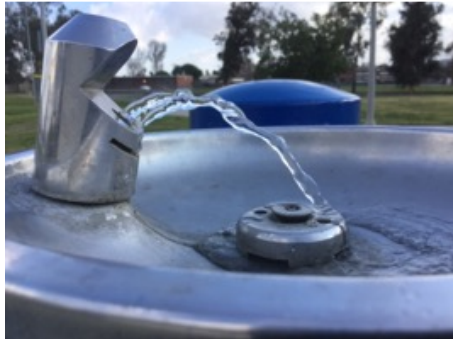
Comment #: JFK-0116

Deficiency: Drinking Fountain - Wheelchair Compliance - Water Flow

The spout does not provide a flow of water 4 high minimum.

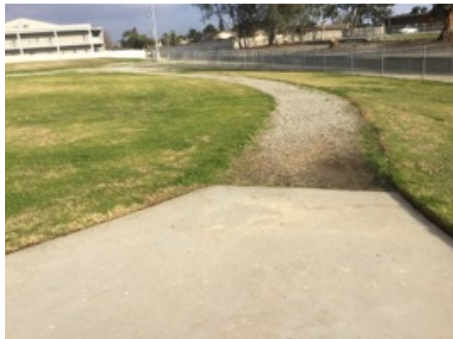
Comment #: JFK-0117

Deficiency: Accessible Route - Surface - Continuity

Accessible route does not provide a firm, stable and slip resistant surface. 500 linear feet long gravel path available along the baseball field

Replace and provide floor and/or ground surfaces that is stable, firm, and slip resistant

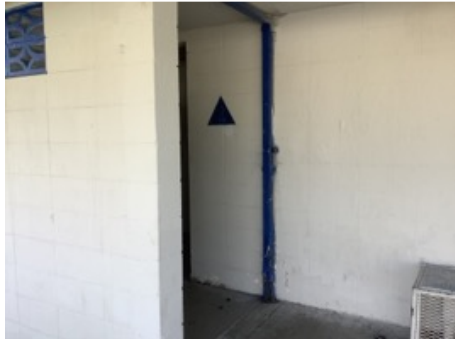
Comment #: JFK-0118

Deficiency: Restroom Doors - Tactile Sign - General

No permanent tactile restroom identification sign has been provided.

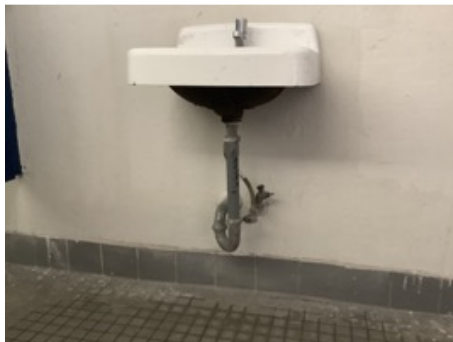
Comment #: JFK-0120

Deficiency: Lavatory - Covered Pipes/Hose Bib - General

The pipe insulation does not cover everything under the sink including water supply lines and hose bib.

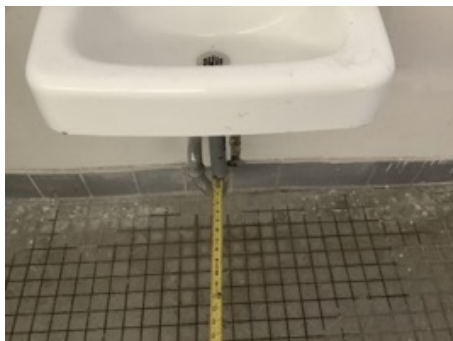
Comment #: JFK-0121

Deficiency: Lavatory - Knee/Toe Clearance - Incremental Depth

The knee clearance at the lavatory does not match the depth to reach the operable parts.

Measurement: 9 inches

Provide knee clearance at the accessible lavatory as noted below.

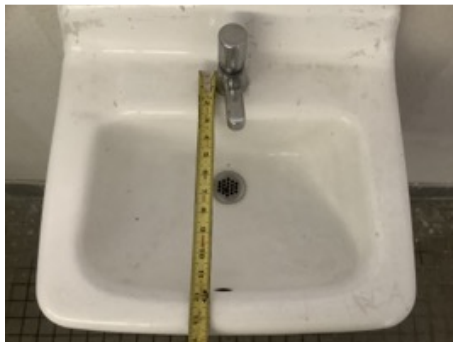
Comment #: JFK-0122

Deficiency: Lavatory - Location - Depth

Lavatory controls are less than 17-inches or more than 19 inches from the face of the lavatory.

Measurement: 13.5 inches

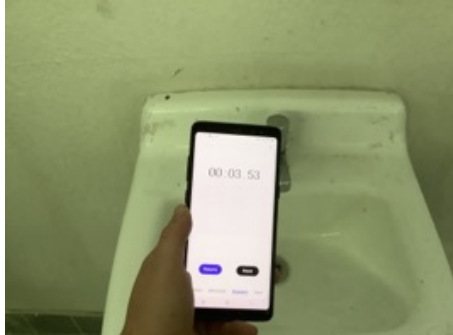
Comment #: JFK-0123

Deficiency: Lavatory - Controls - Self-Closing Valve

At 5 pounds of operating pressure the self-closing sink valve stays on less than the minimum 10 seconds.

Measurement: 3.53 seconds

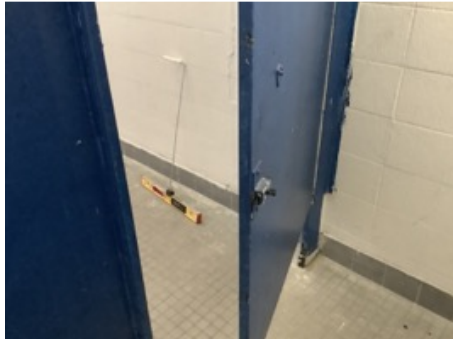
Comment #: JFK-0124

Deficiency: Accessible Toilet Stall - Door - Self-Closing Door

The stall door is not self closing.

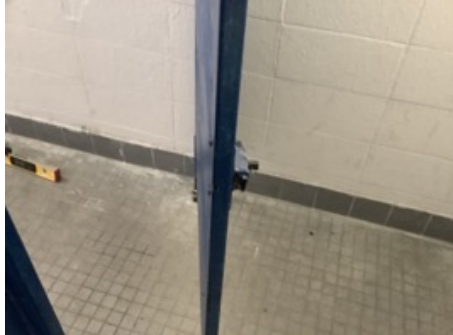
Comment #: JFK-0125

Deficiency: Accessible Toilet Stall - Door Hardware - Handle Both Sides

There is no pull handle on the interior side of the stall door.

Measurement: 0 count

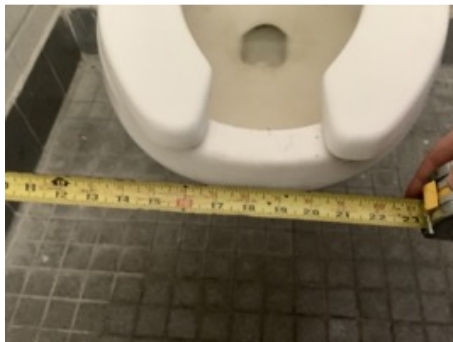
Comment #: JFK-0126

Deficiency: Accessible Toilet Stall - Water Closet - Location

The water closet is not a compliant distance from the adjacent wall.

Measurement: 18.5 inches

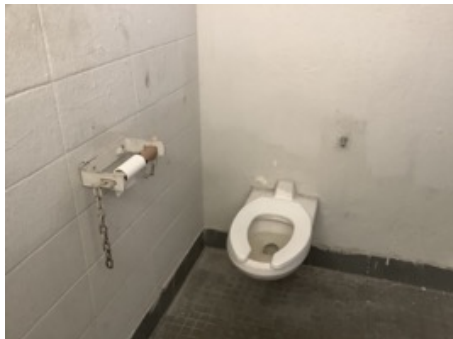
Comment #: JFK-0127

Deficiency: Accessible Toilet Stall - Side Grab Bar - General

No side wall grab bar is installed.

Measurement: 0 inches

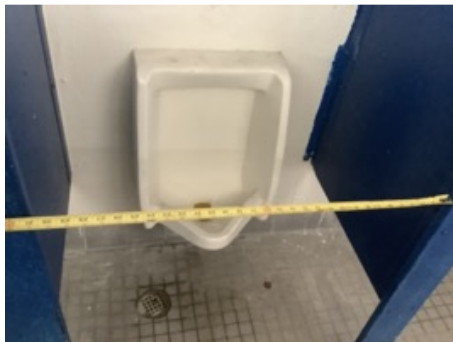
Comment #: JFK-0128

Deficiency: Urinal - Alcove Dimensions - Width

The alcove is deeper than 24 inches and does not provide the required minimum width of 36 inches.

Measurement: 31 inches

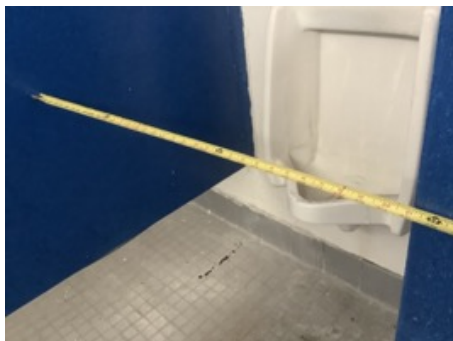
Comment #: JFK-0129

Deficiency: Urinal - Alcove Dimensions - Width

The alcove is deeper than 24 inches and does not provide the required minimum width of 36 inches.

Measurement: 35 inches

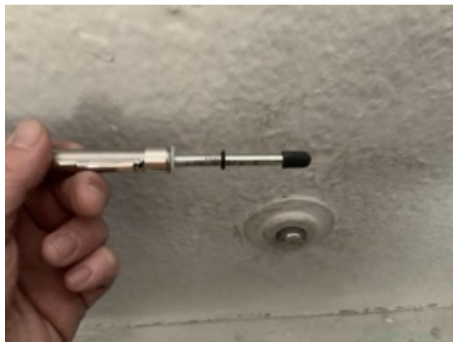
Comment #: JFK-0130

Deficiency: Urinal - Flush Control - Operation

The operable part requires tight grasping, pinching and/or twisting of the wrist to operate.

Measurement: 18 count

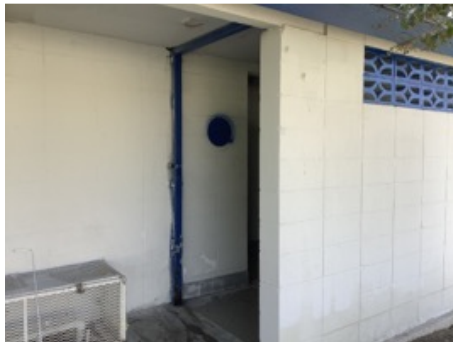
Comment #: JFK-0131

Deficiency: Restroom Doors - Tactile Sign - General

No permanent tactile restroom identification sign has been provided.

Measurement: 0 count

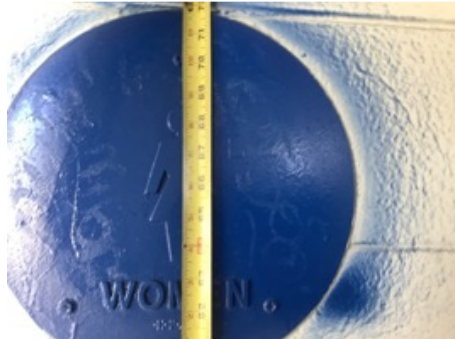
Comment #: JFK-0132

Deficiency: Restroom Doors - Geometric Sign - Height

The geometric sign is not mounted within the allowable height ranges.

Measurement: 66 inches

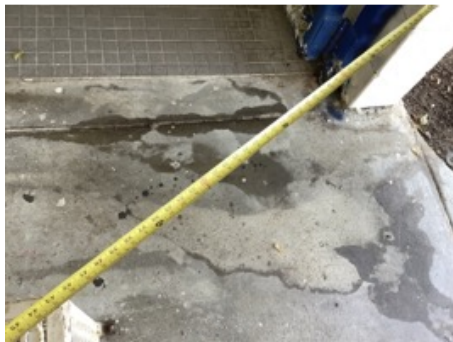
Comment #: JFK-0134

Deficiency: Restroom Access - Dimensions - Width

The clear width to the accessible stall is less than 44-inches clear.

Measurement: 43 inches

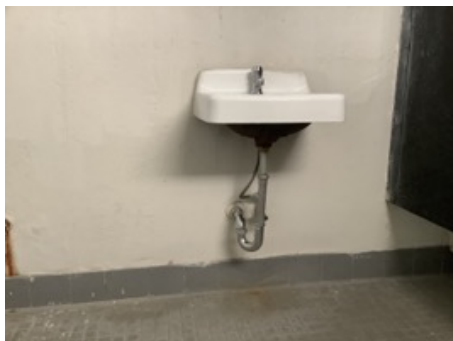
Comment #: JFK-0135

Deficiency: Lavatory - Covered Pipes/Hose Bib - General

The pipe insulation does not cover everything under the sink including water supply lines and hose bib.

Measurement: 1 count

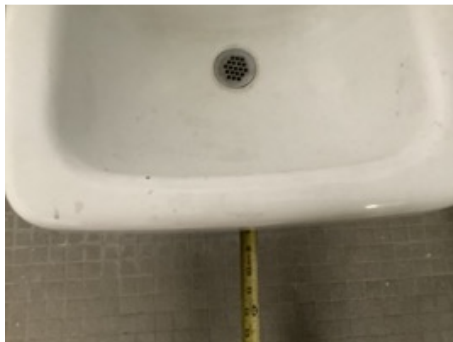
Comment #: JFK-0136

Deficiency: Lavatory - Knee/Toe Clearance - Incremental Depth

The knee clearance at the lavatory does not match the depth to reach the operable parts.

Measurement: 8 inches

Provide knee clearance at the accessible lavatory as noted below.

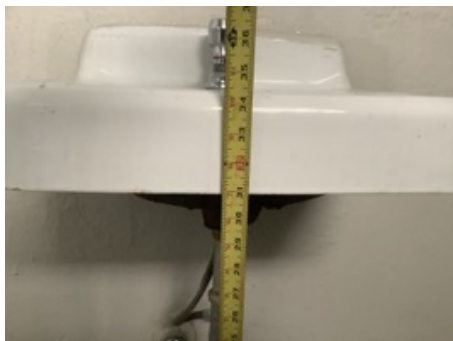
Comment #: JFK-0137

Deficiency: Lavatory - Counter Surface - Height

The height of the lavatory counter surface exceeds the allowable 34 inches AFF.

Measurement: 34.5 inches

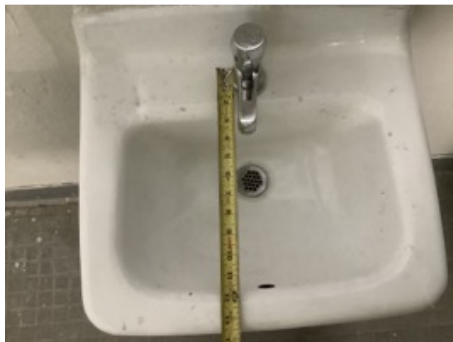
Comment #: JFK-0138

Deficiency: Lavatory - Location - Depth

Lavatory controls are less than 17-inches or more than 19 inches from the face of the lavatory.

Measurement: 13.5 inches

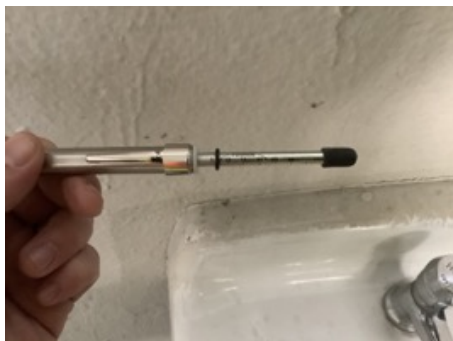
Comment #: JFK-0139

Deficiency: Lavatory - Controls - Operational Force

At 5 pounds of operating pressure the self-closing sink valve stays on less than the minimum 10 seconds.

Measurement: 7 lbf

Replace with lever operated, push type, or electronically controlled mechanisms, or approved controls with 5 lbf maximum operating force. Self-closing valves shall remain on for at least 10 seconds.

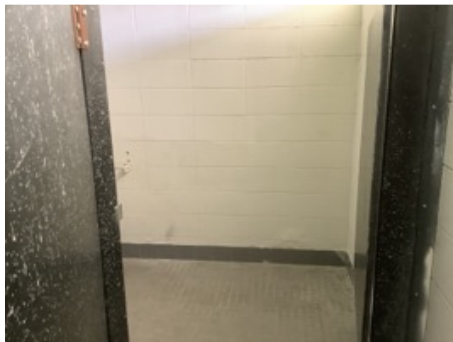
Comment #: JFK-0140

Deficiency: Accessible Toilet Stall - Door - Self-Closing Door

The stall door is not self closing.

Measurement: 1 count

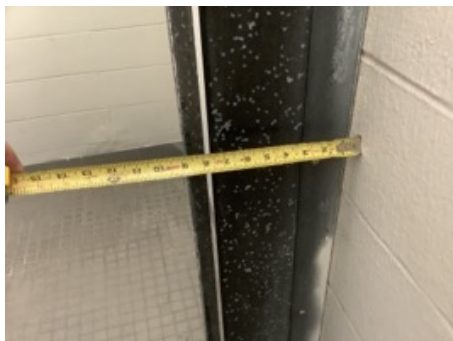
Comment #: JFK-0141

Deficiency: Accessible Toilet Stall - Side Opening Door - 4-Inch Clearance

Where located in the side wall or partition, the door opening shall be 4 inches (102 mm) maximum from the front partition.

Measurement: 7.5 inches

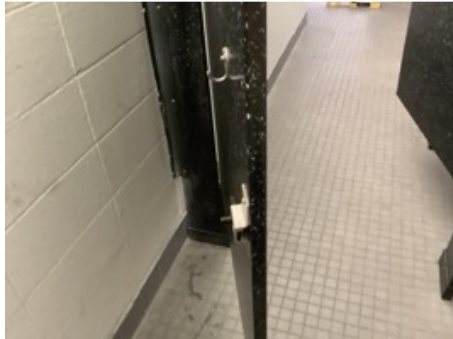
Comment #: JFK-0142

Deficiency: Accessible Toilet Stall - Door Hardware - Handle Both Sides

There is no pull handle on the interior side of the stall door.

Measurement: 0 count

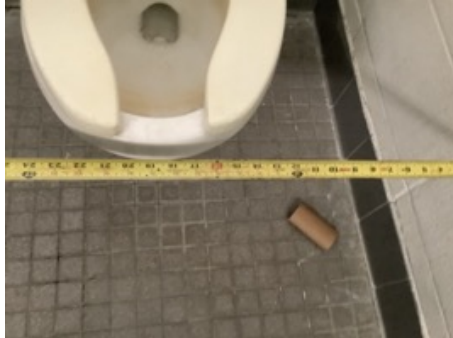
Comment #: JFK-0143

Deficiency: Accessible Toilet Stall - Water Closet - Location

The water closet is not a compliant distance from the adjacent wall.

Measurement: 18.5 inches

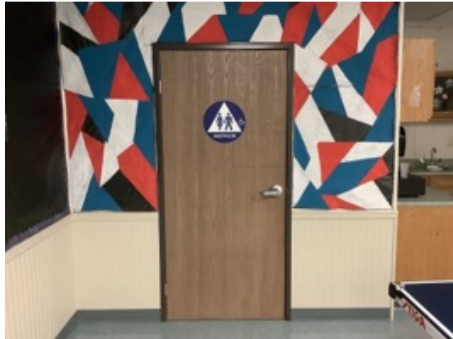
Comment #: JFK-0144

Deficiency: Restroom Doors - Tactile Sign - General

No permanent tactile restroom identification sign has been provided.

Measurement: 0 count

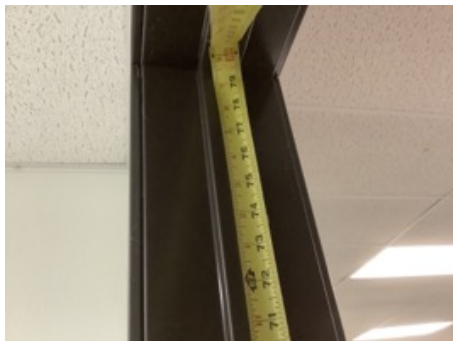
Comment #: JFK-0145

Deficiency: Restroom Doors - Dimensions - Clear Height

The door does not provide clear height.

Measurement: 79.5 inches

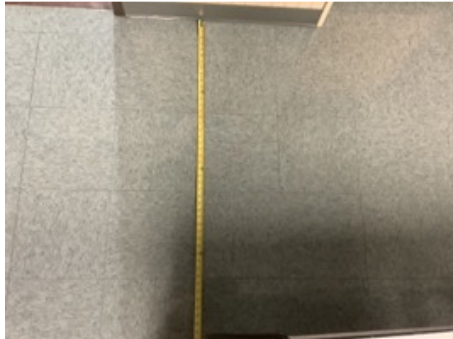
Comment #: JFK-0146

Deficiency: Restroom Doors - Clearances: Front - Latch Clearance

Latch side clearance is not provided at the pull side of the door.

Measurement: 13 inches

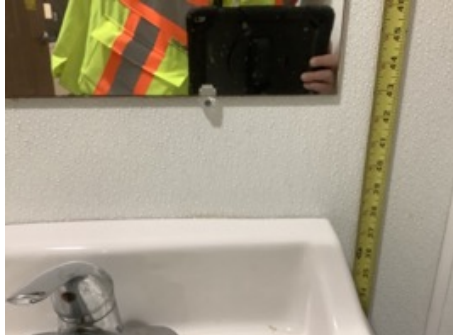
Comment #: JFK-0147

Deficiency: Restroom Interior Space - Amenities - Mirror Height

The mirror height exceeds the allowable 40 inches above the finished floor.

Measurement: 42.75 inches

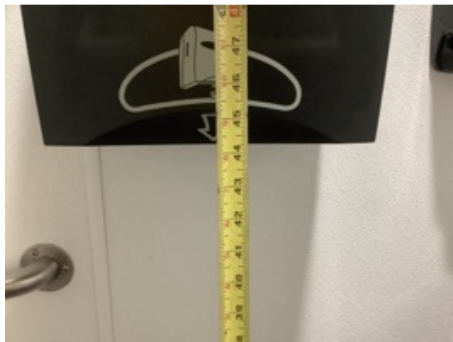
Comment #: JFK-0148

Deficiency: Restroom Interior Space - Protruding Objects - General

Objects in the restroom extend more than 4 inches from the wall with no cane detectable barrier.

Measurement: 10 inches

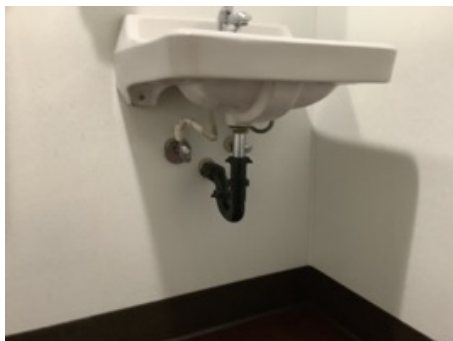
Comment #: JFK-0149

Deficiency: Lavatory - Covered Pipes/Hose Bib - General

The pipe insulation does not cover everything under the sink including water supply lines and hose bib.

Measurement: 0 count

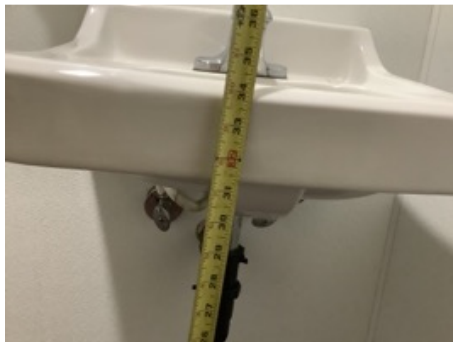
Comment #: JFK-0150

Deficiency: Lavatory - Counter Surface - Height

The height of the lavatory counter surface exceeds the allowable 34 inches AFF.

Measurement: 34.25 inches

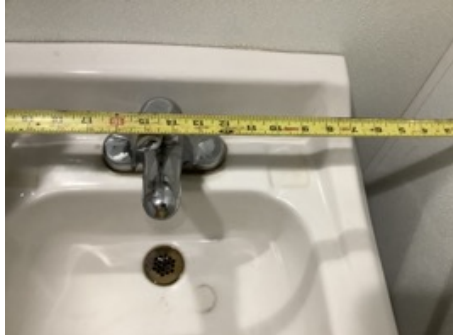
Comment #: JFK-0151

Deficiency: Lavatory - Location - Centerline Distance

The lavatory is not located so that the distance to the adjacent side wall is minimum 18 inches.

Measurement: 14.5 inches

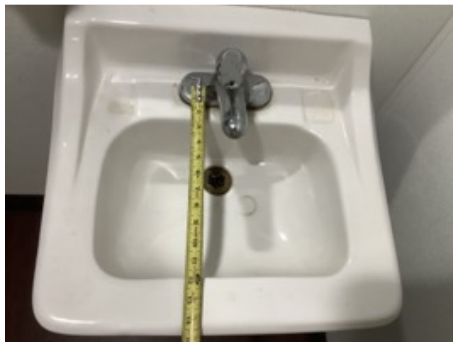
Comment #: JFK-0152

Deficiency: Lavatory - Location - Depth

Lavatory controls are more than 19 inches from the face of the lavatory.

Measurement: 14.5 inches

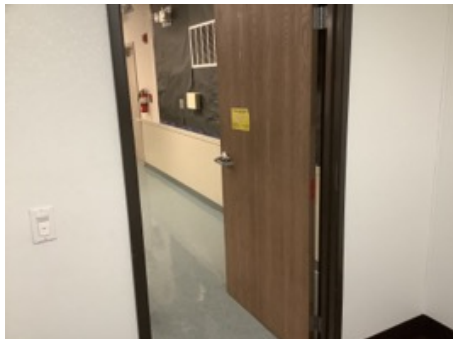
Comment #: JFK-0153

Deficiency: Accessible Toilet Stall - Door - Self-Closing Door

The stall door is not self closing.

Measurement: 0 count

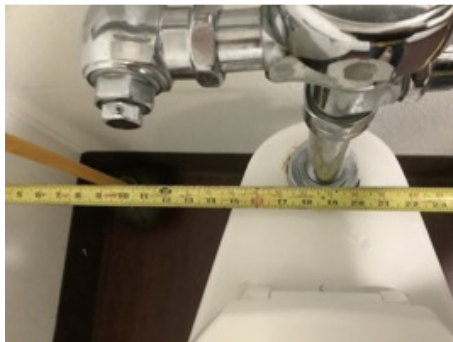
Comment #: JFK-0154

Deficiency: Accessible Toilet Stall - Water Closet - Location

The water closet is not a compliant distance from the adjacent wall.

Measurement: 18.75 inches

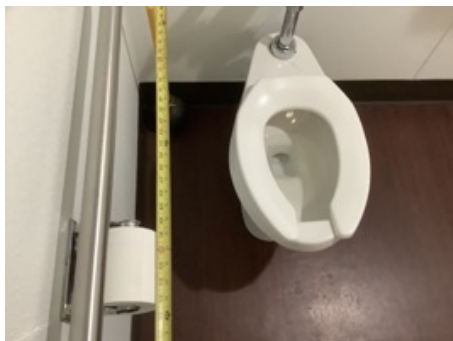
Comment #: JFK-0155

Deficiency: Accessible Toilet Stall - Dispensers - Toilet Paper Location

The toilet paper dispenser is outside of the allowable reach range.

Measurement: 5 inches

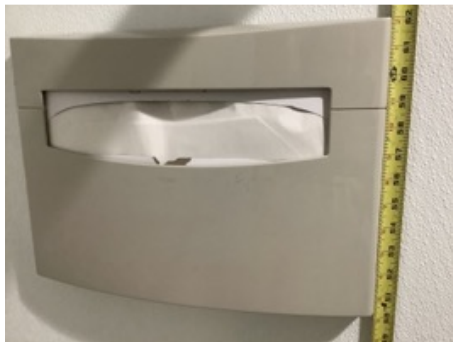
Comment #: JFK-0156

Deficiency: Accessible Toilet Stall - Dispensers - Seat Cover Height

The height of the operable part of the provided seat cover dispenser exceeds the allowable 40 inches AFF, is not located on an accessible route, no 30" x 48" clear floor space and reaching over water closet.

Measurement: 59 inches

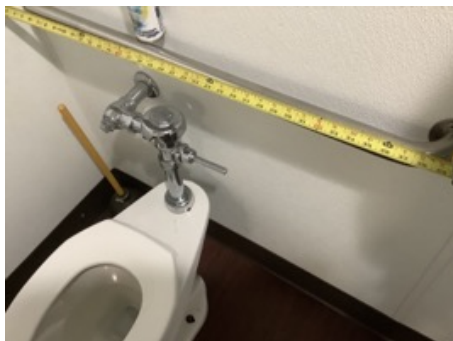
Comment #: JFK-0157

Deficiency: Accessible Toilet Stall - Rear Grab Bar - Open Side Distance From Centerline

The rear grab bar does not extend the full 24 inches past the centerline of the water closet.

Measurement: 20.5 inches

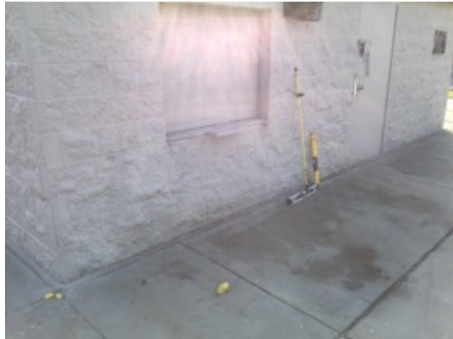
Comment #: JC-001

Deficiency: Accessible Route - Protrusion - Depth

Objects in the path of travel extend more than 4 inches from the wall with no cane detectable barrier. Bottom of counter is 32.5 inches AFF

Measurement: 6 inches

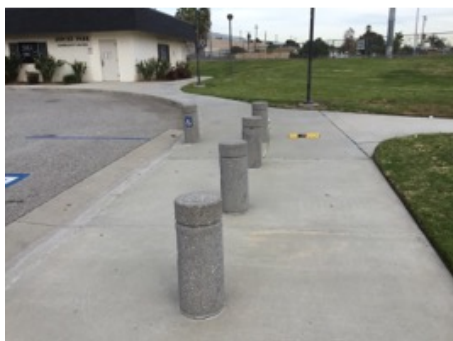
Comment #: JC-002

Deficiency: Accessible Route - Slopes - Running Slope

The slope in the direction of travel exceeds the allowable 5%.

Measurement: 4.9 % grade

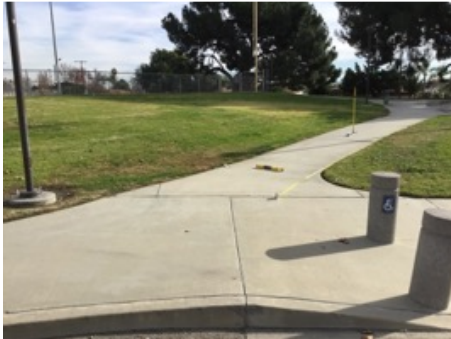
Comment #: JC-003

Deficiency: Accessible Route - Slopes - Running Slope

The slope in the direction of travel exceeds the allowable 5%.

Measurement: 6.1 % grade

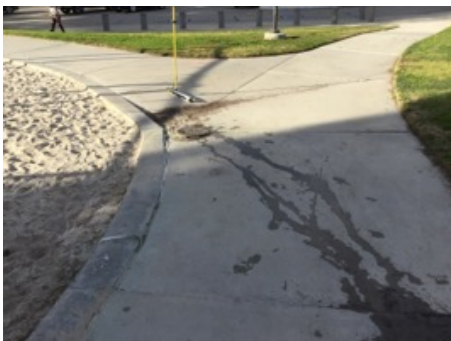
Comment #: JC-004

Deficiency: Accessible Route - Slopes - Running Slope

The slope in the direction of travel exceeds the allowable 5%.

Measurement: 5.5 % grade

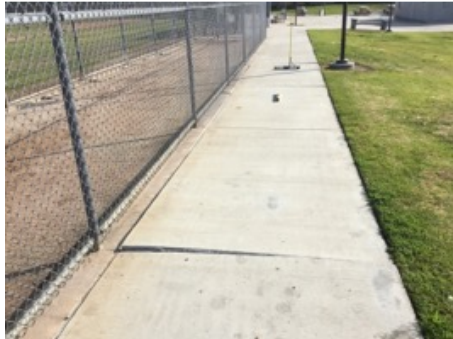
Comment #: JC-005

Deficiency: Accessible Route - Slopes - Running Slope

The slope in the direction of travel exceeds the allowable 5%.

Measurement: 2.5 % grade

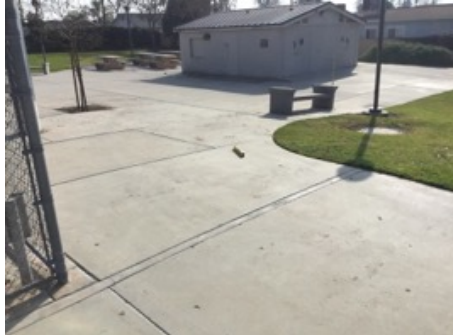
Comment #: JC-006

Deficiency: Accessible Route - Slopes - Running Slope

The slope in the direction of travel exceeds the allowable 5%.

Measurement: 6 % grade

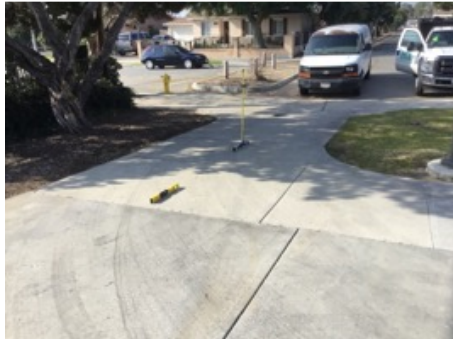
Comment #: JC-007

Deficiency: Accessible Route - Slopes - Running Slope

The slope in the direction of travel exceeds the allowable 5%.

Measurement: 6.7 % grade

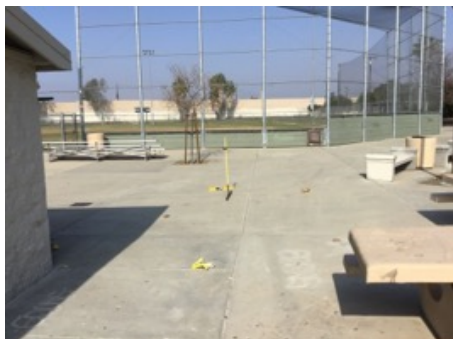
Comment #: JC-008

Deficiency: Accessible Route - Slopes - Running Slope

The slope in the direction of travel exceeds the allowable 5% and cross slopes are 2.3%.

Measurement: 7.1 % grade

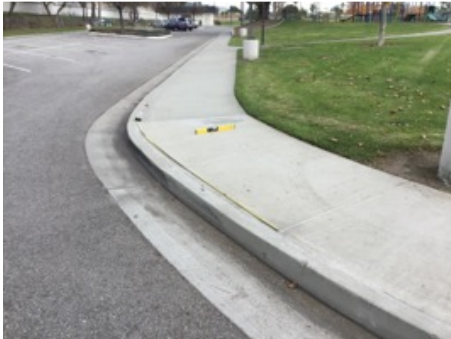
Comment #: JC-009

Deficiency: Accessible Route - Slopes - Cross Slope

The cross slope of accessible routes exceeds 1:48 (2.0 %). Replace two panels.

Measurement: 4 % grade

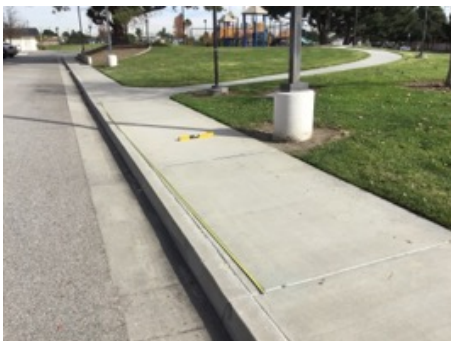
Comment #: JC-010

Deficiency: Accessible Route - Slopes - Cross Slope

The cross slope of accessible routes exceeds 1:48 (2.0 %).

Measurement: 3.1 % grade

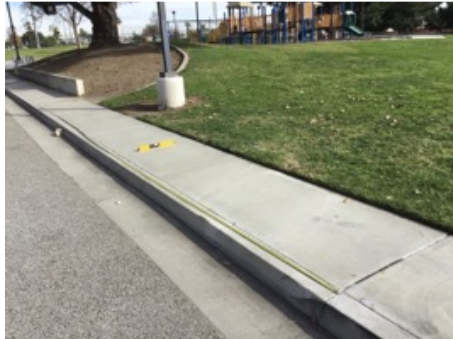
Comment #: JC-011

Deficiency: Accessible Route - Slopes - Cross Slope

The cross slope of accessible routes exceeds 1:48 (2.0 %).

Measurement: 3.6 % grade

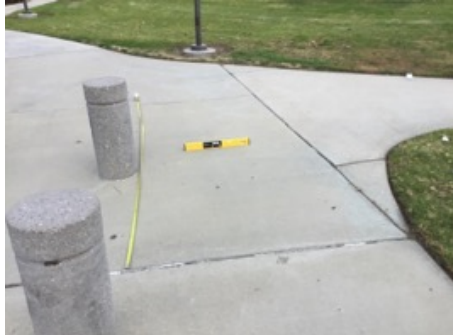
Comment #: JC-012

Deficiency: Accessible Route - Slopes - Cross Slope

The cross slope of accessible routes exceeds 1:48 (2.0 %).

Measurement: 3 % grade

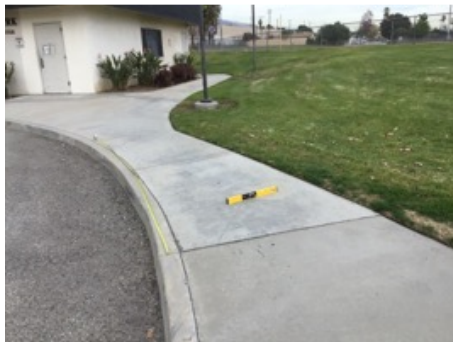
Comment #: JC-013

Deficiency: Accessible Route - Slopes - Cross Slope

The cross slope of accessible routes exceeds 1:48 (2.0 %).

Measurement: 3.7 % grade

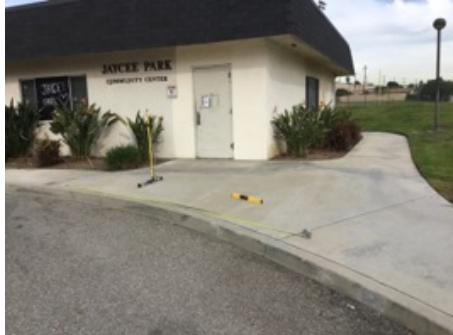
Comment #: JC-014

Deficiency: Accessible Route - Slopes - Cross Slope

The cross slope of accessible routes exceeds 1:48 (2.0 %).

Measurement: 6.2 % grade

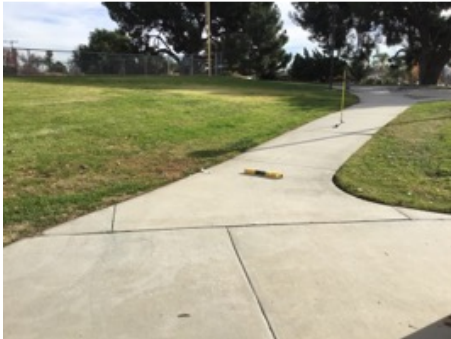
Comment #: JC-015

Deficiency: Accessible Route - Slopes - Cross Slope

The cross slope of accessible routes exceeds 1:48 (2.0 %).

Measurement: 4.3 % grade

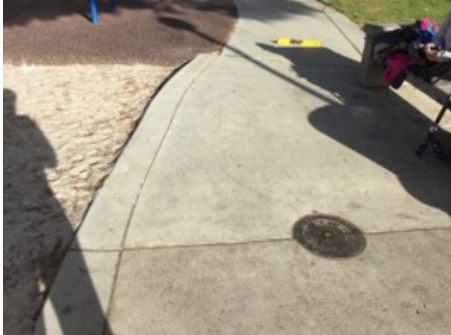
Comment #: JC-016

Deficiency: Accessible Route - Slopes - Cross Slope

The cross slope of accessible routes exceeds 1:48 (2.0 %).

Measurement: 2.7 % grade

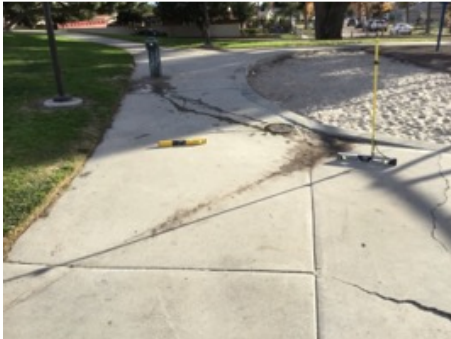
Comment #: JC-017

Deficiency: Accessible Route - Slopes - Cross Slope

The cross slope of accessible routes exceeds 1:48 (2.0 %).

Measurement: 2.8 % grade

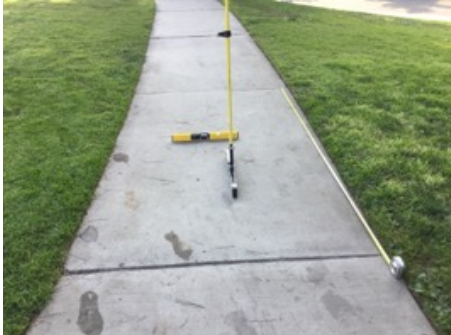
Comment #: JC-018

Deficiency: Accessible Route - Slopes - Cross Slope

The cross slope of accessible routes exceeds 1:48 (2.0 %).

Measurement: 2.6 % grade

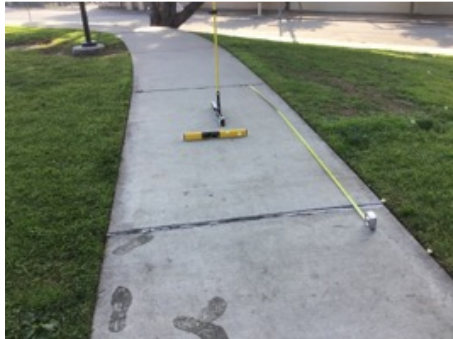
Comment #: JC-019

Deficiency: Accessible Route - Slopes - Cross Slope

The cross slope of accessible routes exceeds 1:48 (2.0 %). 11 panels 60 SF each, 6 feet wide walk

Measurement: 3.9 % grade

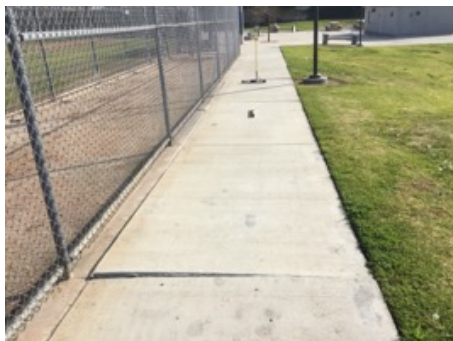
Comment #: JC-020

Deficiency: Accessible Route - Slopes - Cross Slope

The cross slope of accessible routes exceeds 1:48 (2.0 %).

Measurement: 2.7 % grade

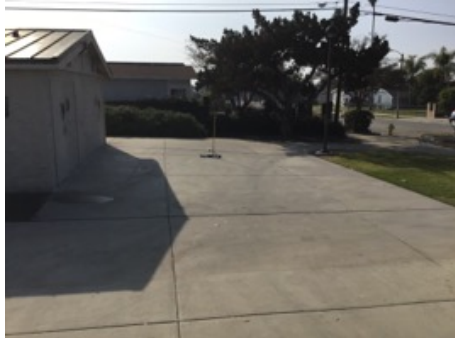
Comment #: JC-022

Deficiency: Accessible Route - Slopes - Cross Slope

The cross slope of accessible routes exceeds 1:48 (2.0 %).

Measurement: 7.7 % grade

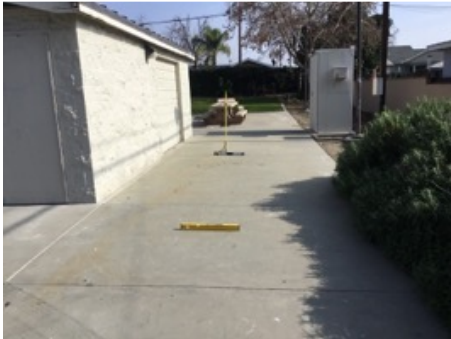
Comment #: JC-023

Deficiency: Accessible Route - Slopes - Cross Slope

The cross slope of accessible routes exceeds 1:48 (2.0 %).

Measurement: 3.8 % grade

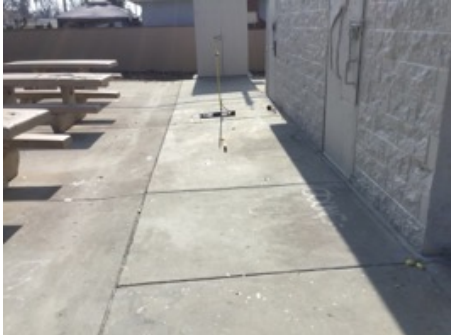
Comment #: JC-024

Deficiency: Accessible Route - Slopes - Cross Slope

The cross slope of accessible routes exceeds 1:48 (2.0 %).

Measurement: 4.5 % grade

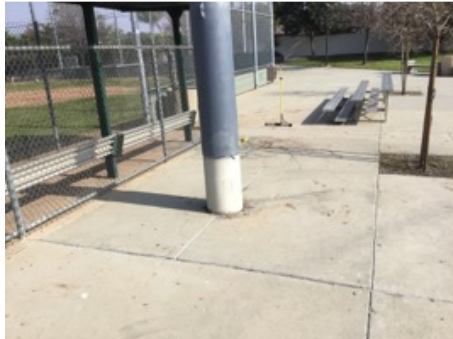
Comment #: JC-025

Deficiency: Accessible Route - Slopes - Cross Slope

The cross slope of accessible routes exceeds 1:48 (2.0 %).

Measurement: 2.9 % grade

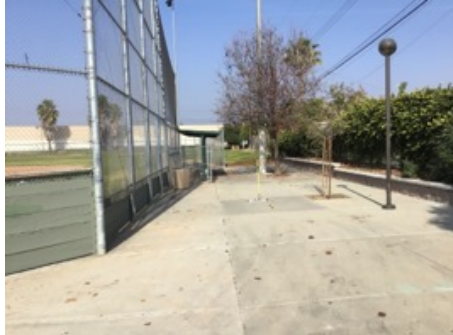
Comment #: JC-026

Deficiency: Accessible Route - Slopes - Cross Slope

The cross slope of accessible routes exceeds 1:48 (2.0 %).

Measurement: 3.4 % grade

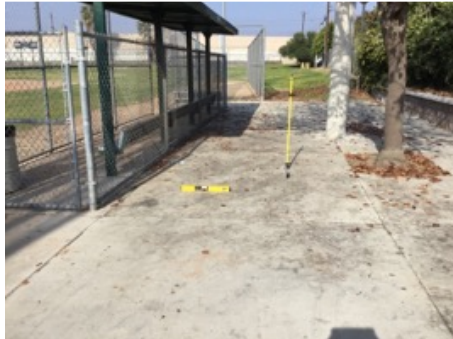
Comment #: JC-027

Deficiency: Accessible Route - Slopes - Cross Slope

The cross slope of accessible routes exceeds 1:48 (2.0 %).

Measurement: 2.7 % grade

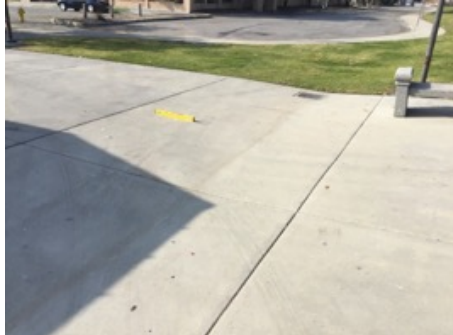
Comment #: JC-028

Deficiency: Ramps - Slopes - Running Slope

The running slope of the ramp is 8.2% and is considered a ramp requiring landings and handrails.

Measurement: 8.2 % grade

Remove and replace the ramp. The running slope of the curb ramp segments shall be in-line with the direction of sidewalk travel. Ramp runs shall have a running slope not steeper than 1:12.

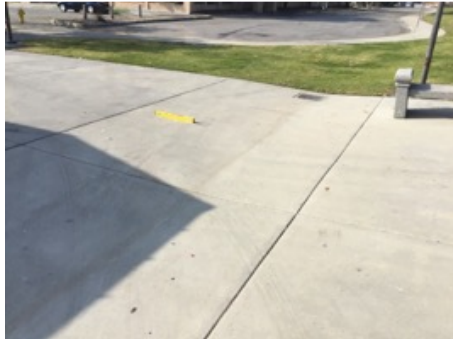
Comment #: JC-029

Deficiency: Ramps - Handrails - Both Sides

Handrails are not provided on both sides of the ramp.

Measurement: 8.2 count

Install missing handrails so they are provided on both sides of stairs and ramps.

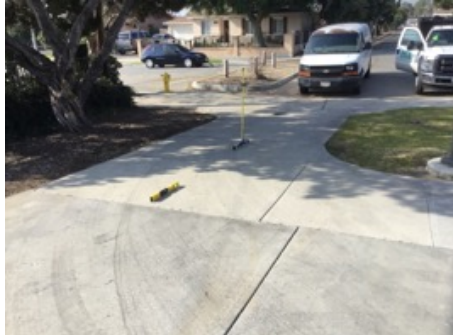
Comment #: JC-030

Deficiency: Ramps - Handrails - Both Sides

Handrails are not provided on both sides of the ramp.

Measurement: 6.7 count

Install missing handrails so they are provided on both sides of stairs and ramps.

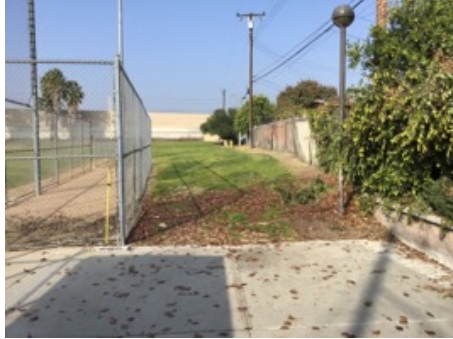
Comment #: JC-031

Deficiency: Accessible Routes - All Routes - Connect Bldg Route

There is not an accessible route that connects accessible buildings or facility, elements within the same site including areas of sport activity. No walk between site approach at end of street and walk at east side of park.

Measurement: 0 count

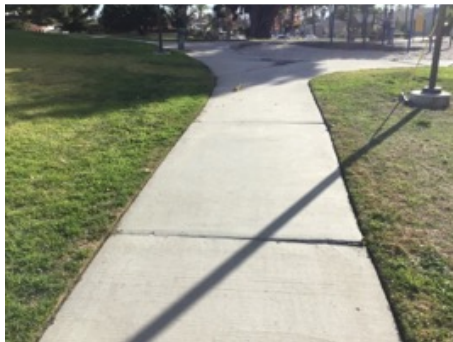
Comment #: JC-032

Deficiency: Accessible Route - Vertical Displacement - Height

Accessible route has multiple locations where changes in level over 1/4" vertical or 1/2" beveled occur.

Measurement: .75 inches

Replace/grind locations where changes in elevation occur. Changes in level of 1/4" high maximum shall be permitted to be vertical and without edge treatment. Changes in level between 1/4" high minimum and 1/2" high maximum shall be beveled with a slope not steeper than 1:2. ADA Advisory: Change in level of 1/2" is permitted to be 1/4" vertical plus 1/4" beveled.

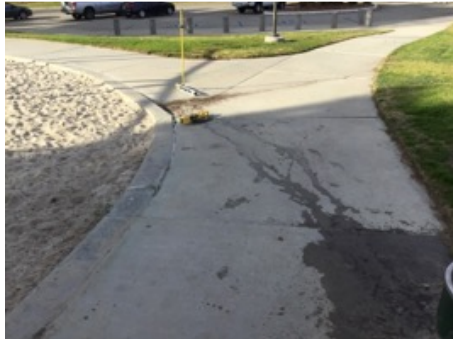
Comment #: JC-033

Deficiency: Accessible Route - Vertical Displacement - Height

Accessible route has multiple locations where changes in level over 1/4" vertical or 1/2" beveled occur.

Measurement: 1.5 inches

Replace/grind locations where changes in elevation occur. Changes in level of 1/4" high maximum shall be permitted to be vertical and without edge treatment.

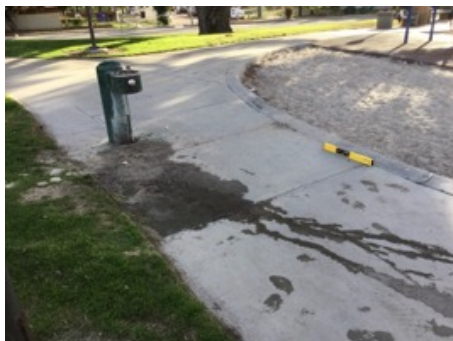
Comment #: JC-034

Deficiency: Accessible Route - Vertical Displacement - Height

Accessible route has multiple locations where changes in level over 1/4" vertical or 1/2" beveled occur.

Measurement: .75 inches

Replace/grind locations where changes in elevation occur. Changes in level of 1/4" high maximum shall be permitted to be vertical and without edge treatment.

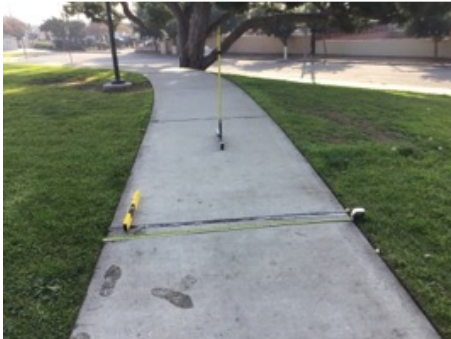
Comment #: JC-035

Deficiency: Accessible Route - Vertical Displacement - Height

Accessible route has multiple locations where changes in level over 1/4" vertical or 1/2" beveled occur.

Measurement: .75 inches

Replace/grind locations where changes in elevation occur. Changes in level of 1/4" high maximum shall be permitted to be vertical and without edge treatment. Changes in level between 1/4" high minimum and 1/2" high maximum shall be beveled with a slope not steeper than 1:2. ADA Advisory: Change in level of 1/2" is permitted to be 1/4" vertical plus 1/4" beveled.

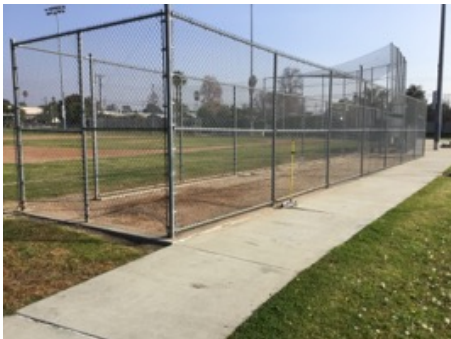
Comment #: JC-036

Deficiency: Accessible Route - Vertical Displacement - Height

Accessible route has multiple locations where changes in level over 1/4" vertical or 1/2" beveled occur.

Measurement: 1.25 inches

Replace/grind locations where changes in elevation occur. Changes in level of 1/4" high maximum shall be permitted to be vertical and without edge treatment. Changes in level between 1/4" high minimum and 1/2" high maximum shall be beveled with a slope not steeper than 1:2. ADA Advisory: Change in level of 1/2" is permitted to be 1/4" vertical plus 1/4" beveled.

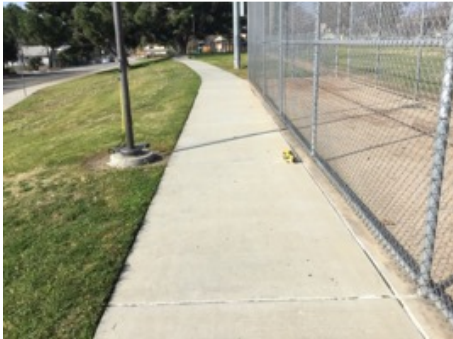
Comment #: JC-037

Deficiency: Accessible Route - Vertical Displacement - Height

Accessible route has multiple locations where changes in level over 1/4" vertical or 1/2" beveled occur.

Measurement: .88 inches

Replace/grind locations where changes in elevation occur. Changes in level of 1/4" high maximum shall be permitted to be vertical and without edge treatment.

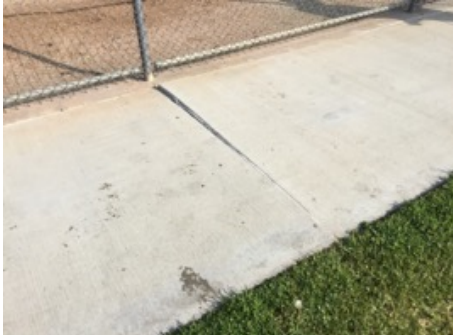
Comment #: JC-038

Deficiency: Accessible Route - Vertical Displacement - Bevelment Slope

Accessible route has multiple locations where changes in level over 1/4" vertical or 1/2" beveled occur.

Measurement: 1.25 inches

Replace/grind locations where changes in elevation occur. Changes in level of 1/4" high maximum shall be permitted to be vertical and without edge treatment.

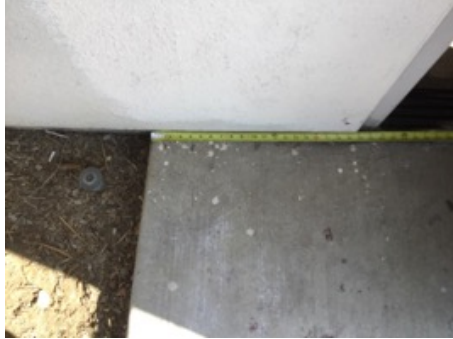
Comment #: JC-039

Deficiency: Exterior Doors/Doorways/Gates - Clearances: Front - Latch Clearance

24-inches (exterior) not provided at latch side clearances.

Measurement: 21.5

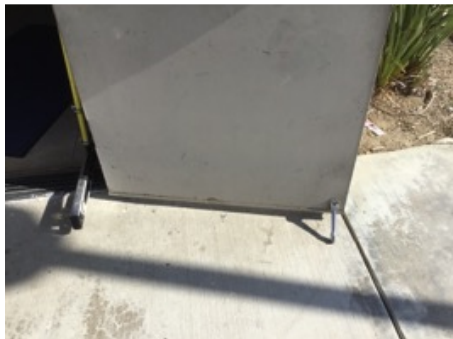
Comment #: JC-040

Deficiency: Exterior Doors/Doorways/Gates - Hardware - Smooth Surface

Lower 10 inches of door is not smooth.

Measurement: 2 inches

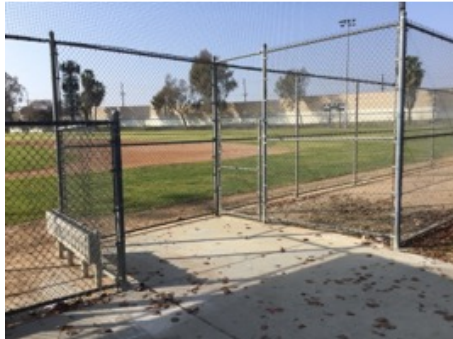
Comment #: JC-041

Deficiency: Exterior Doors/Doorways/Gates - Hardware - Smooth Surface

Lower 10 inches of door is not smooth.

Measurement: 3.5 inches

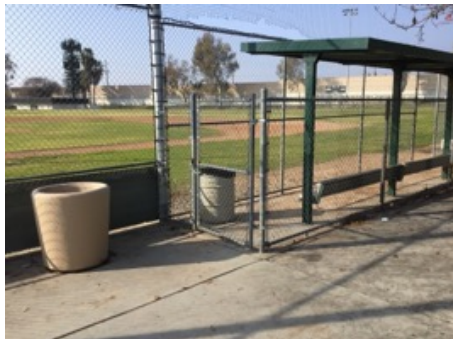
Comment #: JC-042

Deficiency: Exterior Doors/Doorways/Gates - Hardware - Smooth Surface

Lower 10 inches of door is not smooth.

Measurement: 3.5 inches

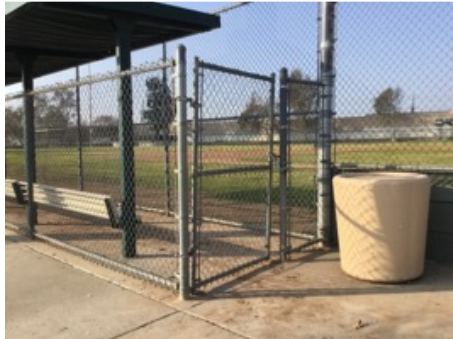
Comment #: JC-043

Deficiency: Exterior Doors/Doorways/Gates - Hardware - Smooth Surface

Lower 10 inches of door is not smooth.

Measurement: 3.5 inches

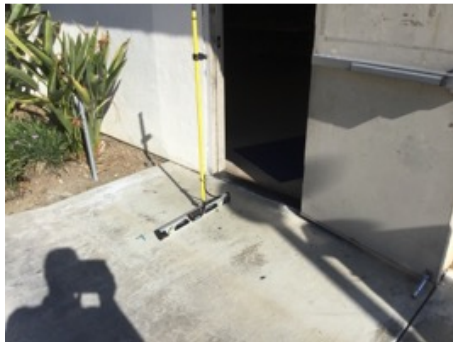
Comment #: JC-044

Deficiency: Exterior Doors/Doorways/Gates - Landing - Slopes

Slopes more than 1:48 (2%) grade, or changes in elevation are located at door landings. Interior landing is level, but exterior landing has running slope of 4.5% (with cross slope of 1.3%).

Measurement: 4.5 % grade

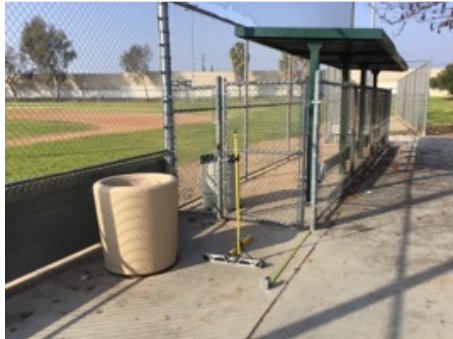
Comment #: JC-045

Deficiency: Exterior Doors/Doorways/Gates - Landing - Slopes

Slopes more than 1:48 (2%) grade, or changes in elevation are located at door landings.

Measurement: 2.5 % grade

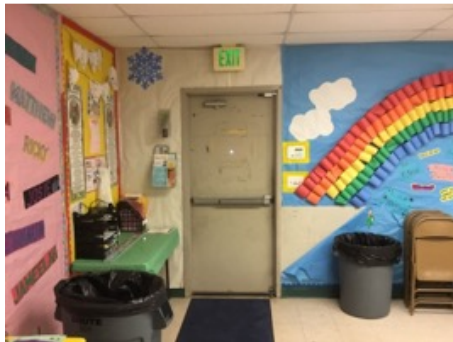
Comment #: JC-046

Deficiency: Exterior Doors/Doorways/Gates - Tactile Sign - General

No permanent tactile exit sign has been provided.

Measurement: 0 count
