APPENDIX A

FACILITY ASSESSMENT PHOTO REPORTS

CITY HALL

1.0 Site Assessment

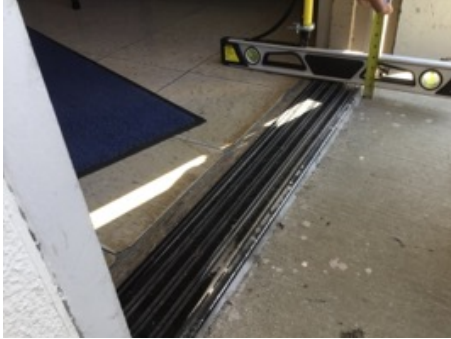
Comment #: JC-047

Deficiency: Exterior Doors/Doorways/Gates - Threshold - Height

The threshold height exceeds the allowable tolerances.

Measurement: .75 inches

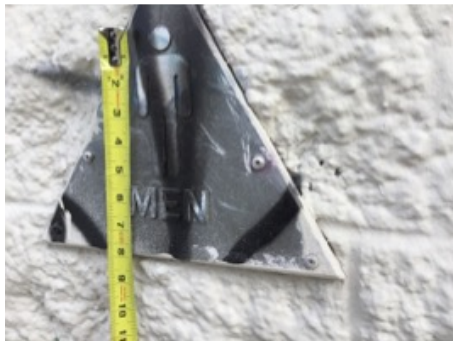
Comment #: JC-048

Deficiency: Exterior Doors/Doorways/Gates - Tactile Sign - Pictogram Field Size

The provided pictogram field height is less than the allowable 6 inches.

Measurement: 5.5 inches

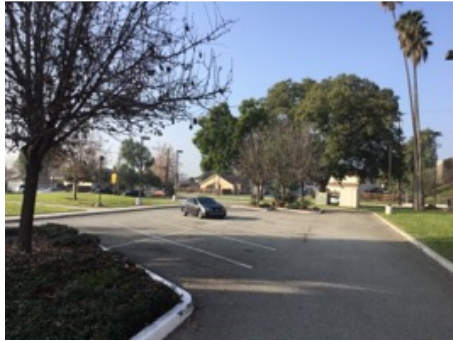
Comment #: JC-049

Deficiency: Parking - General Parking - Total Space Count

Total parking spaces found. There are 32 parking spaces in the parking lot. However, there is not an accessible parking area. Instead, there is an area in the parking lot, between the play equipment area and the community center building, that has a configuration for 2 accessible passenger unloading/loading spaces. Parents drop off and pick up their children for an after-school program

Measurement: 0 count

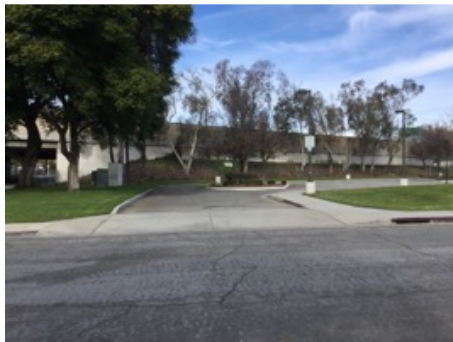
Comment #: JC-050

Deficiency: Parking - Tow Away Sign - General

There is no "Unauthorized Parking Sign" sign at the entrance to the off-street parking.

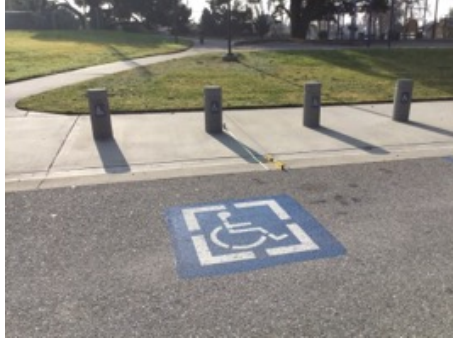
Comment #: JC-051

Deficiency: Parking - Signage - Van Stall

The van accessible stall is not identified with the words "Van Accessible".

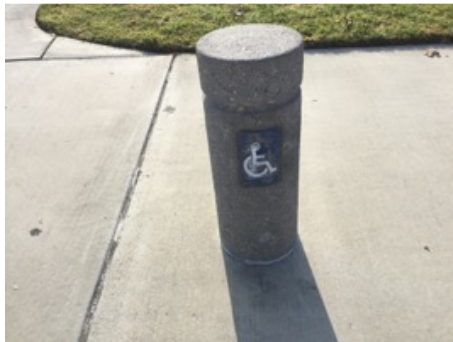
Comment #: JC-052

Deficiency: Parking - Signage - Height

The bottom of the sign is lower than 60 inches (1524 mm) above the finished floor.

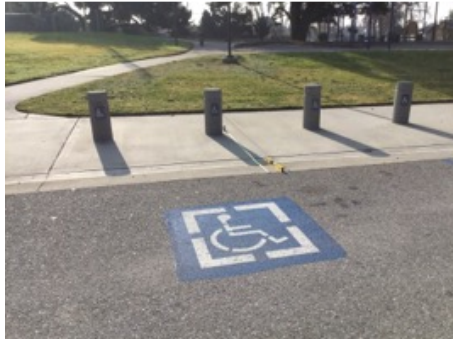
Comment #: JC-053

Deficiency: Parking - Signage - Minimum Fine

The parking identification sign does not include the text "Minimum Fine \$250" below the ISA.

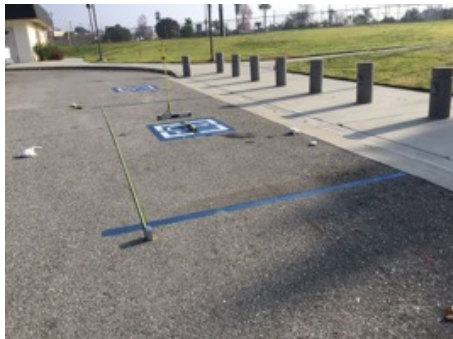
Comment #: JC-054

Deficiency: Passenger Drop-off/Loading - Access Aisle - Floor and ground surfaces

No access aisles provided. 7.5% slope due to gutter between parking stall and adjacent walk.

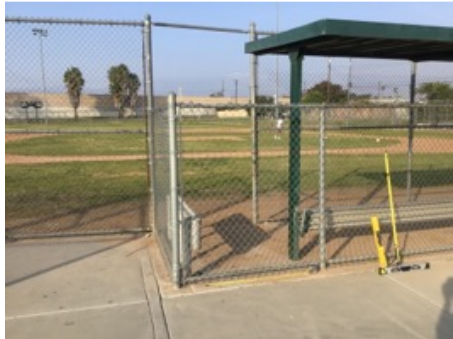
Comment #: JC-056

Deficiency: Area of Sport Activity - Team or player seating - Wheelchair Space

At least one wheelchair space providing a 1:48 maximum slope is not provided in team or player seating areas serving areas of sport activity and/or is not located on an accessible route. While space is provided, it is not under the shade structure.

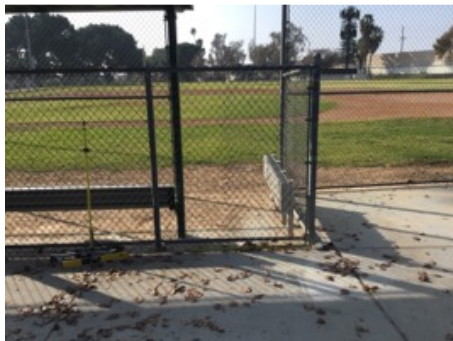
Comment #: JC-057

Deficiency: Area of Sport Activity - Team or player seating - Wheelchair Space

At least one wheelchair space providing a 1:48 maximum slope is not provided in team or player seating areas serving areas of sport activity and/or is not located on an accessible route.

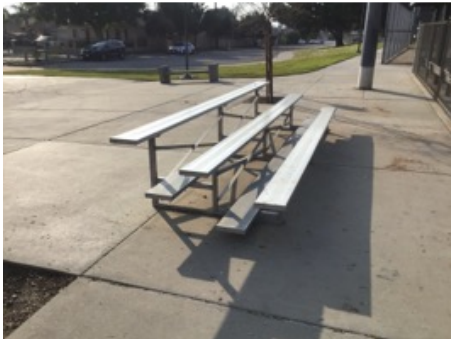
Comment #: JC-058

Deficiency: Bleachers - Wheelchair Seating - Location

Wheelchair spaces are not an integral part of bleacher seating. Each of 3 benches approximately 16 feet long. 24 seats with a minimum of 2 wheelchair seating spaces required.

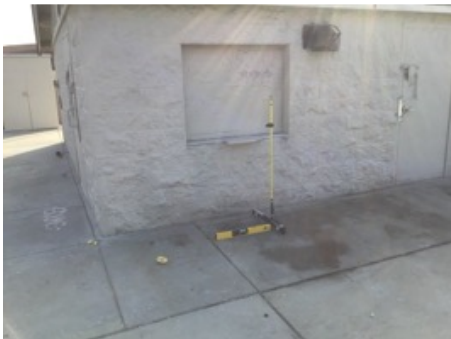
Comment #: JC-059

Deficiency: Condiments/Amenities - Condiments Counter - Clear Floor Space Grade

The slope for the parallel approach exceeds the maximum slope 1:48 (2.0833%).

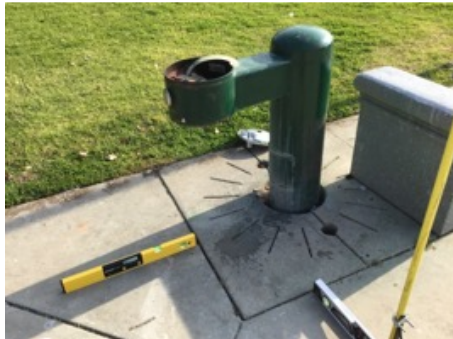
Comment #: JC-060

Deficiency: Drinking Fountain - Number Provided - Hi/Lo

One standing and one wheelchair accessible drinking fountain is not provided at each location.

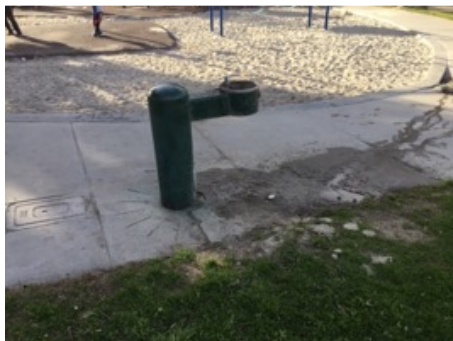
Comment #: JC-061

Deficiency: Drinking Fountain - Number Provided - Hi/Lo

One standing and one wheelchair accessible drinking fountain is not provided at each location.

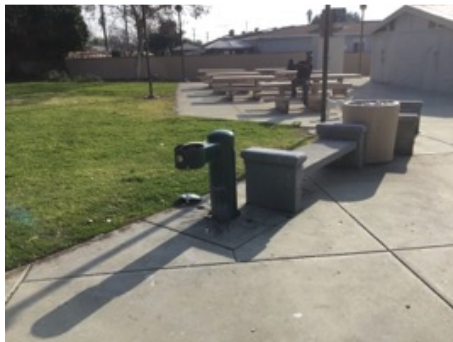
Comment #: JC-062

Deficiency: Drinking Fountain - Number Provided - Hi/Lo

One standing and one wheelchair accessible drinking fountain is not provided at each location.

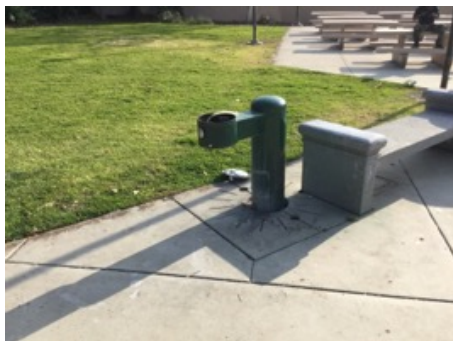
Comment #: JC-063

Deficiency: Drinking Fountain - Number Provided - 50 percent

When dispersed, 50% are not compliant for standing and/or 50% are not complaint for wheelchair accessible on the site are .

Remove/replace so when more than the minimum number of drinking fountains are provided, 50 percent of the total number of drinking fountains shall be provided for standing person, and 50 percent of the total number of drinking fountains shall be provided as wheelchair accessible. Must be evenly distributed for a total of 100% of the drinking fountains.

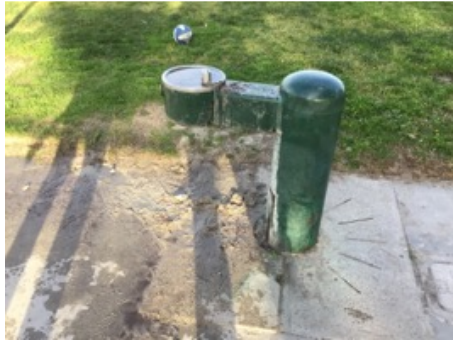
Comment #: JC-064

Deficiency: Drinking Fountain - Typical at Both - Pedestrian Protection

Pedestrian protection provided at drinking fountains.

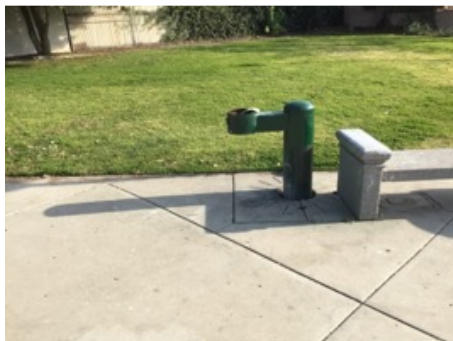
Comment #: JC-065

Deficiency: Drinking Fountain - Typical at Both - Pedestrian Protection

Pedestrian protection provided at drinking fountains.

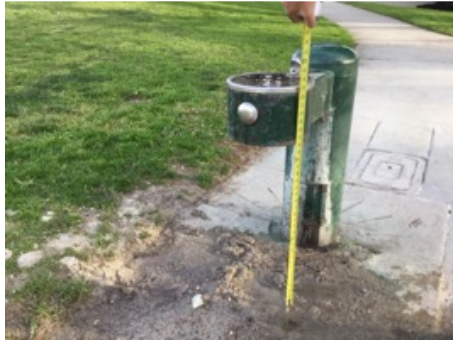
Comment #: JC-066

Deficiency: Drinking Fountain - Wheelchair Compliance - Clear Floor Space

A 30" x 48" clear floor space is not provided for a forward approach at drinking fountain.

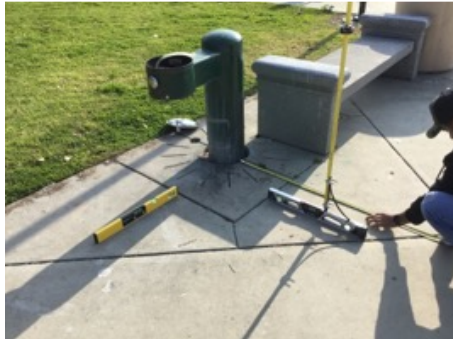
Comment #: JC-068

Deficiency: Drinking Fountain - Wheelchair Compliance - Clear Floor Grades

30" x 48" clear floor space slopes exceed 1:48 (2.083%)

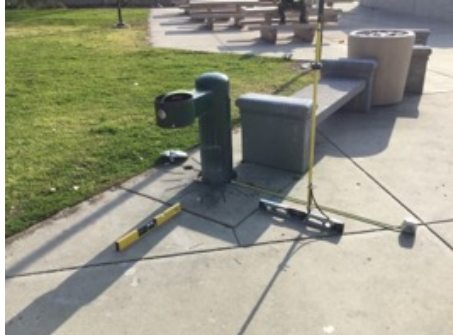
Comment #: JC-069

Deficiency: Drinking Fountain - Wheelchair Compliance - Clear Floor Grades

30" x 48" clear floor space slopes exceed 1:48 (2.083%)

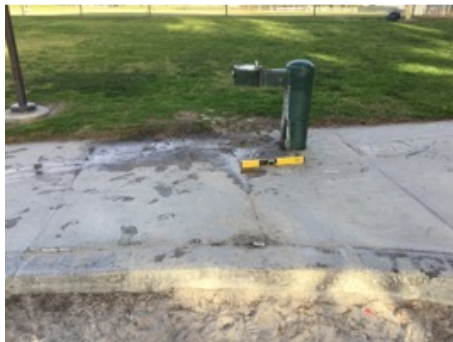
Comment #: JC-070

Deficiency: Drinking Fountain - Wheelchair Compliance - Clear Floor Space-Centered
30" x 48" clear floor space positioned for a forward approach is not centered on the unit. Approach is NOT from north side. Based upon bubbler or spout location, approach is from west side. But still min 30" x 48" clear floor space, but not level. Correct previous record.

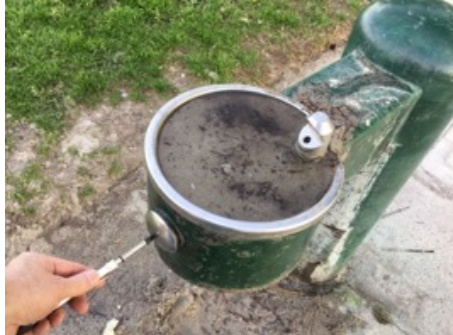
Comment #: JC-071

Deficiency: Drinking Fountain - Wheelchair Compliance - Operable Parts-Force

Is the force required to activate operable parts 5 pounds maximum?

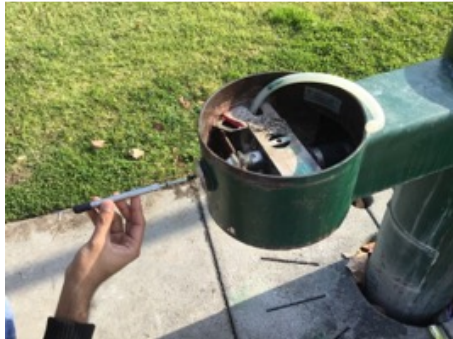
Deficiency: Drinking Fountain - Wheelchair Compliance - Operable Parts- Force

The force required to activate operable parts shall be 5 pounds (22.2 N) maximum.

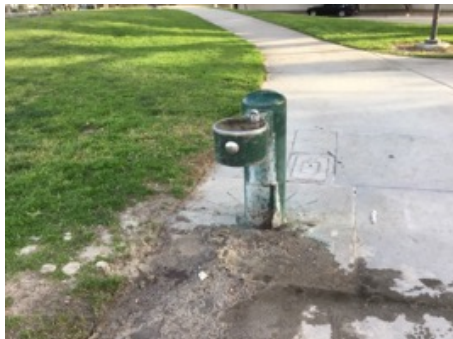
Deficiency: Drinking Fountain - Wheelchair Compliance - Water Flow

Adjust water pressure. The spout shall provide a flow of water 4 inches (102 mm) high minimum and shall be located 5 inches (127 mm) maximum from the front of the unit. The angle of the water stream shall be measured horizontally relative to the front face of the unit. Where spouts are located less than 3 inches (76 mm) of the front of the unit, the angle of the water stream shall be 30 degrees maximum. Where spouts are located between 3 inches (76 mm) and 5 inches (127 mm) maximum from the front of the unit, the angle of the water stream shall be 15 degrees maximum.

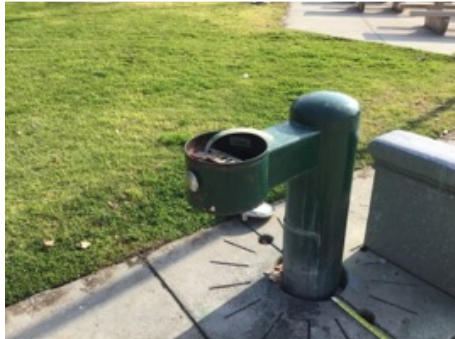
Comment #: JC-074

Deficiency: Drinking Fountain - Wheelchair Compliance - Water Flow

The spout does not provide a flow of water 4 high minimum. Top with bubbler or spout was missing at time of assessment.

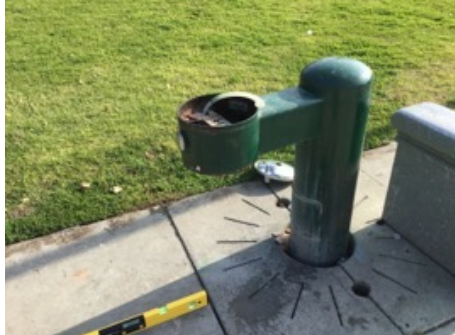
Comment #: JC-075

Deficiency: Drinking Fountain - Wheelchair Compliance - Spout Height

The spout outlets exceeds 36 inches maximum above FF or ground.

Readjust height, or replace so unit provides a spout outlets 36 inches (914 mm) maximum above the finish floor or ground.

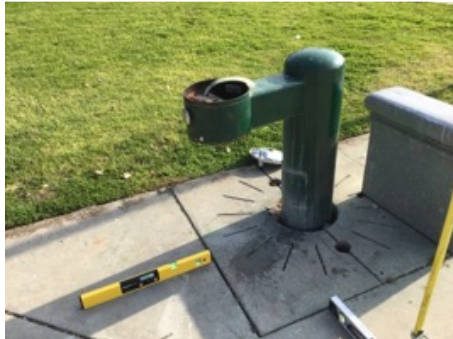
Comment #: JC-076

Deficiency: Drinking Fountain - Wheelchair Compliance - Spout Location

The spout is not located 15" minimum from the vertical support and 5" maximum from the front edge of the unit, including bumpers. Spout was missing at time of assessment.

Replace and provide a unit that has spout located 15 inches (381 mm) minimum from the vertical support and 5 inches (127 mm) maximum from the front edge of the unit, including bumpers.

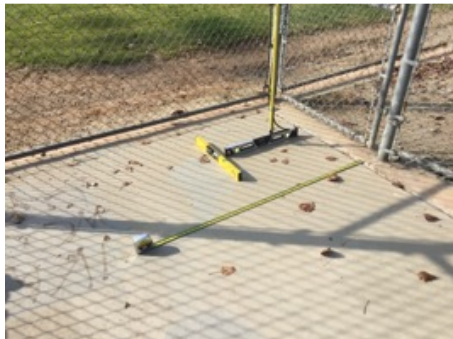
Comment #: JC-077

Deficiency: Exterior Doors/Doorways/Gates - Landing - Slopes

Slopes more than 1:48 (2%) grade, or changes in elevation are located at gate landings.

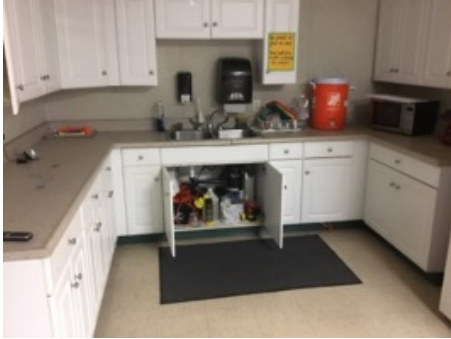
Comment #: JC-078

Deficiency: Kitchen - Counter Surface/Sink - Height

The height of the lavatory counter surface exceeds the allowable 34 inches AFF.

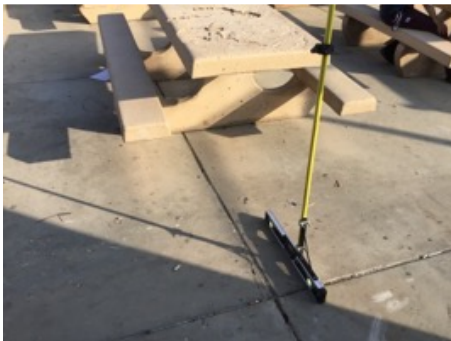
Comment #: JC-079

Deficiency: Picnic Tables - Wheelchair seating - Approach

Wheelchair spaces do not adjoin accessible routes. Slope of 6.7% for locations approaching picnic tables and at location of wheelchair seating.

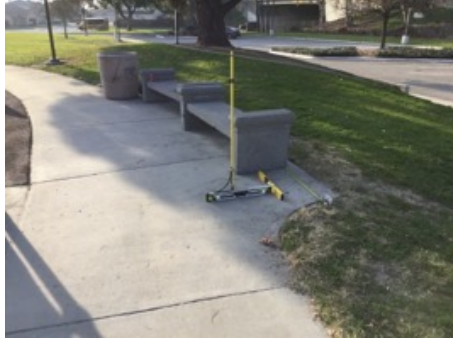
Comment #: JC-080

Deficiency: Benches - Wheelchair seating - Companion seats alignment

In row seating, companion seats are not located with a shoulder alignment point adjacent to wheelchair spaces measured 36" from the front of the wheelchair space.

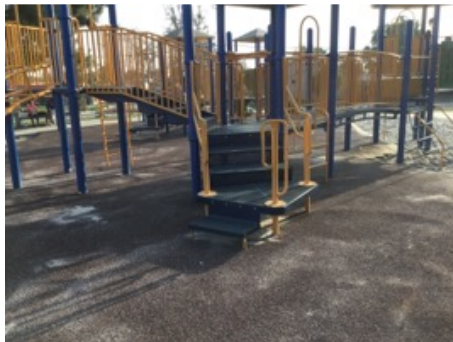
Comment #: JC-081

Deficiency: Playgrounds - Transfer System - Contrast Striping

Transfer step does not provide contrast striping, or contrast striping is not compliant.

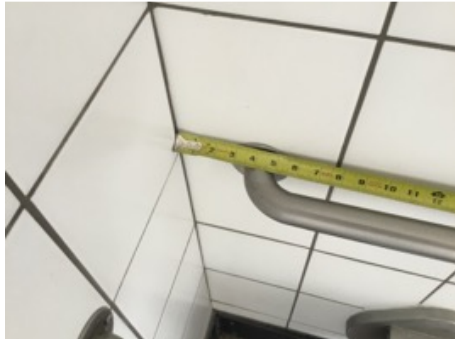
Comment #: JC-082

Deficiency: Accessible Toilet Stall - Rear Grab Bar - Open Side Distance From Centerline

The rear grab bar does not extend the full 24 inches past the centerline of the water closet.

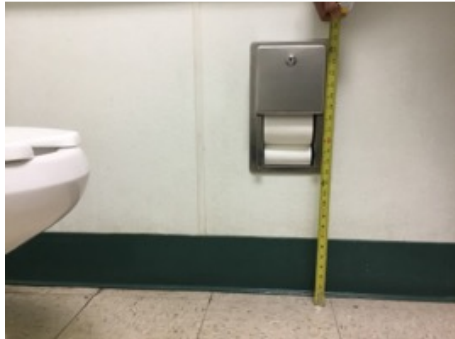
Comment #: JC-086

Deficiency: Accessible Toilet Stall - Dispensers - Toilet Paper Height

The toilet paper dispenser outlet height is outside the allowable range.

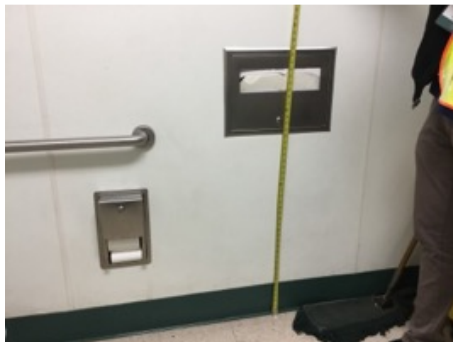
Comment #: JC-088

Deficiency: Accessible Toilet Stall - Dispensers - Seat Cover Height

The height of the operable part of the provided seat cover dispenser exceeds the allowable 40 inches AFF.

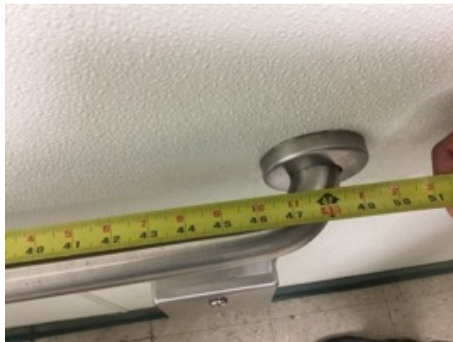
Comment #: JC-089

Deficiency: Accessible Toilet Stall - Side Grab Bar - End Distance to Rear Wall

The side grab bar does not extend minimum 54 inches from the rear wall.

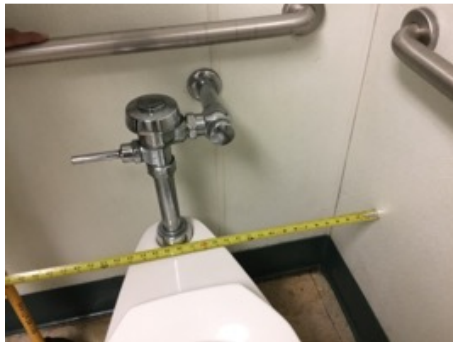
Comment #: JC-091

Deficiency: Accessible Toilet Stall - Water Closet - Location

The water closet is not a compliant distance from the adjacent wall.

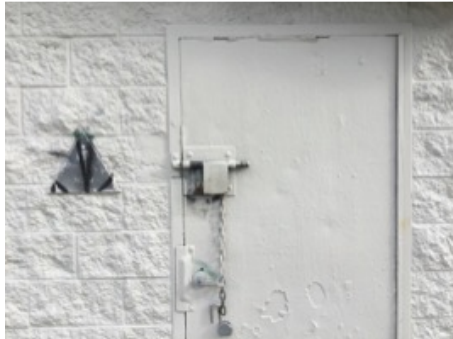
Comment #: JC-094

Deficiency: Restroom Doors - Tactile Sign - General

No permanent tactile restroom identification sign has been provided.

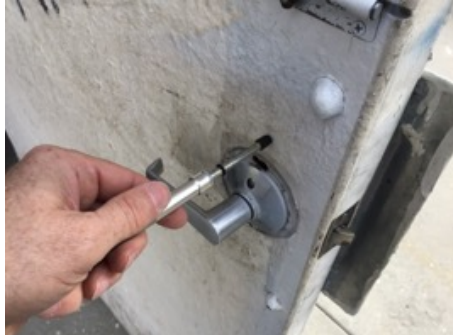
Comment #: JC-095

Deficiency: Restroom Doors - Operation - Opening Force

The force required to operate the door exceeds the allowable 5 lbf.

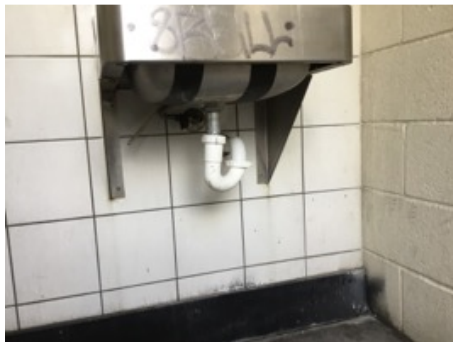
Comment #: JC-096

Deficiency: Lavatory - Covered Pipes/Hose Bib - General

The pipe insulation does not cover everything under the sink including water supply lines and hose bib.

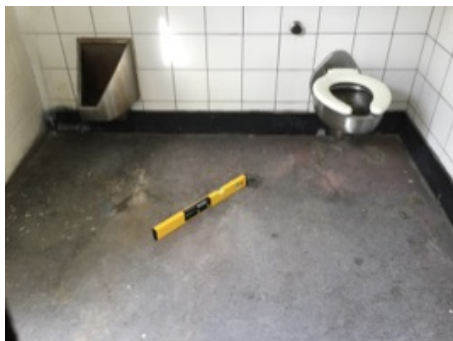
Comment #: JC-097

Deficiency: Restroom Interior Space - Floor Surface - Slopes

The floor surface has slopes that exceeds the allowable 1:48 (2%) grade in any direction.

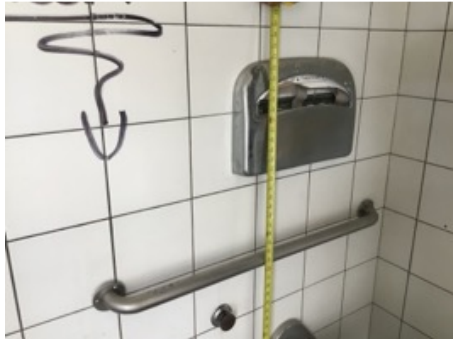
Comment #: JC-098

Deficiency: Accessible Toilet Stall - Dispensers - Seat Cover Height

The height of the operable part of the provided seat cover dispenser exceeds the allowable 40 inches AFF and is located over the water closet so not located on an accessible route and exceeding reach ranges.

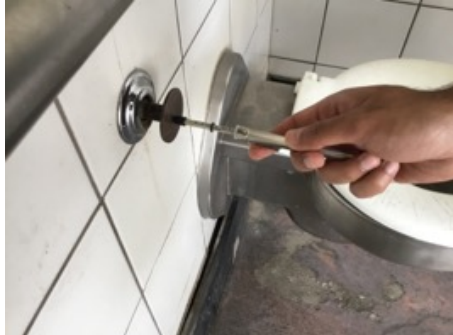
Comment #: JC-099

Deficiency: Accessible Toilet Stall - Water Closet - Flush Control Operating Force

The operational force of the flush valve exceeds the allowable 5 lbf.

Measurement: 18 lbf

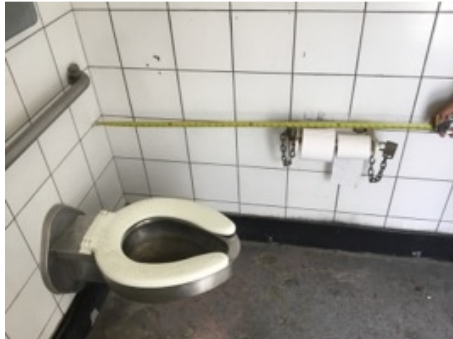
Comment #: JC-0100

Deficiency: Accessible Toilet Stall - Dispensers - Toilet Paper Location

The toilet paper dispenser is outside of the allowable reach range.

Measurement: 11.5 inches

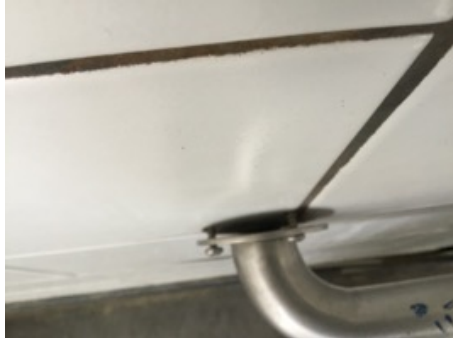
Comment #: JC-0101

Deficiency: Accessible Toilet Stall - Rear Grab Bar - Allowable Stresses

The rear grab bar does not allow for 250 lbf of stresses. Grab bar is coming off of wall at time of assessment.

Measurement: 1 count

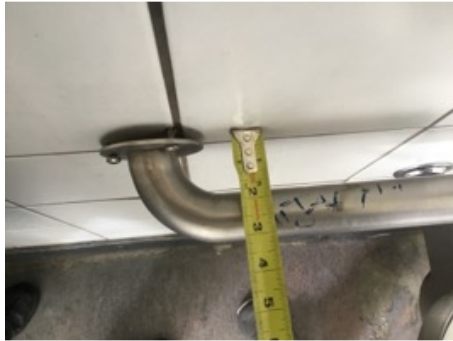
Comment #: JC-0102

Deficiency: Accessible Toilet Stall - Rear Grab Bar - Wall Clearance

The rear grab bar does not provide clearance to the wall of 1 1/2 inches. 1.5 inches when grab bar pushed back up against wall.

Measurement: 1.75 inches

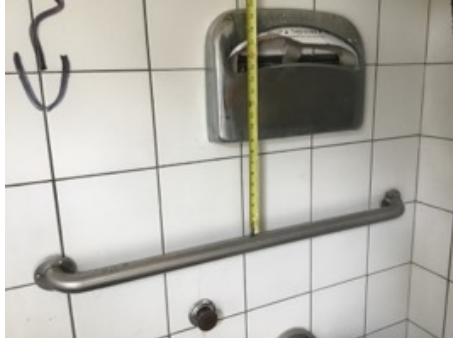
Comment #: JC-0103

Deficiency: Accessible Toilet Stall - Rear Grab Bar - Above Clearance

The rear grab bar does not have a minimum 12 inch clear space above the grab bar. Toilet seat cover dispenser located above rear grab bar.

Measurement: 9 inches

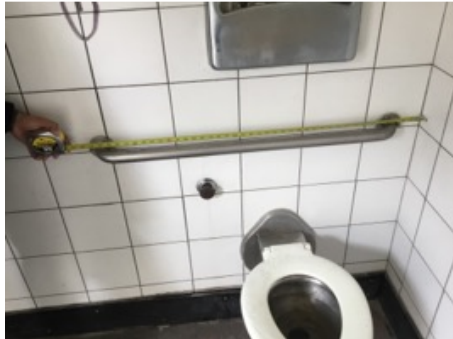
Comment #: JC-0104

Deficiency: Accessible Toilet Stall - Rear Grab Bar - Open Side Distance From Centerline

The rear grab bar does not extend the full 24 inches past the centerline of the water closet.

Measurement: 22 inches

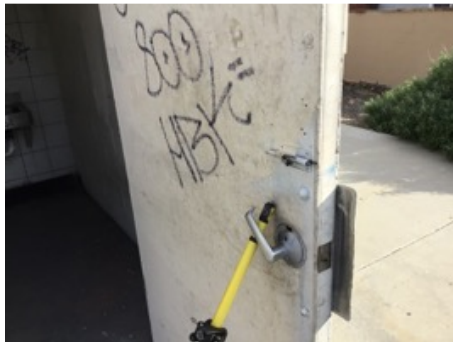
Comment #: JC-0105

Deficiency: Exterior Doors/Doorways/Gates - Hardware - Handle Height

Door hardware is not located 34-inches minimum to 44-inches maximum AFF.

Measurement: 48 inches

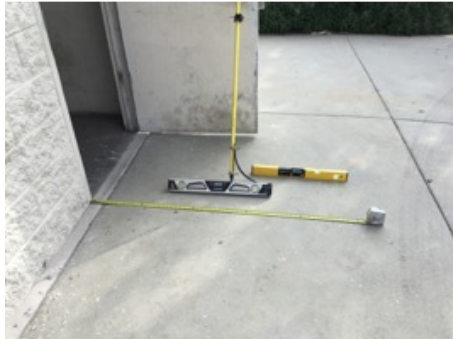
Comment #: JC-0106

Deficiency: Exterior Doors/Doorways/Gates - Landing - Slopes

Slopes more than 1:48 (2%) grade, or changes in elevation are located at door landings.

Measurement: 2.8 % grade

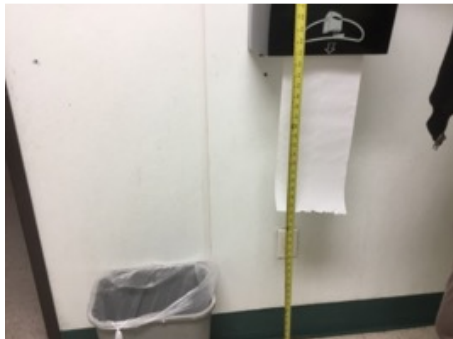
Comment #: JC-0107

Deficiency: Restroom Interior Space - Amenities - Paper Towel Height

The paper towel dispenser exceeds the maximum allowable height.

Measurement: 42 inches

In California, all operable parts, including coin slots, shall be 40 inches (1016 mm) maximum above the finish floor. ADA allows accessories to meet reach ranges as noted below;

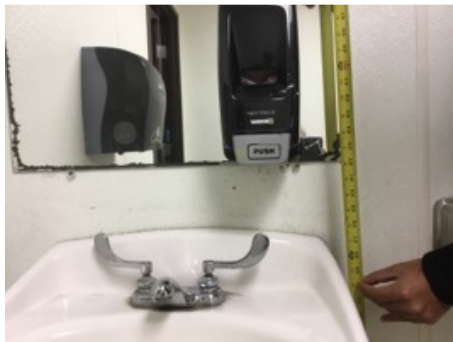
Comment #: JC-0108

Deficiency: Restroom Interior Space - Amenities - Soap Dispenser Height

The soap dispenser exceeds the maximum allowable height. There is a second dispenser within reach ranges but does not have soap at time of assessment.

Measurement: 42 inches

In California, all operable parts, including coin slots, shall be 40 inches (1016 mm) maximum above the finish floor. ADA allows accessories to meet reach ranges as noted below;

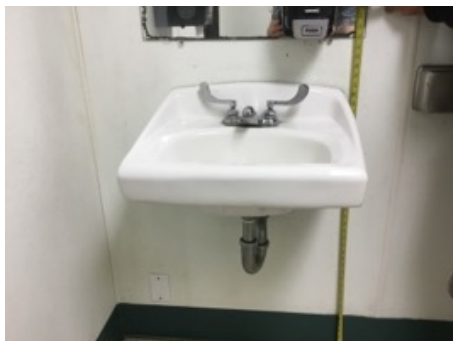
Comment #: JC-0109

Deficiency: Restroom Interior Space - Amenities - Mirror Height

The mirror height exceeds the allowable 40 inches above the finished floor.

Measurement: 42 inches

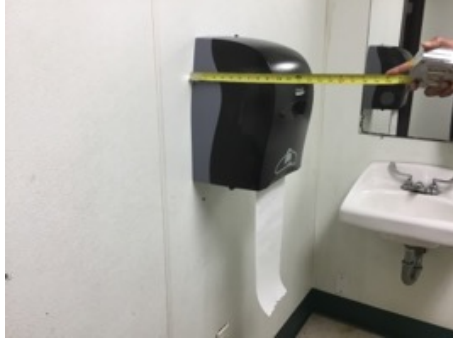
Comment #: JC-0110

Deficiency: Restroom Interior Space - Protruding Objects - General

Objects in the restroom extend more than 4 inches from the wall with no cane detectable barrier.

Measurement: 9.75 inches

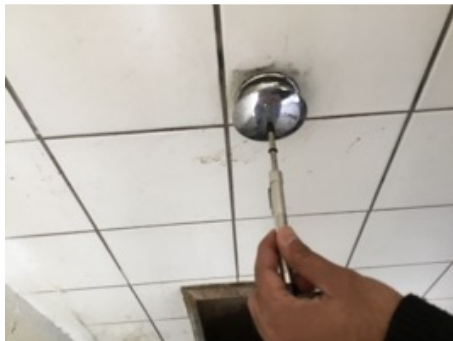
Comment #: JC-0111

Deficiency: Urinal - Flush Control - Operational Force

The operational force of the flush valve exceeds the allowable 5 lbf.

Measurement: 20 lbf

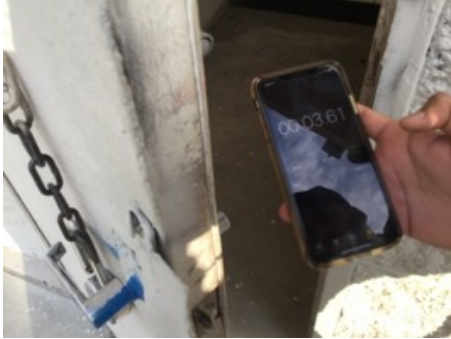
Comment #: JC-0112

Deficiency: Exterior Doors/Doorways/Gates - Operation - Closing Speed

The door closes faster than the minimum 5 seconds.

Measurement: 4 seconds

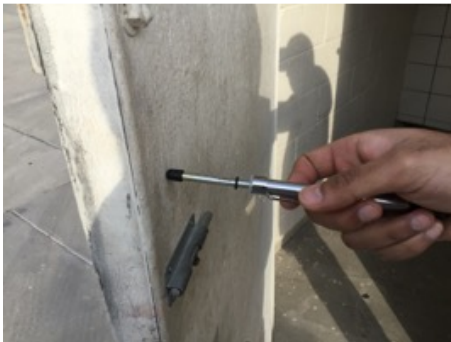
Comment #: JC-0113

Deficiency: Restroom Doors - Operation - Opening Force

The force required to operate the door exceeds the allowable 5 lbf.

Measurement: 9 lbf

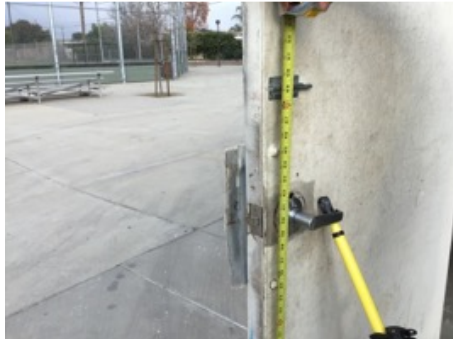
Comment #: JC-0114

Deficiency: Restroom Doors - Hardware - Handle Height

The door hardware is located outside the allowable height ranges.

Measurement: 49 inches

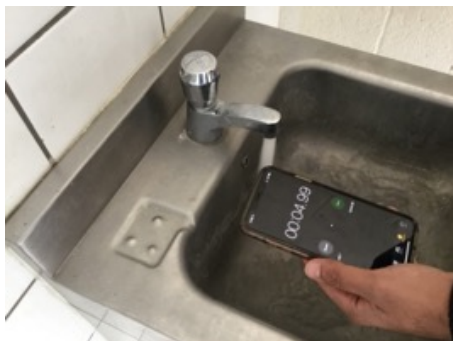
Comment #: JC-0115

Deficiency: Lavatory - Controls - Self-Closing Valve

At 5 pounds of operating pressure the self-closing sink valve stays on less than the minimum 10 seconds.

Measurement: 5 seconds

Replace with lever operated, push type, or electronically controlled mechanisms, or approved controls with 5 lbf maximum operating force. Self-closing valves shall remain on for at least 10 seconds.

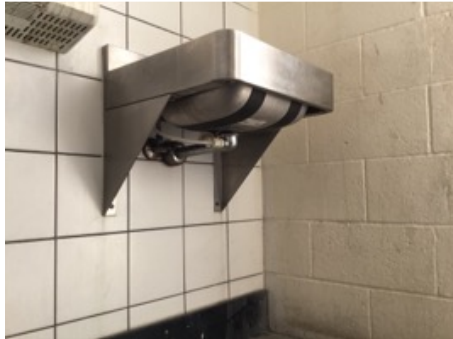
Comment #: JC-0116

Deficiency: Lavatory - Covered Pipes/Hose Bib - General

The pipe insulation does not cover everything under the sink including water supply lines and hose bib.

Measurement: 0 count

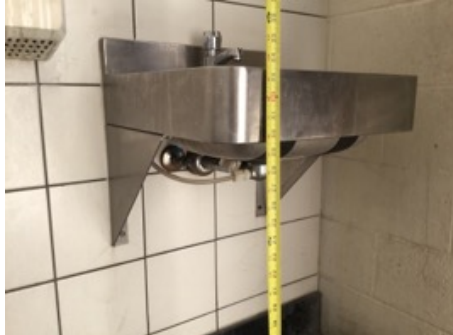
Comment #: JC-0117

Deficiency: Lavatory - Knee/Toe Clearance - Height

The knee clearance at the lavatory is less than the allowable 29 inches.

Measurement: 28.5 inches

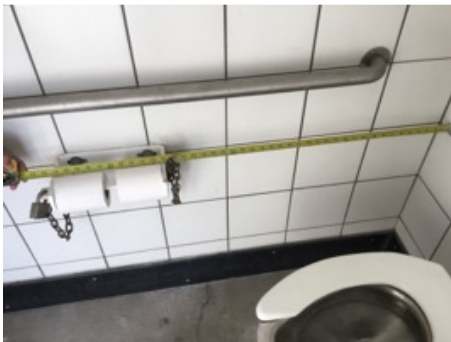
Comment #: JC-0118

Deficiency: Accessible Toilet Stall - Dispensers - Toilet Paper Location

The toilet paper dispenser is outside of the allowable reach range.

Measurement: 11.5 inches

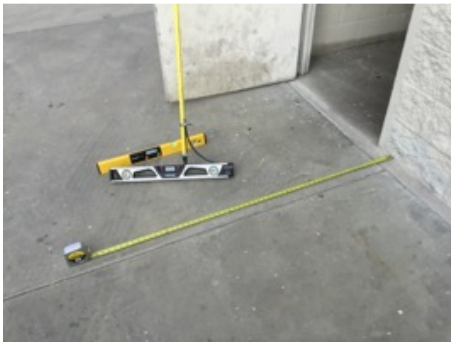
Comment #: JC-0119

Deficiency: Exterior Doors/Doorways/Gates - Landing - Slopes

Slopes more than 1:48 (2%) grade, or changes in elevation are located at door landings.

Measurement: 4.1 % grade

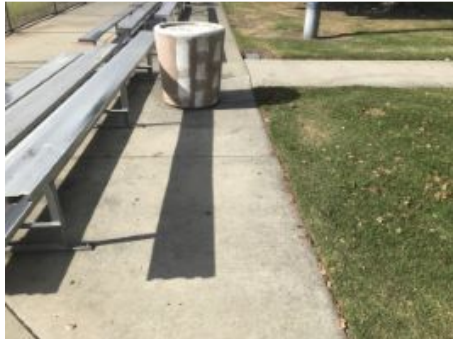
Comment #: MTVU-01

Deficiency: Accessible Route - Clear Width - General

Accessible route widths do not provide minimum 48-inches clear. The placement of the planter restricts the width of the walkway to 18".

Measurement: 18 inches

Relocate trash receptacle to provide a clear width of 48 inches (1219 mm) minimum. When, because of right-of-way restrictions, natural barriers or other existing conditions, the enforcing agency determines that compliance with the 48-inch (1219 mm) clear sidewalk width would create an unreasonable hardship, the clear width may be reduced to 36 inches (914 mm).

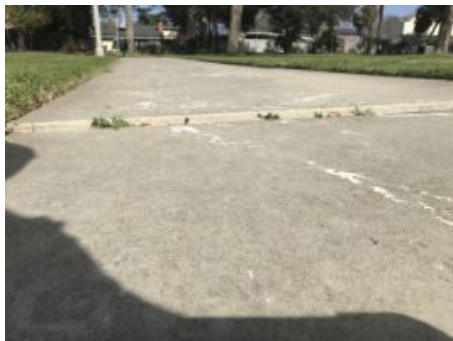
Comment #: MTVU-02

Deficiency: Accessible Route - Vertical Displacement - Height

Accessible route has multiple locations where changes in level over 1/4" vertical or 1/2" beveled occur. The pedestrian route has an approximate 24 lineal feet of ground surface with 1-3/16" changes in vertical level which are not beveled or ramped.

Measurement: 1.19 inches

Replace/grind locations where changes in elevation occur. Changes in level of 1/4" high maximum shall be permitted to be vertical and without edge treatment.

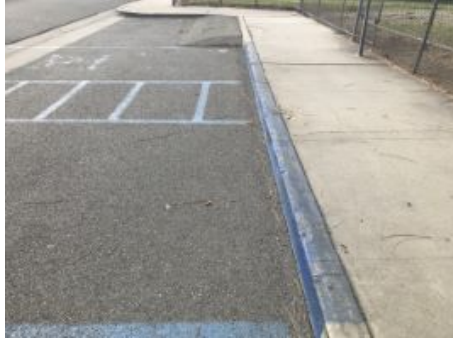
Comment #: MTVU-03

Deficiency: At Grade Transitions - Curb Ramp - General

No curb ramp is provided where accessible route crosses a curb.

Measurement: 0 count

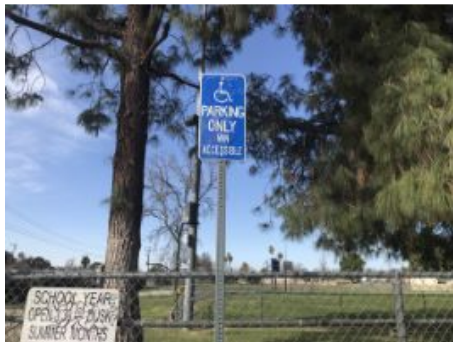
Comment #: MTVU-04

Deficiency: Parking - Signage - Minimum Fine

The parking identification sign does not include the text "Minimum Fine \$250" below the ISA and van and car accessible stalls.

Measurement: 0 count

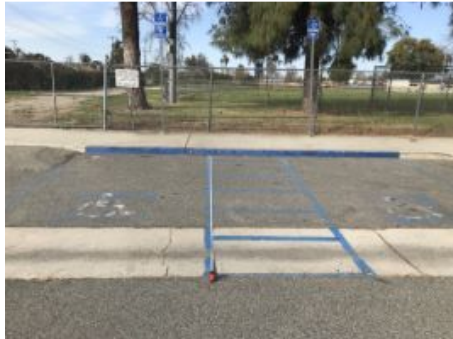
Comment #: MTVU-05

Deficiency: Parking - Accessible Stall - Length

The accessible van/car stall is less than 216 inches (18 ft. or 5486 mm) long. The length of the parking stalls is 16' 8".

Measurement: 16.67 inches

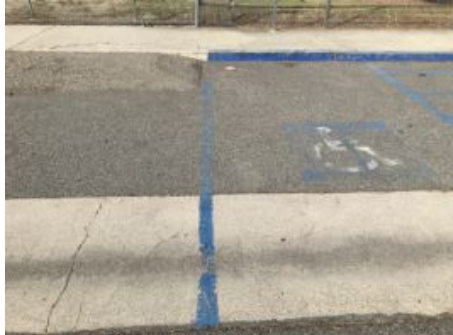
Comment #: MTVU-06

Deficiency: Parking - Accessible Stall - Markings

Stall markings at both stalls are faded and need to be maintained.

Measurement: 2 count

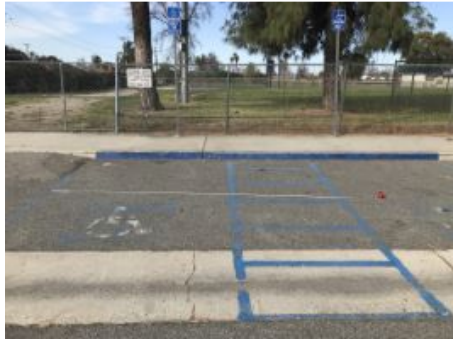
Comment #: MTVU-07

Deficiency: Parking - Accessible Stall - Van Stall Width

The van stall is not a minimum 144 inches wide, OR 108 inches when the adjacent access aisle is minimum 96 inches wide. The van parking space is 9' wide. The access aisle serving car and van parking spaces is 5'3" inches wide.

Measurement: 63 inches

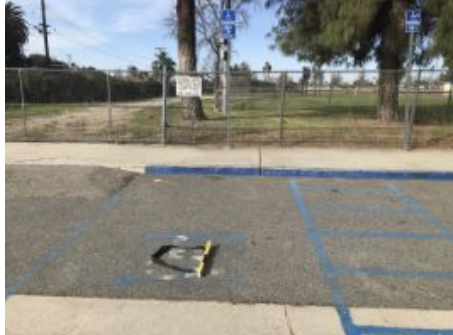
Comment #: MTVU-08

Deficiency: Parking - Accessible Stall - Slopes

The slope of the van/car stall in any direction exceeds 1:48 (2.0%) grade. Van accessible stall has slopes of 3.7%. Swale also runs through access aisle and stalls should be relocated, or reconfigured.

Measurement: 3.7 % grade

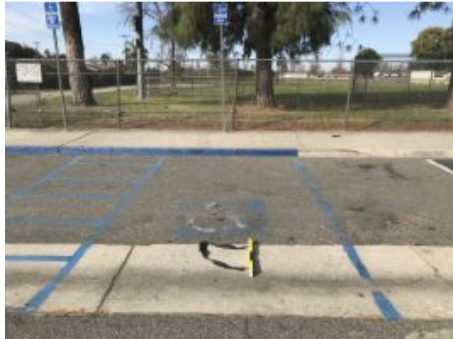
Comment #: MTVU-09

Deficiency: Parking - Accessible Stall - Slopes

The slope of the van/car stall in any direction exceeds 1:48 (2.0%) grade. The standard accessible car stall has slopes of 5%. Swale also runs through access aisle and stalls should be relocated, or reconfigured.

Measurement: 5 % grade

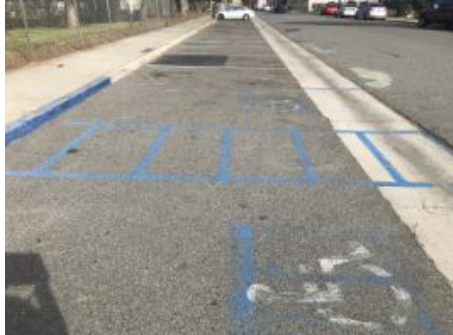
Comment #: MTVU-10

Deficiency: Parking - Access Aisle Markings - "No Parking"

Markings are faded and does not discourage parking in the access aisle.

Measurement: 1 count

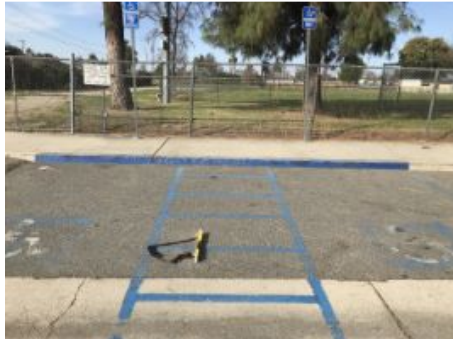
Comment #: MTVU-11

Deficiency: Parking - Access Aisle - Slope

The slope of the access aisle in any direction exceeds 1:48 (2.0%) grade. Swale also runs through access aisle and stalls should be relocated, or reconfigured.

Measurement: 3.2 % grade

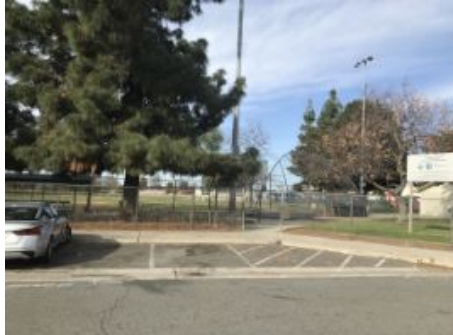
Comment #: MTVU-12

Deficiency: Parking - Accessible Route - Adjacent

The access aisle is not connected to the shortest accessible route that leads to an facility entrance. The accessible parking stalls are located at the farthest end from the park entrance. The parking lot contains 19 total parking stalls, including accessible stalls. The parking lot requires 1 van and 0 standard accessible stalls. 1 van and 1 standard car accessible stalls are provided. The

Measurement: 1 count

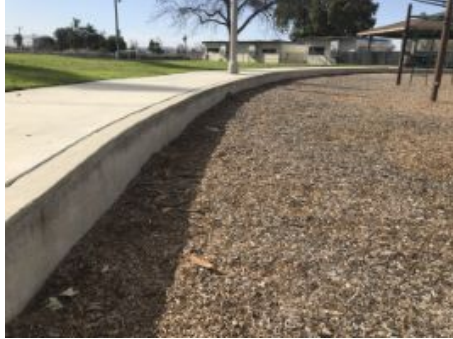
Comment #: MTVU-13

Deficiency: Accessible Route - Change in Level - Warning Curbs

Warning curb / guide rail is not installed at locations where there is an elevation change of more than 4" above finish grade.

Measurement: 0 inches

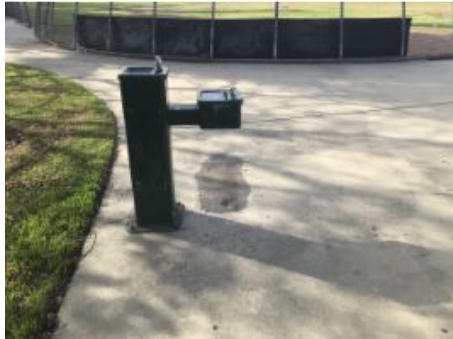
Comment #: MTVU-14

Deficiency: Drinking Fountain - Typical at Both - Pedestrian Protection

Pedestrian protection is not provided at drinking fountains.

Measurement: 0

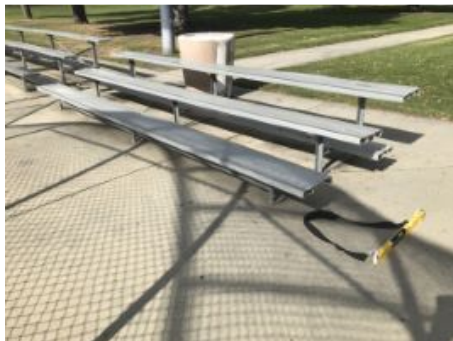
Comment #: MTVU-15

Deficiency: Bleachers - Wheelchair Seating - Location

Wheelchair spaces are not an integral part of bleacher seating. Surface of area adjacent to bleachers has slopes of 4.1%

Measurement: 4.1 % grade

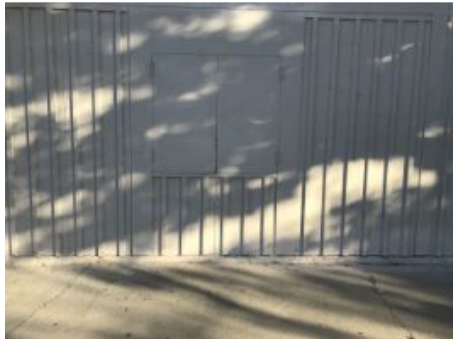
Comment #: MTVU-16

Deficiency: Transaction Counters - Reach Ranges - Side Approach

Counter height is 36-inches above adjacent grade.

Measurement: 36 inches

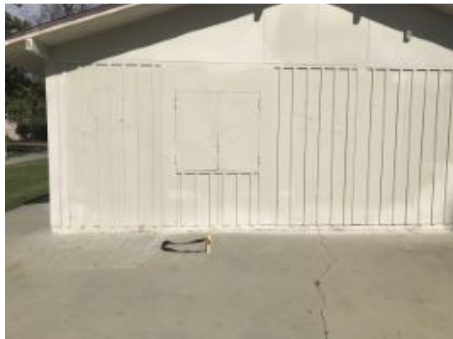
Comment #: MTVU-17

Deficiency: Transaction Counters - Clear Floor Space - Slopes

The dining area service counter does not have 30" minimum by 48" minimum clear floor space for a parallel approach.

Measurement: 0 count

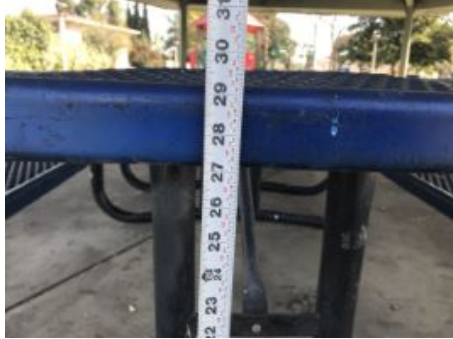
Comment #: MTVU-18

Deficiency: Seating - Picnic Table - Count

There are not a minimum of 5% accessible seats provided at all types of tables. There are 10 tables. The toe and knee clearance at the picnic table is 9-1/2" in depth.

Measurement: count

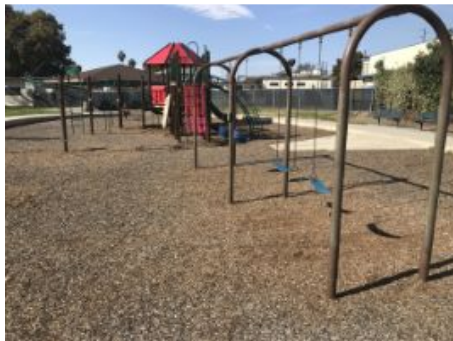
Comment #: MTVU-19

Deficiency: Playgrounds - Ground Surface - Use Zone

It is unknown if the 'use zone' ground surfaces comply with ASTM F 1292 (1999 edition or 2004 edition). The playground ground surface is comprised of wood mulch. Changes in level are present at the bottom of the ramp and throughout the play area. The playground ground surface is comprised of wood mulch. Changes in level are present at the bottom of the ramp and throughout the play

Measurement: 1 count

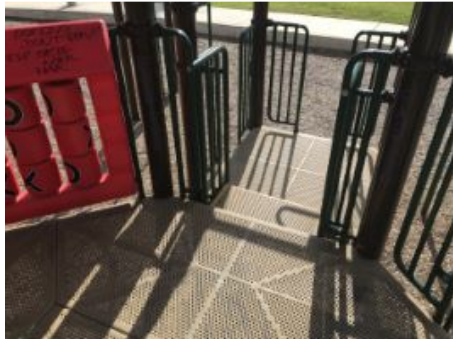
Comment #: MTVU-20

Deficiency: Playgrounds - Transfer System - Contrast Striping

Transfer step does not provide contrast striping, or contrast striping is not compliant.

Measurement: 0 count

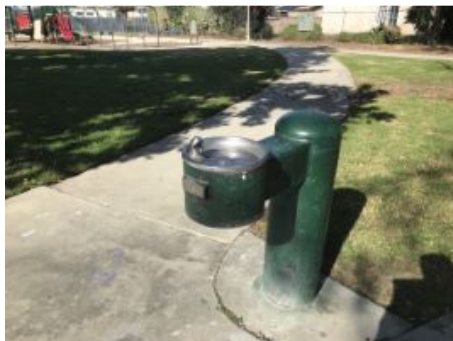
Comment #: MTVU-21

Deficiency: Drinking Fountain - Number Provided - Hi/Lo

One standing and one wheelchair accessible drinking fountain is not provided at each location.

Measurement: 1 count

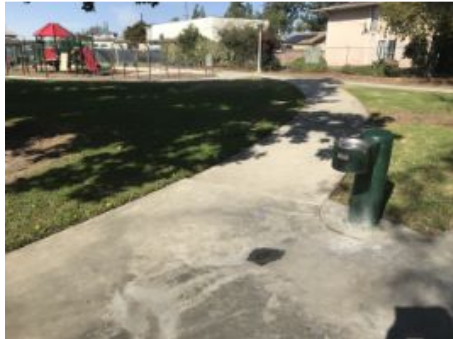
Comment #: MTVU-22

Deficiency: Drinking Fountain - Typical at Both - Pedestrian Protection

Pedestrian protection is not provided at drinking fountains.

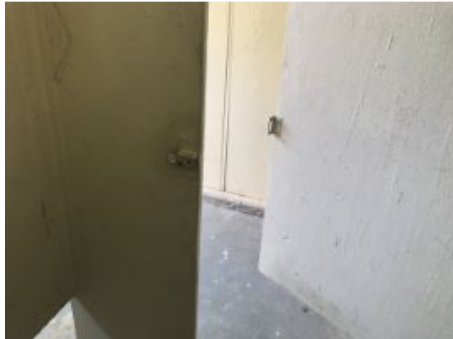
Comment #: MTVU-23

Deficiency: Accessible Toilet Stall - Door Hardware - Handle Both Sides

There is no pull handle on the interior side of the stall door.

Measurement: 0 count

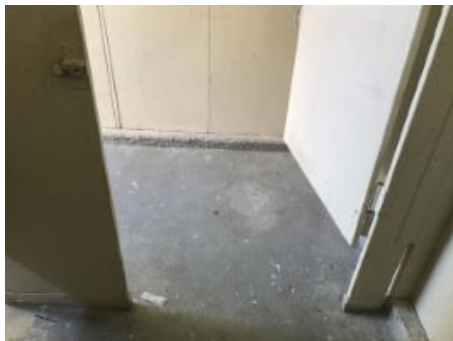
Comment #: MTVU-24

Deficiency: Accessible Toilet Stall - Door - Self-Closing Door

The stall door is not self closing.

Measurement: 0 count

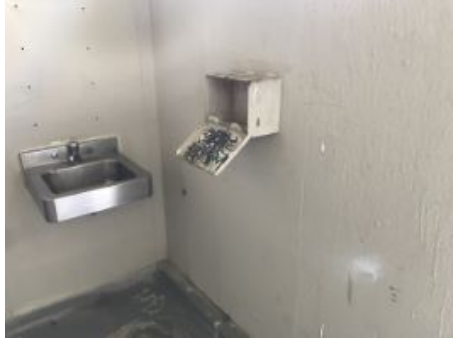
Comment #: MTVU-25

Deficiency: Restroom Interior Space - Amenities - Paper Towel Height

The paper towel dispenser exceeds the maximum allowable height. The high side reach to the dispenser is 48" & 53 inches above the finish floor/ground surface.

Measurement: 53 inches

ADA allows accessories to meet reach ranges as noted below;

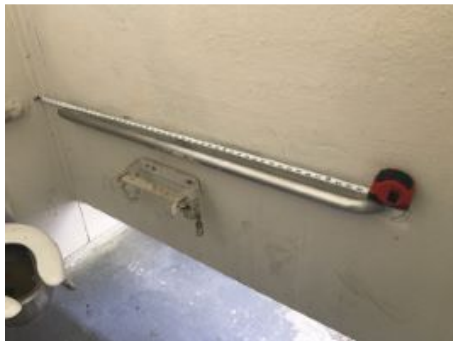
Comment #: MTVU-26

Deficiency: Accessible Toilet Stall - Side Grab Bar - Rear Distance to Rear Wall

The side grab bar does not extend minimum 54 inches from the rear wall.

Measurement: 53 inches

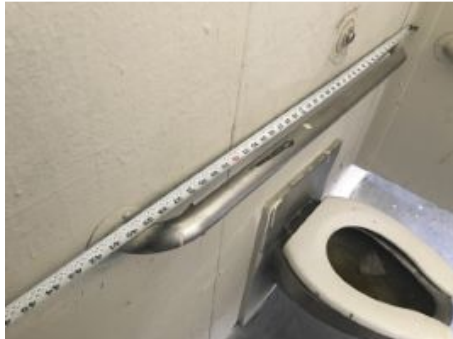
Comment #: MTVU-27

Deficiency: Accessible Toilet Stall - Rear Grab Bar - Open Side Distance From Centerline

The rear grab bar does not extend the full 24 inches past the centerline of the water closet.

Measurement: 22 inches

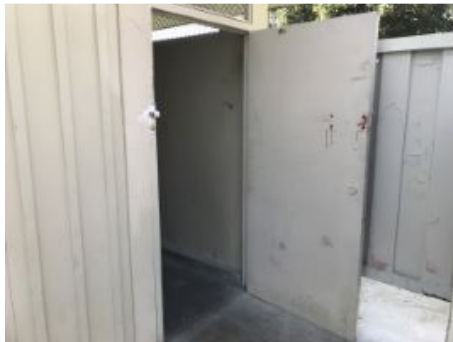
Comment #: MTVU-28

Deficiency: Restroom Doors - Geometric Sign - Height

The geometric sign is not mounted within the allowable height ranges. The baseline of the text is located 61" above the ground. The centerline of the symbol is located 64-1/2" above the ground. During open hours the door is held in an open position and therefore rendering the sign inaccessible.

Measurement: 61 inches

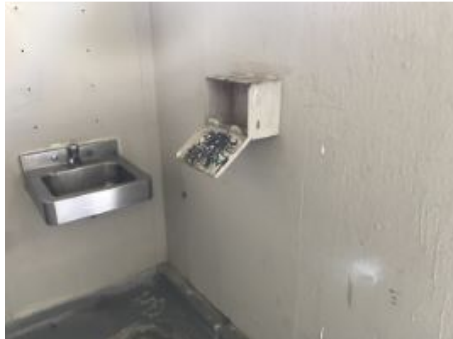
Comment #: MTVU-29

Deficiency: Restroom Interior Space - Protruding Objects - General

Objects in the restroom extend more than 4 inches from the wall with no cane detectable barrier. The underside of the dispenser box is located 45 inches above the floor and protrudes 5-1/2 inches horizontally into the circulation path.

Measurement: 5.5 inches
